Neston St Mary and St Helen – Bell frame

REPORT & QUOTATION

STRUCTURAL REPORT

Client: St Mary and St Helen, Neston, PCC

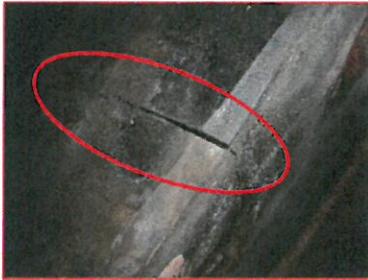
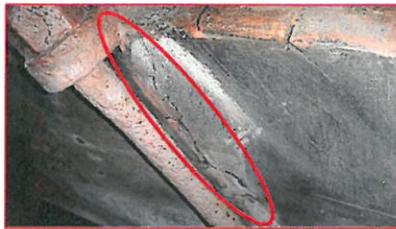
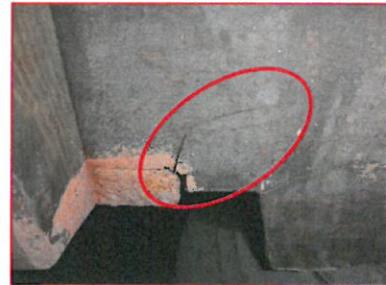
The seven smaller bells are hung from hardwood timber headstocks formed from Elm, the undersides of which are carved to fit over the canon heads of the bells. They all sustain fractures from the pressure of the bell heads and appear to be cracking around their stay fixings and gudgeon boxes. We noted that the headstock of the 5th bell has suffered from wet rot which has now dried out; the timber is now very brittle and beginning to crumble. We also noted that this headstock has a very large crack on its underside and this must be monitored regularly; if the handling properties of this bell suddenly change, we advise that it must not be swung. None of the bells which hang from timber headstocks are balanced as the timber has become misshapen and warped over the years, this will make the bells 'oddstruck' whilst adversely affecting their handling properties.

Above: Images showing the cracks on some of the headstocks.

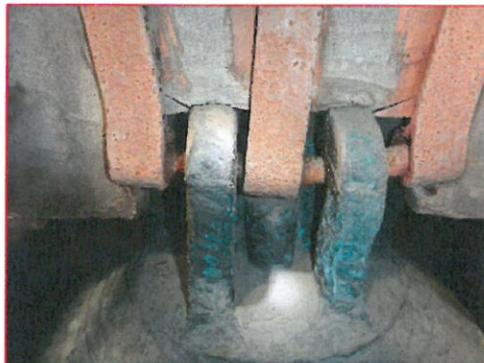
The 2nd, 4th, and 6th bells are attached to their headstocks with traditional ironwork consisting of six hinged eyebolts and three top connecting brackets each; whilst the 2nd bell is fitted with the additional false gudgeon. We noted that the hinged bars are no longer straight and are distorted due to the periodical tightening of the bolts and the timber headstocks shrinking. We also noted that all of the ironwork is rusty on its surface.

Above: An image showing how the ironwork is becoming distorted.

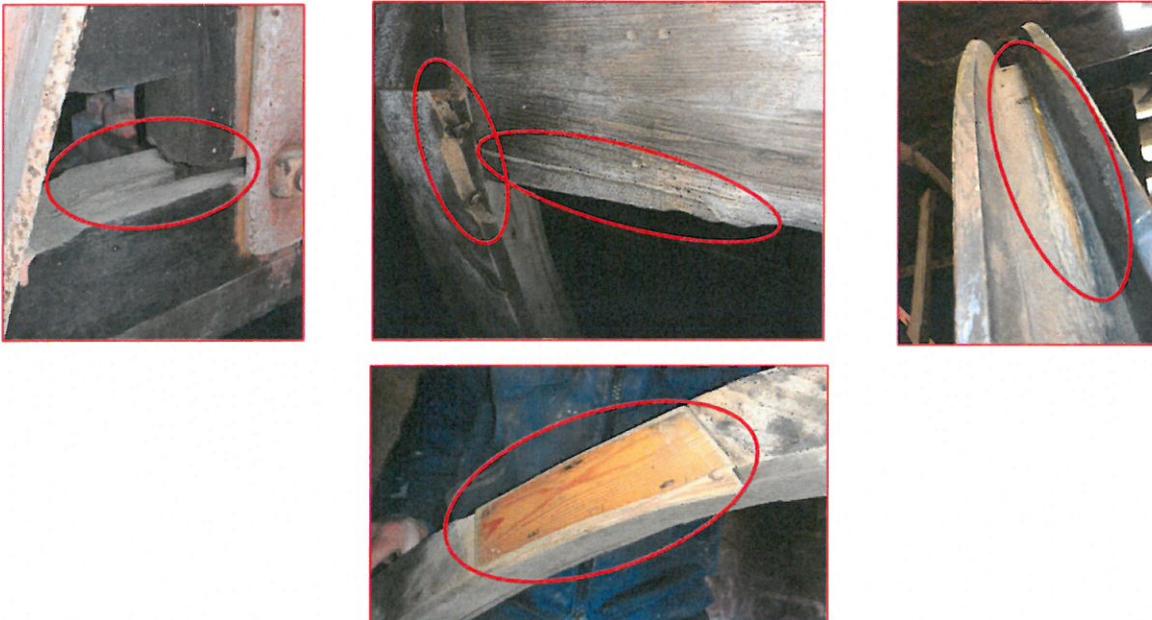
The bell wheels have dilapidated and had quick repairs made to them over the years. The shrouding (rims) nails are rusting which is allowing the segments to come away, and the feather joints fixing the shrouding together have burst; repairs to replace missing segments of shrouding have been made on the wheels and more are coming away from the soling. The soling (tracks) on all the wheels are now very worn from the passage of bellropes over them. We noted that there cracked are spokes on all the wheels and that all the timber centres are no longer as firm as they should be.

Above: Images showing the condition of the bell wheels, including: Split spokes, burst feather fillets, replacement shrouding, and worn soling.

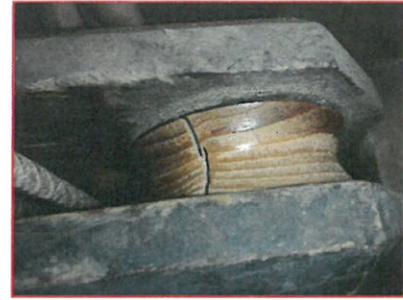
All of the roller boxes are of a single wheel pattern. The roller wheels are formed of timber sheaves, fitted on plain pins in hardwood boxes. The pins are drilled, tapped, and fitted with Stauffer lubricators for periodical lubrication. We noted that the lubricator on the pin of the Treble bell has gone missing. All of the roller wheels are grooved due to the passage of the bellropes over them and are rickety on their spindles. We noted that the sheave of the 2nd bell has completely split horizontally and that many of the boxes have cracks and are very tired.

Above: An image showing the split sheave of the 2nd bell.

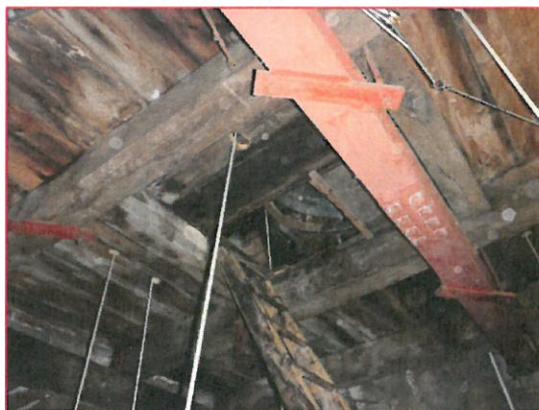
The bellframe is seated on the bell chamber floor. The floor is supported by four 10" timber support beams which span the east to west direction and are built into the walls. A further two support beams of similar size span the north to south direction and rest on squinches at all four corners of the tower; these only support the primary layer of supports at their beam ends. An additional transverse beam RSJ (Rolled Steel Joist) girder has been fitted beneath the pit of the Tenor bell as the timber support beams are not an appropriate size to firmly withstand the dynamic forces of the swinging bells. This underpinning work was carried out by Mears of Whitechapel in 1956.

Above: An image showing the support beams which supports the bell installation.

We also noted that the bellframe appeared to be exhibiting vertical movement which we were unable to measure. However, we managed to video record the deep creaking noise that could be heard coming from the support beams. We advised that all the tie rods and components which fix the bellframe to the RSJ girder below should be tightened, and that a careful analysis should be undertaken after the frame has been serviced.

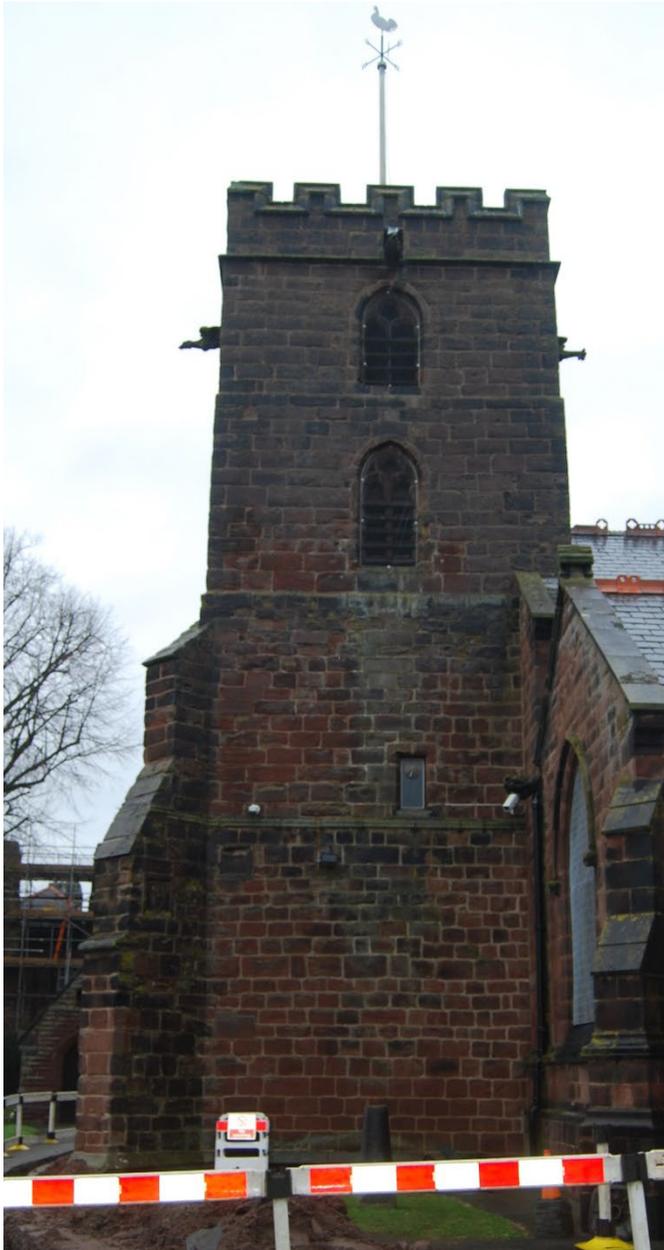
2.01 South Elevation Wall:

This wall contains louvre window openings at belfry and clock chamber levels and a small, glazed window opening giving light to the ringing chamber. The masonry appears to be in generally fair condition, consistent with its age, with no evidence of any significant cracking, recent or ongoing movement.

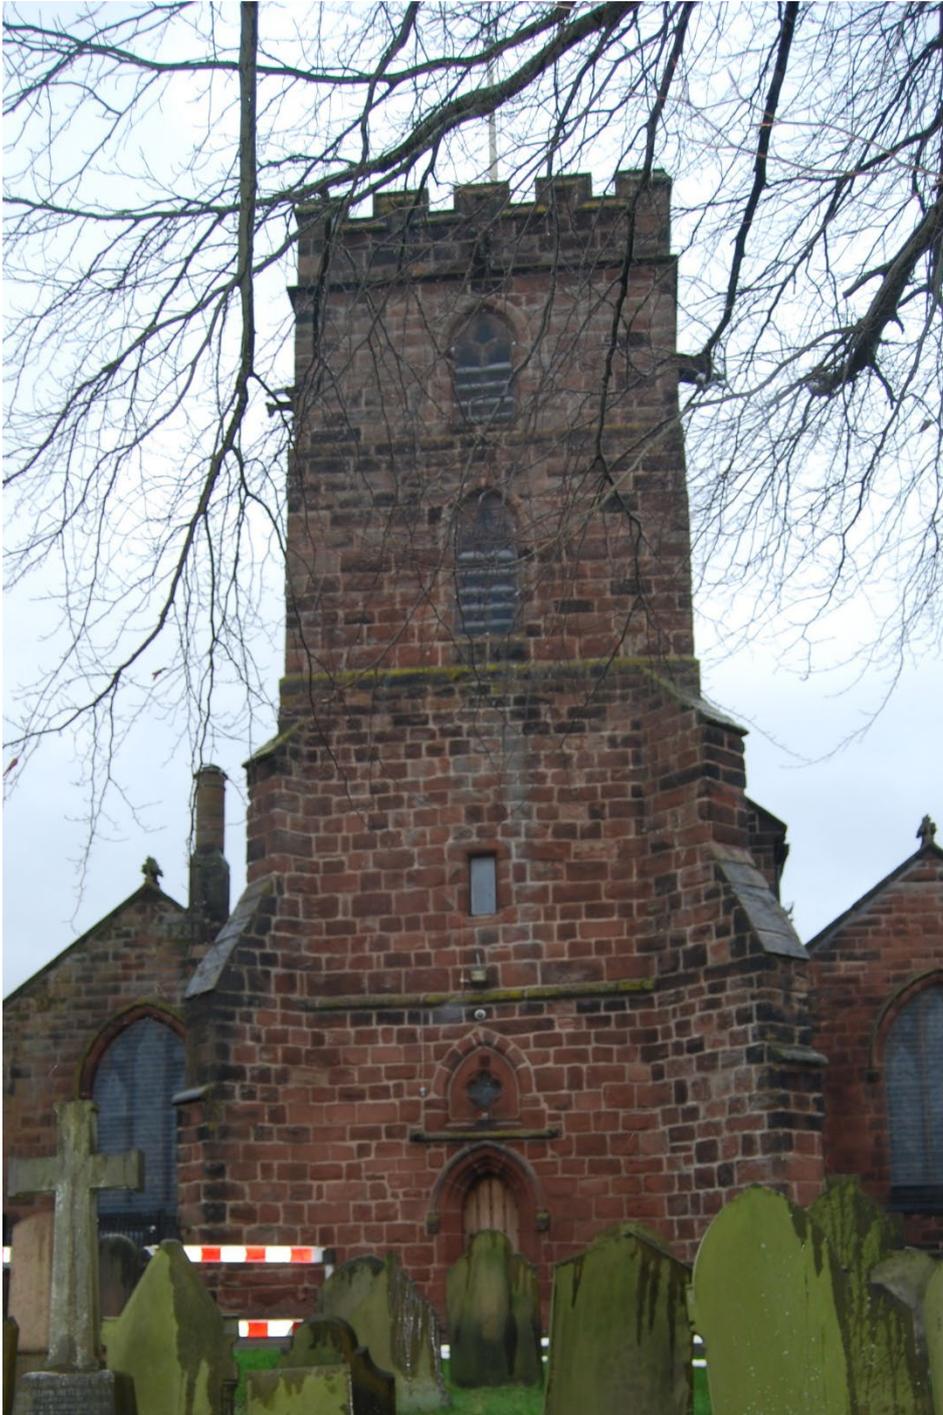
2.02 West Elevation Wall

This wall contains louvre window openings at belfry and clock chamber levels, a small, glazed window opening giving light to the ringing chamber and a door opening at ground level with a small quatrefoil window immediately above this. Again, the masonry appears to be in generally fair condition, consistent with its age, with no evidence of any significant cracking, recent or ongoing movement.

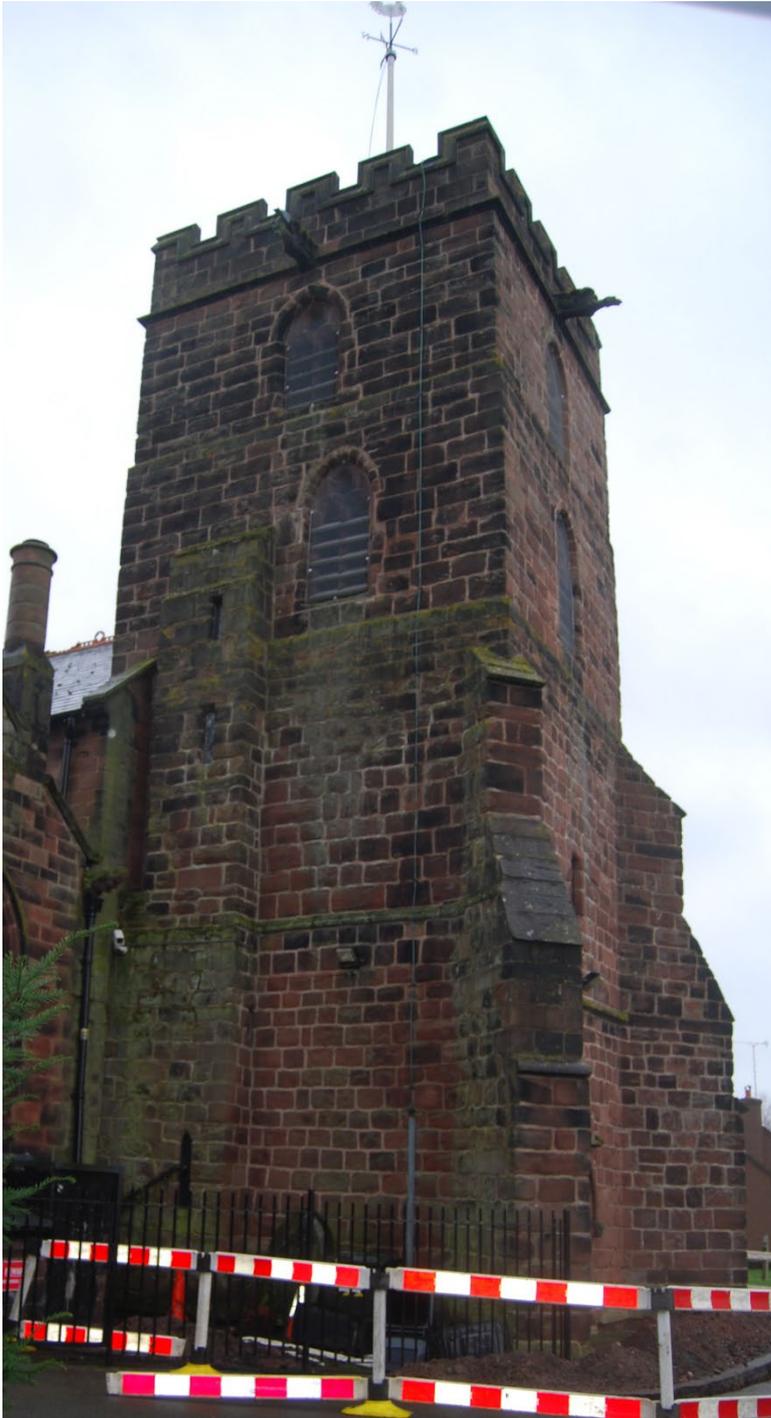
2.03 North Elevation Wall

This wall contains louvre window openings at belfry and clock chamber levels. To the north east corner, there is a small projection which houses the spiral staircase and extends up to clock chamber level. There are two small window openings towards the top of this projection which give light to the staircase. Again, the masonry appears to be in generally fair condition, consistent with its age, with no evidence of any significant cracking, recent or ongoing movement.

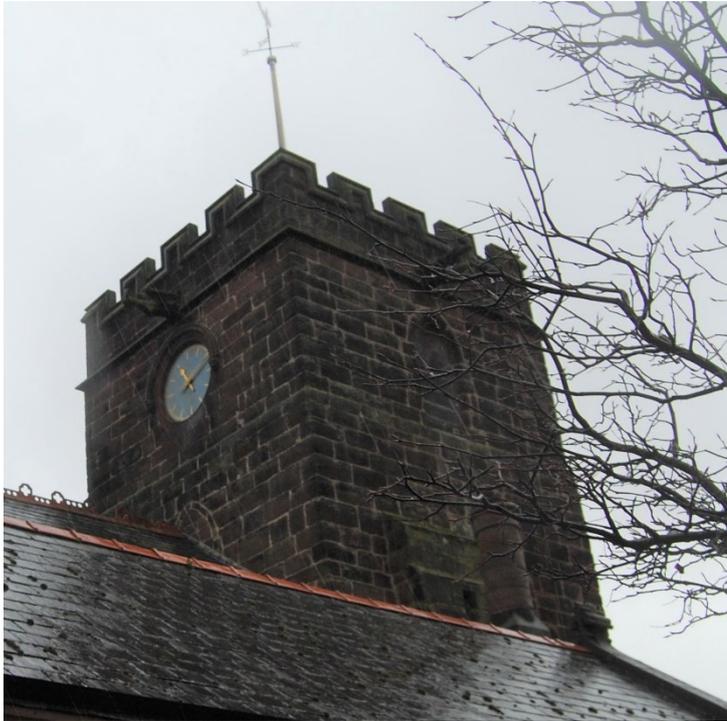
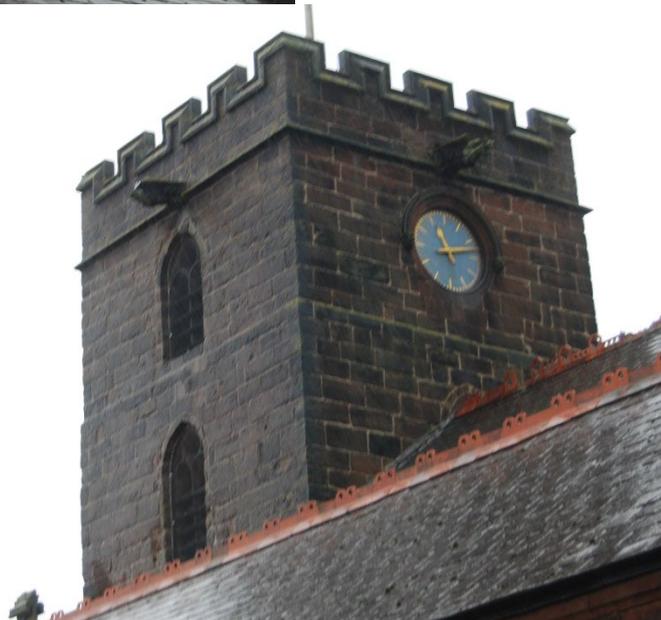
2.04 East Elevation Wall

This wall contains a clock face at belfry level with a blocked-up opening below it, partly exposed above nave roof level. Again, the masonry appears to be in generally fair condition, consistent with its age, with no evidence of any significant cracking, recent or ongoing movement.

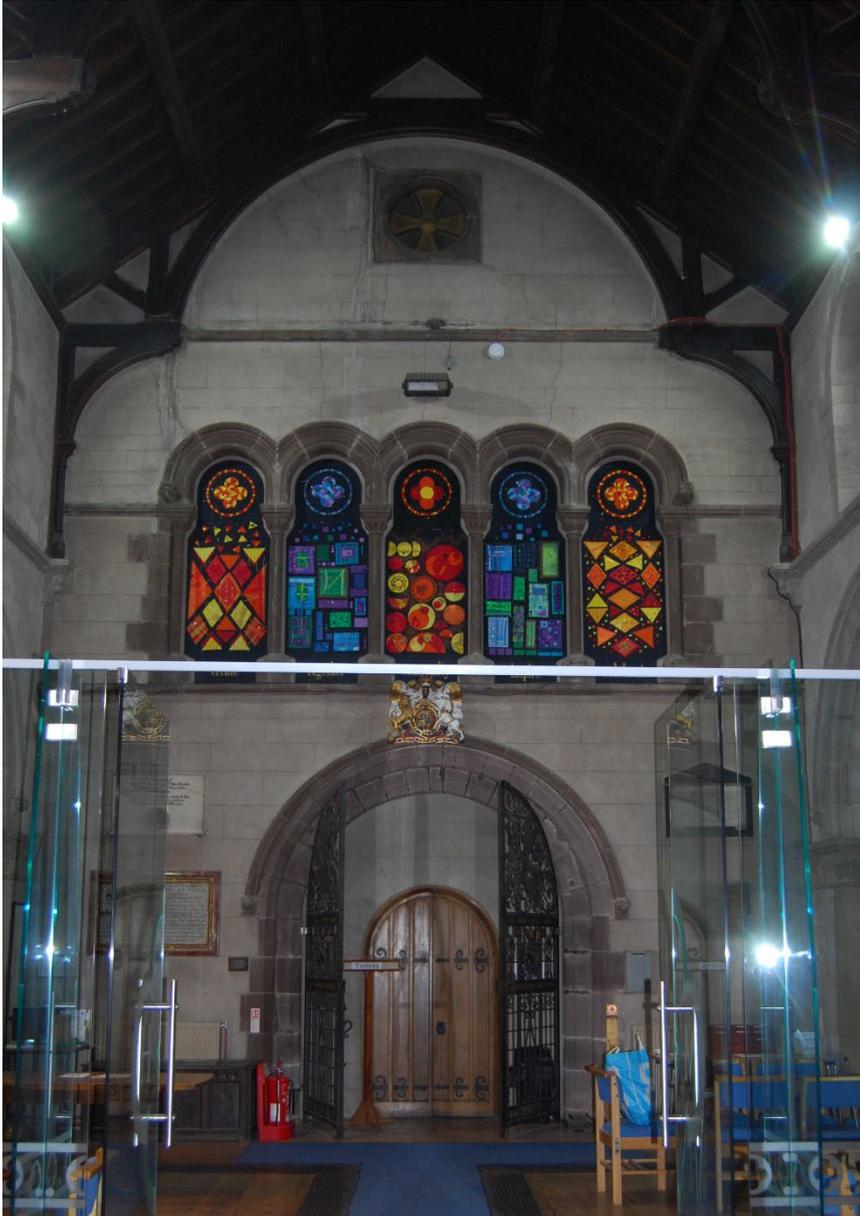
3.01 East Elevation Wall (From Nave):

This wall contains a large arched opening which takes up almost the full width of the tower internally and extends up to just below ringing chamber floor level. The arch has been partly infilled with masonry and contains a smaller double door opening. Above the larger arch is a blind, decorated arcade. The masonry to this elevation has been rendered and scored with horizontal and vertical grooves to resemble coursed masonry. There is evidence of minor cracking and crazing to the render throughout the elevation. This appears to be mainly old and longstanding and is considered to be due to shrinkage/thermal movement.

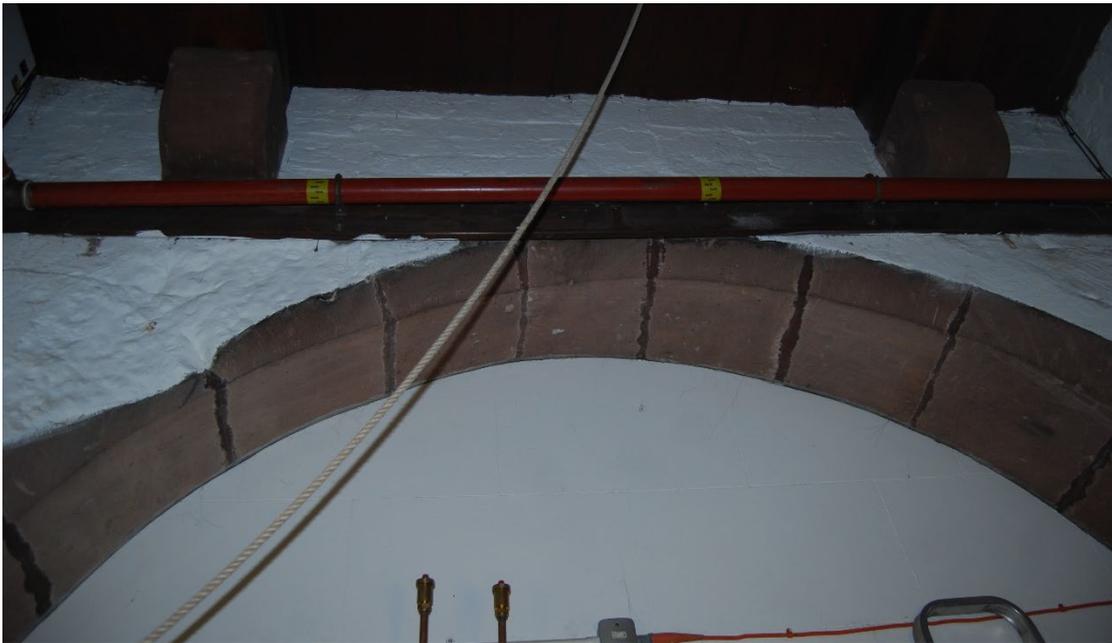
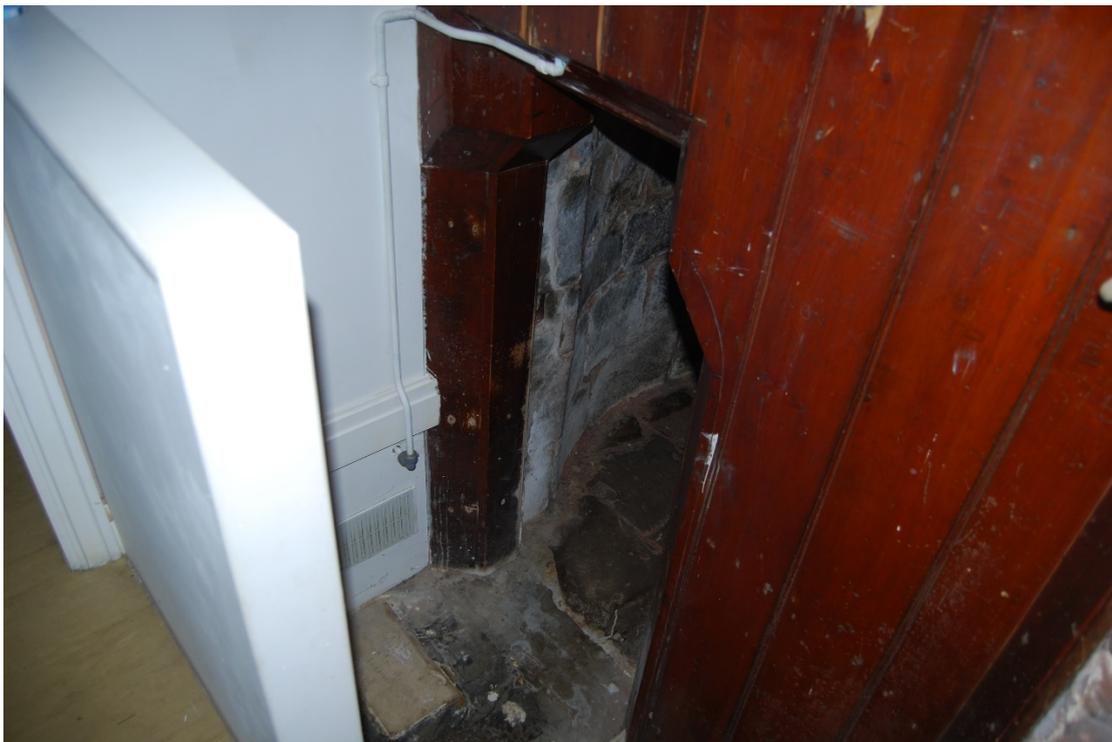
3.02 Ground Floor Chamber:

The original floor level has been raised to match the nave floor level. Toilets and a central heating boiler have been installed relatively recently. The walls, where exposed, have been painted and the masonry appears to be in generally fair condition, consistent with their age, with no evidence of any significant cracking, recent or ongoing movement.

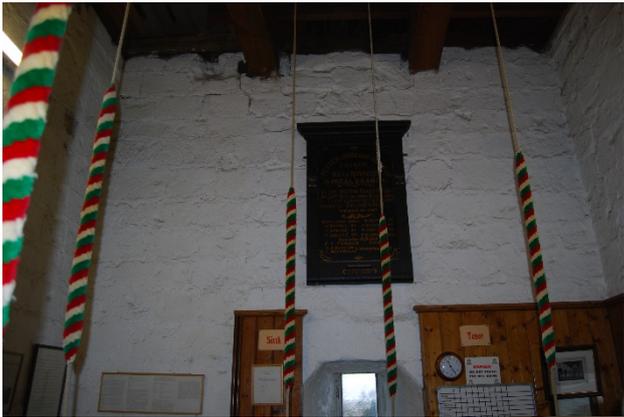
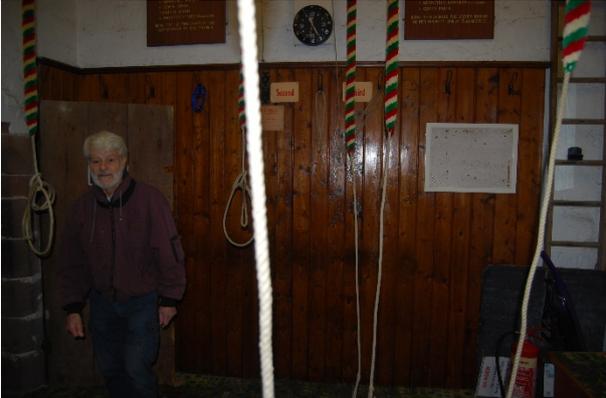
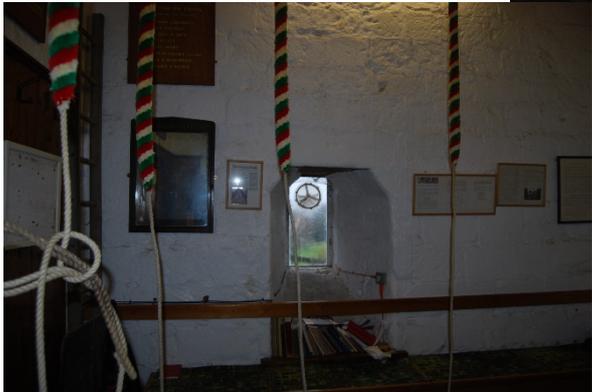
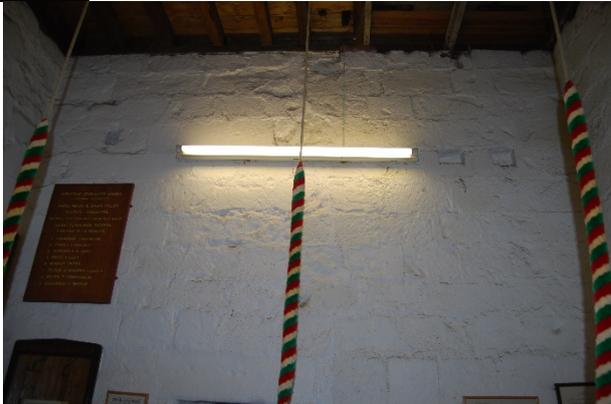
3.03 First Intermediate Chamber (Ringing Chamber):

The walls at this level are partially obscured by timber panelling. Where they are exposed, they have been painted. There does not appear to be evidence of any significant cracking, recent or ongoing movement to the masonry.

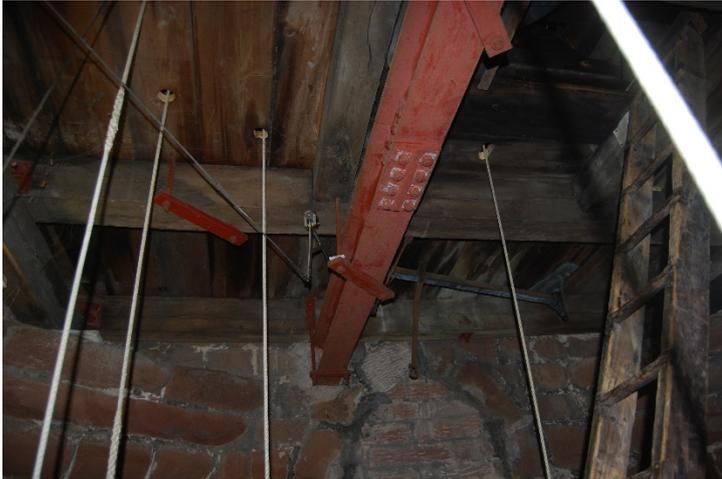
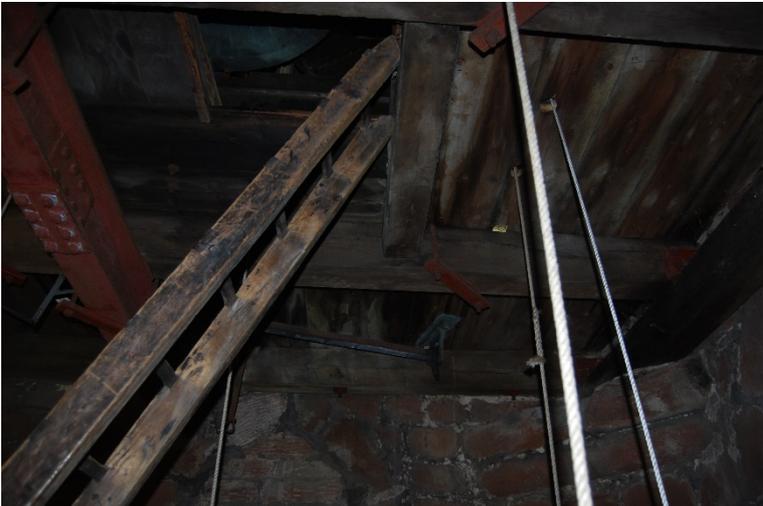
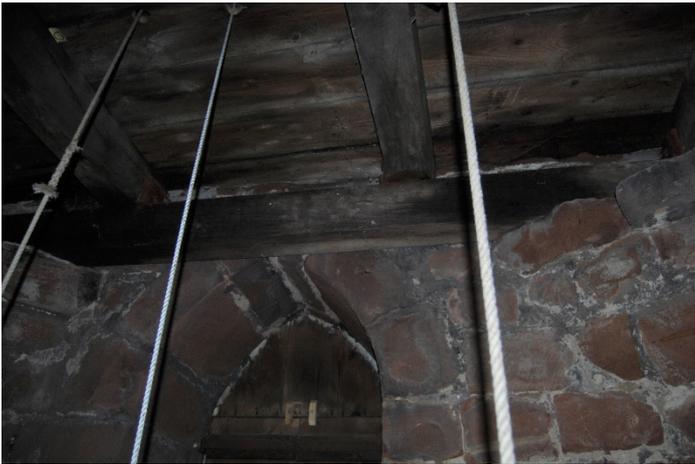
3.04 Second Intermediate Chamber (Clock Chamber):

The walls at this level are of exposed stone masonry construction. There are what appear to be the beginnings of squinch arches below belfry floor level, the purposes of which are unknown. Possibly there was some intention of building a spire at some time in the past. There does not appear to be any evidence of significant cracking, recent or ongoing movement to the masonry.

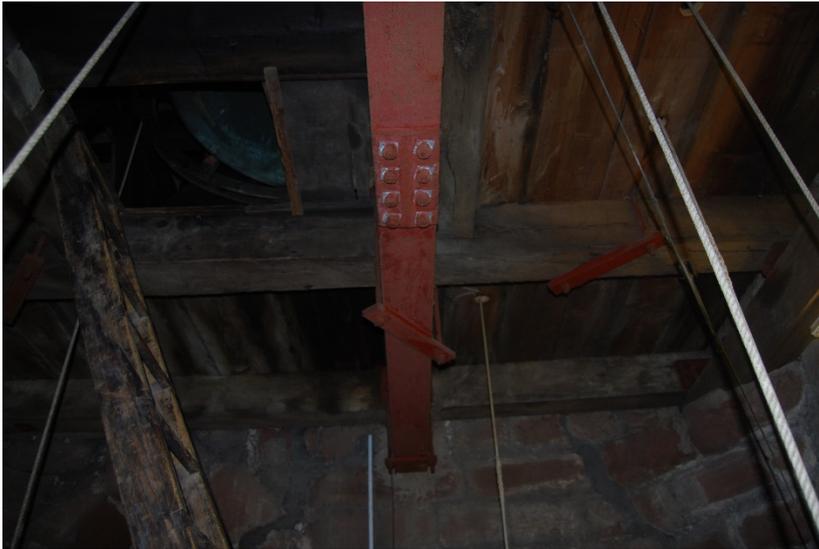
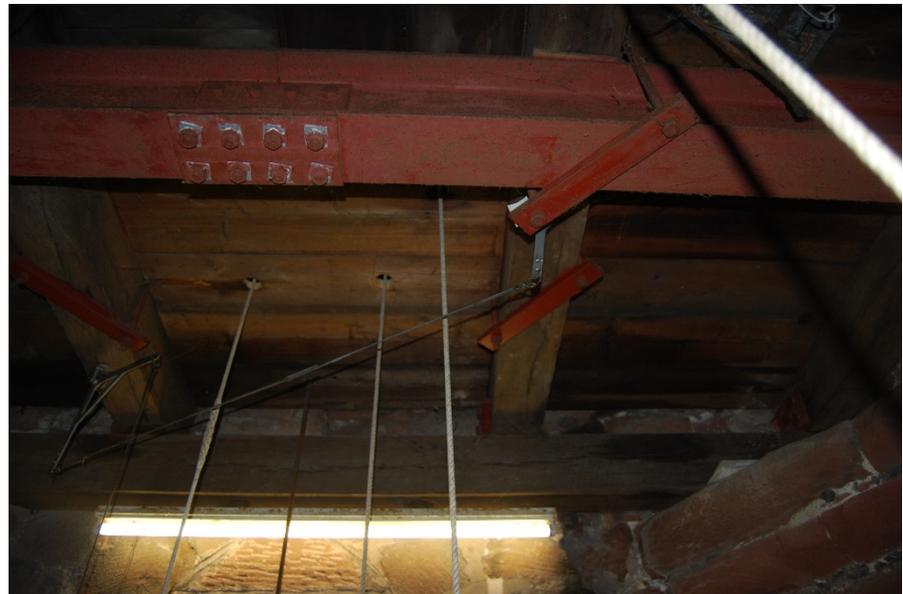
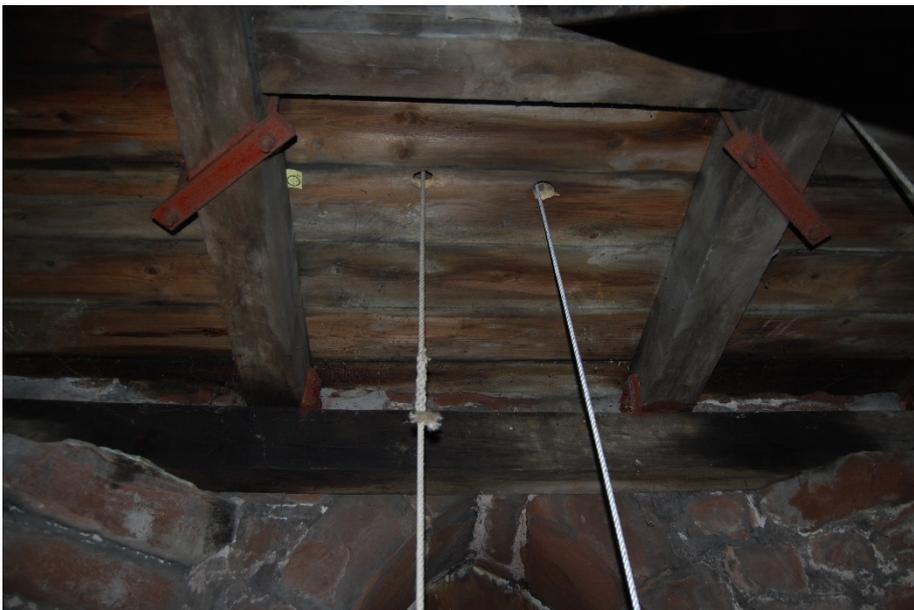
The floor of the belfry is exposed above this level and consists of floorboards supported on four timber beams which run east west which, in turn, are supported on two timber beams which run north south and are adjacent to the east and west walls, partially supported on the squinches noted above. The timber beams appear to be the original bell frame foundation beams. There have evidently been structural problems with the bell frame and foundation beams because efforts have been made to strengthen them since the original installation in the late 19th Century. These strengthening measures include the installation of a steel beam running north south and built into the north and south elevation walls, together with a number of bolted steel clamps between the bottom sills of the bell frame and the east west timber beams below. Steel angle brackets have also been installed at the junctions of the upper and lower foundation beams. The steel beam has been spliced at its centre with a bolted steel plate to the bottom flange and bolted steel plates to both sides of the web. Surprisingly, there is no plate to the top flange.

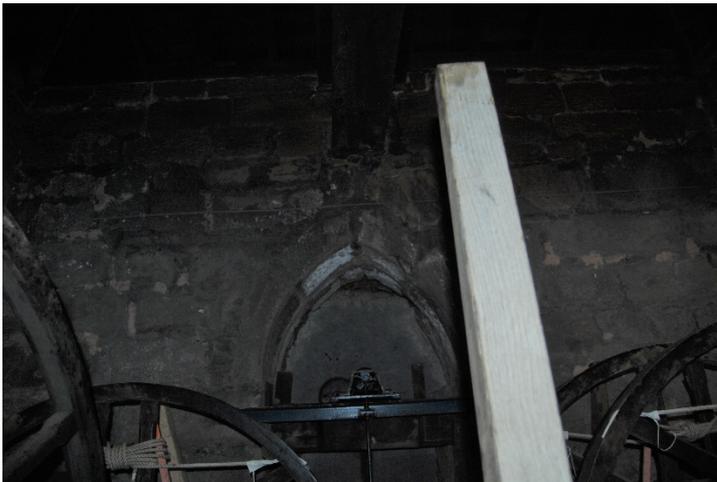
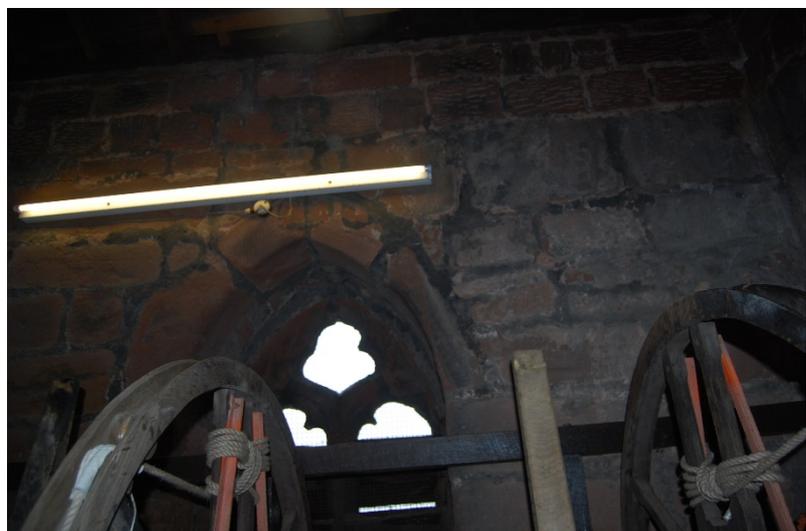
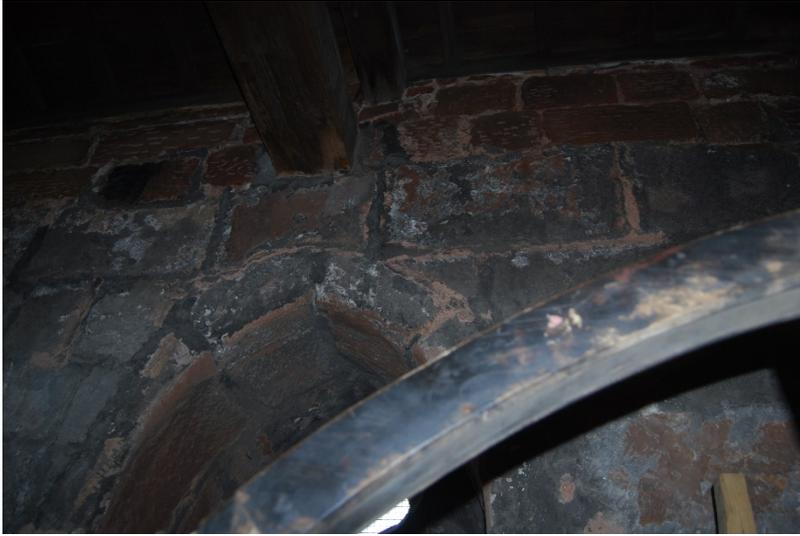
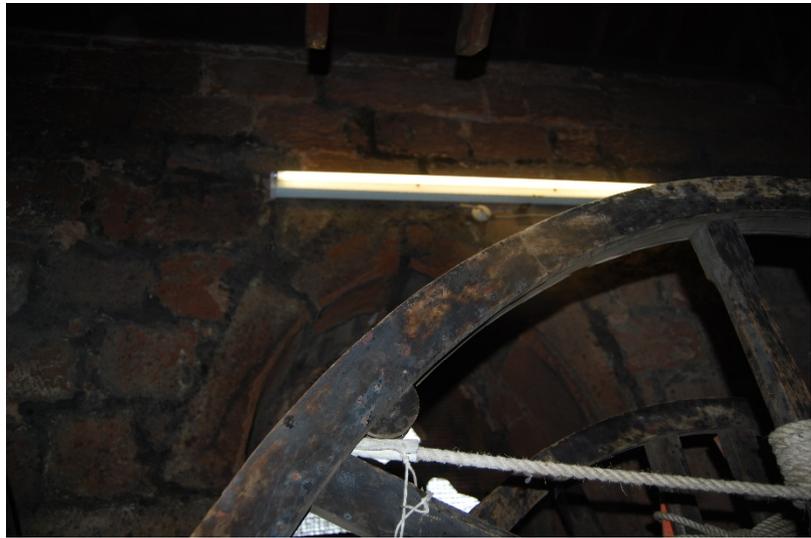
3.05 Fourth Intermediate Chamber (Belfry):

The walls at this level are of exposed stone masonry construction and, where they are not obscured by the bell frame, the masonry appears to be in fair condition, consistent with its age, with no evidence of any significant cracking, recent or ongoing movement or other structural distress.

There is a ring of eight bells, tenor weight 14cwt 2qr 24lb, at this level, hung in a timber frame for full circle ringing. All the bells except the treble and tenor swing north south. The existing bell frame is given in diagrammatic form in Appendix A to this report. The bell frame fits so tightly in the tower that there are gallows ends to all the north south frame sills to allow the bells to swing freely and some of the tower masonry has been chipped away to make room for the bell installation. The bell frame members are rather slender, and the top sills are split at almost every right-angle joint where ferrous metal coach bolts or screws are penetrating the timber. At the time of the visit, it was raining, and rainwater was being blown through the louvre in the north elevation wall and landing on the bells and frame.
