Witton St Helen – Replacement of organ

Note to parish

Report on the pipe organ at St. Helen's Church Northwich after water damage to the swell chamber

SPECIFICATION of Work and Quotation for the repair of recent water damage to the organ:

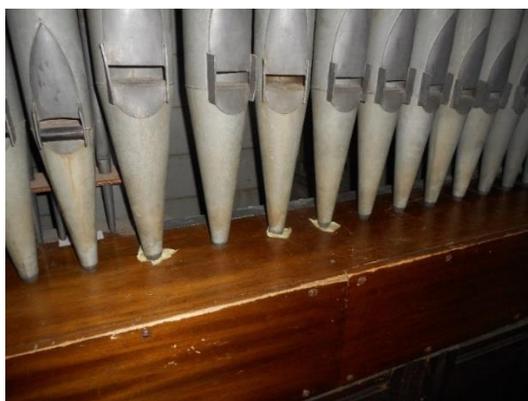
Side front pipes showing blanked off notes

The Great Diapason no. 2 chests are situated to the right of the organ along the passageway to the vestry; the basses form a side case with the trebles at floor level behind the bass chest. Many of these pipes have been blanked off due to the water damage.

SIDE FRONT PIPE CHEST removed for workshop overhaul. Damaged internal pallet motors removed for re-leathering, leather stripped from motors; motors releathered, rebedded and refitted, damaged movements stripped and releathered, the valves cleaned off and reset. Action re-assembled, movements regulated and tested.

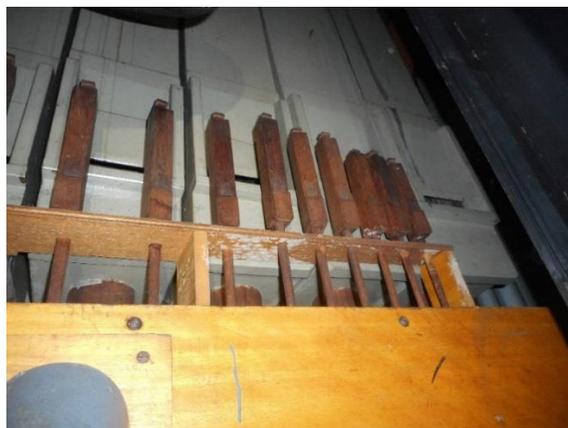
Mold on underside of Bourdon rackboard

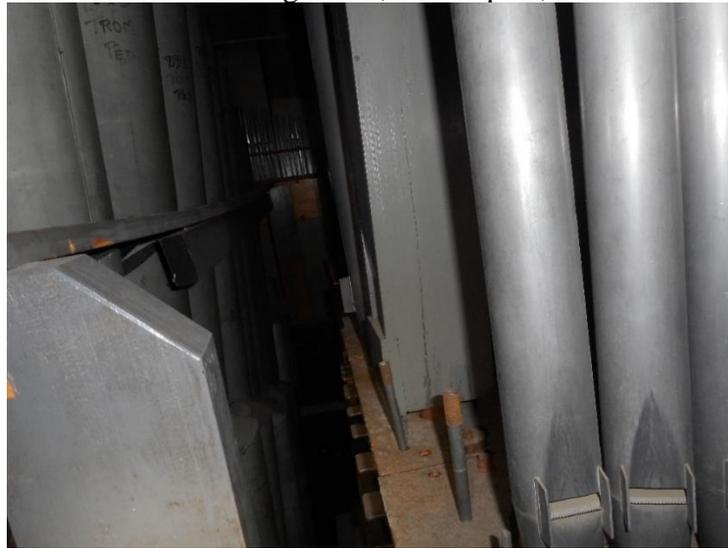
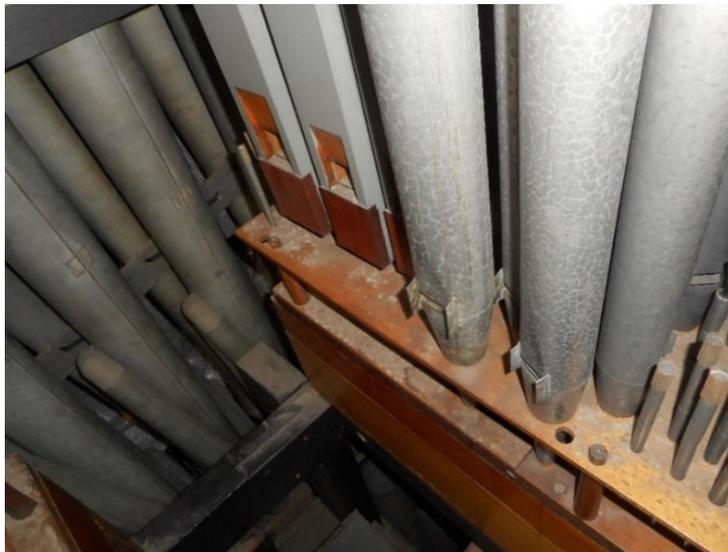
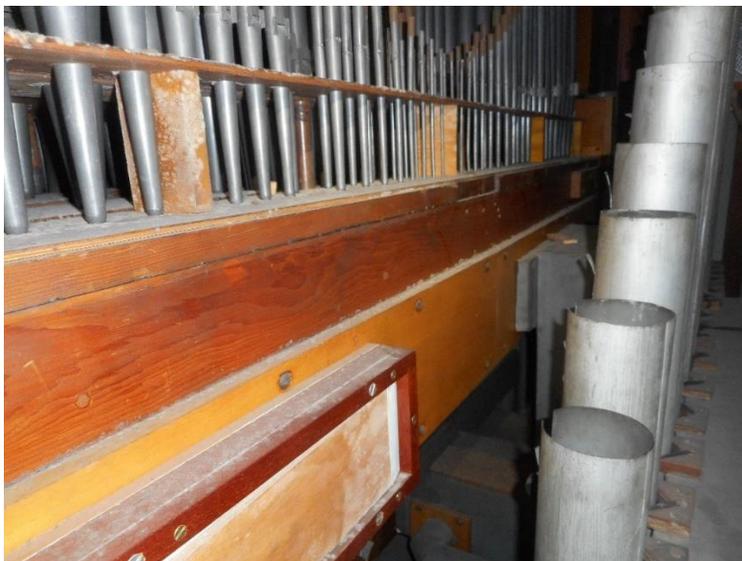
Rusted tuning slides, water spots, mold

PIPEWORK cleaned to remove waterborne dust and debris, rusted tuning slides replaced. Wooden joints checked for soundness, damaged stopper leather replaced as necessary.

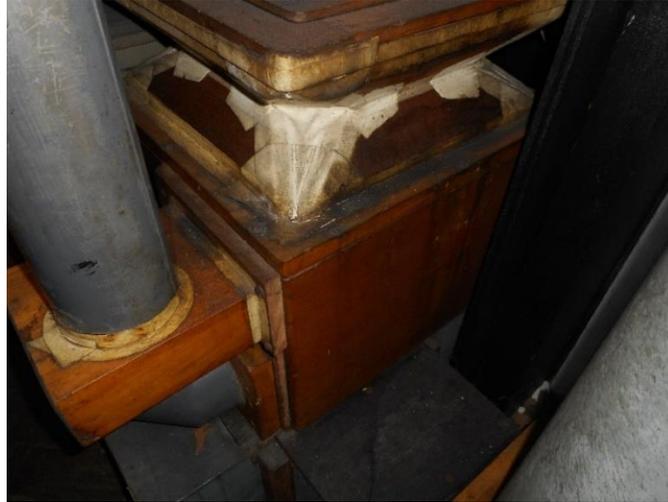
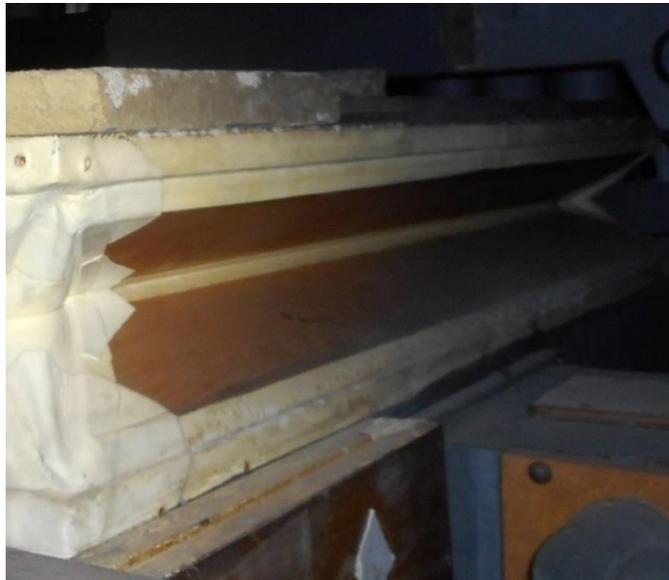
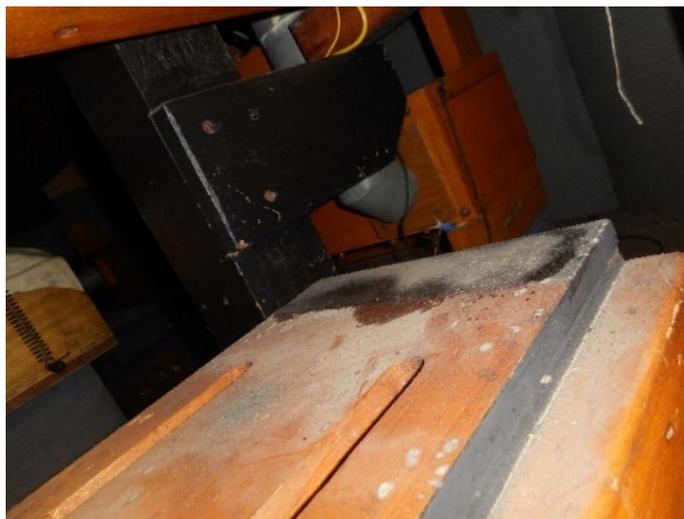
Water damaged leatherwork

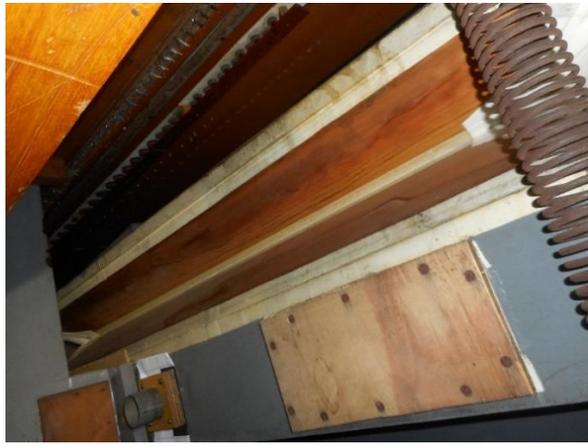
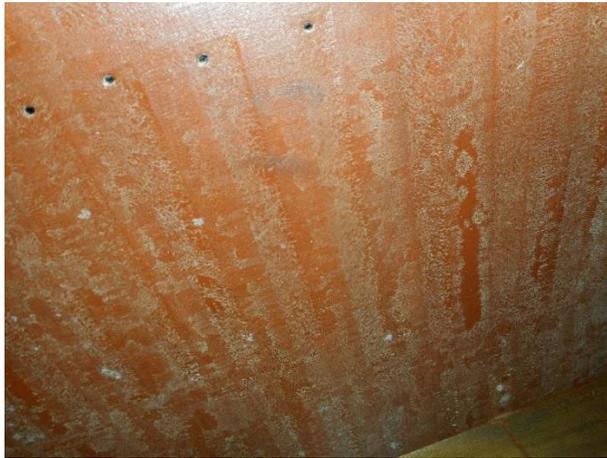
Emergency soundboard bleed holes and glue reaction to water

SOUNDBOARDS The Swell and Choir soundboards stripped down, the pallets, bar coverings, wind-bars and pallet guide-pins removed; the corrupted animal glue cleaned out from the bar channels; any table splits pegged and, where hammer testing indicates, bars screwed to the tables; the bar channels reflooded with new hot glue, the bars and tables cleaned up, the table splits filled, the tables and bars trued up; new internal and external bar coverings fitted to replace those damaged by water; the damaged pallet coverings stripped off, the pallets trued up and recovered in new felt and leather; new phosphor bronze guide-pins fitted to replace those damaged by water or removal, the pallets relaid and new pallet springs and pull-down wires fitted to replace those damaged or corroded by water, the upperboards and slides cleaned off and trued up, the upper-boards refitted with new screws to replace those rusted by water, damaged bedding on the faceboards replaced and new face-board screws fitted to replace those rusted by water.

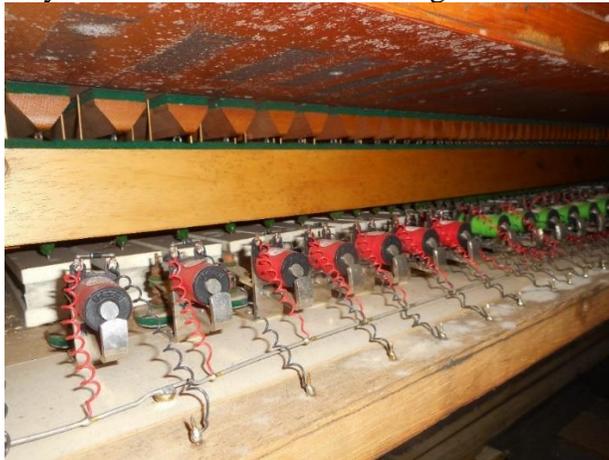
Internal mold and leatherwork damage

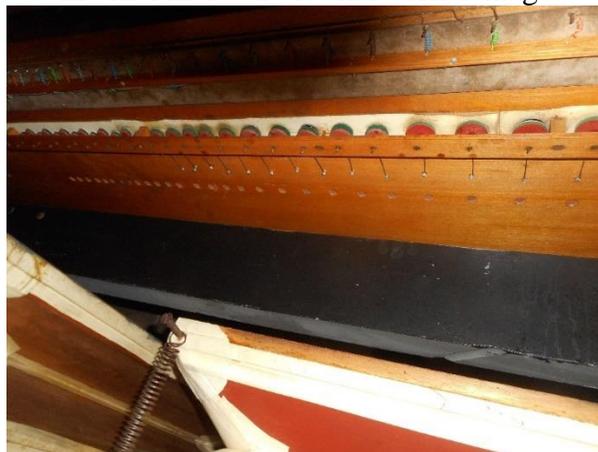
Water damaged key action

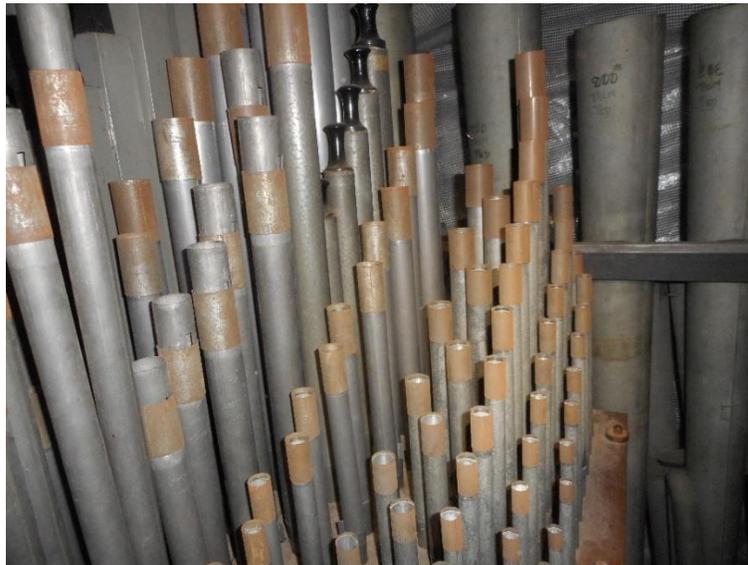
Corroded tuning slides

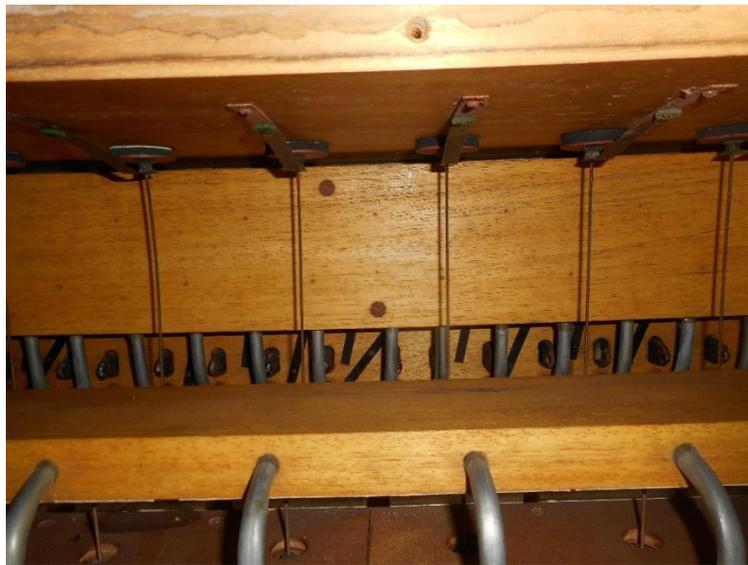
Corrosion and pallet damage inside pedal chest

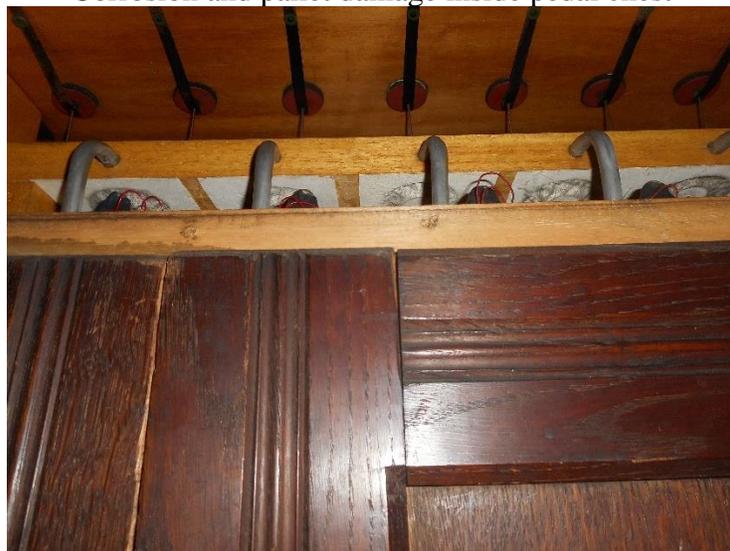
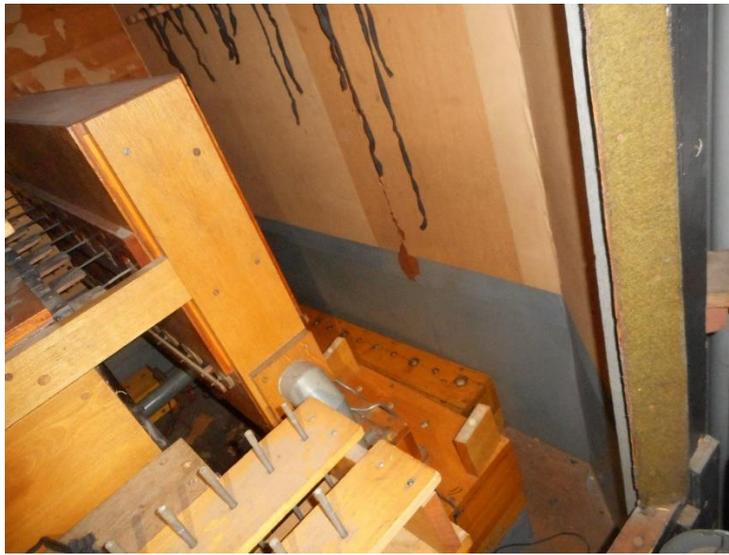
Previously removed pipework

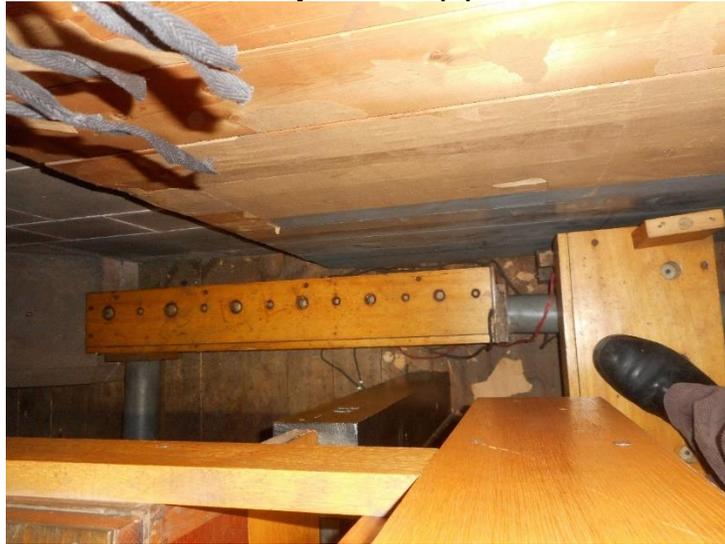
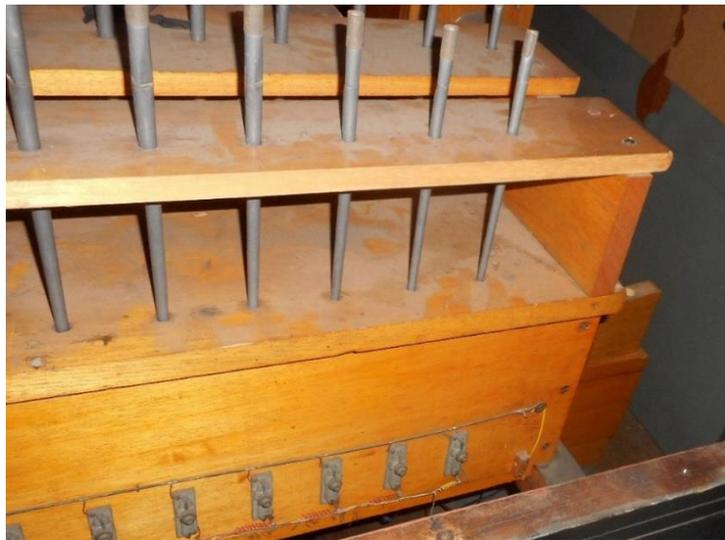
Water marks on chest

Chamber ceiling water marks

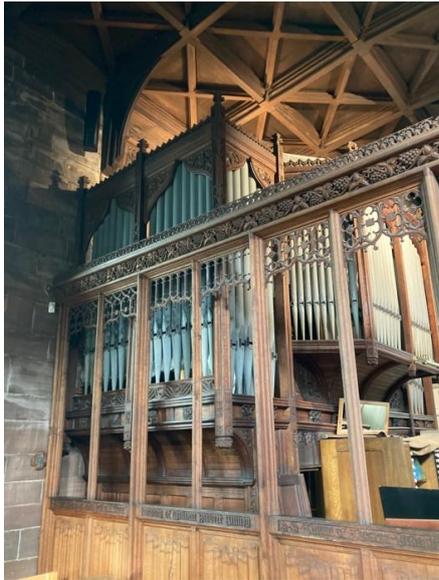
The organ was re-built and enlarged in the 1960's by Smethurst, a Manchester builder. Since then, work on the organ has been undertaken from 1988 to 2004 by David Wells, of Liverpool. At this stage it is unclear as to the origins of the pipework currently in the organ. The semi-detached console, seemingly from the 1960's, is not of the same quality as the fine case and is crudely placed against the carved casework.

The case showing the semi-detached console.
