2020 QUINQUENNIAL INSPECTION SURVEY REPORT

Under the Inspection of Churches Measure 1955
as amended by Ecclesiastical Jurisdiction and The Care Of Churches Measure 2018

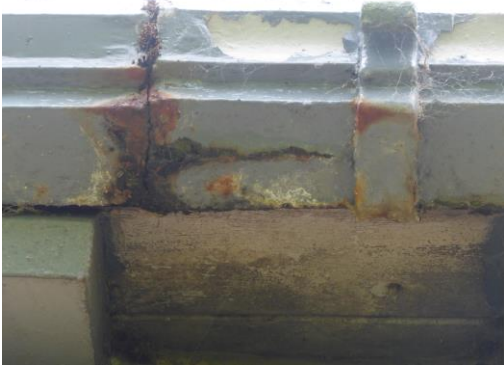
1. Nave North Wall. Cracked joint in gutter section. 3.2

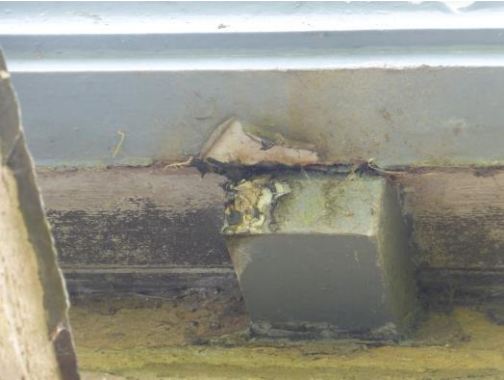
2. Nave North Wall. Blistering paint and rusting corner indicate a crack at the corner. 3.2

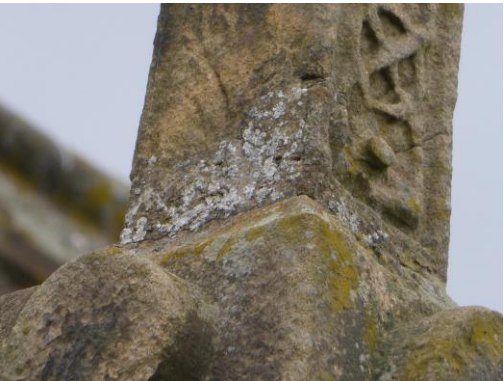
3. South Porch, South Gable. Possible cracks at base of finial cross. 3.2

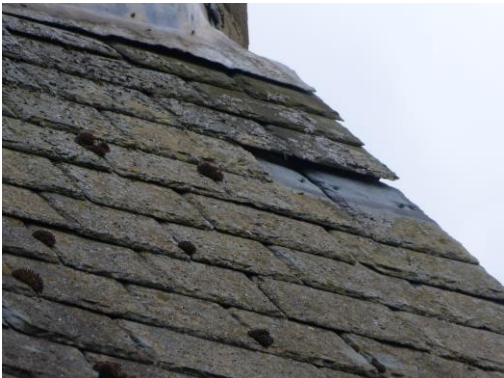
4. Nave North Slope. Missing verge slate at west end exposing nail heads. 4.1

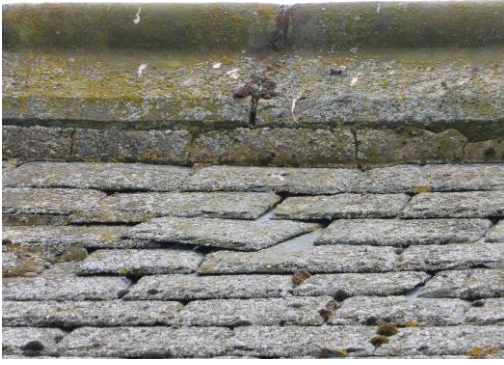
5. Chancel North Slope. Skewed slate near ridge. 4.2

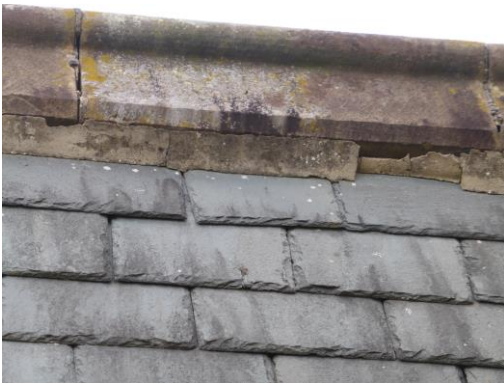
7. South Porch East Slope. Missing section of pointing at ridge tile. 4.7
