# St John the Evangelist, Little Wilbraham

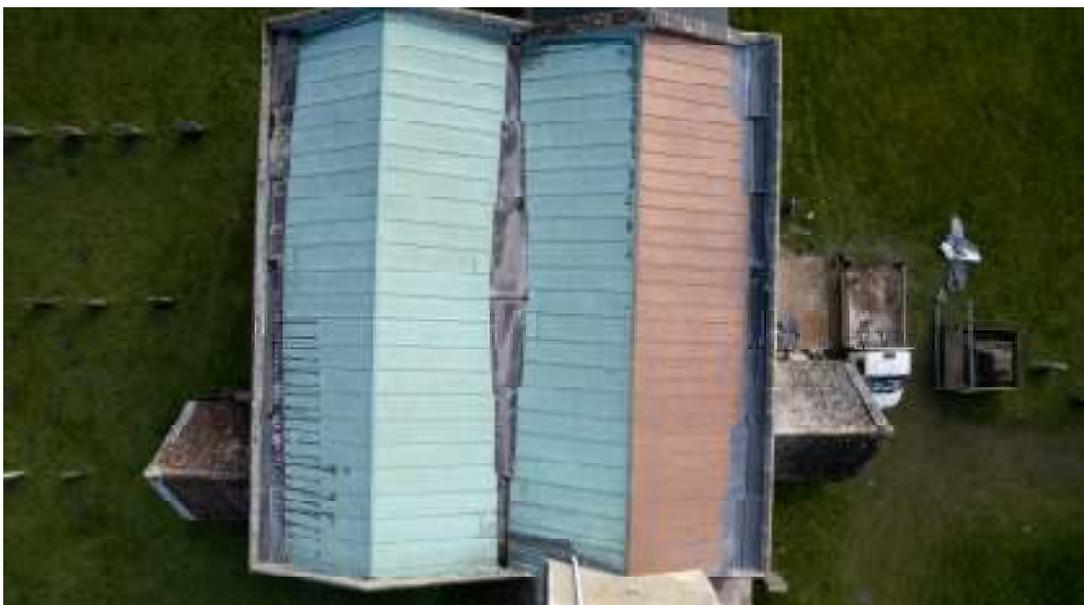
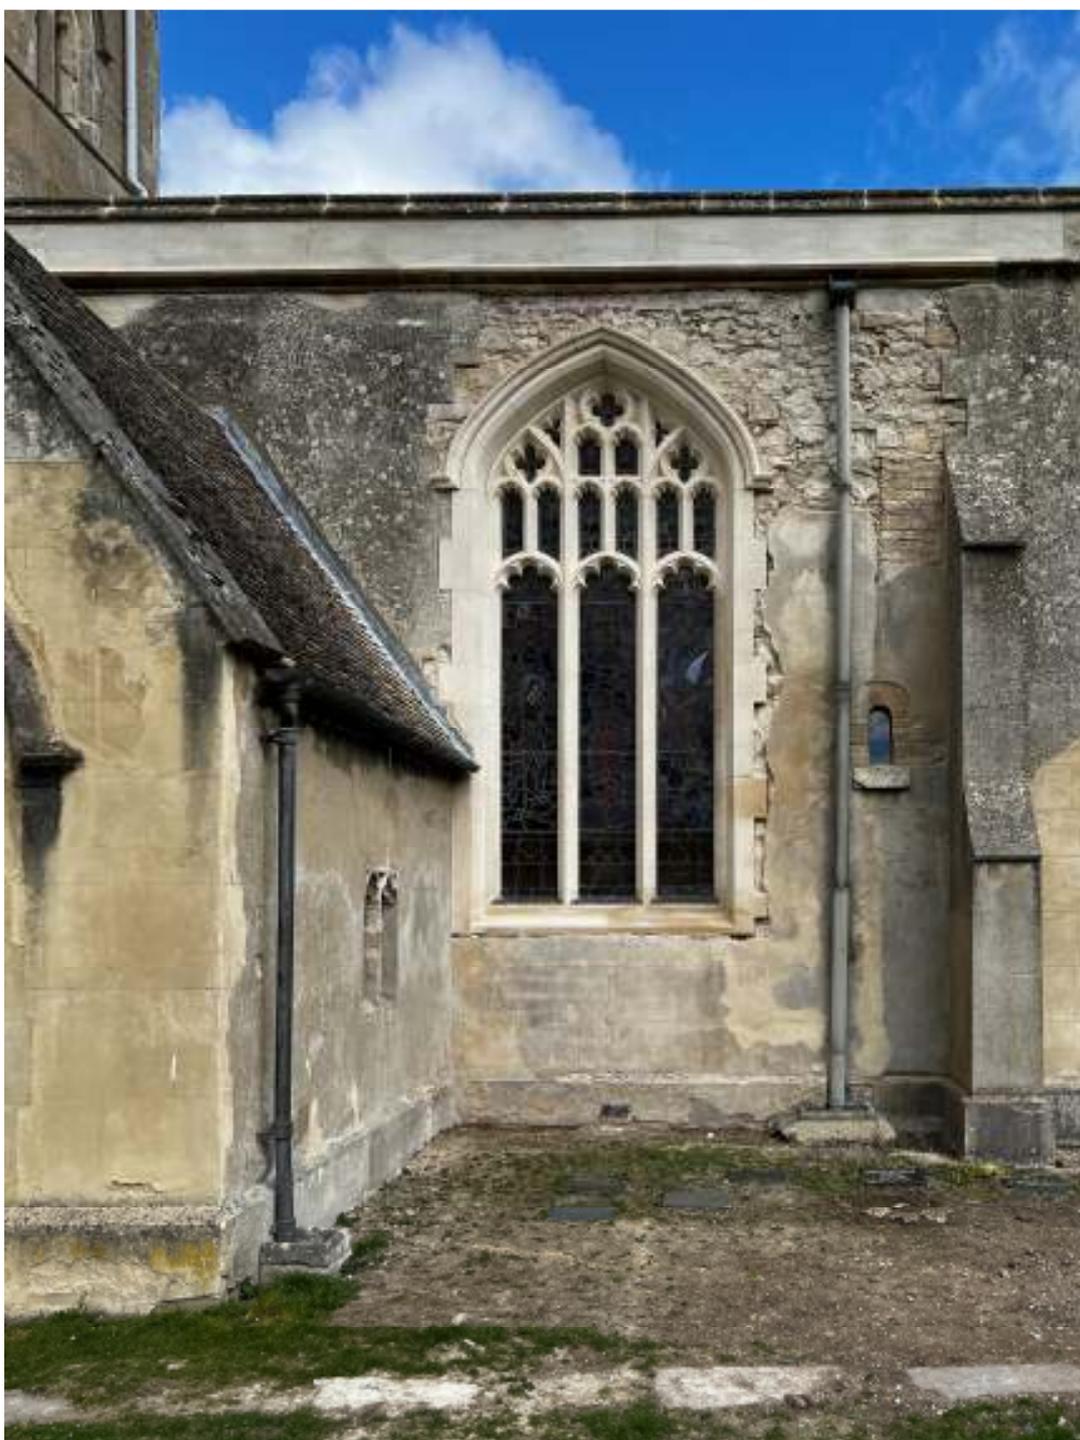
The parapet along the south elevation is made of clunch which, when exposed to the elements, absorbs water and is easily eroded. It had been noted over the past two decades that the parapet was being worn away from the inside and was reduced to a quarter of its original thickness in places. It was then seen that the inside of the south wall was becoming damp near the top and some of the lime wash was flaking off inside the church. About five or six years ago it was seen that the stone tracery on the south window closest to the porch was badly eroded and was even disintegrating in places. Closer inspection revealed that the window was sinking and it started to become bowed outwards about one third of the way up from the bottom.

The Victorians had rendered the south wall, which is quite right for a clunch wall, but they had used concrete rather than lime mortar. Concrete does not "breathe" like lime mortar, it forms a watertight seal. This meant that over the years the wall had been filling with water from the eroded parapet and this water could not escape except inside the church.

In 2020 Father Miles Pateman, then a curate in the benefice, undertook the monumental task of raising funds to effect repairs estimated to cost £120,000. Miles raised £95,000 in grants by the time that he left the benefice in early 2021 and we shall always be grateful for his work on the project. By June 2021 we had bridged the gap by public appeal and a number of substantial private donations and we were in a position to start work. The church was closed on July 11, 2021, and the team moved in. It was quickly discovered that the damage to the parapet was worse than we had dared to believe and that further stonework was required. Removing the lead gutter behind the parapet revealed that the wooden gutter beneath the lead was so rotten that handfuls of the timber could be picked up and water squeezed out.

The window was removed and shipped to the glazier's yard where it was painstakingly reassembled into new stone tracery. The south pitch of the outside of the roof on the south aisle needed to be re-covered with copper laid by a specialist coppersmith. The gutters were redesigned and built to meet modern standards and then relined with lead. In February 2022 the window was returned and the building was once more sealed. The internal and external scaffolding was removed and (after a thorough clean-up operation) the church reopened for services on Mothering Sunday, March 27, 2022.

The only task remaining is to re-render the stonework around the window with lime mortar, but this cannot be done until the chance of frost has passed.
