ST GILES' CHURCH

CHOLLERTON

AN ARCHAEOLOGICAL ASSESSMENT
MAY 2008

PETER F RYDER
B.A., M.Phil., F.S.A
HISTORIC BUILDINGS CONSULTANT

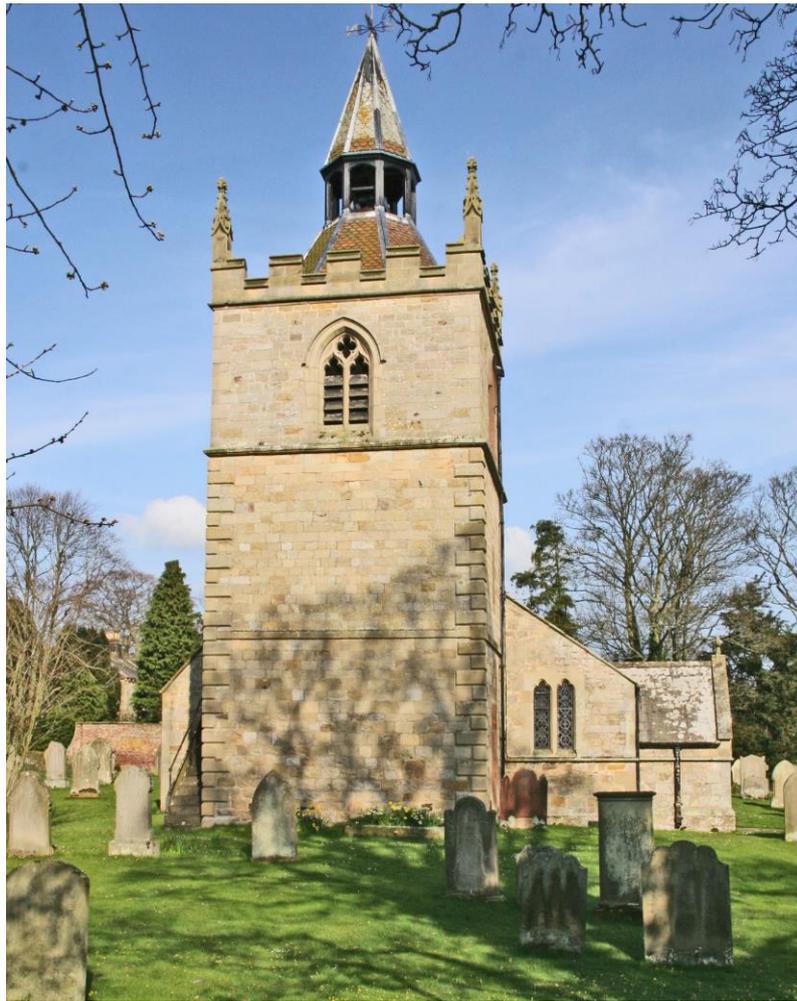
The church from the west

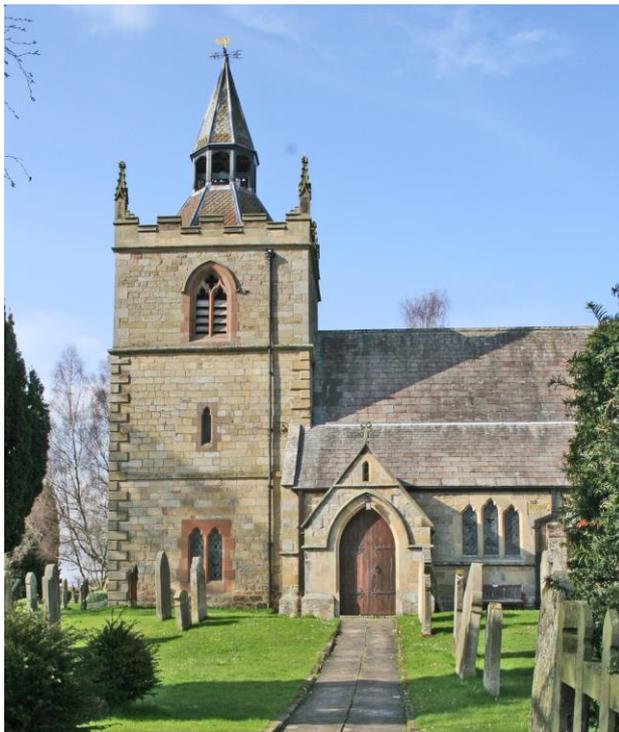
The lower part of the tower (left, seen from the south) shows two quite distinct fabric types. Up to c 2 m there is coursed roughly-shaped stone, and above that coursed better-squared and generally lighter-coloured more uniform fabric. The west face has no opening to the lower two stages; there is an OS benchmark on the lowest-but-one west-facing quoin at the south-west angle. On the south the lower stage has a window of two trefoiled ogee lights in a chamfered surround with alternating jambs and a monolithic lintel

in red sandstone ashlar, the lintel and sill being tooled-and-margined, set in a patch of secondary fabric. To the east of the window is a straight joint representing the south-west angle of the medieval nave, with substantial but not especially distinctive quoining adjacent to the east. The stage above has a single trefoiled ogee light, again in red sandstone ashlar, and set in the infill of a larger opening that came right down to (and possibly through) the band below; the band abuts against the old

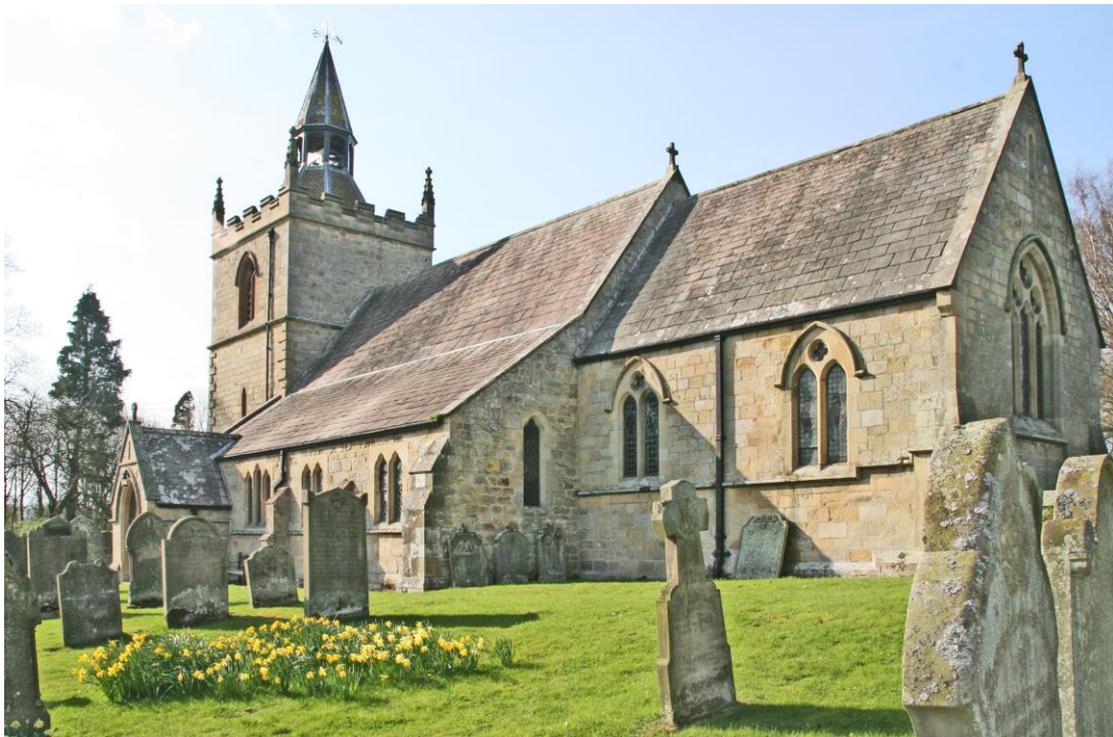
The **South Aisle** (right, seen from south-east) is built of squared and coursed stone; it has a chamfered plinth, and a string-course, rounded above and chamfered below, at window sill level. There are alternating

ashlar quoins at the south-west angle. In the west wall is a window of two trefoil-headed lights, with tooled dressings of grey sandstone.

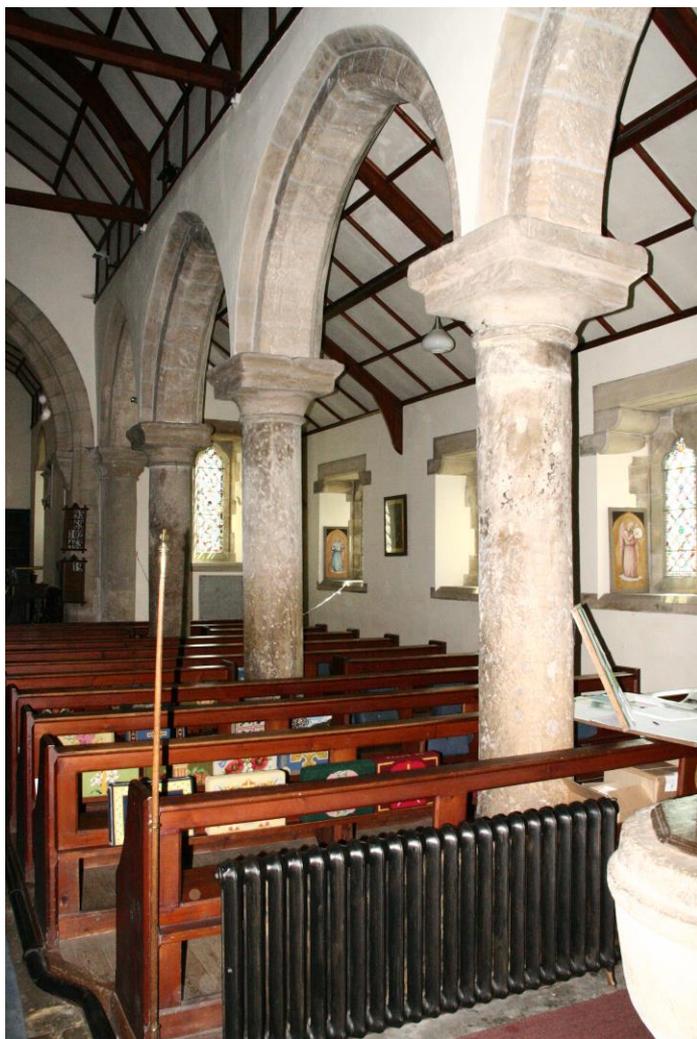
Within the **Nave** the arcades, the only substantial sections of the medieval church to survive, are each of four bays. The south arcade (left, looking south-east) has monolithic circular piers and semicircular responds; the heavy capitals are of simple form, with a ring at the base and a square abacus; the capital of the eastern respond has been renewed. The piers carry

two-centred arches of two chamfered orders, without any hood. The rather decayed moulded bases are set on square plinths with chamfered off-sets.

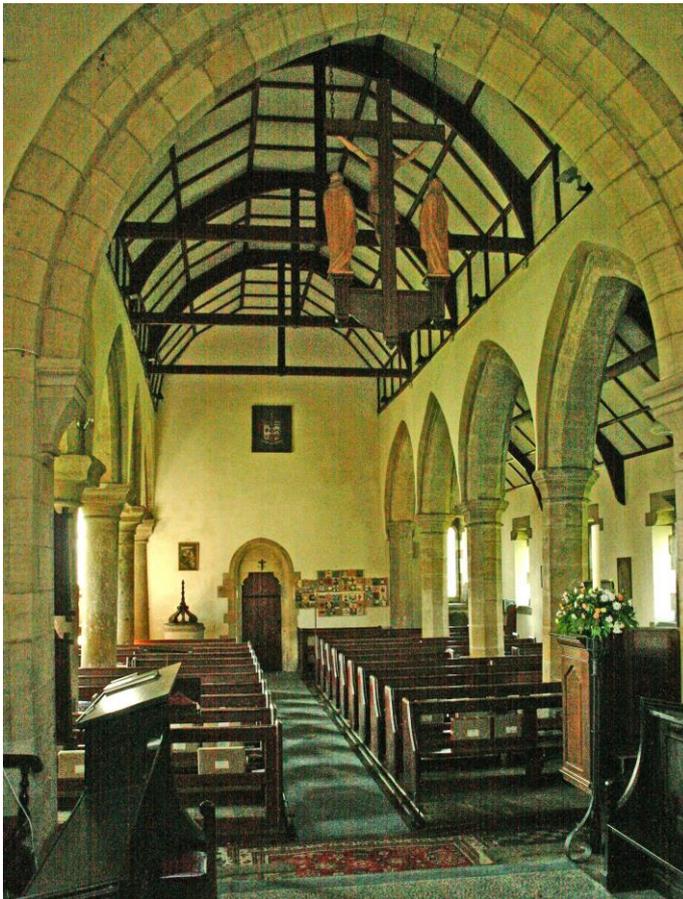
The arch into the **Chancel** (left, looking west) is of two-centred form, and like the arcades is of two chamfered orders without a hood; the inner order is carried on responds in the form of moulded square corbels, whilst the outer is continued down the jambs to broach stops just above the floor. Everything is in lightly-tooled ashlar of late-19th century character. The south and east windows all have segmental-pointed rear arches with chamfers only to their heads; the internal recess of the eastern of the two south windows is continued down to hold a sedile with a level

stone sill, whilst the east window is set at a higher level, above the reredos made up of re-used 17th-century panelling. There is a simple wagon roof.

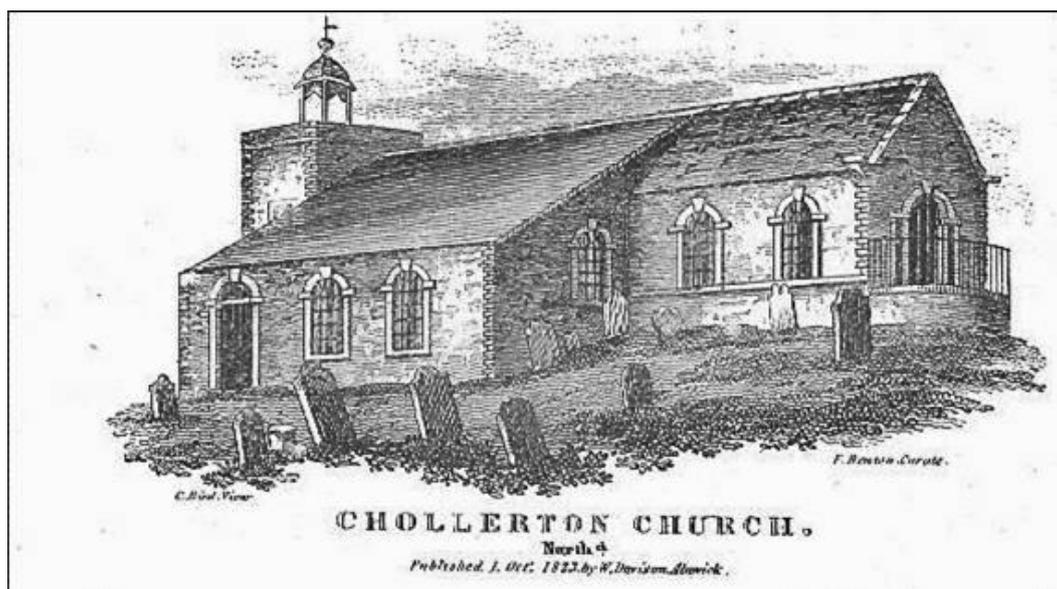
An 1823 drawing (above) shows the church in its Georgian guise. The windows are round-headed sashes in raised surrounds with impostes and keystones, except that in the east end, which is of Venetian form; the low tower is topped by a cupola. The south aisle is unusually wide (4.5m) but its east window is set hard up against the north end of the wall, which could imply that it was inserted before the aisle was widened. A painting of c1860² shows the west tower completely shrouded in ivy, but having an external stair and doorway on the north, exactly as at present, which is puzzling as the NCH plan of 1897 shows only an internal stair³

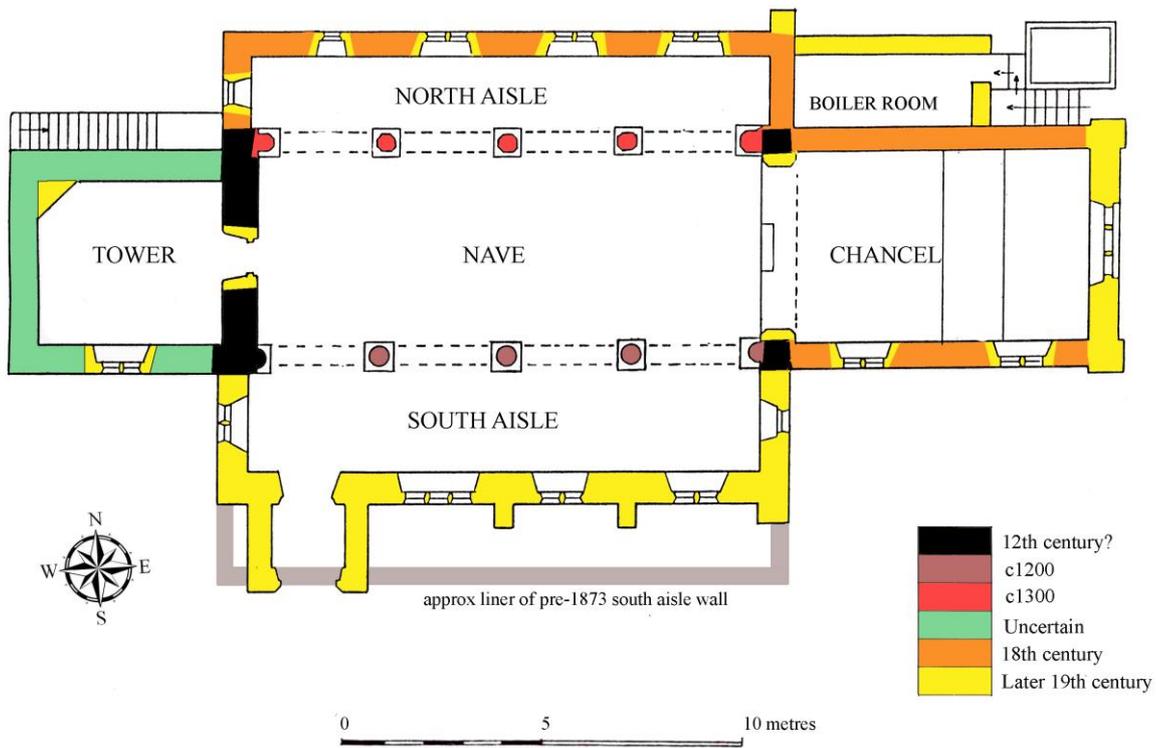
ST GILES CHURCH, CHOLLERTON PROVISIONAL PHASED PLAN

Survey Briggs et al 1983, amended PFR
