# ST MUNGO SIMONBURN

## AN ARCHAEOLOGICAL ASSESSMENT

**JUNE 2008**

**PETER F RYDER**

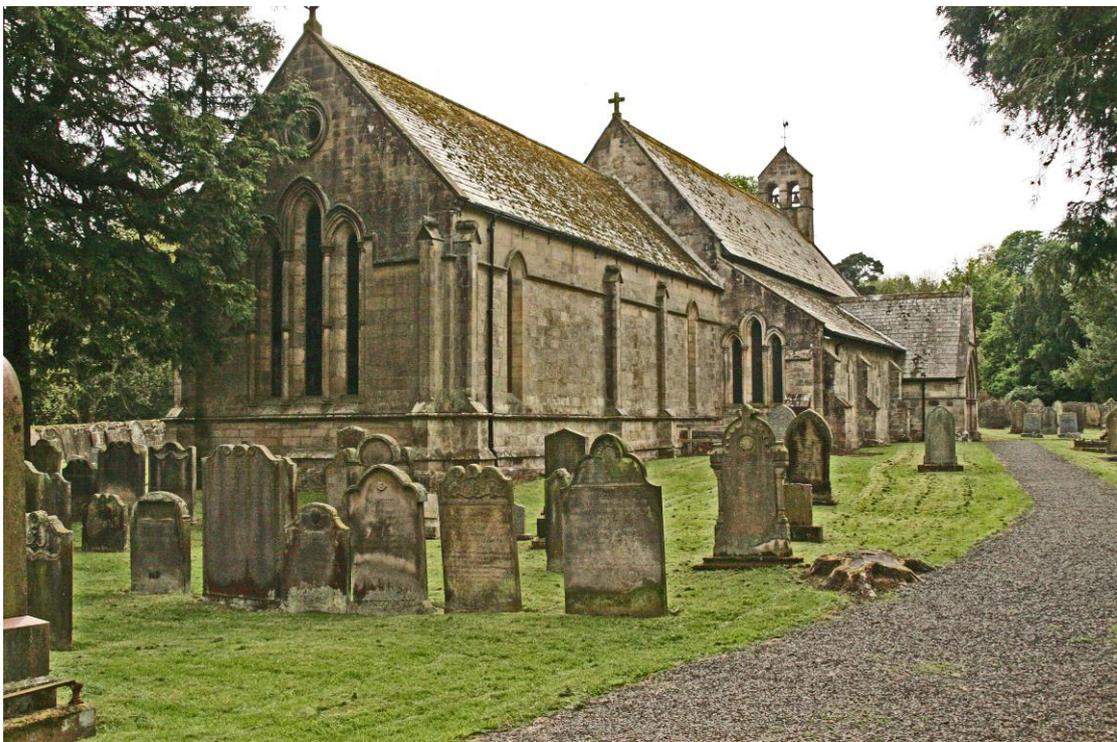
*The church from the north-east*

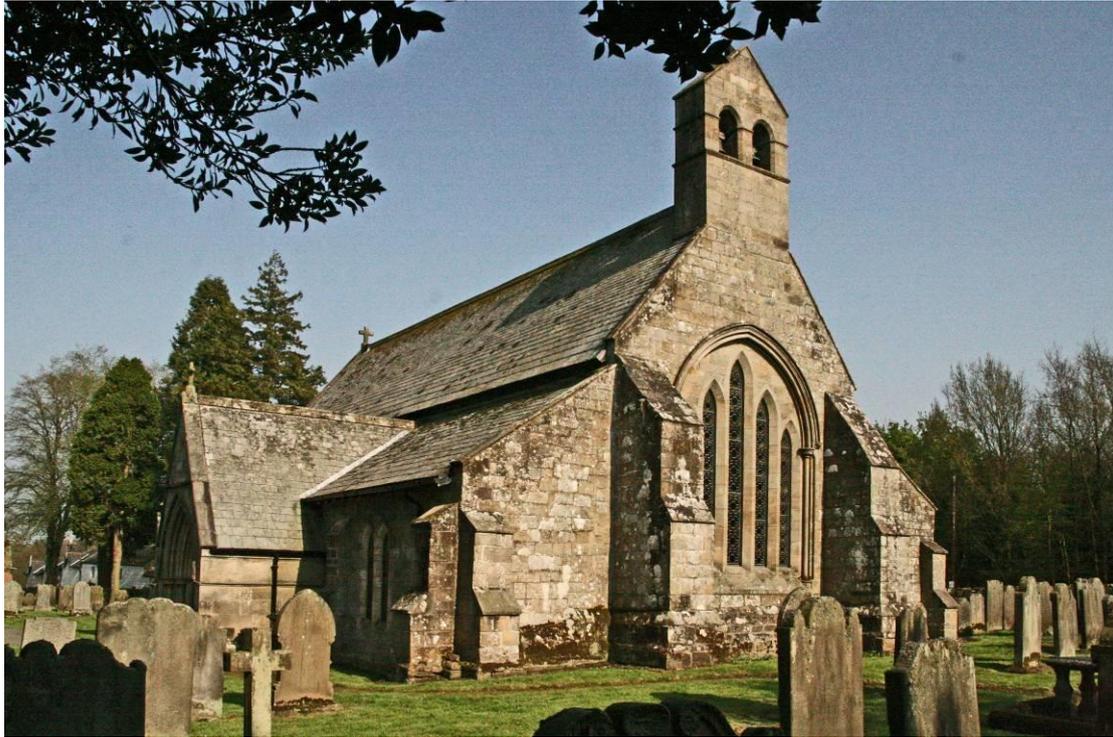
The west end of the **Nave** (above) is built of coursed sandstone in quite large blocks, and has a two-part chamfered plinth which is continued round the two massive stepped buttresses; these look medieval, although they seem to have been restored to some extent and their off-sets look to be 19<sup>th</sup>-century stone. The big west window is all in finely-tooled 19<sup>th</sup> century ashlar and of five stepped lancets within a larger segmental-pointed arch; the gable above has a 19<sup>th</sup>-century bellcote with a pair of arched openings with chamfered surrounds and an impost band, beneath a gabled top with a weathercock. The east gable of the nave has a plain cross finial.

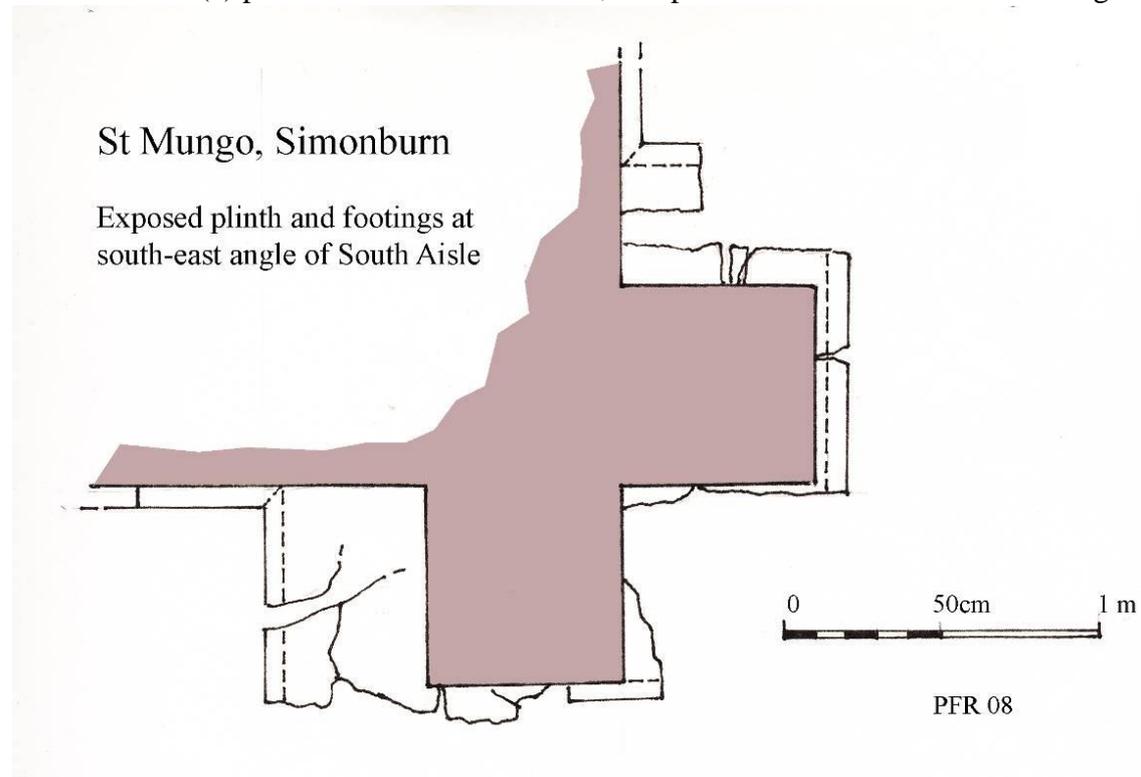
of the south-eastern buttresses. These footings (plan, above) are a little difficult to interpret, but appear to survive from a rather different and larger pair of buttresses. In the east wall of the aisle, which has a stepped triplet of Victorian lancets, the plinth and a couple of courses of walling above have the appearance of undisturbed medieval masonry..

Honeyman was certainly wrong about the south-east chapel, the outline of which he reconstructs in dotted lines on his plan. He argues that the footings beneath the south-eastern angle of the present aisle represent the remains of a buttress midway along the east side of his putative chapel, extended by 18<sup>th</sup>-century re-use of old materials. However there is certainly a medieval plinth course surviving beneath the eastern bay of the south wall of the aisle wall, and returning south on the west side of the said footings, which it is difficult to explain as anything other than having always been the base of an external buttress or buttresses<sup>4</sup>.

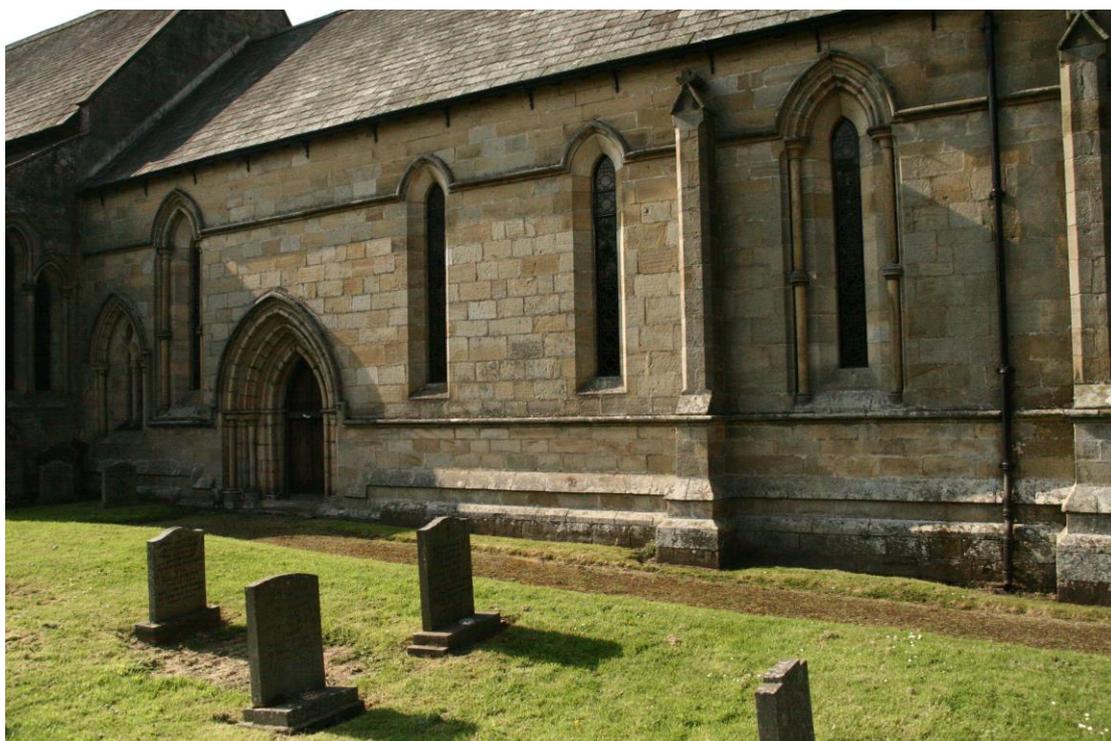
The south wall (above) is of good-quality coursed and squared stone, often tooled-and-margined. At its west end is a low-side window consisting of a pair of small lancets divided by a circular shaft with a moulded cap and base, within a larger two-centred arch with nail-head moulding and jamb shafts; the hoodmould in this case is former by the lower string, carried over the arch and then returning vertically down to its normal level. Old illustrations make it clear that this window is a restoration of an older feature, but it is not quite clear how much of the original survives. Further east is a tall lancet with a moulded head and jamb shafts, and a deep casement moulding to its outer jambs; parts of its head look as if they might be ancient. The priest's door

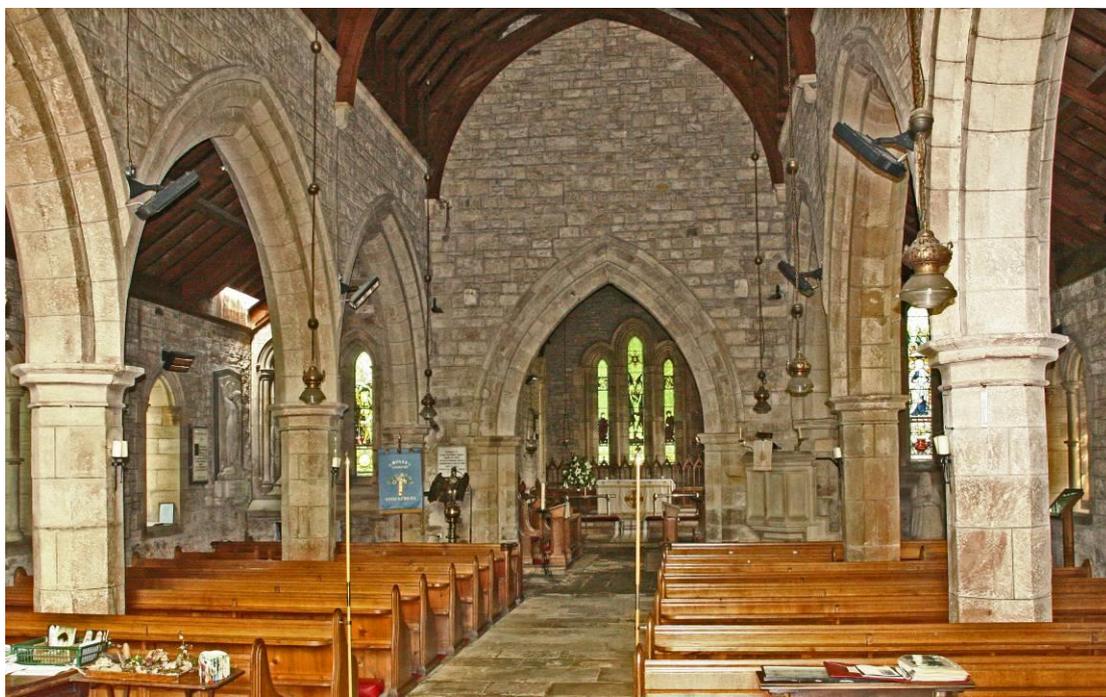
*Interior looking east*

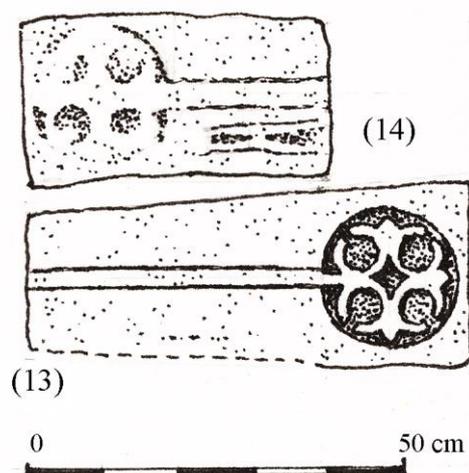
Cross Slabs re-used in west face of western buttress on south side of South Aisle
