The Church of Our Lady, Seaton Delaval

Archaeological Assessment April 2006

PETER F RYDER
B.A., M.Phil, F.S.A
HISTORIC BUILDINGS CONSULTANT

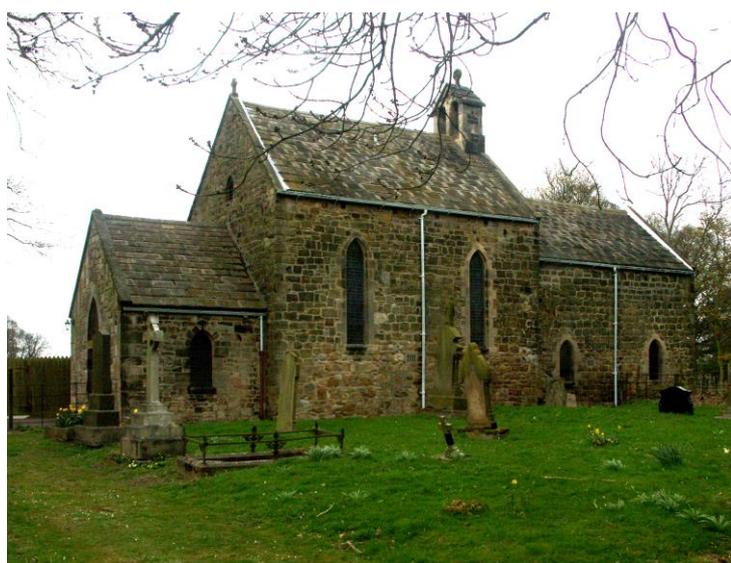
In the centre of the west wall, inside the porch, the west door is a very plain square-headed opening with a semicircular sunk tympanum bordered by a single line of indented zigzag ornament; all that remains visible of the design carved upon the tympanum is what seems to be a head at the top centre, inclining slightly to the r. The door-head has a simple hoodmould chamfered above and below; directly above are a series of three heraldic panels set in ogee cusped frames, re-set remnants (along with five more on the

internal face of the wall) of a late 14th century tomb², and above these is a very plain square-headed window of uncertain date, with a rough relieving arch a course above its monolithic lintel. Higher up, above the porch roof, is an opening into the roof-space which has a crude two-centred arch, apparently cut through rough walling stones. The gable has a coping chamfered on its underside, and a 19th or 20th century cross finial; the northern slope shows a clear structural break between the walling below and the later coping.

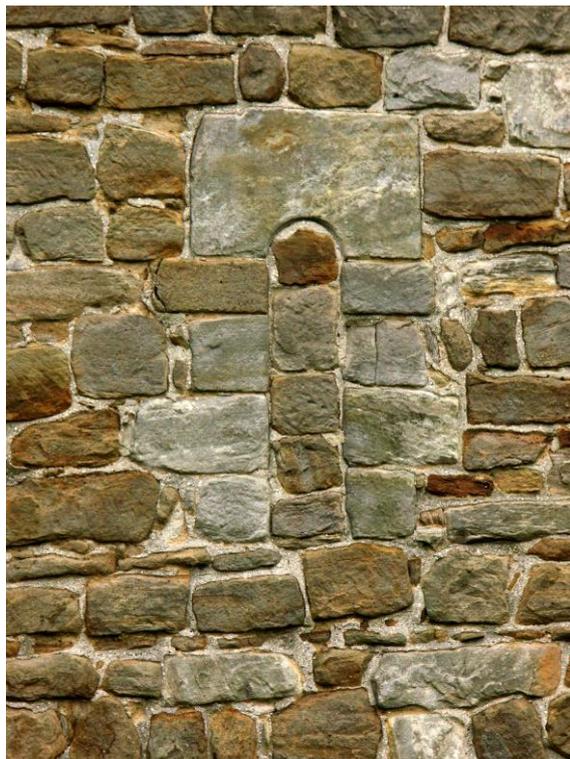
The north side of the nave now has no openings, although there is one blocked window, west-of-centre (left), set in the better-squared masonry of the upper section of wall; it is a simple Romanesque character, with its semicircular head cut into the soffit of a large rectangular block, and rough alternating jambs. Higher up, and slightly east-of-centre, is an odd feature what seems to be an infilled vertical slot cut in the top c2.5 m of the c 6 m high wall.

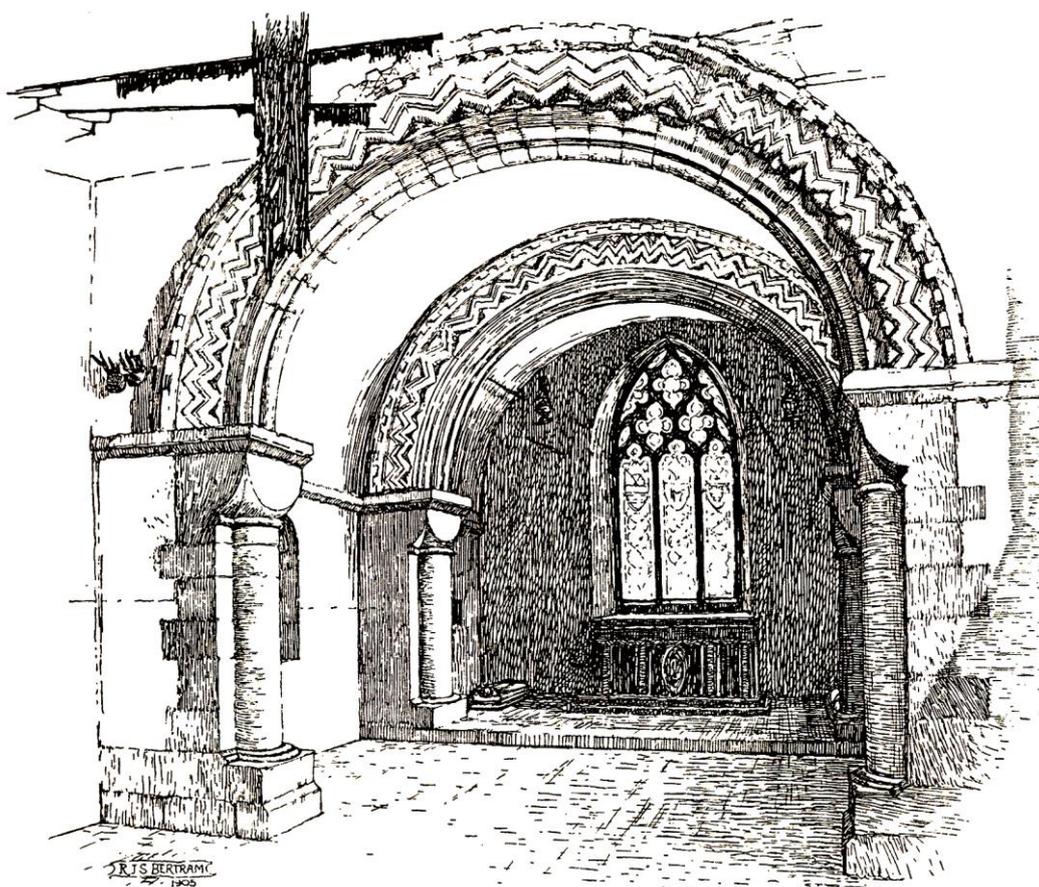
SEATON DELAVAL CHAPEL, INTERIOR.

On the east is the arch into the **Chancel**. This rises from responds with attached half shafts, carrying heavy cushion capitals and an impost band, grooved and chamfered on its lower angle. The arch is semicircular and of two orders, the inner with a soffit-roll between two hollows, and the outer with bold chevron, under a billet-moulded hood with chip-carved patterns ('star ornament') on its face; the east face has a simpler hood. The impost bands of the two arches are continued along the side walls of the chancel and sanctuary, forming the springing of a simple barrel vault, interrupted only by the rear arches of the windows.

The arch into the **Sanctuary** is virtually identical to that between chancel and nave, except for some minor details of its hoodmould, which towards the west has incised chevrons rather than chip-carved geometrical patterns. Both arches are of identical width, but the sanctuary is 0.60 m narrower than the chancel, a reduction achieved by the internal thickening of the walls.
