**The Parish Church of St Michael and All Angels,
Newburn-on-Tyne, and its West Tower**
Archaeological Assessment
combined with
Archaeological Recording of West Tower
after 2006 Fire

PETER F RYDER
B.A., M.Phil., F.S.A
HISTORIC BUILDINGS CONSULTANT

St Michael and All Angels, Newburn and its West Tower

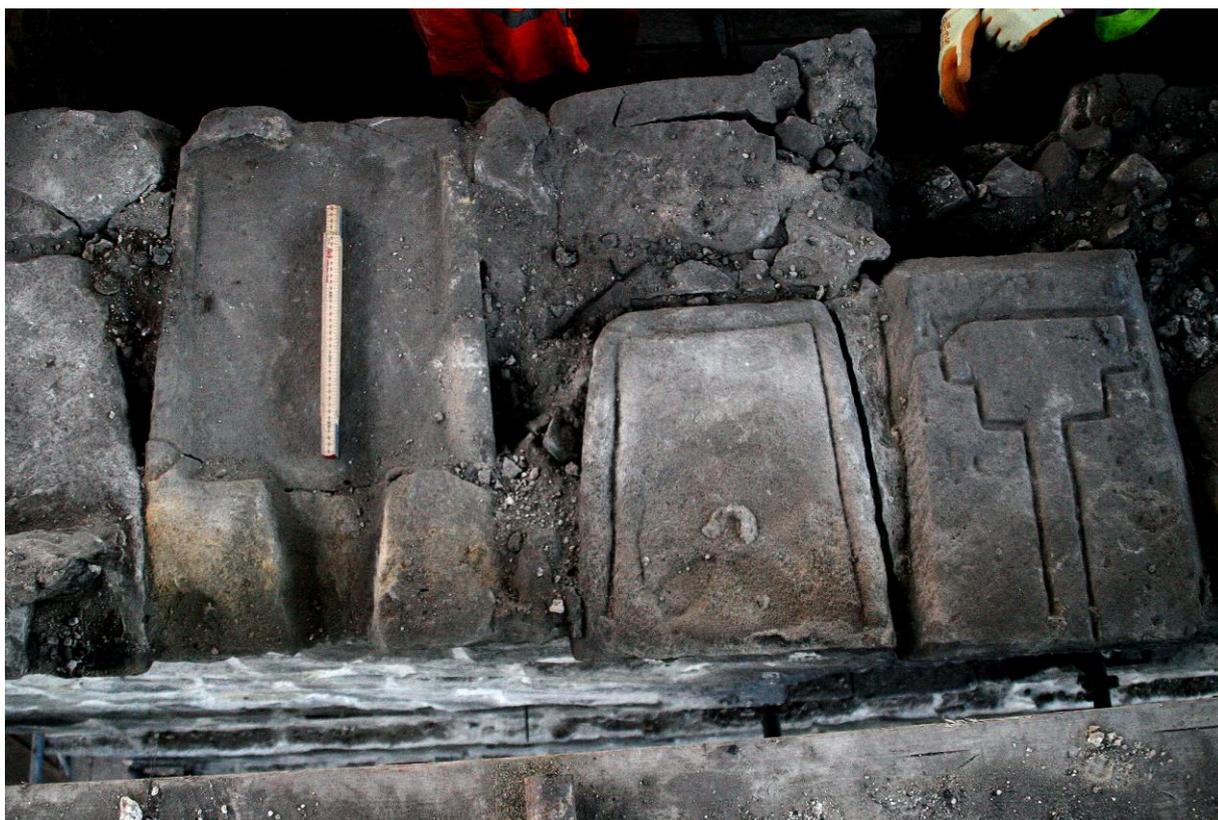
Large sections of the wall head of the tower were rebuilt in 2006/7; whilst the actual parapet had been rebuilt, at least in part, the wall top included several slabs hollowed out as drains, with narrower spouts which ran out beneath the parapet. Towards the east end of the northern wall head two sections of medieval cross slab grave covers had been re-used, face up, immediately to the east of one drain/spout. Another section of one of the same slabs retrieved from the western wall head had been turned upside down and its rear face hollowed out as a drain.

Re-used cross slabs and drain slab on north wall head of tower, 23 1 2007

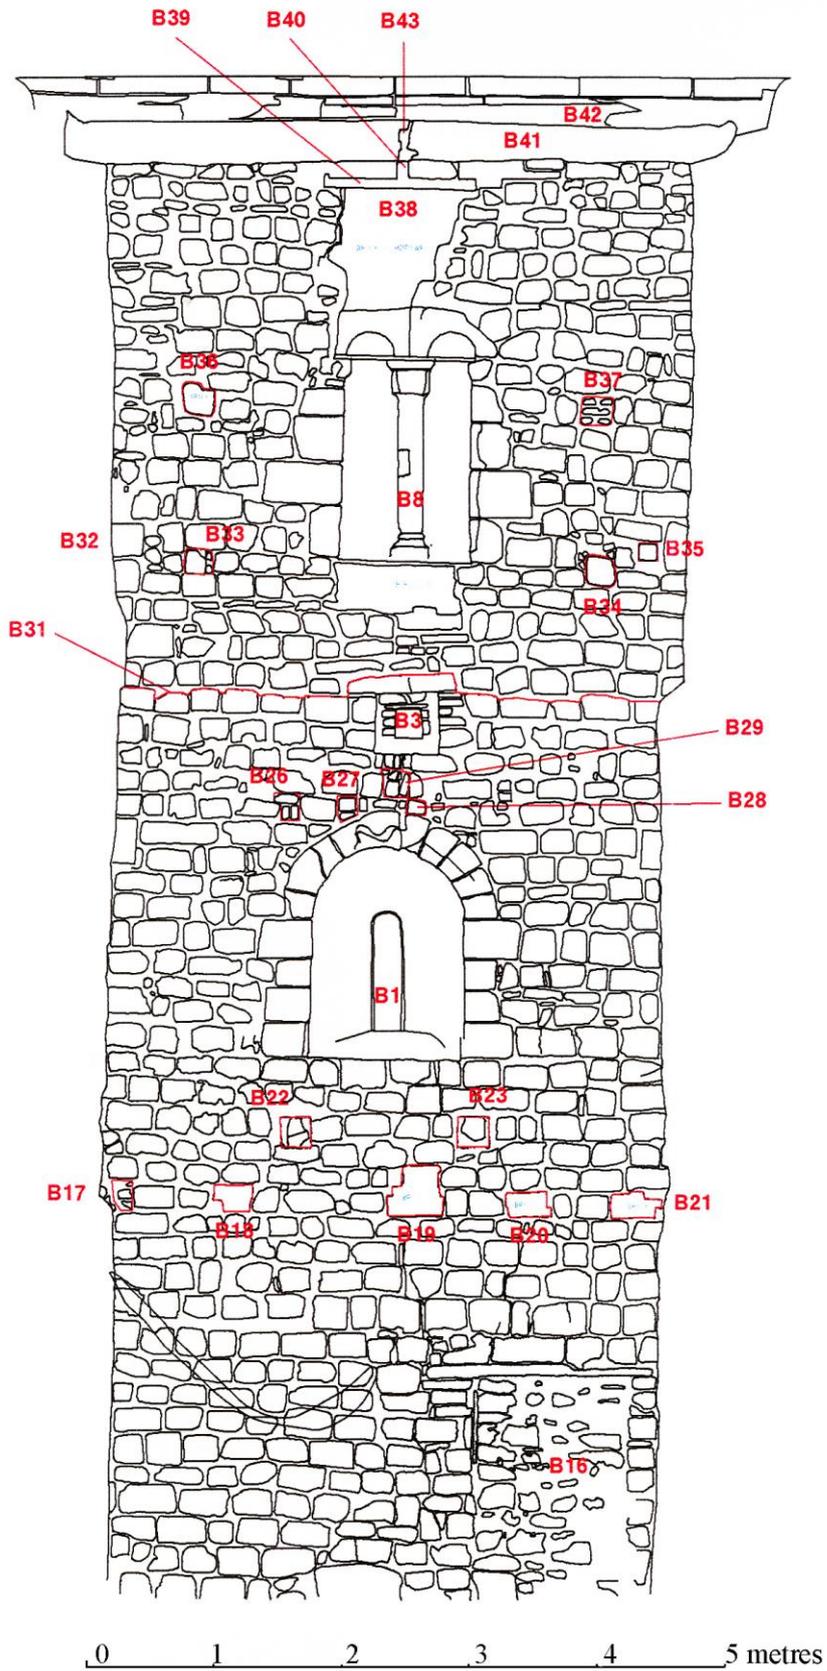
Fig.4
 West Tower
 Internal Elevation
 of South Wall

- B17-21 A line of bricked-in sockets a course below the second-floor corbels B22 and B23.
- B22/23 Quadrant-section corbels, damaged by the fire, that carried the second floor timbers.

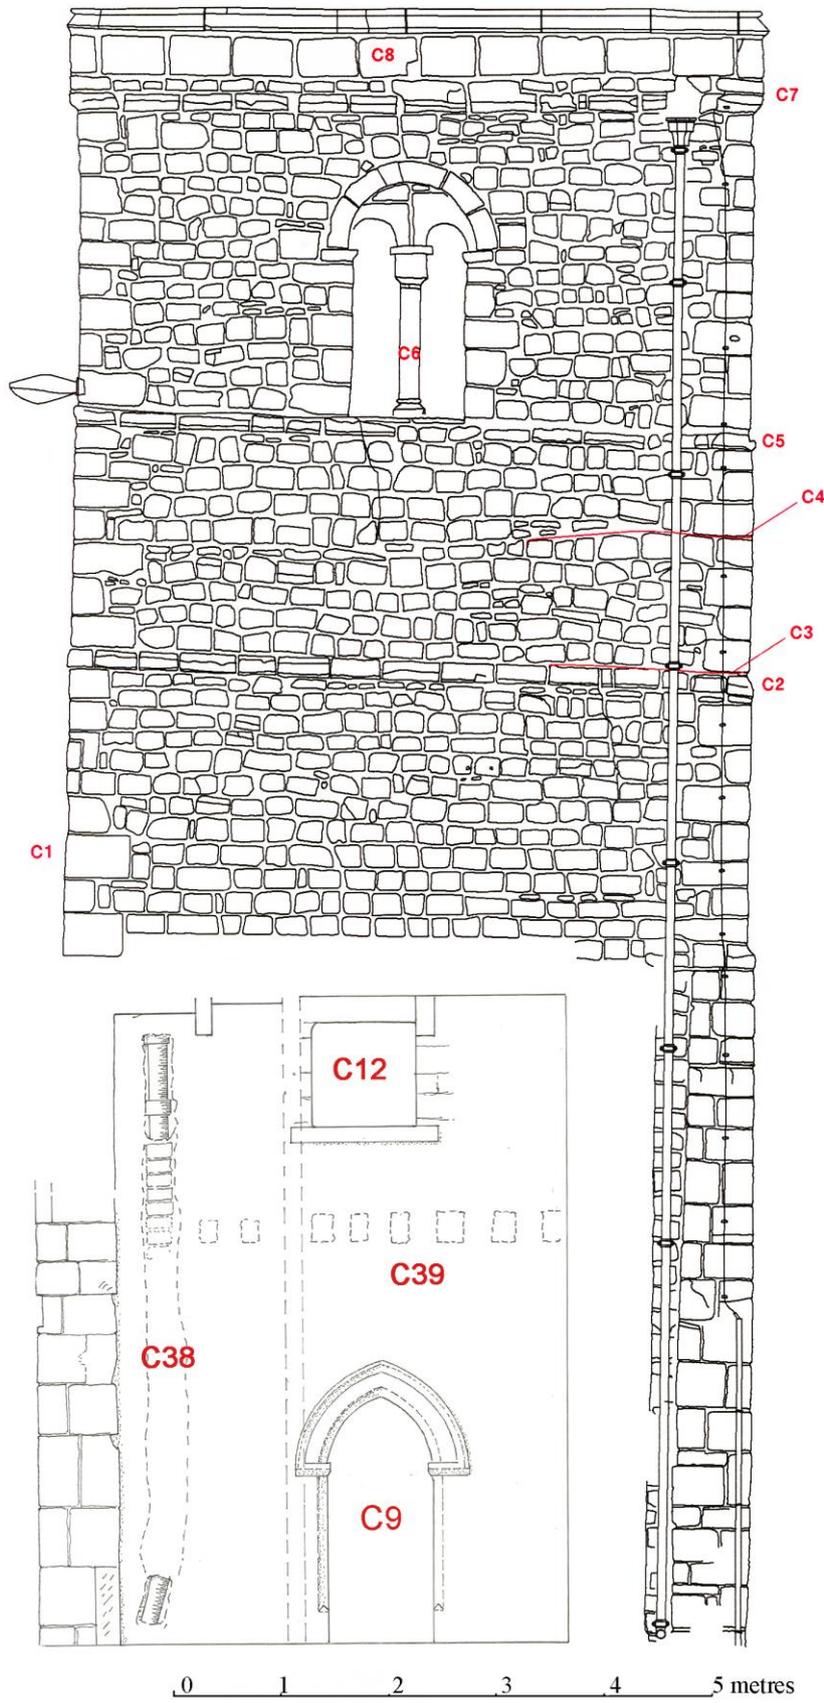
Fig.5
 West Tower
 North Elevation

- C6 Northern belfry opening renewed base and shaft and capital. Five thin flagstones make up sill. Internal jambs and head damaged; inner part of capital and block above gone, leaving inner slabs of heads of lights hanging in mid air. Shaft and outer heads of lights renewed.

- C7 Oversailing course, cut into for drainpipe at west end.
- C8 Parapet
- C9 Doorway from west end of north aisle into tower. Towards aisle this has a two-centred arch with a hollow chamfer, broken by imposts, chamfered beneath, which link to a hoodmould/label that is chamfered on its lower angle. The doorway is rebated, and its inner jambs cut square with the wall; the rear arch has a segmental head (with a chamfer to the arch only). Diagonally-tooled ashlar dressings of 19th-century character. Attached to the external face of the wall around and above the head are several memorial tablets.

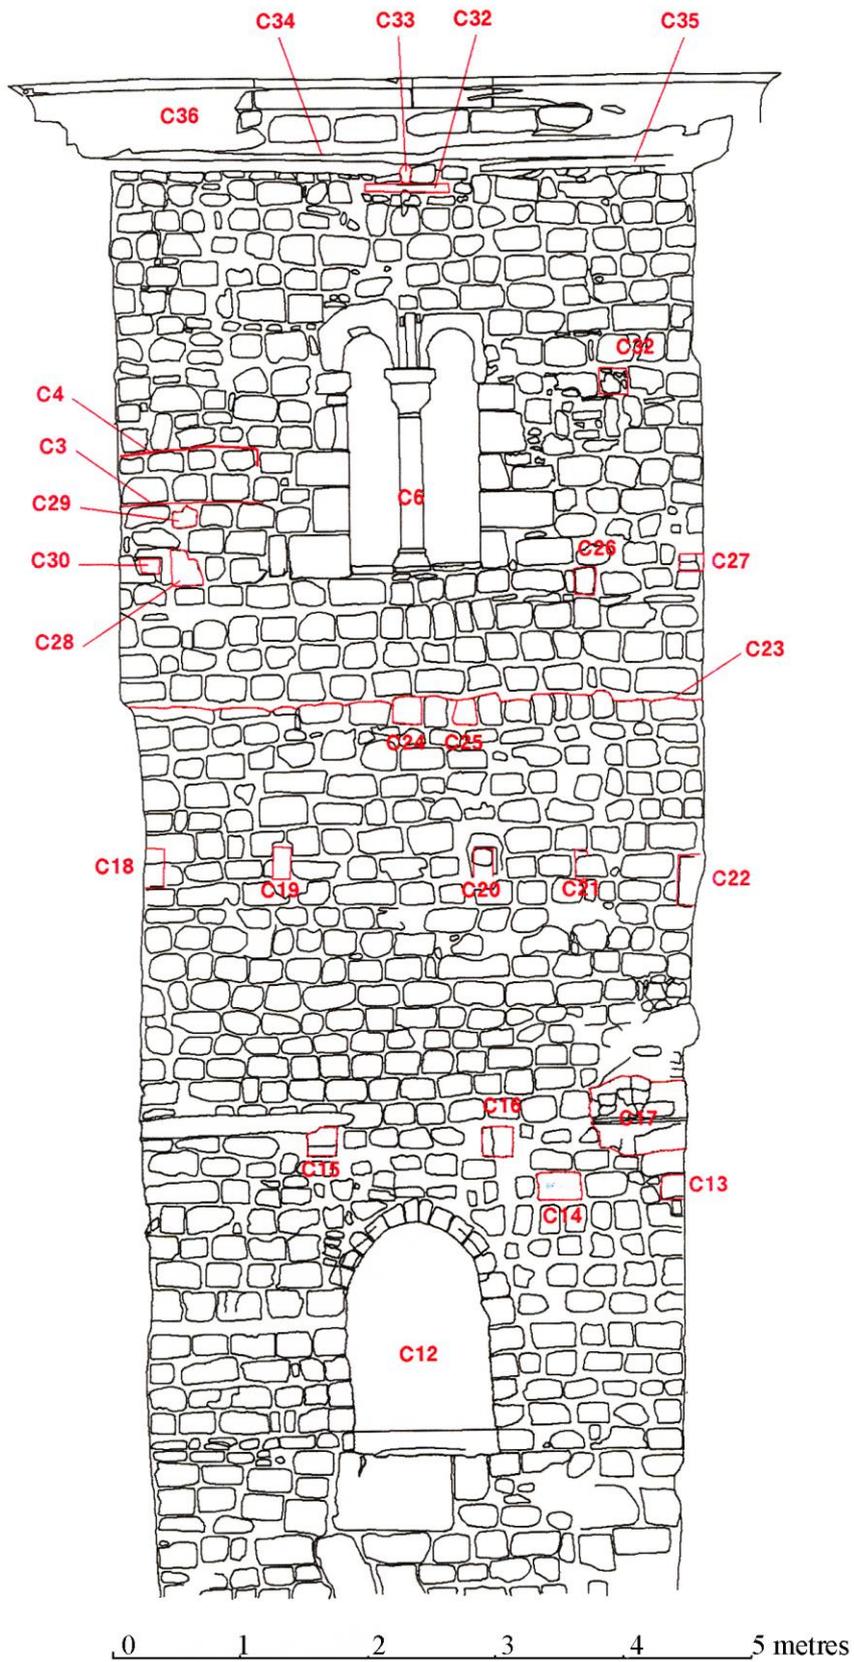
Fig.6

- C15/16 Quadrant-section corbels, damaged, to carry the second-floor timbers.
- C17 At the same level as C15/16, a projection spanning the north-east corner of the tower, incorporating a metal plate; above the plate is loose stone and some brick, and a bulge in the wall face. This loose material was cleared in December 2006 and revealed a crudely-cut sub-circular opening into a cavity/flue beyond, which extended a short distance upwards (behind the 'bulge'), but rather further down; c 0.9 m below was the top of what looks like a vertical pipe c 250mm in diameter (throwing small stones in suggested that this was blocked c 1 m down). The north side of this cavity may be infill (see C 37). A flue seems to have continued up the internal angle of the tower above this feature – a c1900 photograph (Newcastle City Library ref 26069) shows a vertical pipe or chimney rising above the parapet at this point.

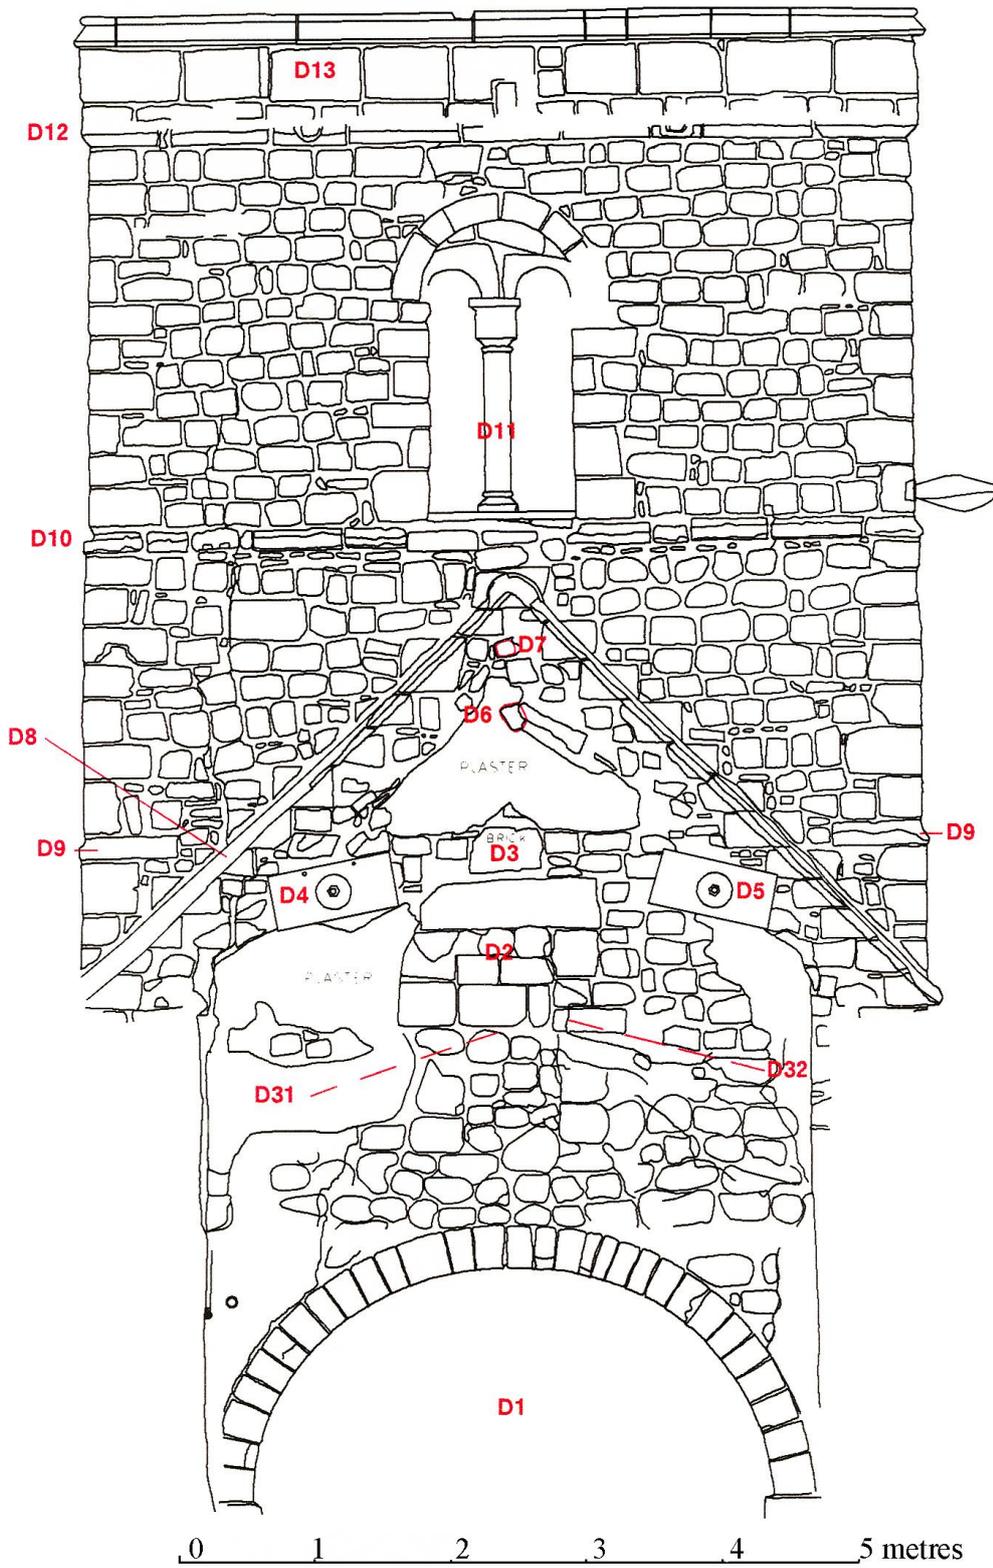
Fig.7
 West
 Tower
 East
 Elevation

The tower opens to the nave by a wide and lofty semicircular arch (D1), virtually the full width of the nave (fig.7). Its head is of one plain square order, made up of pairs of voussoirs which each span approximately half the thickness of the wall, neatly curved on both extrados and intrados. The western face of the arch was badly damaged in the fire and all its dressings have been renewed; on the east damage has been disguised by the cutting of a new chamfer, which has a chamfered stop three voussoirs above each impost. All these dressings were quite neatly cut, but there was nothing definite to show that they had been heavily re-cut or renewed, as one might suspect at first glance. Towards the nave the lower metre or so of each jamb has been cut back diagonally, and finished above with an ogee-like stop c 1 m above the floor. The imposts are large blocks, chamfered beneath, with a groove directly above the chamfer; on the west they seemed to return into the side walls of the tower, seemingly indicating that arch and side walls are of one build.

- D11 The belfry opening, with a cemented sill, and renewed base and shaft. On the inner face the rear surface of the northern light has spalled away, and the internal jambes are quite badly damaged. Shaft and heads of lights renewed except for inner block of northern light.

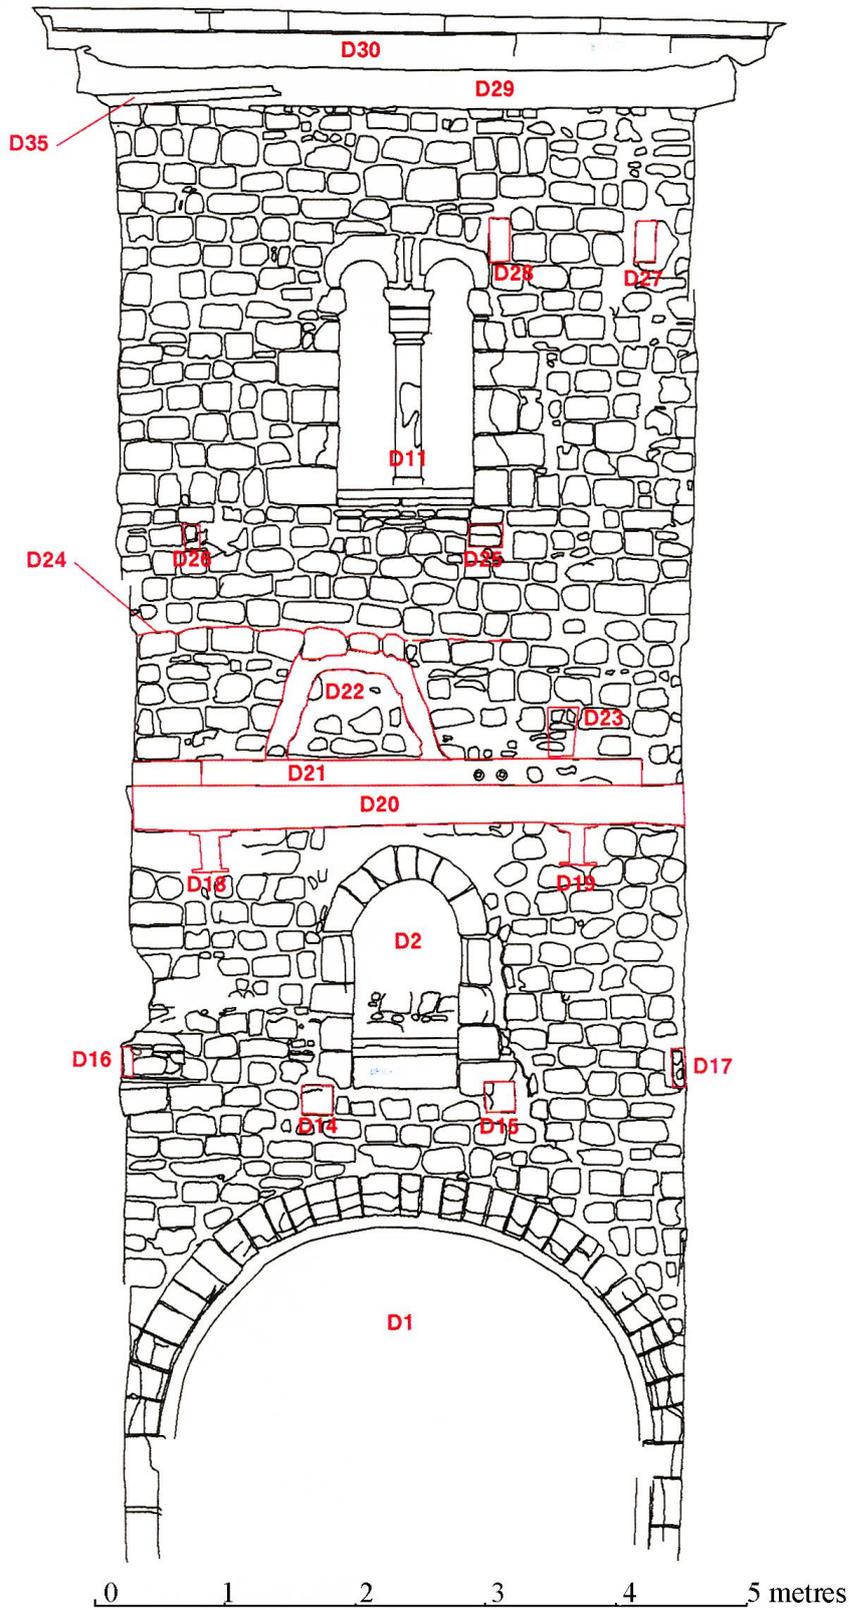
Fig.8

jambes are of plain square section, except for a broad chamfer towards the nave, rising to an ogee-like stop c 1 m above the floor. The imposts are large blocks, chamfered beneath, with a groove directly above the chamfer; on the west they seem to return into the side walls of the tower, perhaps implying that the arch was constructed first. The arch is of a single square order, and some of the voussoirs look surprisingly 'square', with a fresh diagonal tooling. There are no through stones. Towards the tower the upper parts of the jambes, imposts and arch itself are all badly burned and broken.

- D14/15 Quadrant-section corbels, damaged, that carried the timbers of the second floor.
- D16 Narrow socket for a timber running on the internal face of the north wall, in this case cut into the masonry of projection C17.

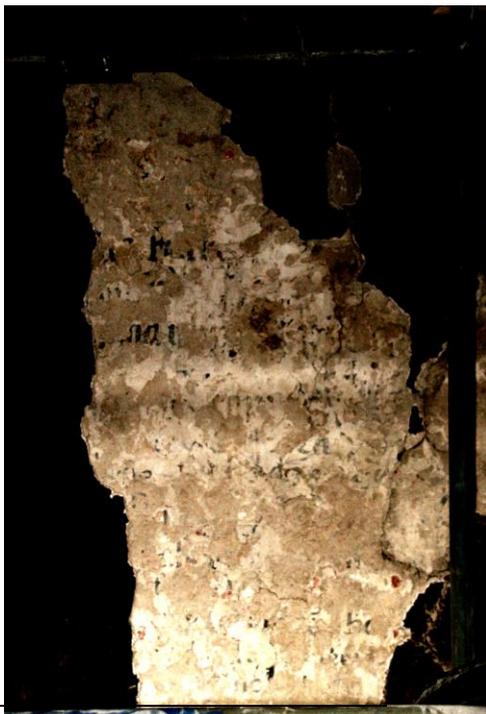
When the nave wall above the north arcade was partially stripped of plaster fragmentary remains of wall paintings – texts in black letter – were uncovered (left), and thought to be of early post-medieval date. It is understood that similar remains had been seen during mid 20th century works and deemed of little interest.

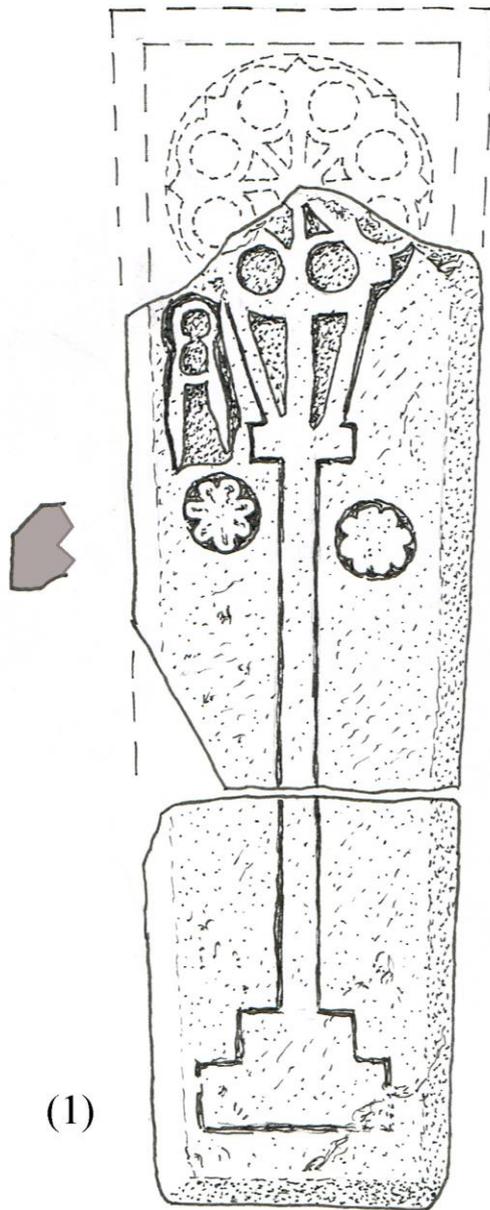
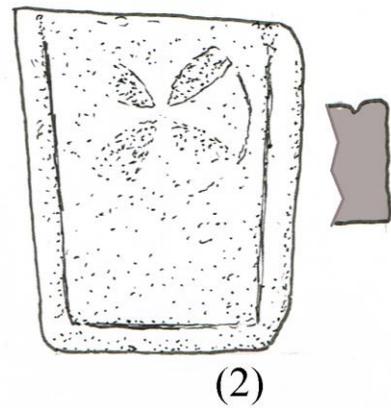
Cross Slab Grave Covers
from tower parapet
Newburn Parish Church
2007

In 2006/7 three pieces of medieval cross slab grave cover were found re-used in the wall head of the tower; two of these (one re-used face-up on the north wall and one face-down on the west) fitted to make up the greater part of slab (1).

- (2) A small slab of whitish gritstone 0.62 long, and tapering from 0.145 to 0.37 m. It has an incised border line, and a very worn cross paté with sunk segments between the arms. The top of the slab seems to be missing – the border line seems to have continued further – so the question is as to whether this is a virtually complete stone (in which case it is of quite unusual form, a grave marker bearing a cross) or possibly part of a more normally-proportioned elongate slab, in which case the cross is unusually positioned, unless it had two crosses, towards head and foot, and we are looking at the lower one. Probably 12th century.
