St John the Baptist

Meldon

An Archaeological Assessment

July 2014

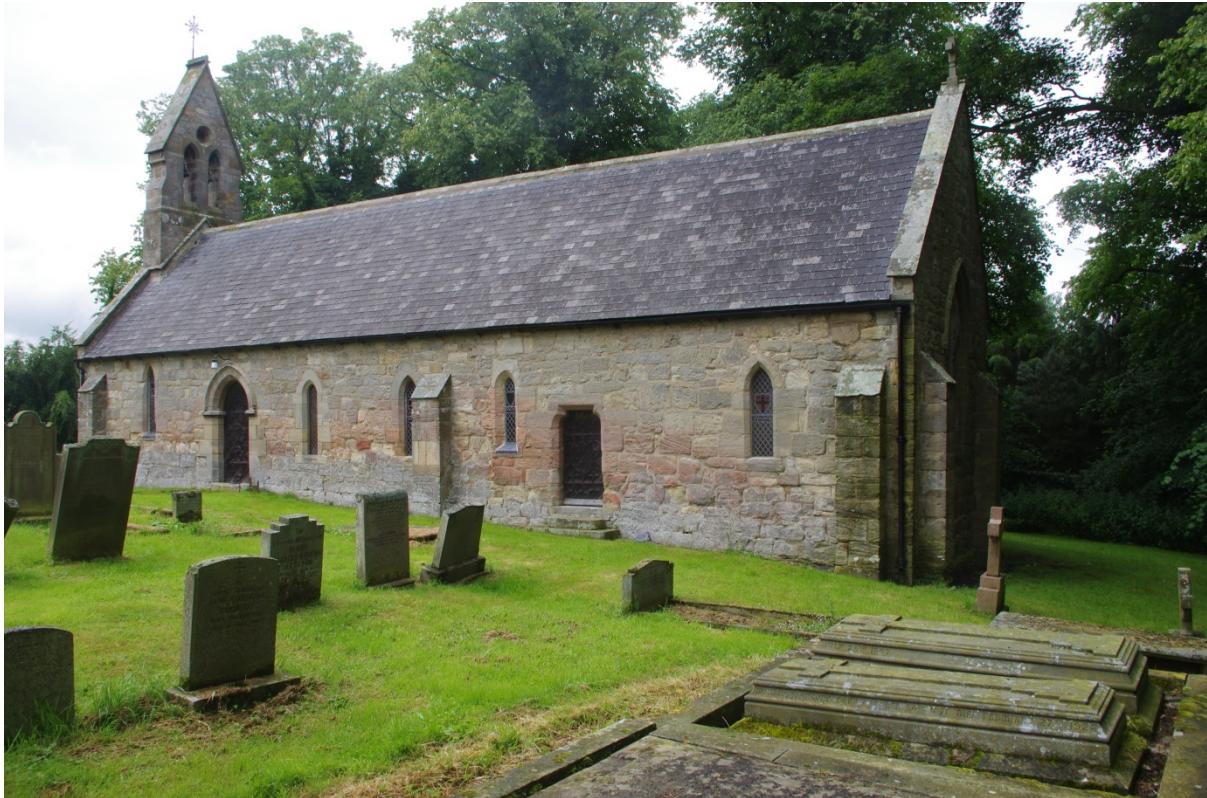
The church from the south-east

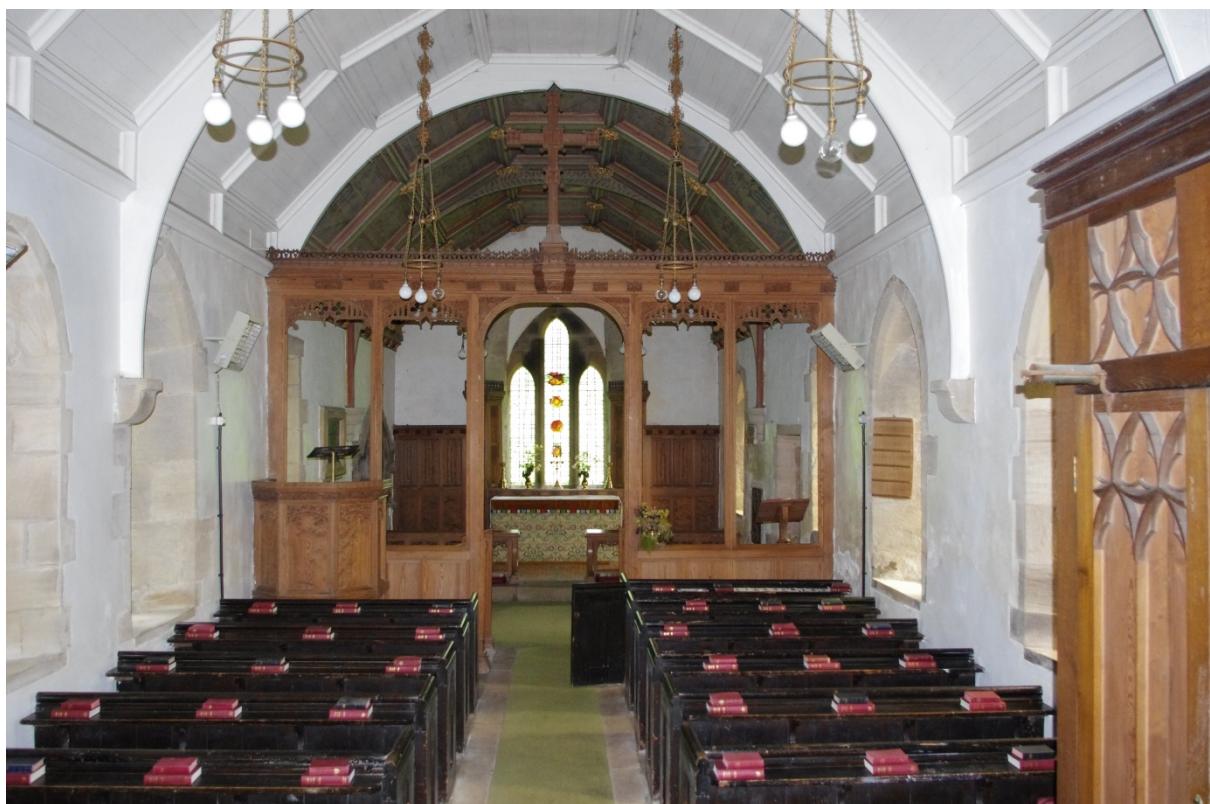
Interior looking east

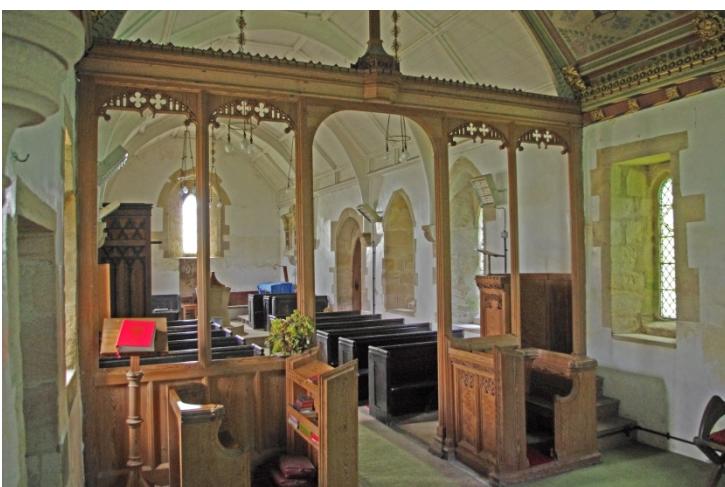
The interior

Looking north-west
