St Mary the Virgin
Longframlington
Northumberland

An Archaeological Assessment

March 2009

PETER F RYDER
B.A, M.Phil, F.S.A
HISTORIC BUILDINGS CONSULTANT

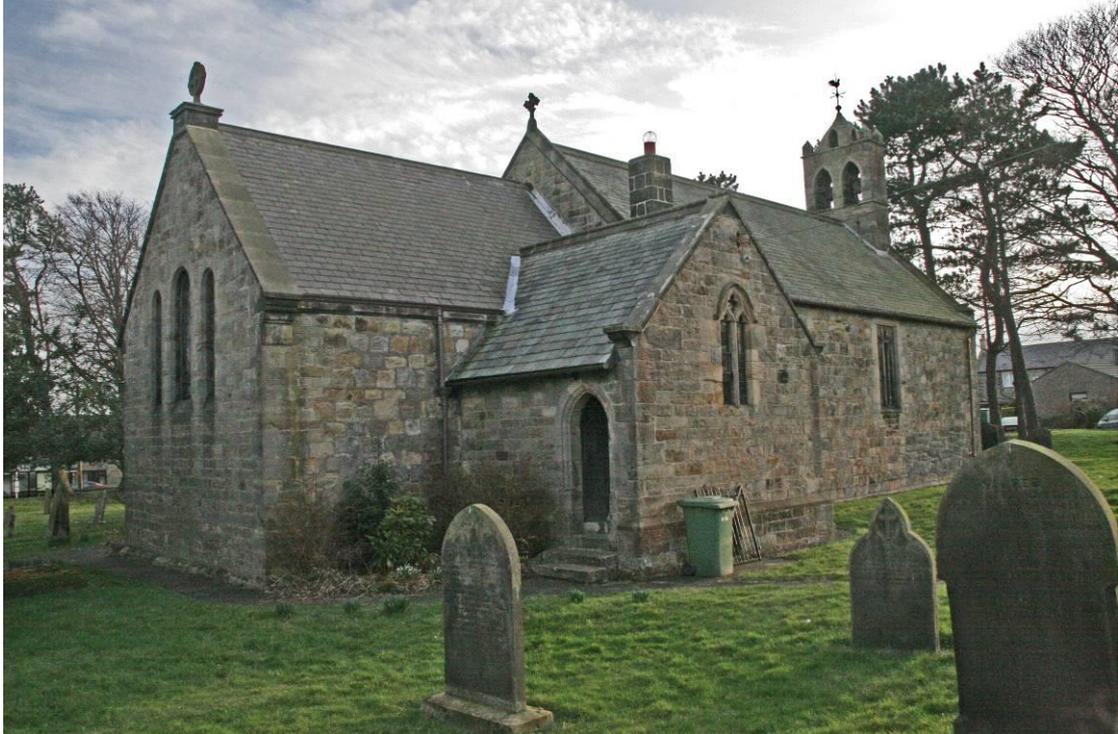
The church from the north-east

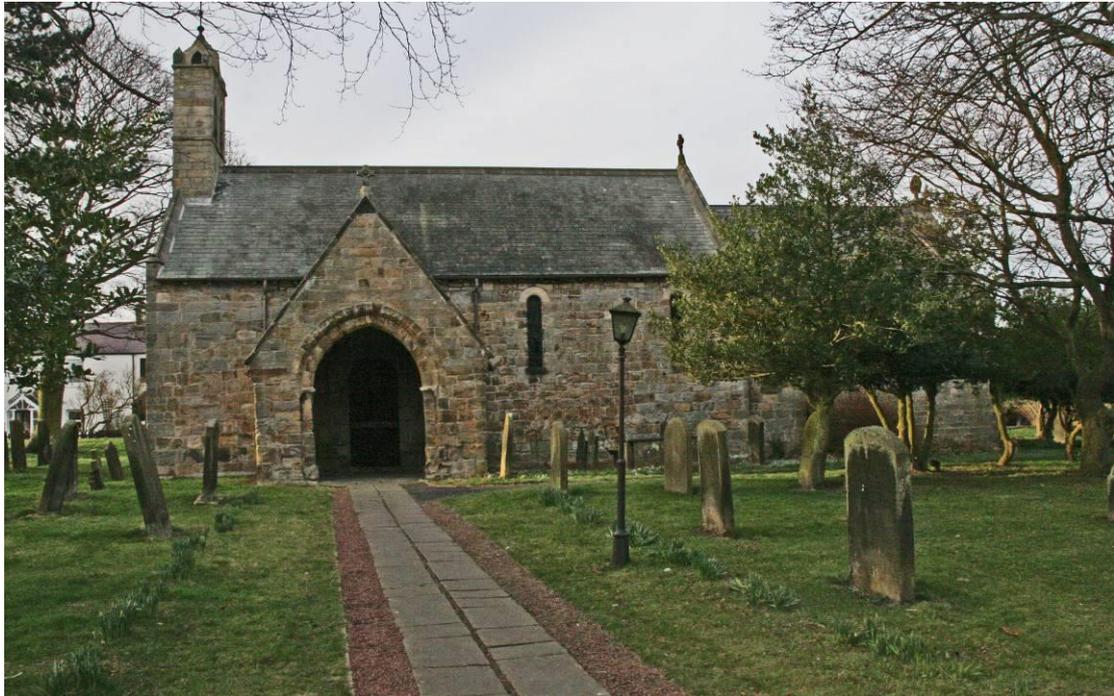
The church from the south

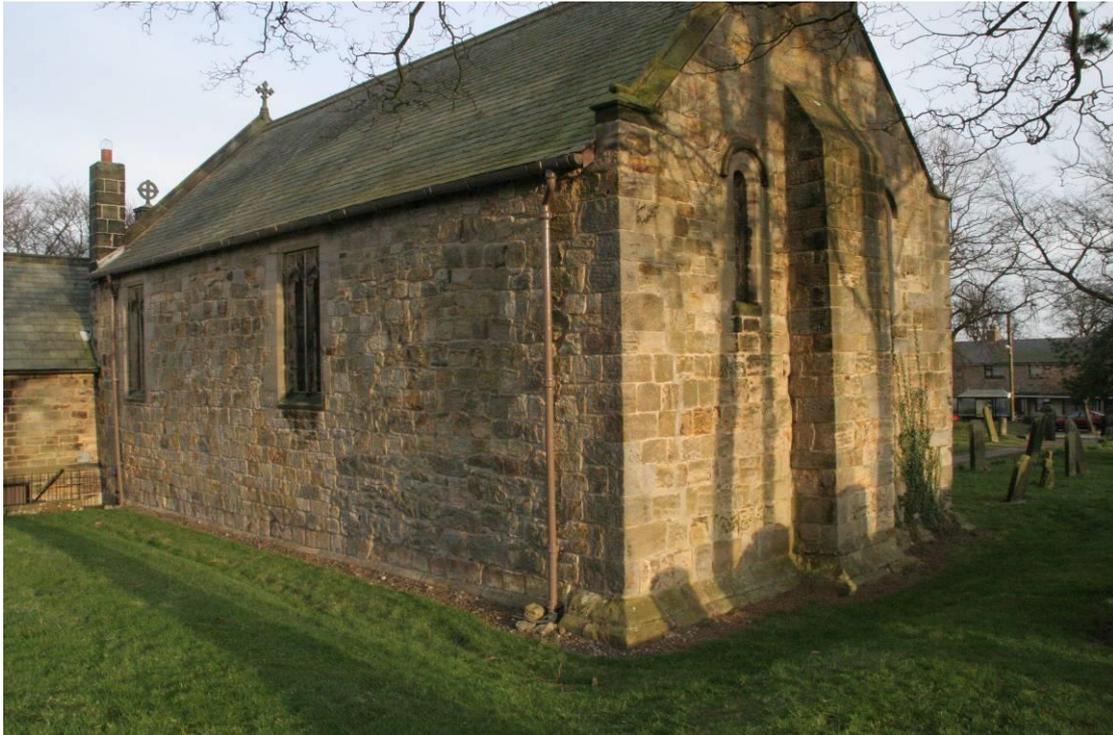
At the west end of the wall there is a ragged break, with a vertical line of 19th-century patching, c 0.50 m short of the angle quoin, perhaps indicating that the north-west quoin has been rebuilt. There are two square-headed windows in the north wall, each of two trefoiled ogee-headed lights with pierced but uncusped spandrels; all their dressings are of late-19th century diagonally-tooled ashlar. At around 0.75 m from the east end of the wall (ie the west wall of the vestry) there is an irregular vertical joint in the lower courses, again hard to interpret. The lower part of the north-eastern quoin is concealed by the vestry, whilst above the angle of the nave is topped by an ashlar chimney stack which looks, in its present form, relatively recent.

The nave from the north-west

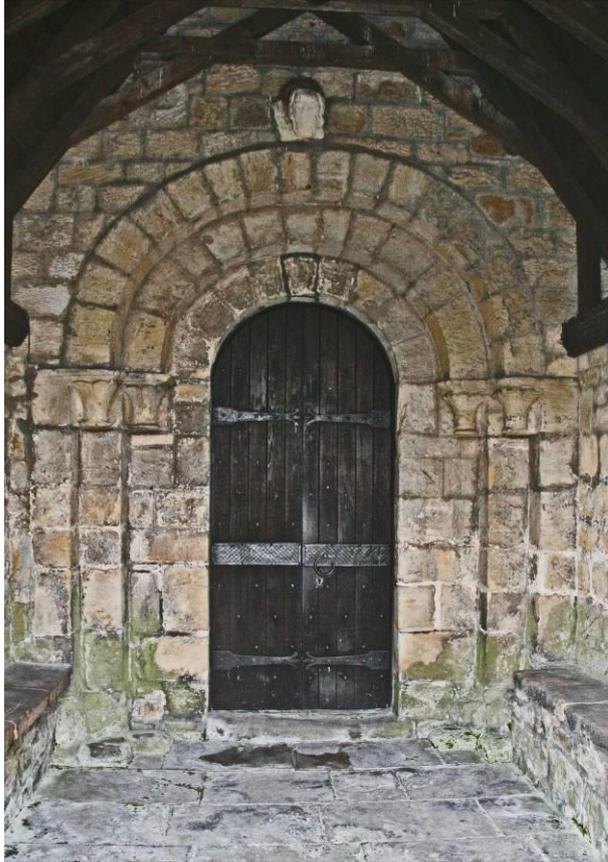
The South Doorway

The inner doorway is a fine piece of late 12th-century work, a semicircular arch of three square orders; although not ornate, this is quite an ambitious portal for a church of this side³. The inner orders is continued down to the ground, whilst the outer two have been carried on jamb shafts; these have gone, together with their bases, but their waterleaf capitals remain. A straight joint immediately outwith the west jamb shows that the doorway was set in a shallow gabled projection, rising higher than the aisle wall (cf, on a grander

scale, the north door at Brinkburn Priory); the walling above the arch appears to have been renewed. Above the outer order of the arch is a carving of a bearded human head (probably a representation of Christ) in whitish sandstone, now rather worn.

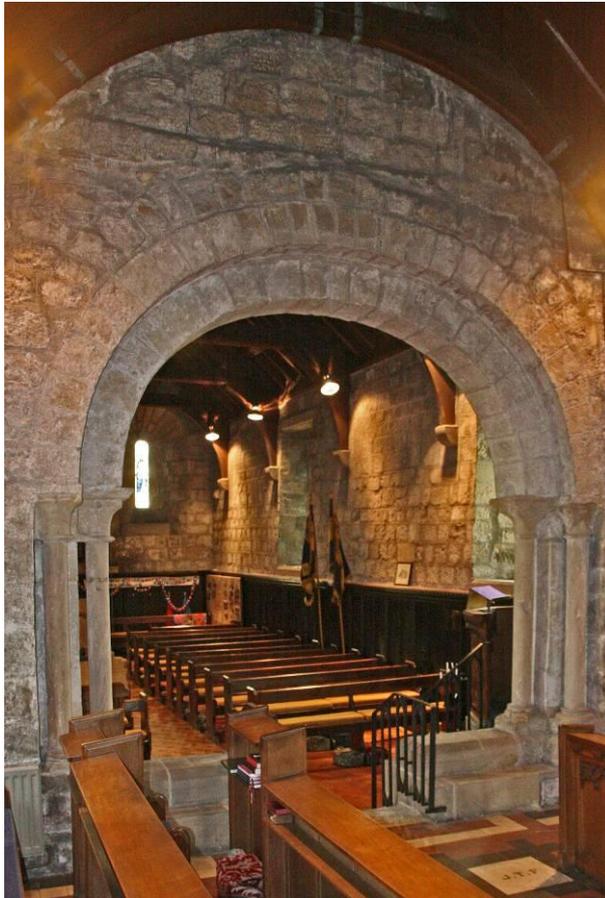
The Chancel Arch from the south-east

The arch into the Chancel is arguably the most important architectural feature of the building; it is roughly semicircular (there has been a little movement) and of two square orders, set on detached shafts – which really do stand well clear of the jambs - with good waterleaf capitals and hold-water bases, now rather damaged; the impostes are hollow chamfered on the lower angle. The bases are set c 1m above the level of the nave floor, and between them is a low ashlar screen wall, with a central opening, all of late 19th century date. nave floor two steps up, also low screen wall chamfered on upper margins all C19. In

wall above arch there is an outer series of roughly-shaped voussoirs, commencing c 1.2 m above the impostes; such outer orders are often a Victorian feature but this may not be the case here. The eastern face of the arch is similar.

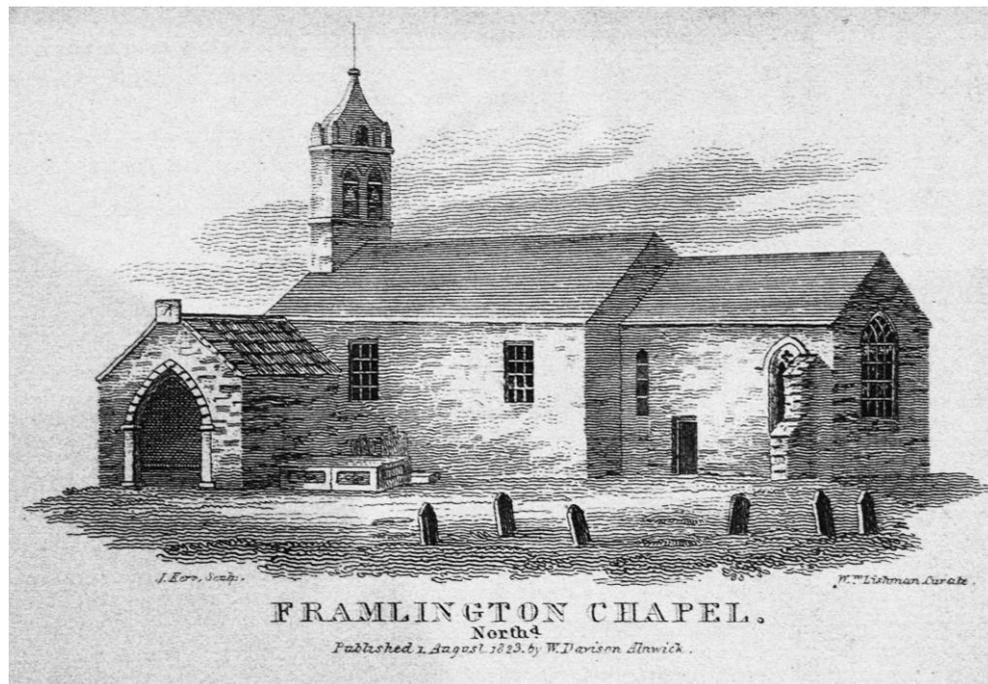
Davison's print of 1823 (a copy is hung in the church) (above) and Wilson's 1870 drawing and plan provide a useful record of the church before its late Victorian restoration. Many of the windows had been enlarged into plain square-headed sashes; there was a big stepped buttress at the east end of the chancel south wall (presumably countering some structural problem) and a plain Gothic-arched window in the east end, holding a sash with intersecting glazing bars in its head.

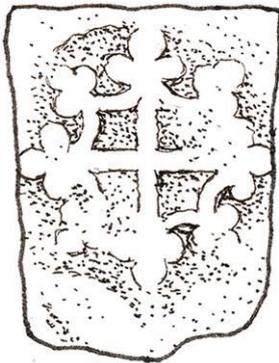
Cross Slab Grave Cover
St Mary the Virgin, Longframlington

The western section of the north wall looks undisturbed, except perhaps for its upper metre or so; c 3.5 m above the floor there are remains of three cut-back corbels, the first only 0.20 m or so from the west wall, the second c 2m beyond and the third just short of the 19th-century corbel carrying the second roof truss; there does not seem to be any sign of corresponding corbels on the south wall. The two square-headed windows both retain some old work in their inner splays, although their lintels and sills are 19th-century ashlar. Built into the eastern splay of the western window is the upper part of a 13th or 14th century cross slab grave cover.

built into eastern internal splay of
the western of the two windows on
the north side of the nave
