The Church of St Wilfrid Kirkharle

An Archaeological Assessment
May 2006

St Wilfred, Kirkharle

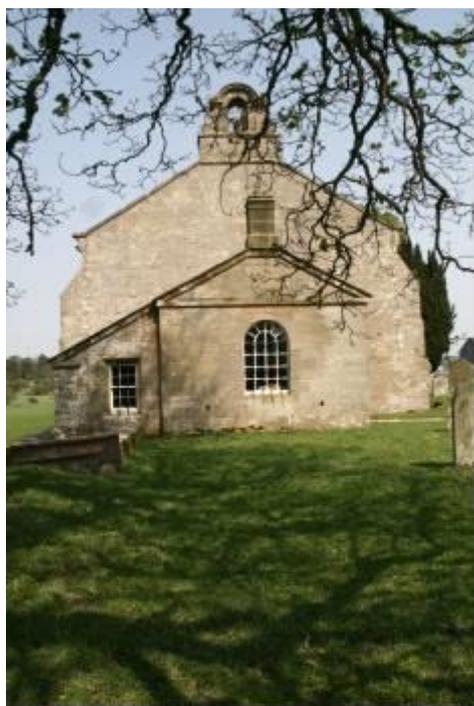
The west end of the **Nave** (left) is of good-quality coursed well-squared fawn sandstone, with some breaks in coursing where the re-used medieval fabric of the main wall abuts against the in-situ masonry of the buttresses at either end. The broad shallow-pitched gable has moulded kneelers and a square-section coping, and is capped by a Classical-styled bellcote that has a moulded round arch under an archivolt carried on raised pilasters.

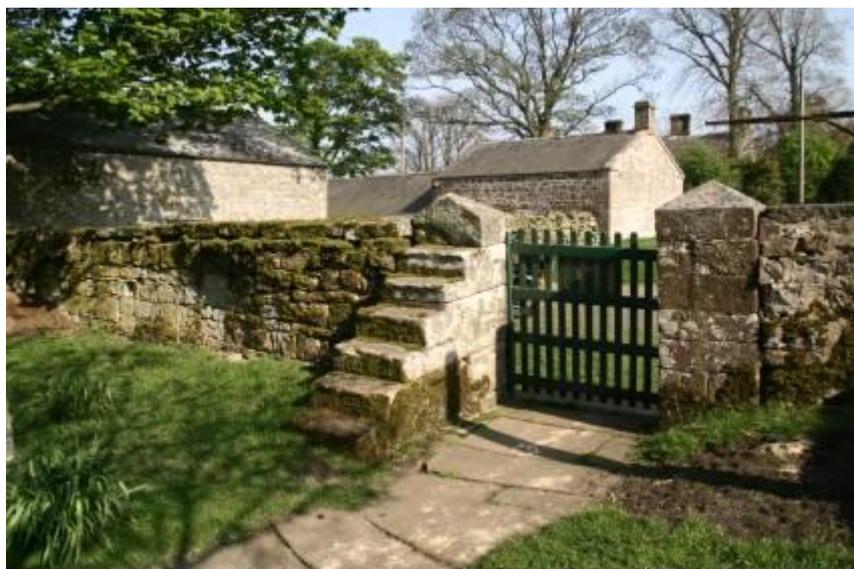
with their low pyramidal caps and the adjacent mounting block (left). The north wall is more in the nature of a retaining wall, 0.6 m high on the uphill (churchyard) side and c 2 m on the downhill side. Towards the north-west angle, beyond the boiler room stair, there is a raised mound running along its inner face, of uncertain origin; could this be debris from the demolished parts of the medieval church?.

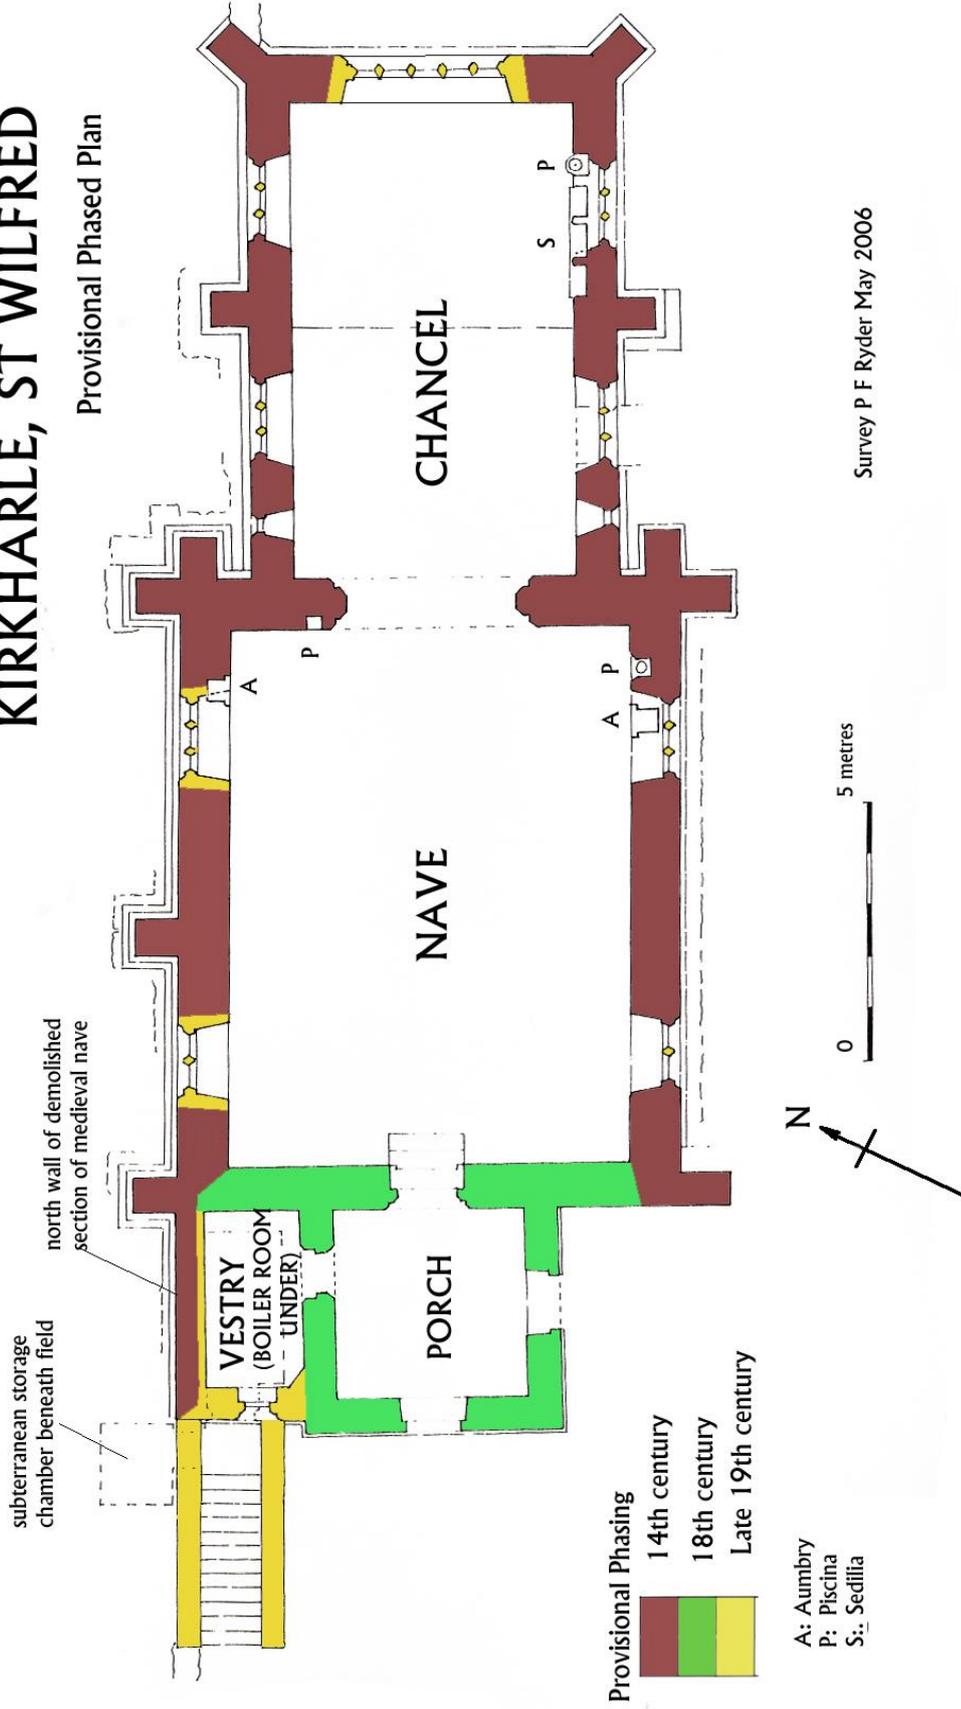
Provisional Phased Plan

Kirkharle is an unusual church for Northumberland in being virtually entirely a building of the first half of the 14th century; the only physical evidence of any preceding structure is a pair of late 12th century cross slabs now standing against the internal face of the north wall of the sanctuary (Ryder 2002, 81 & 110). All the surviving medieval architectural features are of the earlier 14th century, although the discontinuities between the plinths of nave and chancel, and the apparent disturbed masonry around the chancel arch, suggest that there may have possibly been two phases of work.

It is clear that the 14th-century nave has been shortened; this probably took place during Sir William Loraine's alterations in the first half of the 18th century; at least a bay of the nave, and perhaps also a west tower and south porch, have been lost.
