# St Michael and All Angels, Ilderton

## Archaeological Assessment

September 2012

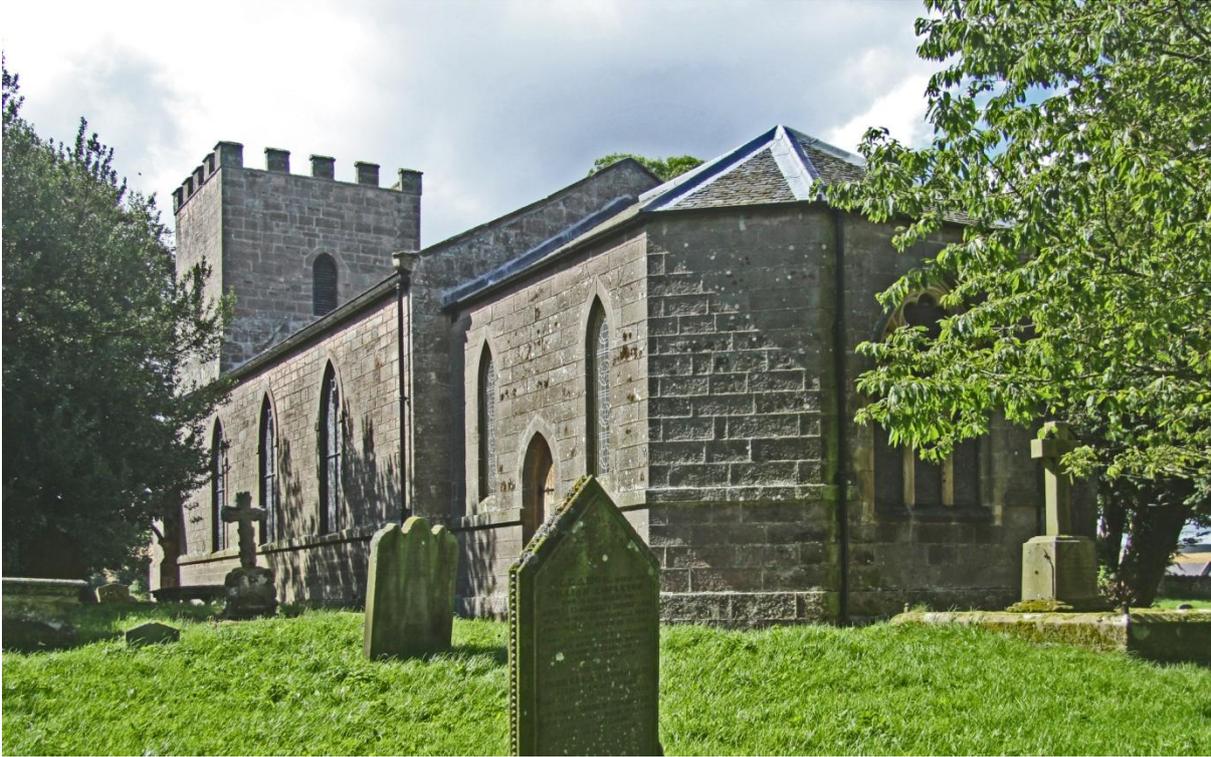
*The church from the south-east*

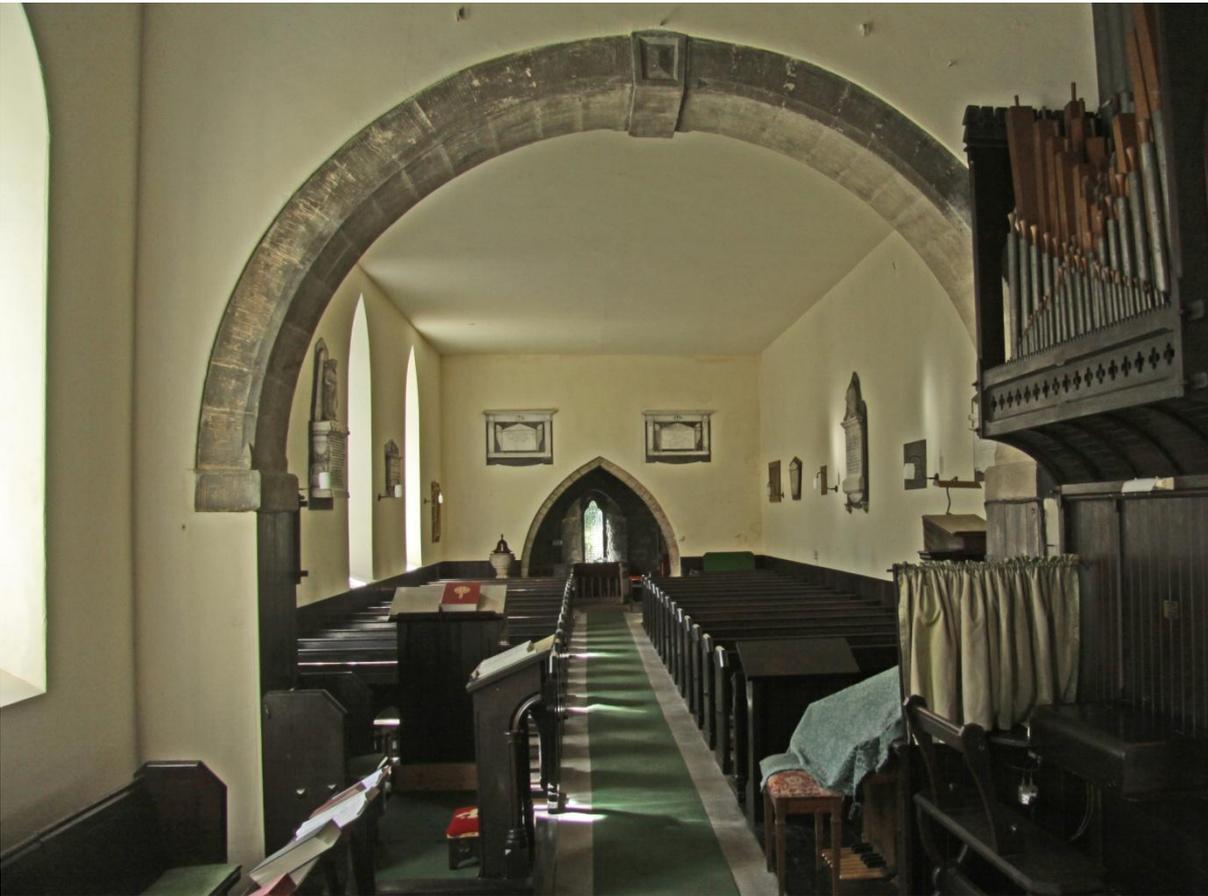
*Interior looking west*
