The Church of the Holy Cross Haltwhistle

Archaeological Assessment
June 2005

PETER F RYDER
B.A., M.Phil, F.S.A
HISTORIC BUILDINGS CONSULTANT

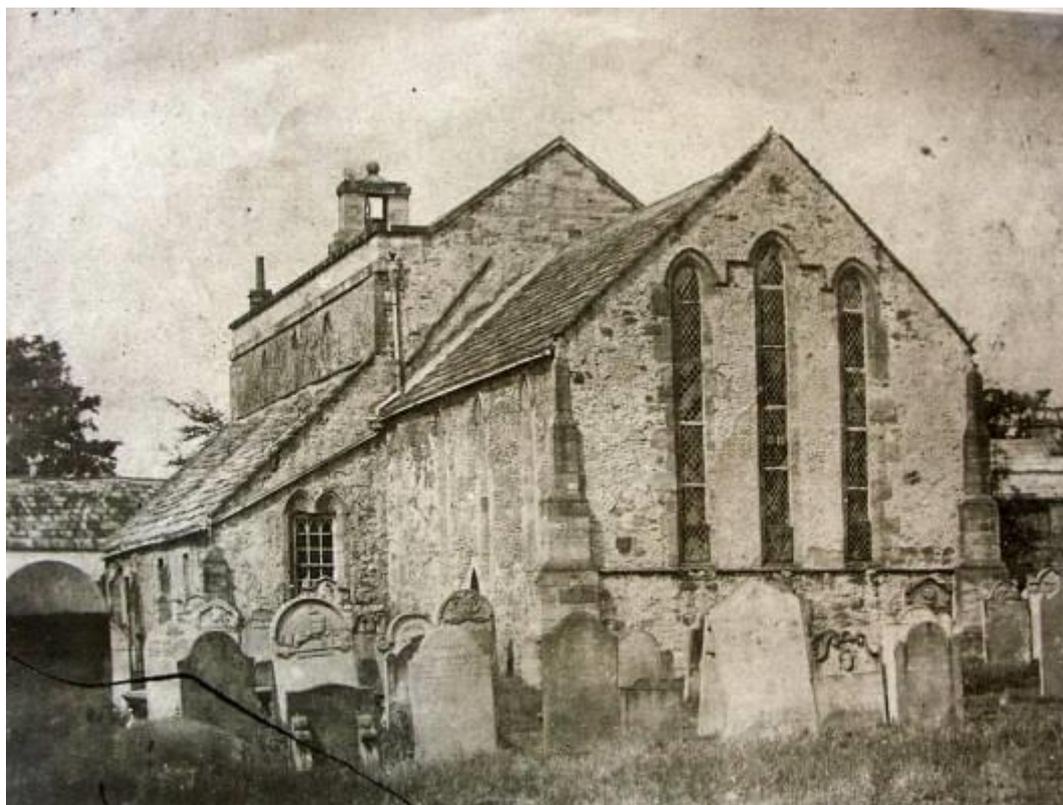
The church from the south-east, before the 1870 restoration

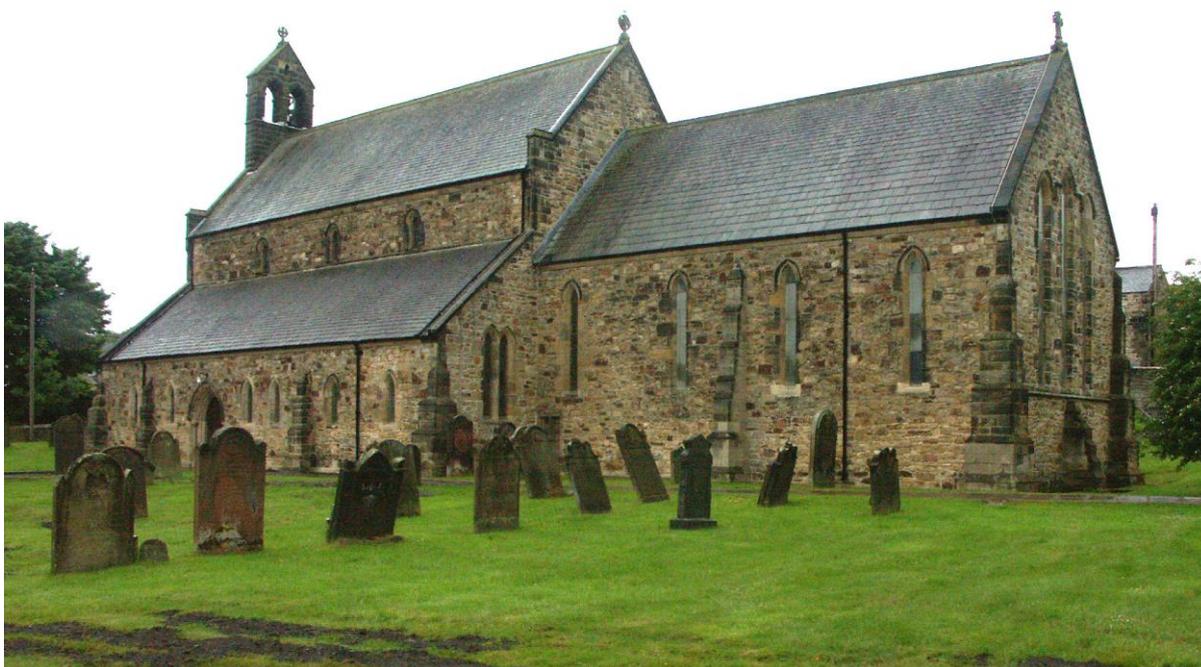
The church from the south-east

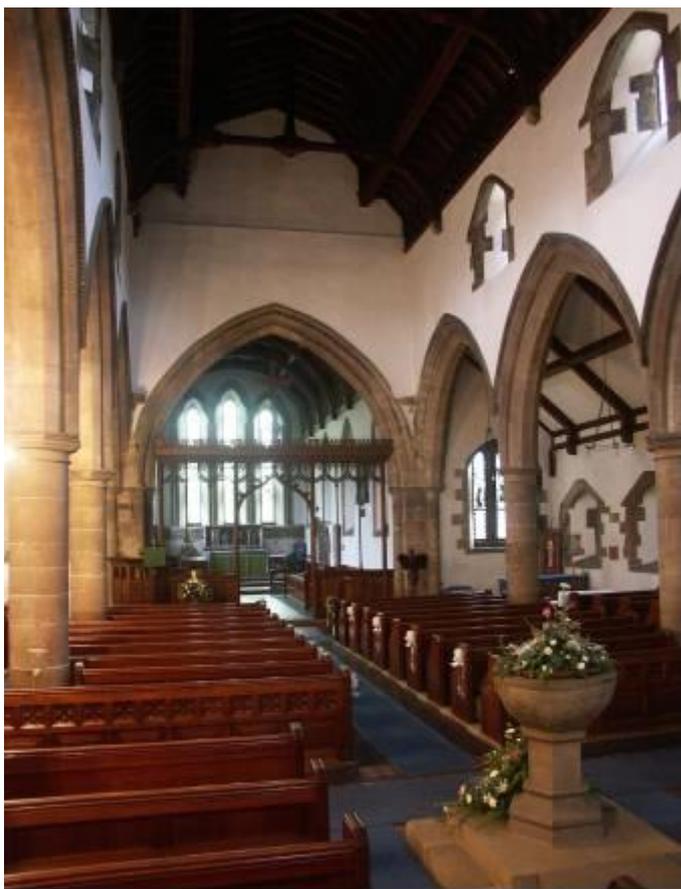
Interior looking east

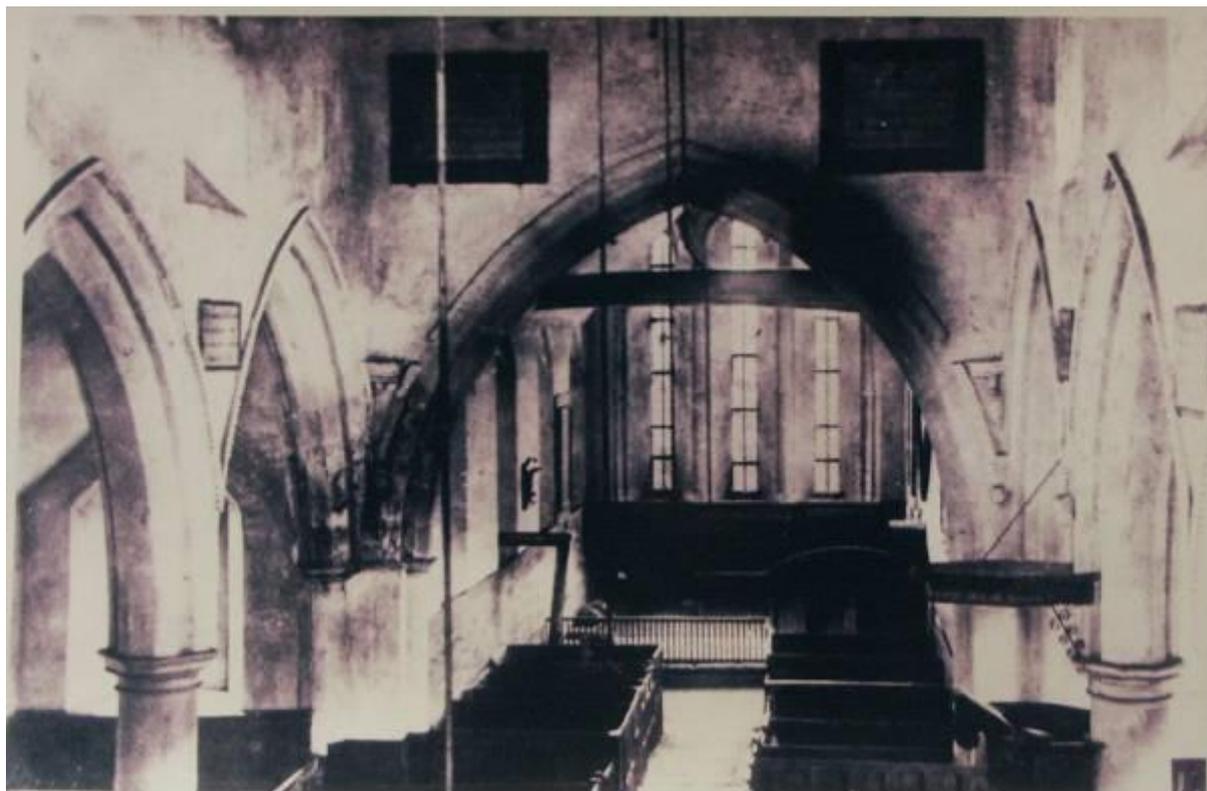
Interior view looking east before the 1870 restoration, taken from the western gallery

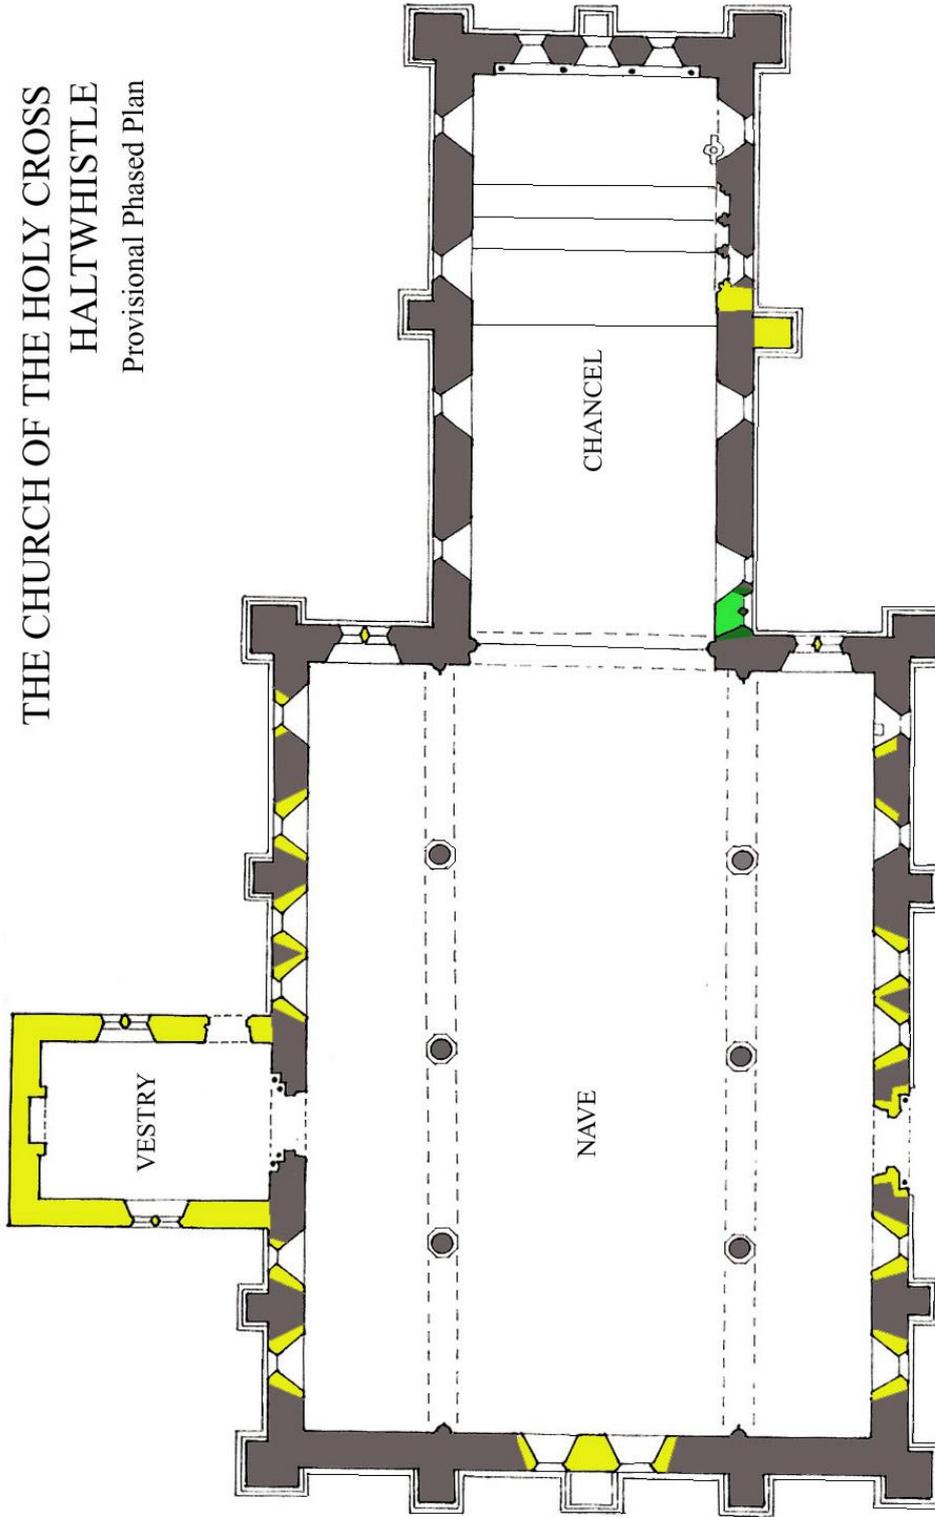
THE CHURCH OF THE HOLY CROSS
 HALTWHISTLE
 Provisional Phased Plan

note: 1870 rebuilding of the west end and south aisle all may have been more extensive than shown
