HOLY TRINITY CHURCH

EMBLETON

An Archaeological Assessment

September 2010

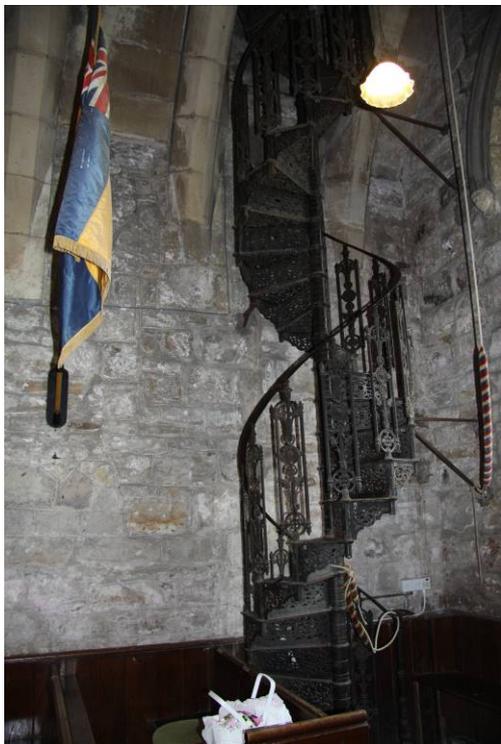
Interior of the tower looking south-west; the central vaulting rib cuts the rear arch of a 12th-century window.

The internal walls of the lower stage of the tower are of roughly-coursed rubble; in the side walls the internal surrounds of 12th-century windows are visible, their arches being cut into by the central of the three chamfered ribs of the present vault, of segmental-pointed section. The stonework of the vault looks rather 'fresh' but is presumably genuine medieval work re-tooled in the 19th century; an attractive mid-19th century wrought-iron spiral stair rises against the south wall and passes through a circular hole in the vault to give access to the ringing chamber. The 19th-century west window has rough stonework in its inner jambs, but a casement-moulded hood with mask stops, perhaps of plaster.

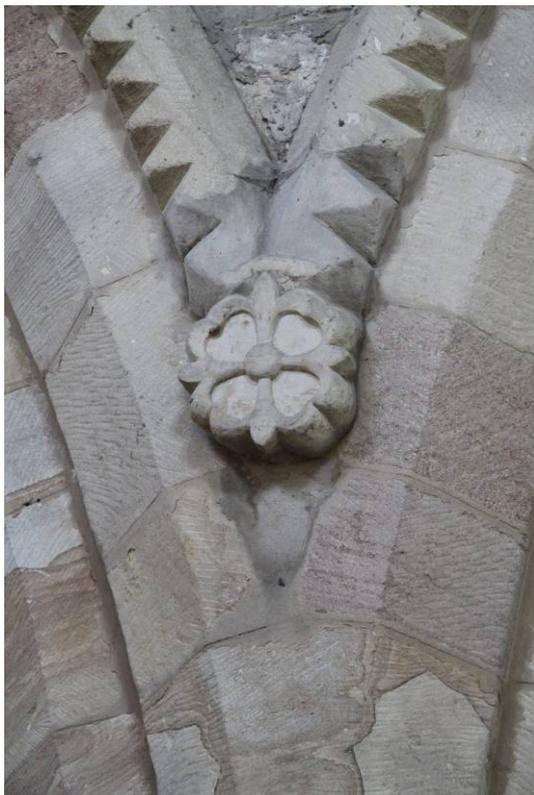
The arcades have two-centred arches, each of two chamfered orders, of early 13th-century date and showing some interesting detail. The hoodmoulds have nail-head ornament; on the north they end above the piers in large mask stops similar to those of several of the windows, and almost certainly of 19th-century date, but on the south they have foliate cross terminals that may be genuinely medieval. The outer orders have unusual stops above the capitals, towards the nave in the form of single dog-tooth ornaments (except for the eastern pier of the south arcade which has more elaborate foliate motifs, now badly damaged) and to the aisle in broach stops. The octagonal piers have moulded capitals and bases. The eastern responds are corbels with stiff-leaf foliage and moulded bases.

Hoodmould stop of the south arcade, showing dog-tooth ornament on hoodmould above.

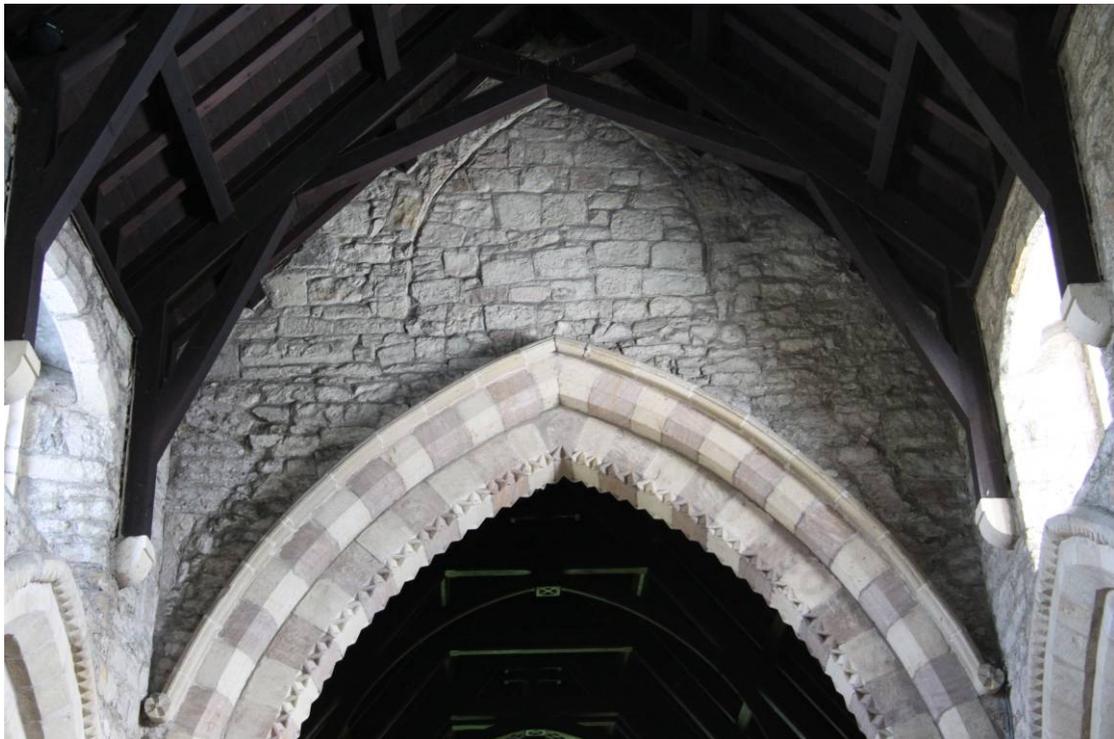
The **Chancel** is entered under a tall two-centred arch of two chamfered orders, the inner, with bold dog-tooth ornament on its chamfer, carried on corbels which have short shafts with Transitional-style capitals – these look to be genuine late-12th century work re-used - and the outer continued down the jambs; there is a hoodmould with cross paté stops. The voussoirs of the arch are of alternating pink and yellow sandstone. In the rubble walling above the chancel arch above the chancel arch the line of an early steep-pitched roof is visible (pre-dating the clerestory) and, in the gable, the outline of a large and rather mysterious Gothic-arched window (see ‘The Development of the Church’, below).

The 1866-7 chancel arch and older walling above, with early roof-line and outline of large window of uncertain date.

been a deliberate defensive feature. The chancel roof had clearly been lowered – not one but two old roof-line appear on the east wall of the nave, the upper corresponding to the chancel gable which had been left unaltered.

The date of the blocked window above the chancel arch remains a mystery. It is not shown in Grimm’s drawing, and so must be post-1783 – but neither does it appear in either the 1828 print or Wilson’s sketch, so was it a short-lived late 18th century feature?

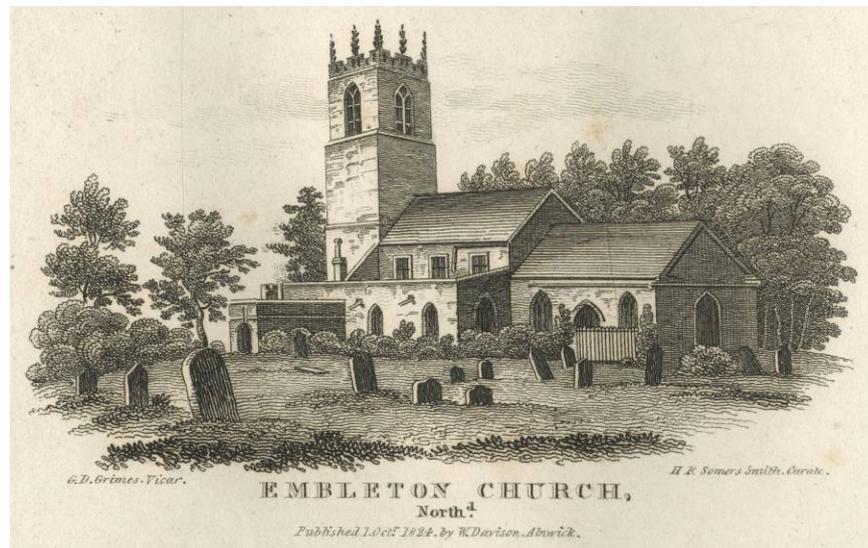
Davison's 1828 print

The County History account dates the remodelling of tower, rebuilding of the aisles and addition of the clerestory all to 1330-1340, which seems a little over-confident; the clerestory is dated from its rear arches which were seen as medieval, although in fact they seem more like early-19th century work. Davison's 1828 print seems to show an earlier clerestory of square-headed windows, which evidence on the internal face of the south wall seems to show were in different positions to the present openings².
