The Church of St Andrew, Bolam, Northumberland

Analysis of the Fabric & Archaeological Assessment

September 2000/ revised December 2015

Analysis of the Fabric and Archaeological Assessment

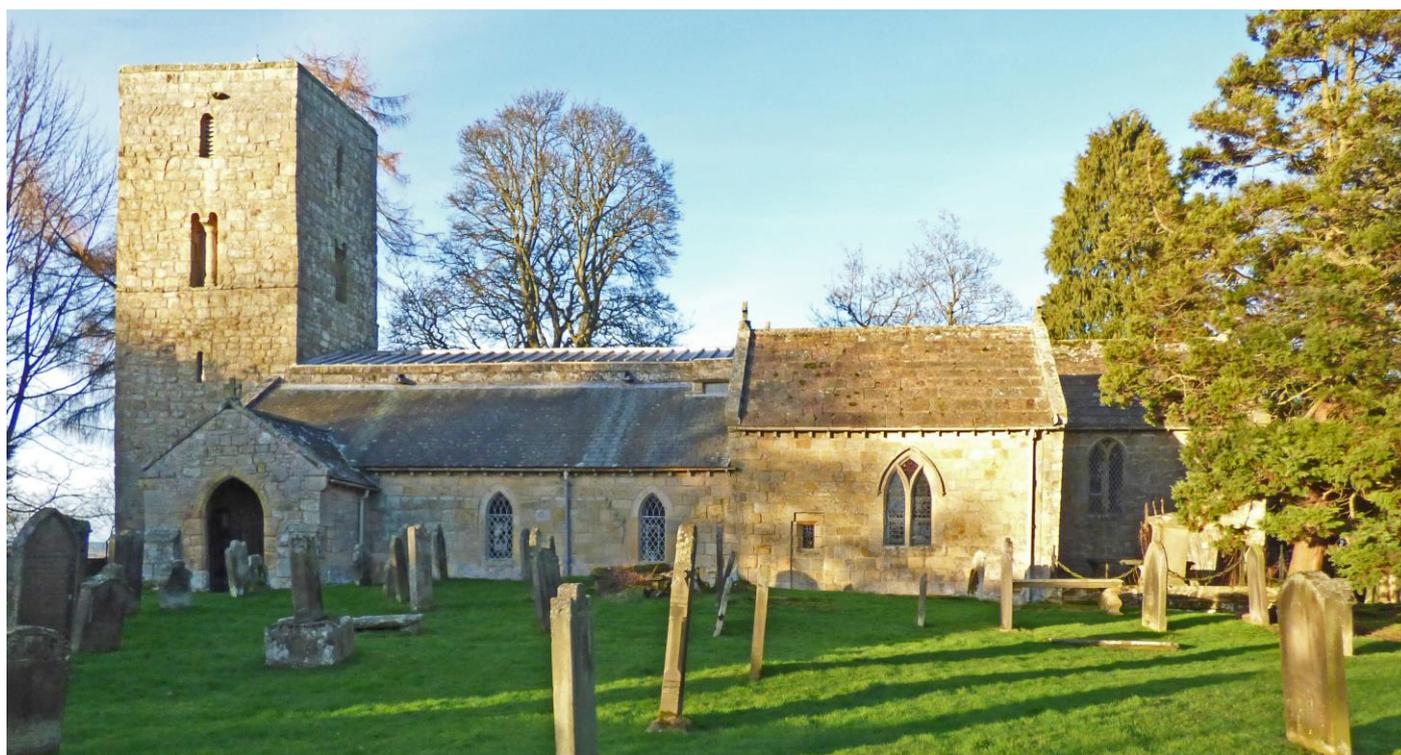
The church from the south

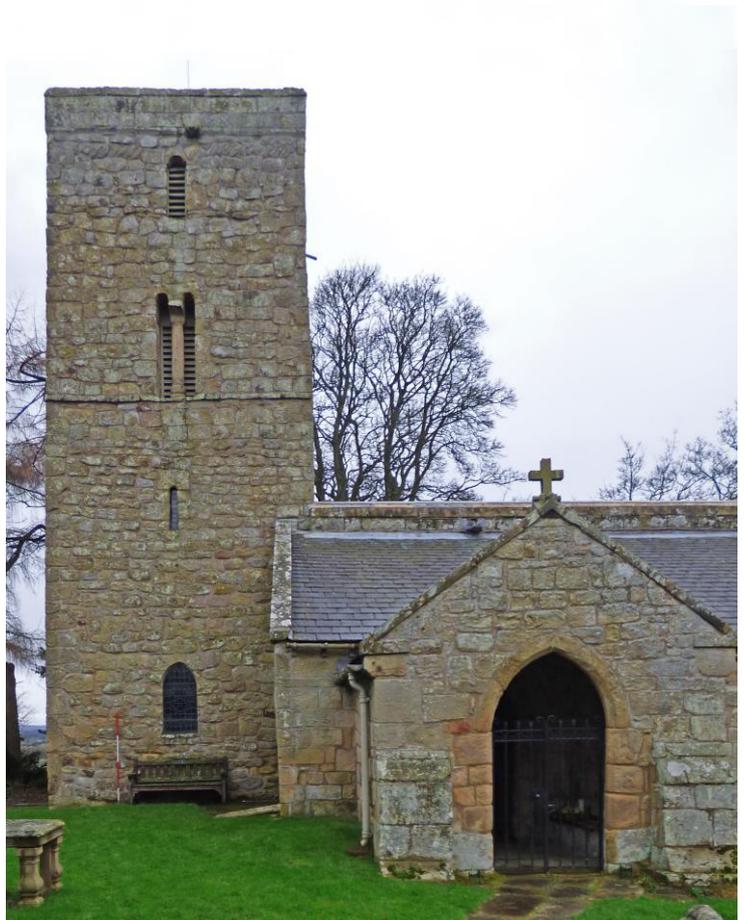
The **West Tower** (right, seen from the south) is constructed of coursed sandstone; there is a marked fabric change at around 1 m below the string course at mid-height, with rather larger and rather better-squared blocks in the upper section. Just below the parapet there is a single course of roughly-shaped stones laid diagonally, in herringbone fashion. The angles quoins are laid in rough side-alternate fashion, the largest being at the base.

The present west window is a plain opening with a roughly-pointed head, clearly cut through the pre-existing fabric; above it are the remains of the upper section of a much narrower light, with its roughly-arched head cut into a single large block. There is a very similar arrangement of a crude inserted window replacing an earlier light on the south. There is no external division between the lower and second stages of the tower, the latter being lit by narrow lights with slightly segmental heads, with very narrow chamfers to both jambs and head, on north, south and west. On the north of the tower this first-stage window comes just above the vestry roof; c 0.50 m outside the line of the vestry wall, and c 1 m below the window, is what looks to be an infilled rectangular socket of uncertain purpose.

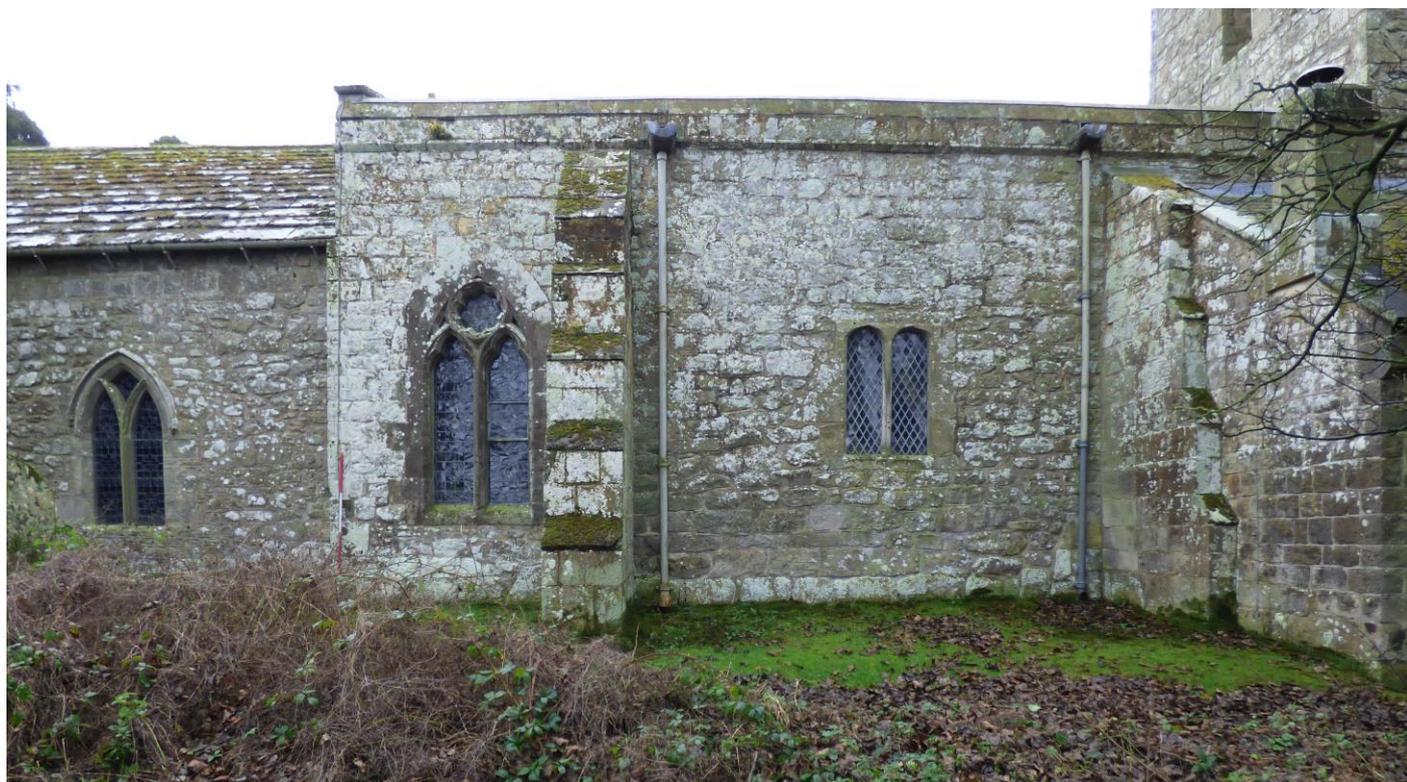
The north wall of the nave (above), to the east of the vestry, is of coursed roughly-squared blocks, some of those in the lower courses being quite large (c 0.40 m high). The wall has two large 19th-century stepped buttresses one overbuilt by the east wall of the later vestry, and the other towards the east end; at the head of the wall is a parapet carried on a single oversailing course; here is one stone drainage spout below this, just to the east of the western buttress. The north door now opens into the vestry; its east jamb is overlapped by the west face of the western buttress, suggesting that the doorway was blocked when the buttress was built, and later re-opened when the vestry was added. It is a simple square-headed opening with a narrow chamfer to lintel and jambs. Above and to the west of the doorway (and inside the vestry) one course has two large squarish blocks that project slightly from the wall face; the significance (if any) of these is uncertain. East of the vestry and between the buttresses is a window of two lights with roughly elliptical heads; its head is a very

crude piece of stonework, and looks of post-medieval date. The mullion is relatively recent, but the chamfered jambs may be genuine medieval work. The section of wall east of the second buttress is of rather smaller blocks, as is the north-eastern nave quoin, which is of smaller and more regular blocks than the western angles, laid in side-alternate fashion. Briggs (1982, 126-8) describes and illustrates the tower and nave quoins; he suggests that a series of small slots in the eastern face of three of the blocks of the north-eastern quoin may have housed pins for some structure such as an altar screen. A rather more prosaic explanation as fittings for a former down-pipe (the plinth below is partly cut away as if for a drain) seems rather more plausible. The line of the quoin steps back c 0.10 m westwards at the level of the chancel eaves. In this eastern section of the wall is a mid-19th century window with dressings of diagonally-tooled ashlar, of two trefoil-headed lights with an octofoil in the two-centred arched head.

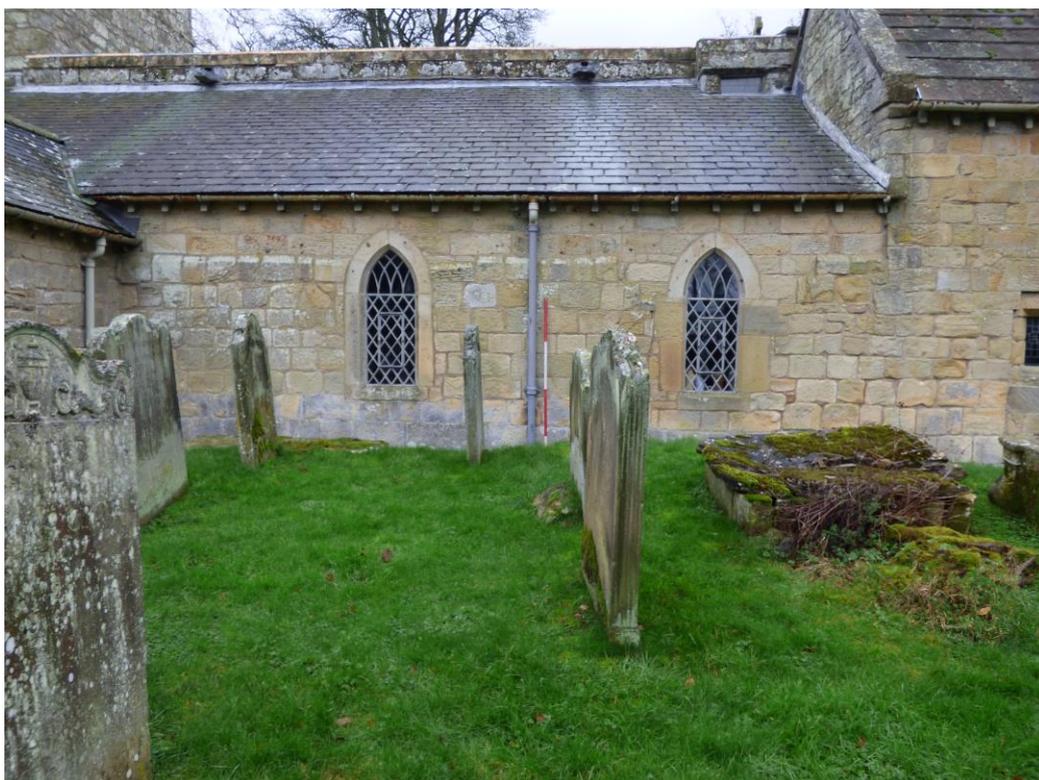
The **South Aisle** (right) is built of neatly-coursed squared sandstone blocks, and has a chamfered plinth, although a rise in the ground level means this is not exposed to the west of the porch, which is set very close to the west end of the south wall. The west window of the aisle is a simple roughly-pointed light, of exactly the same type as those in the south and west walls of the lower stage of the tower. There are some disturbed areas higher in the wall; the wall has a plain projecting square-section coping, returned on its footstone in a typical early-19th century manner.

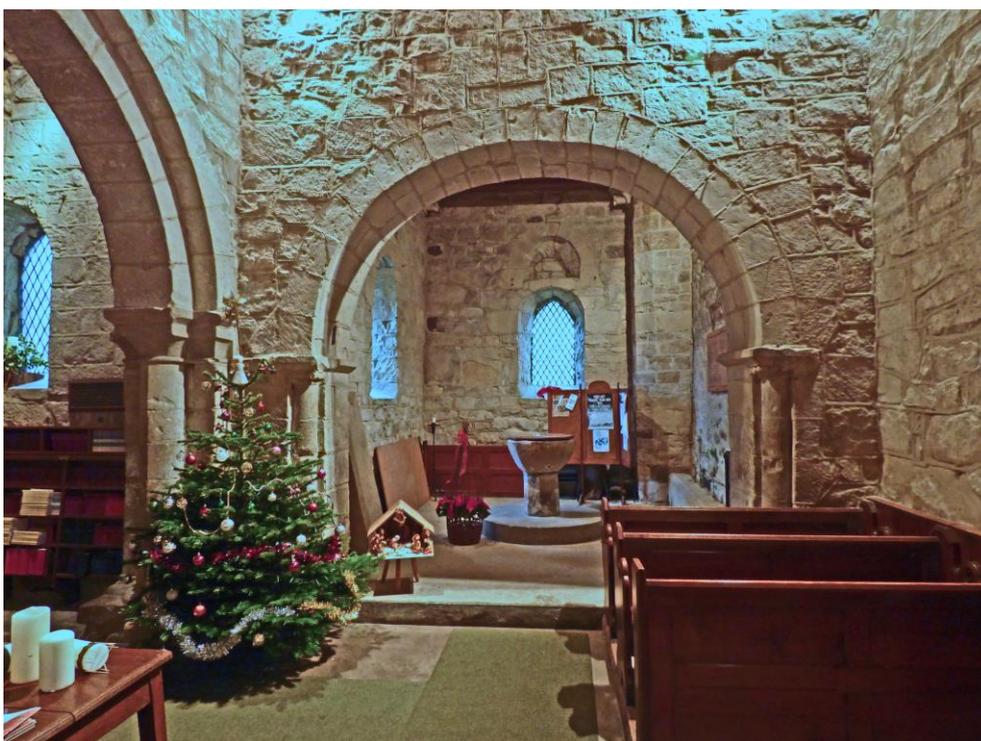
The **Tower** opens to the nave by a broad semicircular arch of plain square section (left); none of the voussoirs extend the full thickness of the wall, and all have a light diagonal tooling, on both faces and soffit, suggesting that it is in its original condition. The arch springs from imposts chamfered on their lower angle (towards the nave the impost is continued back along the wall on the south, but not on the north); at the eastern angles of the responds are attached jamb shafts with shallow

acanthus-carved capitals (which look as if they might be a secondary reworking of the impost blocks) and simple moulded bases. One block of the southern respond, c 1.0 m from the ground, has an incised circle upon it, of uncertain purpose.

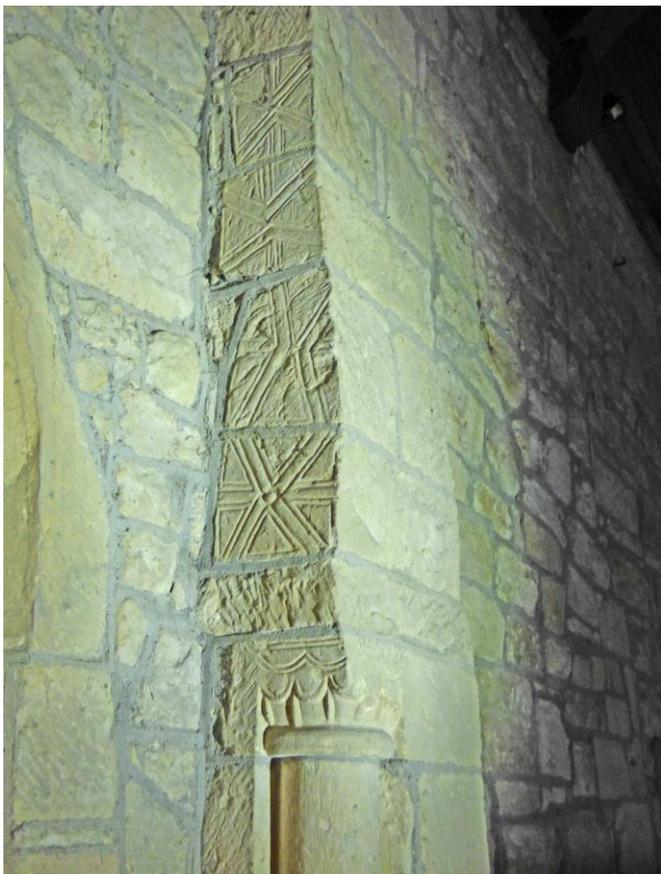
Remains of Sanctuary Arch (on north)

The jambs of the former arch to the **Sanctuary** are intact, and of square plan except for a sunk attached shaft towards the nave, its bases hidden by the present floor. The capitals are variations on a scalloped theme, with a cabled necking; once again the northern is rather more elaborate than the southern. In the walling directly each capital are four voussoirs from the destroyed, the two lower apparently in situ' a ninth has been reused nearby in the north wall of the sanctuary. All nine show incised lozenge patterns in a style sometimes termed 'Early Geometric', characteristic of late 11th and early 12th century carving.

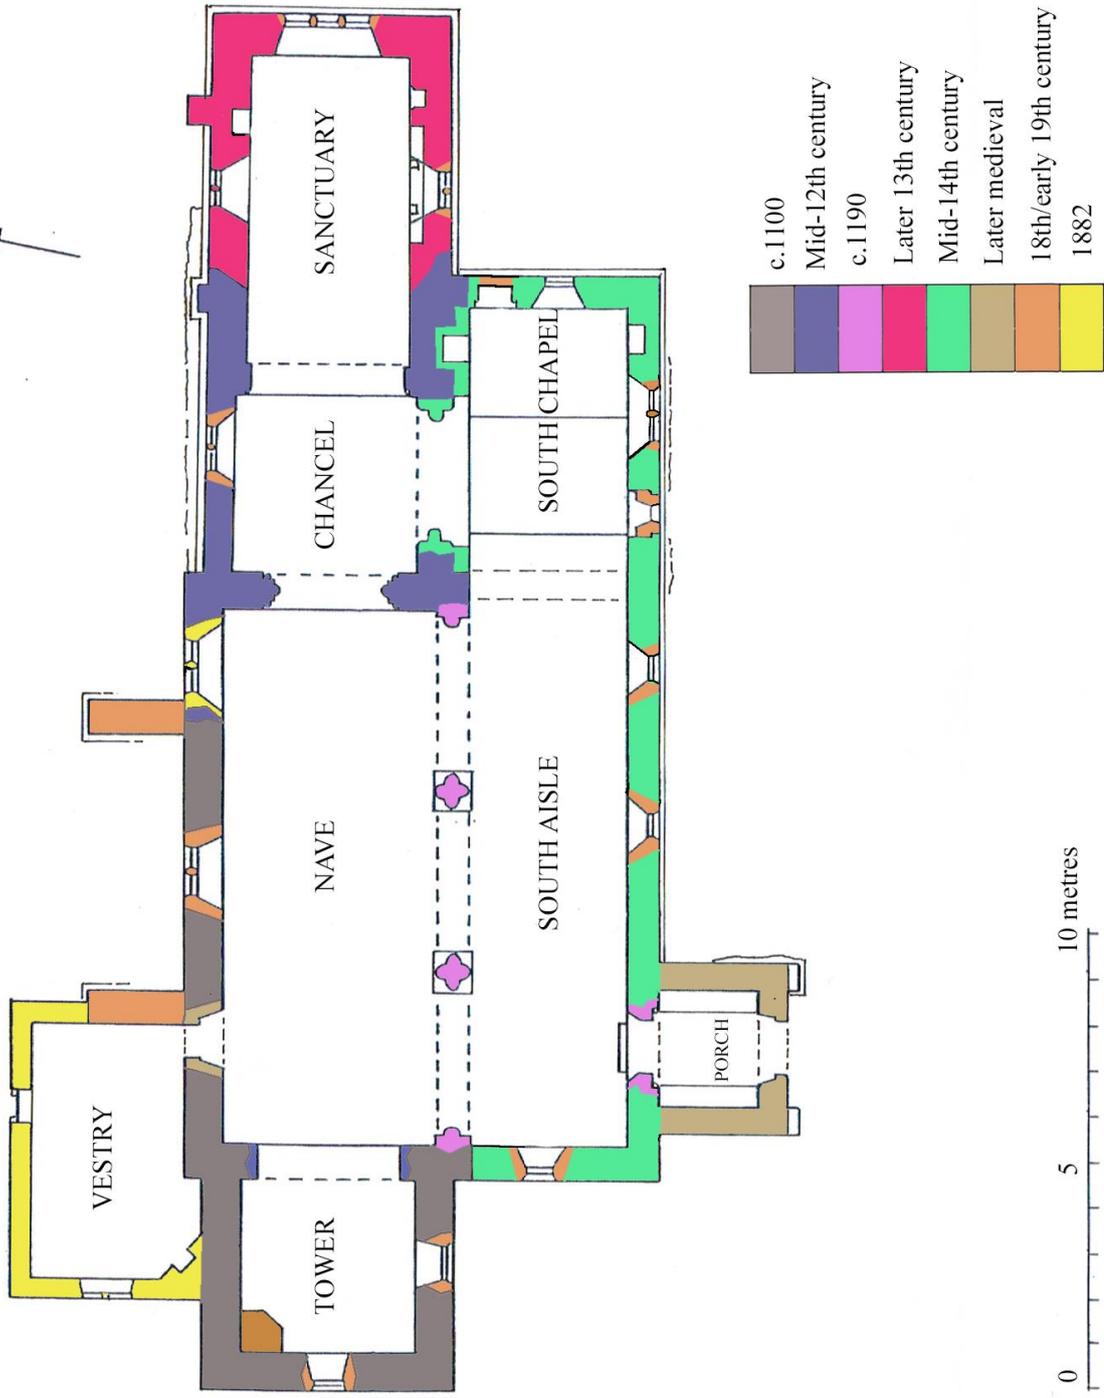
ST ANDREW. BOLAM
PROVISIONAL PHASED PLAN

Plan by N and H D Briggs, revised and annotated PFR
