THE CHURCH OF ST MARY
LESBURY
NORTHUMBERLAND
AN ARCHAEOLOGICAL ASSESSMENT

JUNE 2020

PETER F RYDER
B.A., M.Phil, F.S.A
HISTORIC BUILDINGS CONSULTANT

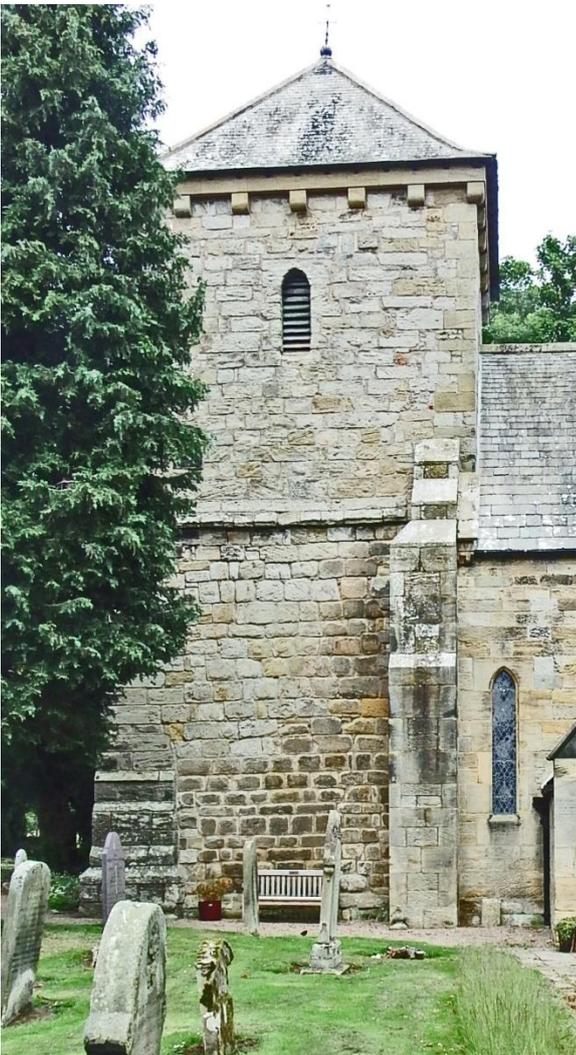
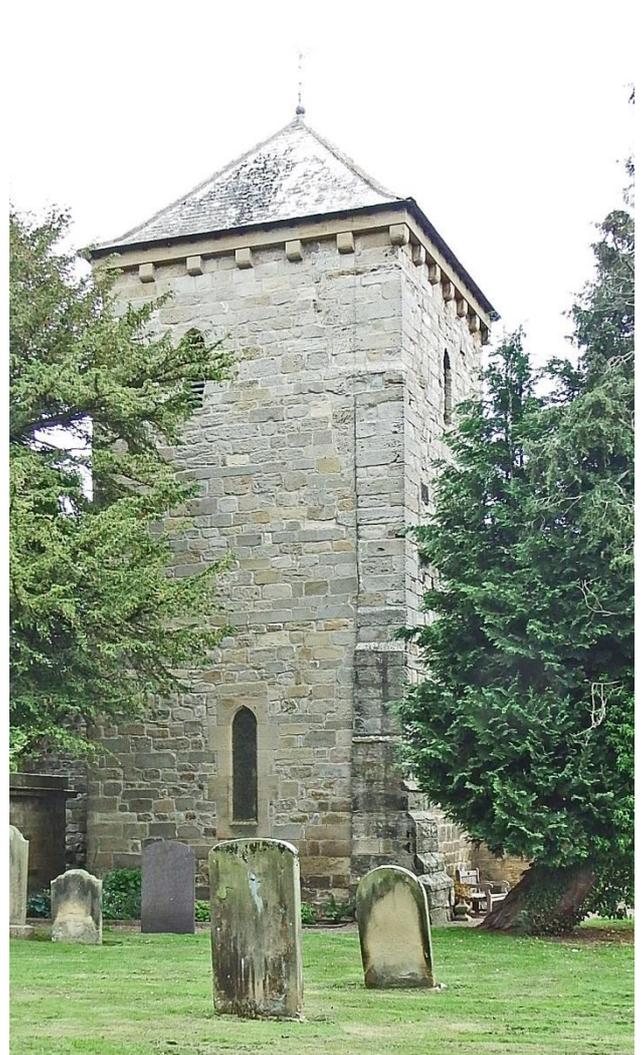
The **West Tower** has a very complex fabric, with evidence of much patching, repair and partial rebuilding. The south-west angle in particular looks to have been rebuilt to its full height, in greyer more close-jointed stone; it has a clasping buttress of irregular form, rising higher on the west than on the south, although its multi-stepped base projects further on that side. The angle quoins at the other corners have all been renewed in the 19th century. Beginning with the west elevation, there is a shallow square-edge plinth of footing at the base of the wall, and a central lancet with a narrow chamfered surround, its dressings all in 19th century ashlar; there is some evidence that it replaces an earlier wider opening. The lower part of the wall is of well squared locks, and may have been re-faced in the 19th century, but at around two-thirds height is a course with some very elongate blocks (up to c 2 m long) and above that older fabric; the belfry opening, set well north of centre, has a worn segmental-pointed arch cut into a single slab. The top of the tower has a projecting ashlar course carried on block corbels, and a low pyramidal slater spire. The south elevation has an old quite broad chamfered plinth, over-built by the south-west buttress, and at just above mid-height a bold string/set-back, which ends short of the rebuilt south-west corner; the belfry opening, set centrally, is like that on the west.

The tower from the south (left) and south-west (right)

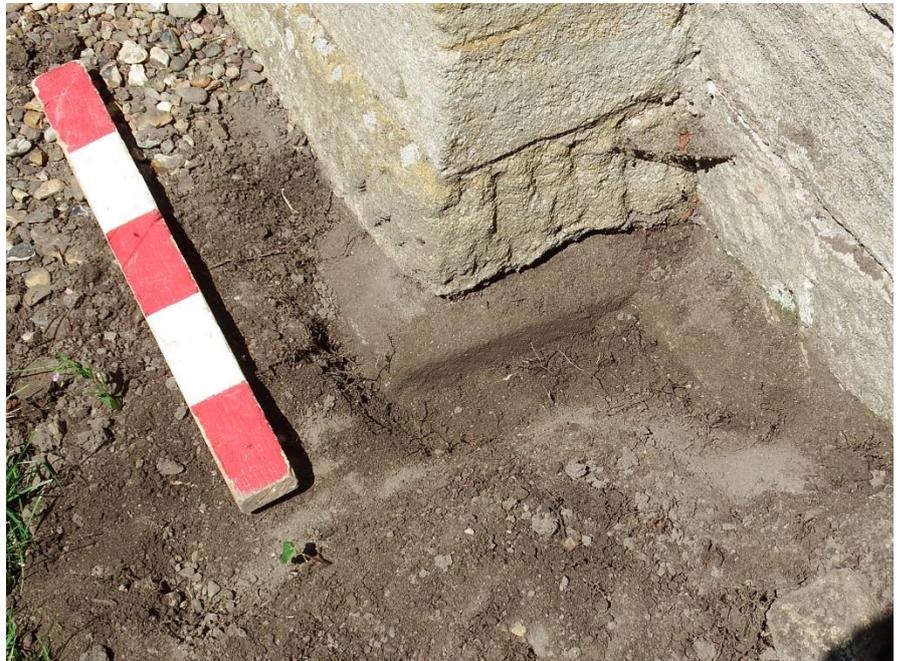
watching brief in 1998 sections of another probably 13th century plinth were seen further east, just below the present ground level (right). The basal course of the present plinth, of roughly-tooled stone (not designed to be seen) sits directly on, and slightly overhangs, the clearly earlier fabric beneath. This earlier plinth goes round both pilaster buttresses.

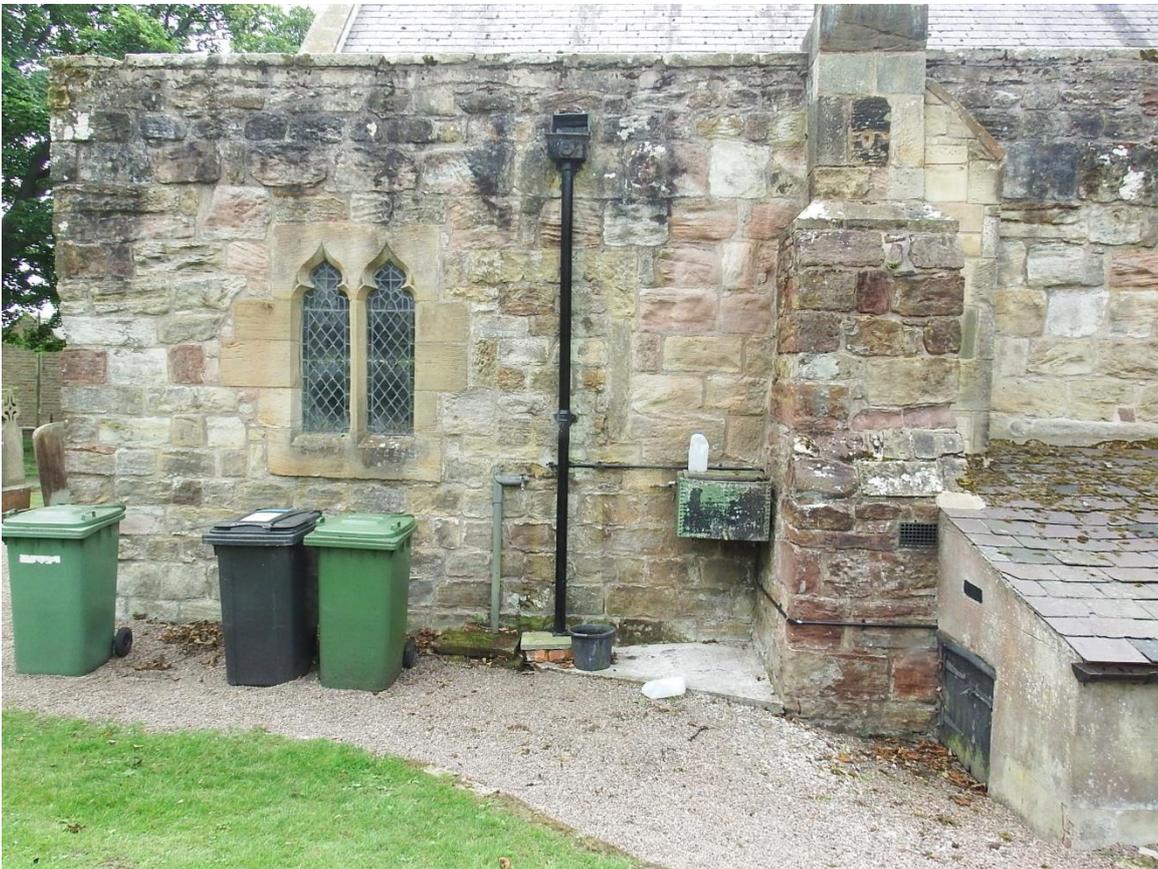
The east end of the chancel aisle from the north; note blocked window (behind drainpipe) which is cut across internally by the wall that divides the former vestry from the remainder of the aisle

The east end of the aisle has a square-headed doorway of Georgian character at its south end, with large upright blocks in the jambs, and a very narrow chamfer; directly above is a very similar rather narrower opening, now blocked, with in the course above its lintel a central wedge-shaped block. To the north of the lower doorway is a possible small square window, blocked, c 1.5 m above the ground. The stonework of this wall is reddened in parts, as if by fire.

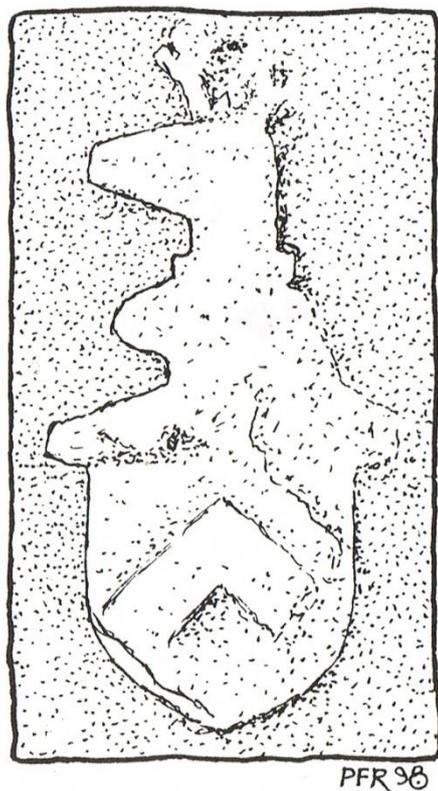
During the 1998 watching brief two carved stones were recorded, which had been found a few months previously under the floor slabs at the south-west corner of the chancel. Near identical, each is a rectangular panel, probably from a later medieval tomb, bearing a stag's head above a shield charged with a single bend. They are currently lying outside the church, and should really be brought inside and ideally mounted, with some explanatory material.
