BELFORD
THE CHURCH OF ST MARY
AN ARCHAEOLOGICAL ASSESSMENT
JULY 2020

PETER F RYDER
B.A., M.Phil, F.S.A
HISTORIC BUILDINGS CONSULTANT

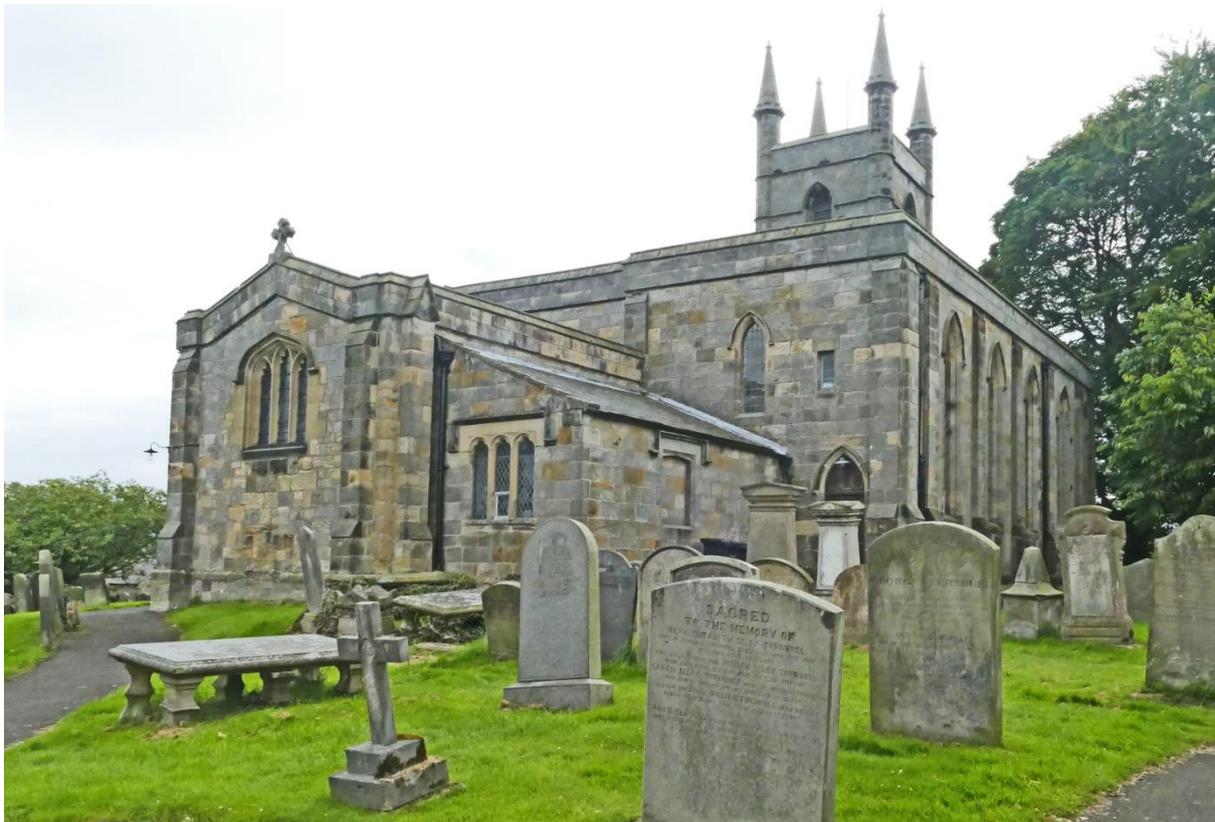
The church from the north-east

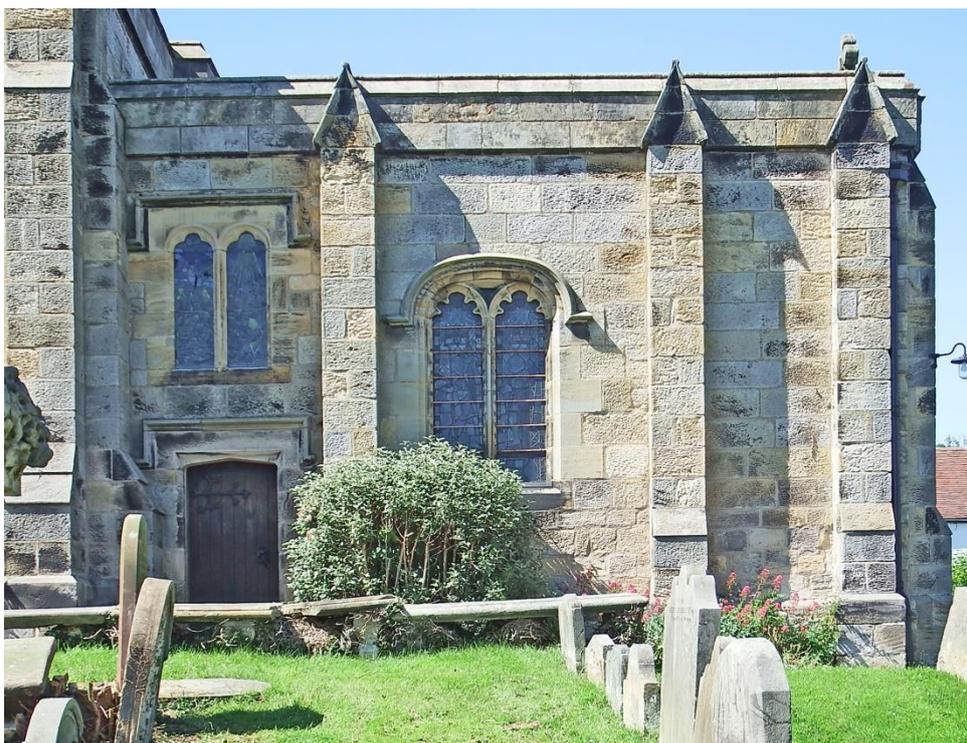
*The Chancel
from the
south*

The **Chancel**, considerably lower than the nave, has a south elevation of three irregular bays. The narrow western bay has a priest's door with a Tudor arch within a square frame: in the spandrels of the head is the incised date '1615'; above is a square-headed window of two trefoil-headed lights. Although, according to old illustrations both these openings seem to replicate older features, their stonework all seems 19th century. The central bay has a larger window of two cinquefoil-headed lights under an elliptical arch, in a hollow-chamfered surround. The narrow eastern bay is blind.

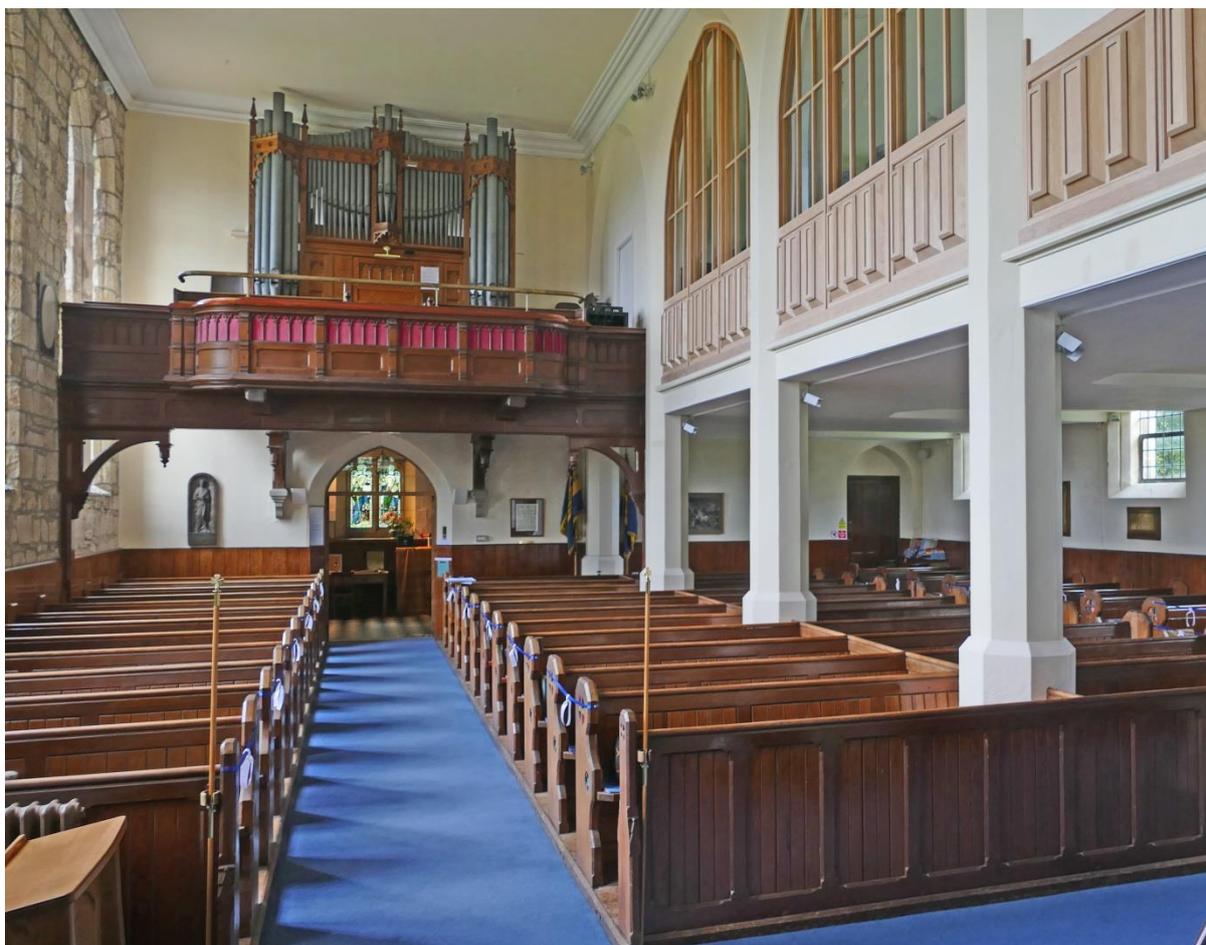
The nave looking north-west

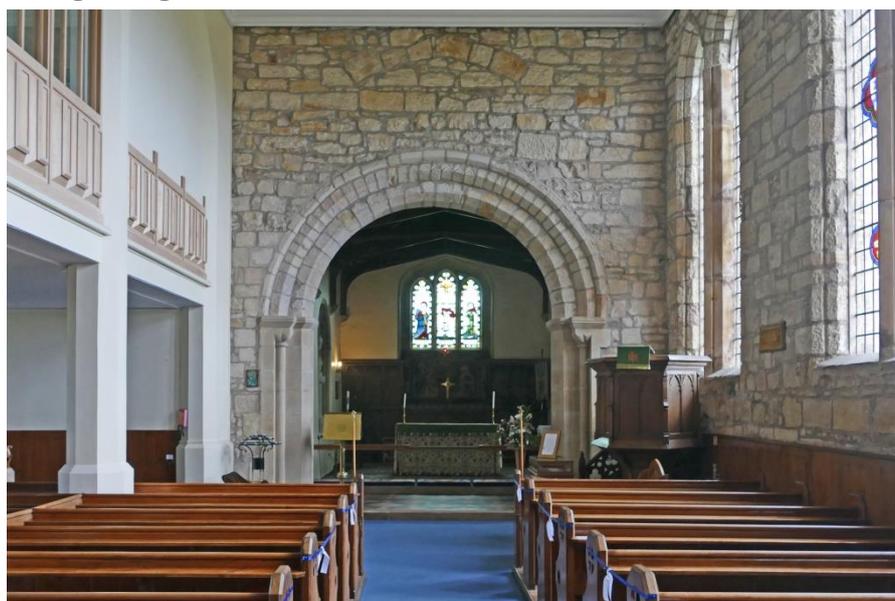
The east wall of the nave is of roughly-coursed stone, with some larger and better-squared blocks in the upper courses, and towards the south ends. The **Chancel** arch is large, and semicircular; its jambs are all of 19th century ashlar; the outer order is carried on jamb shafts with scalloped capitals, and there is an impost band., grooved and chamfered beneath. The arch is of two roughly chamfered orders; at the apex of the outer there are five voussoirs with chevron ornament and there is a hoodmould, roll-moulded above and chamfered below. About 1.5 m above the northern impost there are two blocks with relief-carved beasts, possibly a lion (l) and centaur (r) and c 2 m above the southern are three re-used chevron-moulded voussoirs. High above, just beneath the ceiling, is what looks to be a shallow triangular relieving arch made up of eight big blocks.

*The Nave
looking east.*

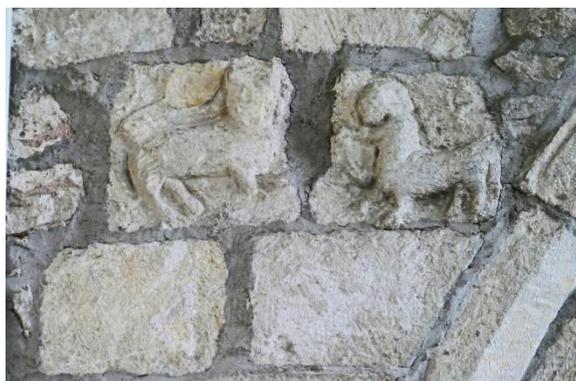
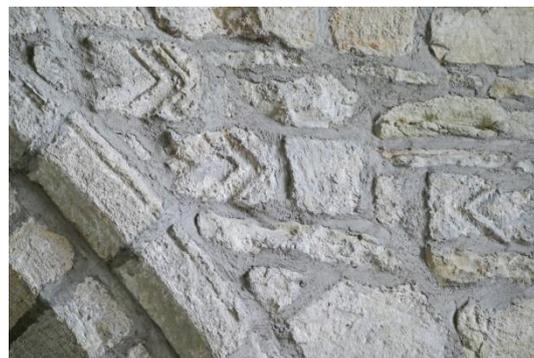
*Re-used
Romanesque
stones l. and
r. of arch*

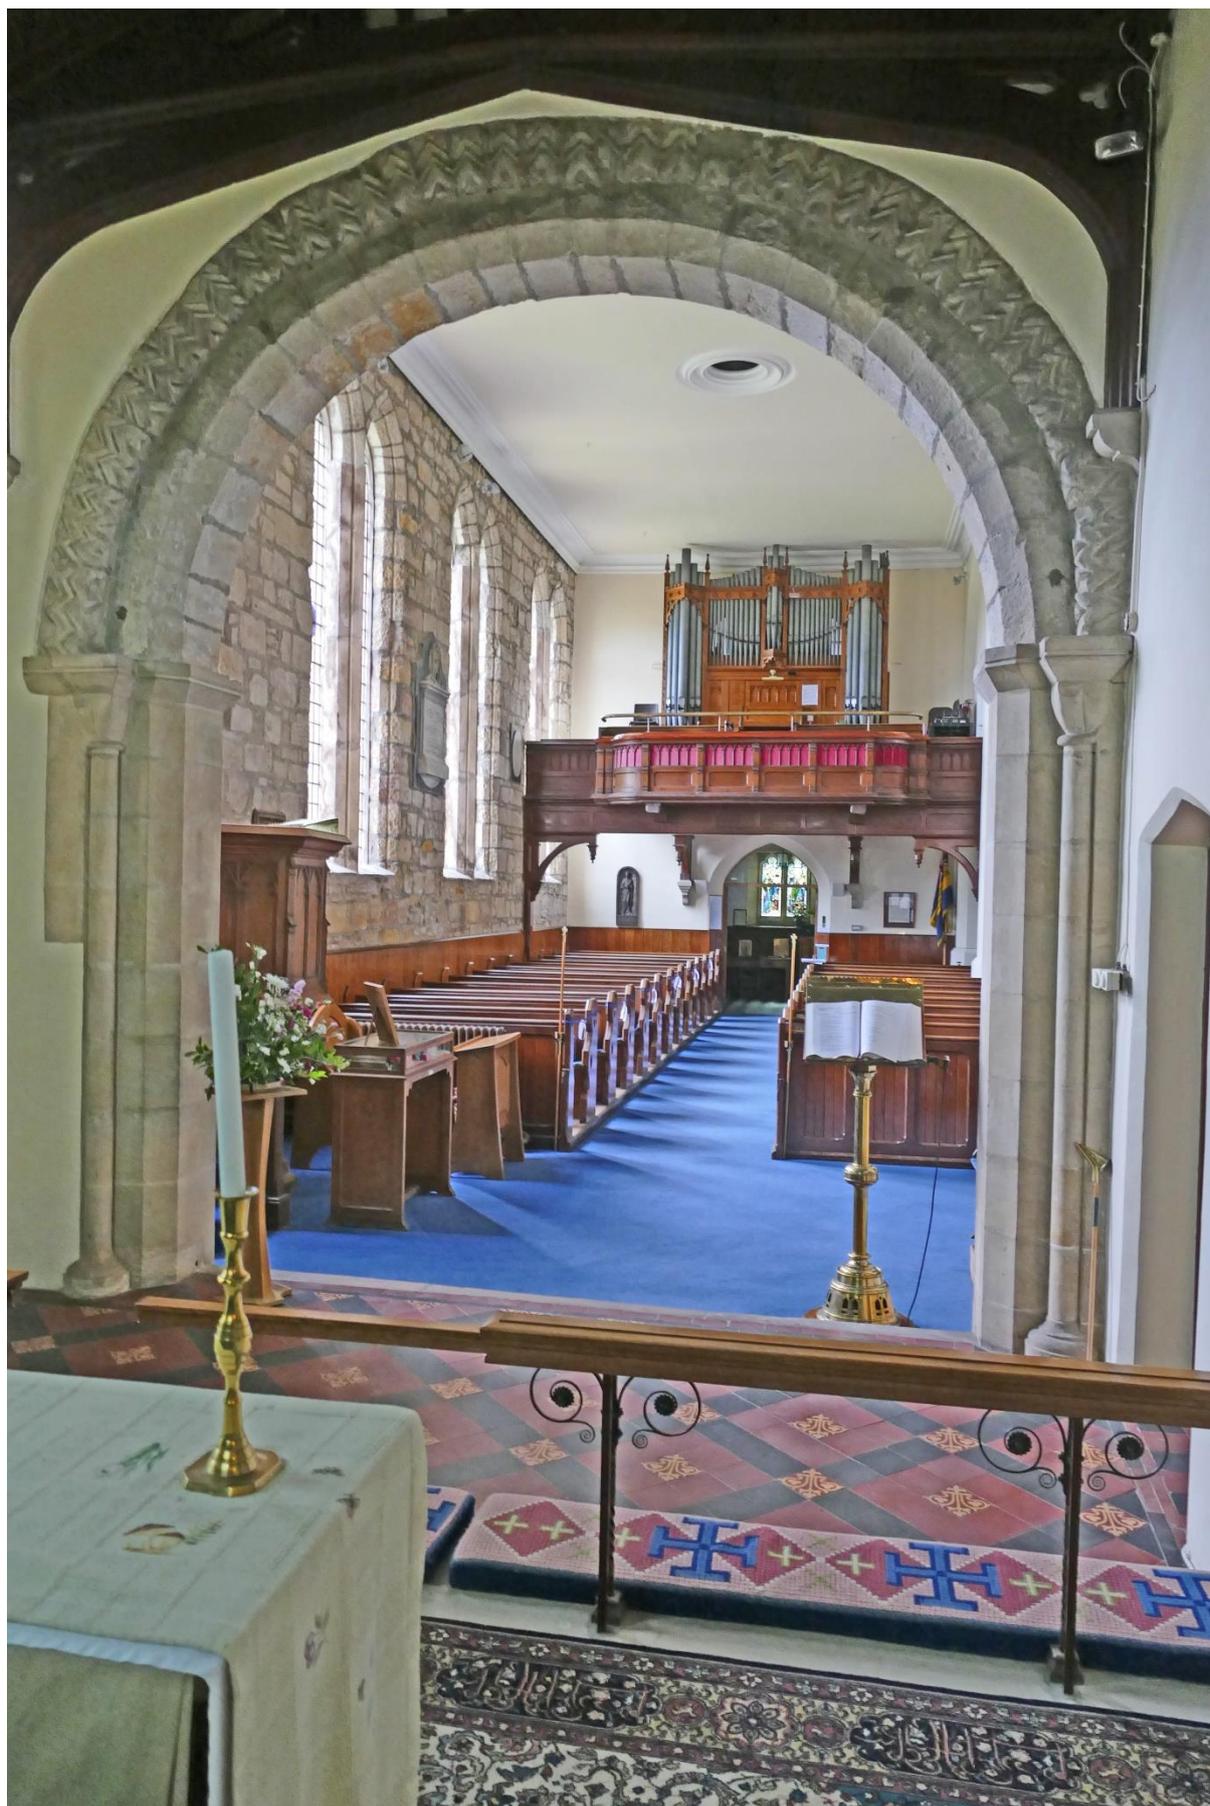
East face of chancel arch

On the east face of the wall, towards the chancel, there are two orders, the inner with abroad hollow chamfer, the outer all chevron. The jambs are of the same section.

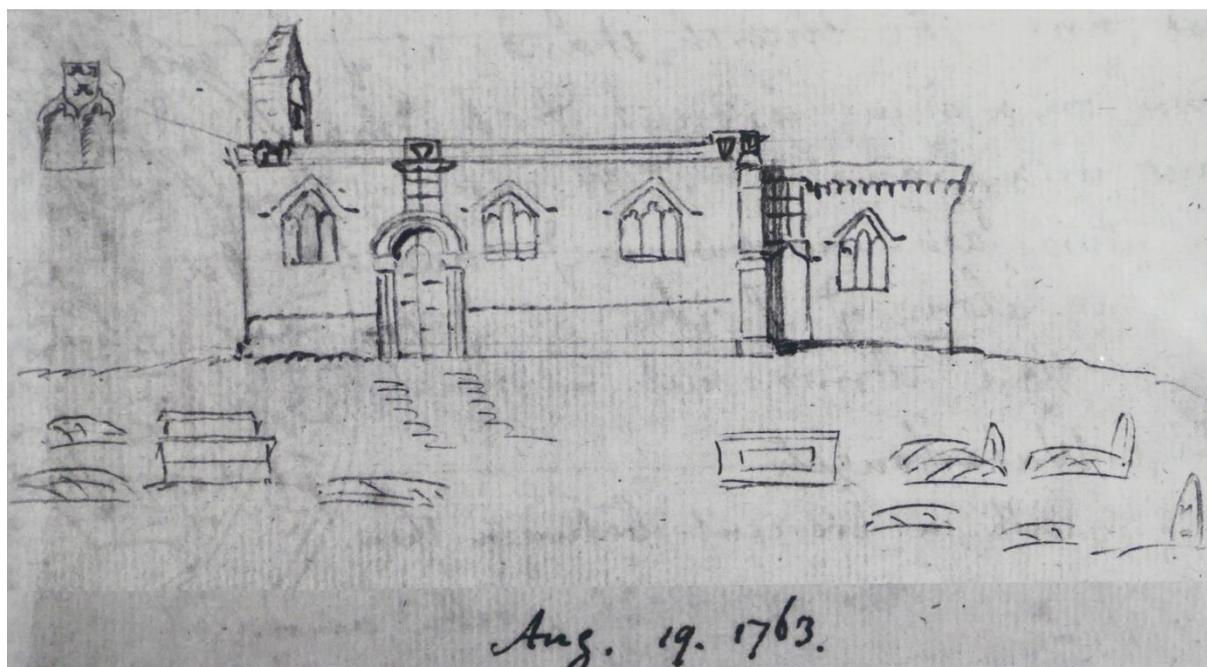
1763 sketch (copy displayed in church)
