# All Saints' Church, Ryal

Northumberland

An Archaeological Assessment March 2020

**PETER F RYDER**  
B.A., M.Phil, F.S.A  
**HISTORIC BUILDINGS CONSULTANT**

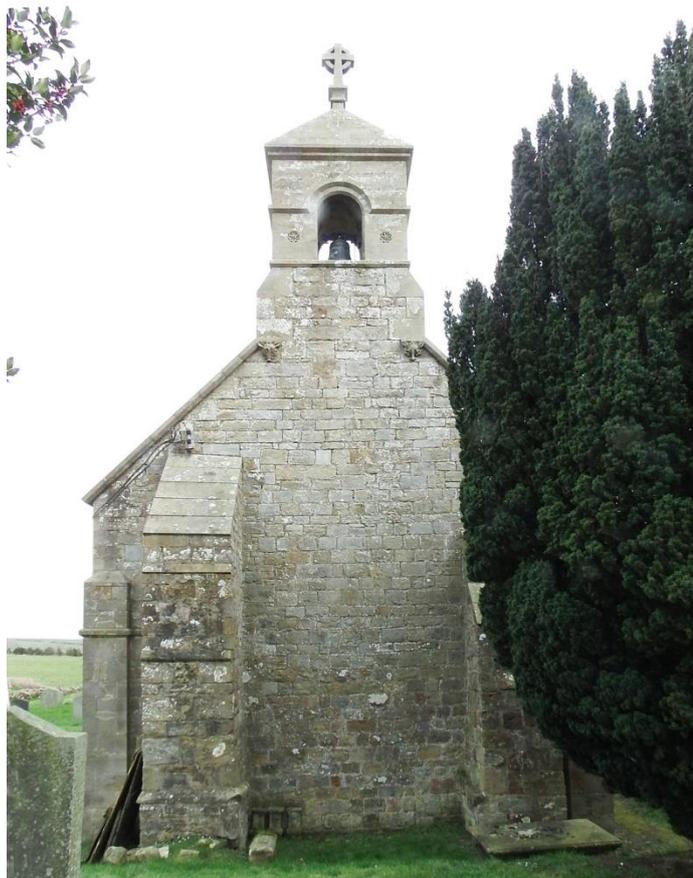
The west end (right) is complicated, and interesting. There are two massive buttresses, fashioned from the stubs of the side walls of a 12<sup>th</sup>-century tower. The best evidence of this is at the north-west corner; the angle pilaster here is all of 1879, and is rounded by the (renewed) string, but immediately to its south, on the short length of wall before the northern buttress, is an old weathered section of string, which then returns for a couple of stones westward along the north face of the buttress. The northern is the larger of the two buttresses (1.8 m long and 1.2 m

wide) and at its outer end seems to rest on the footings of a section of wall which steps out on both faces. Might this widening be to accommodate a newel stair in the north-west corner of the former tower? The southern buttress is only 1.2 m long but rests on a broader footing which on the south has a chamfered plinth, a little above the level of that of the nave.

The walling between the buttresses is of coursed squared stone, in quite large blocks; only the bases of the jambs of the former tower arch, 2.1 m wide, are visible suggesting that most of the fabric is post-12<sup>th</sup> century reconstruction.

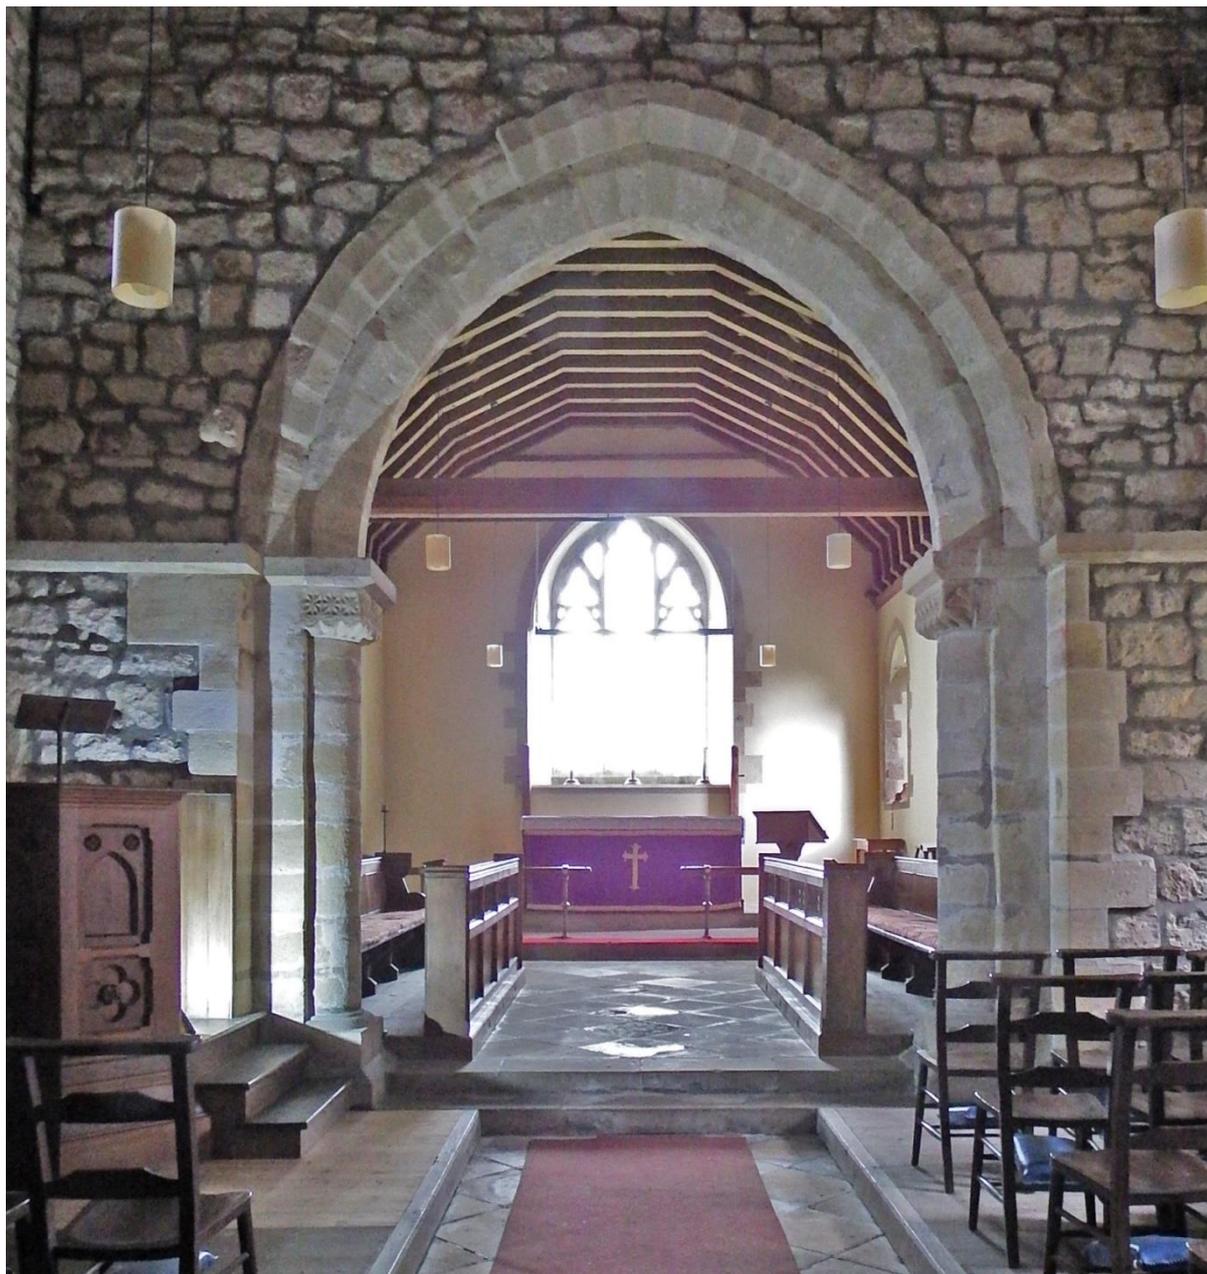
*The chancel arch*

The side walls of the nave show no pre-1879 features except for the lower fabric in the north wall (where there is no real sign of the possible blocked doorway). The east end of the nave contains the chancel arch, which is the best surviving early feature of the building. The arch itself is pointed, and of two chamfered orders (to the nave only), springing from an impost band, chamfered below, that crosses the whole west face of the wall, and also forms a distinct set-back, the wall thinning from c 0.,80 to c 0.,55 m above. The outer order of the arch is continued as a square step down the jamb, but the inner rests of a semicircular-section respond with a scalloped capital, the northern having sunk-star ornament and the lower intersecting arches, both typical Romanesque motifs. There is an

eroded projecting block, perhaps a corbel of some sort, adjacent to the outer order a little above the springing of the arch on the north.

The nave of the church was dated to c1150 by the Rev Kerry, and there is no need to argue with this. The principal surviving feature is the chancel arch, or rather its jambs – the arch itself, to judge from its pointed form, is probably a 13<sup>th</sup> century reconstruction. The decoration of the capitals is certainly of mid-12th century character. The Rev Kerry is clear that the nave plinths, string course, the spacing of its pilaster buttresses and the footprint of the south door

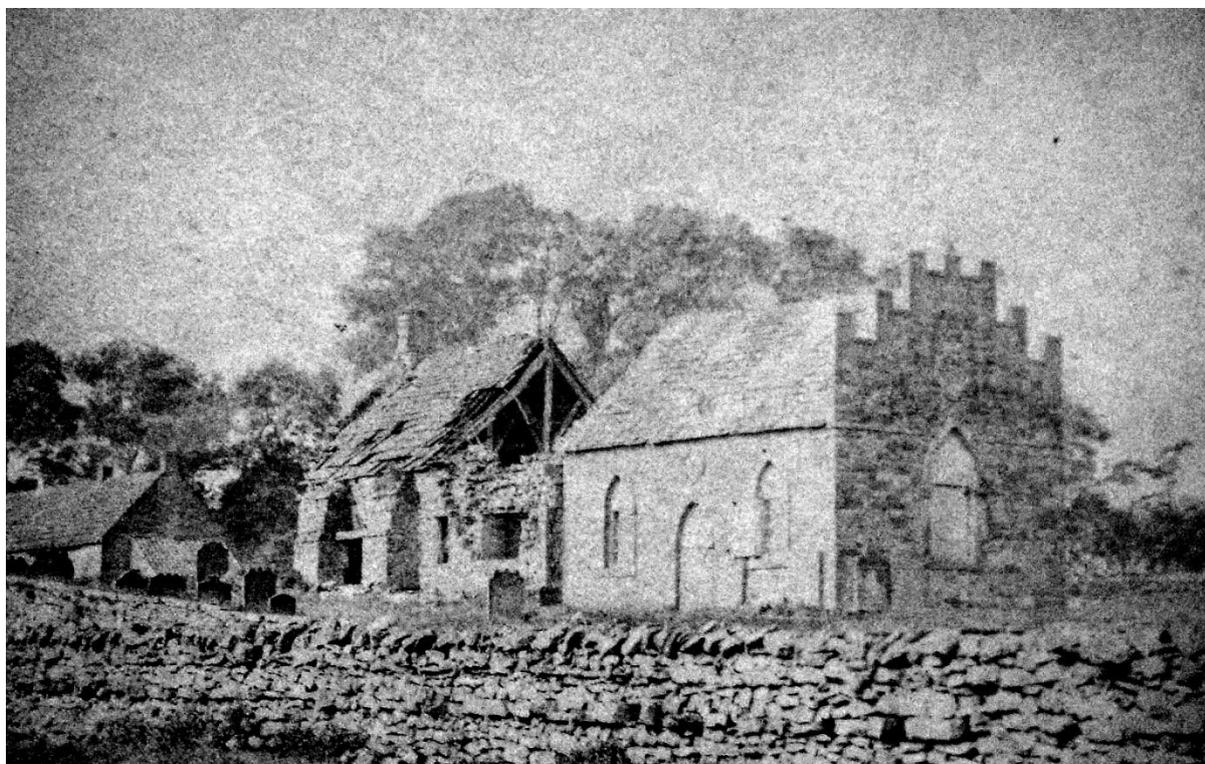
*The church before the 1879 restoration*

However, the Romanesque church did not remain in this form until the 19<sup>th</sup> century restoration, prior to which it was in very poor condition. We are told it had 'numerous' heavy buttresses, and the one surviving pre-restoration photograph shows a pair of huge ones flanking the south door. These were clearly of later medieval or early post-medieval date, and would seem of excessive dimensions for a small Romanesque nave. However, bearing in mind the later medieval history of other churches in the area, Ryal might well have been made defensible at some time. At Bellingham, Corsenside and Elsdon this entailed the creation of stone vaults, and this would certainly have exercised an outward thrust on the walls, which could well have necessitated the construction of these buttresses. At Corsenside the section of the now-removed vault is visible on the internal face of the west wall, and with the eye of faith it is just possible to discern something of the same sort here.....although not enough to be certain. The vault had certainly gone by the 19<sup>th</sup> century, when the photograph shows a collapsing king-post roof over the abandoned nave.

We know that the chancel was rebuilt in 1766; the old photograph shows it as a typically Gothick building, with a stepped east end forming something of an ‘eyecatcher’. Whether this was a total or partial rebuilt is not quite clear, as the present east wall is considerably thicker than the side walls so could retain some medieval fabric. In 1879 the chancel was remodelled by the Architect Ewan Christian – in a manner which bore absolutely no relation to the Romanesque nave, for which the Rev Kerry did the drawings. Its rather attractive wagon roof is probably its best feature, which again contrasts with the heavy king-post trusses over the nave.

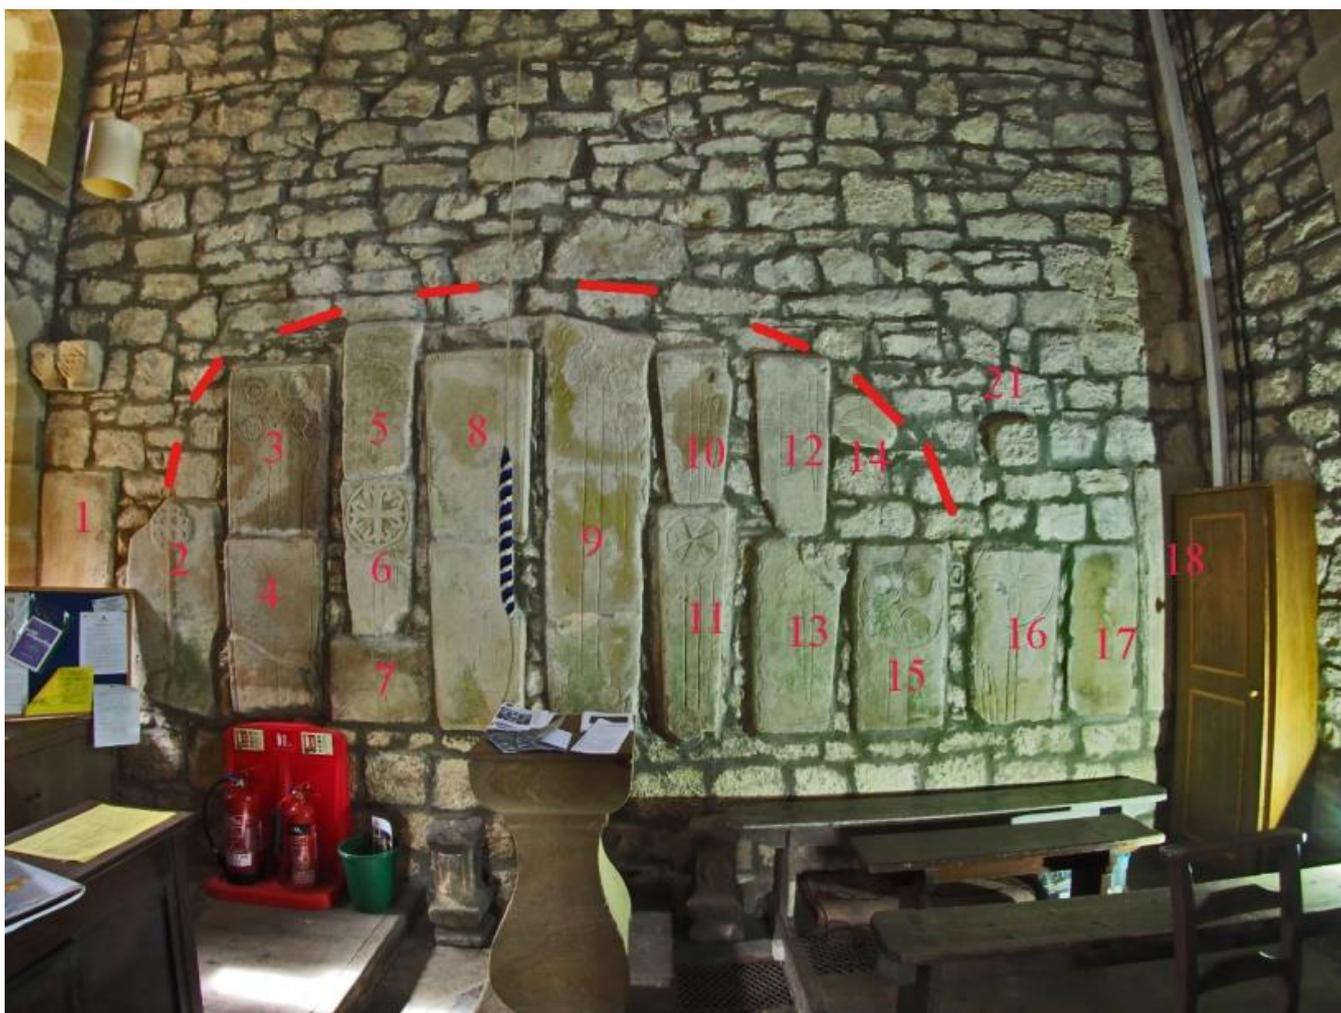
*The re-set cross slabs (numbered), and possible vault line marked in red*

The internal walls of the nave are of bare stone those of the chancel plastered. The most striking feature is the west wall, across which no less than nineteen medieval cross slabs have been re-set. The only structural feature visible on this face of the wall is what appears to be a blocked doorway, high up on the south – a straight joint (the north jamb?) is visible, although an opening here would be very much on the line of the south wall of the former tower.

The creation of the vault might also have entailed the thickening of the walls, as happened externally on the nave walls at Corsenside and internally on the aisle walls at Elsdon. There is a hint that this happened to the north wall at Ryal, where there is little sign internally of the former north door hinted at in the external fabric; however, the wall is much the same thickness as on the south, where the doorway, which the Rev Kerry assures us was fully attested in the surviving fabric, could only be accommodated by a wall of the present thickness.

Probably the most memorable feature of the church is the collection of medieval cross slabs now set in the internal face of the west wall of the nave, one of the best groups of such memorials in the county, and worthy of some proper interpretative material. They have been described and illustrated<sup>3</sup>, with the exception of (21) which is in Appendix 2, along with the earlier drawings.

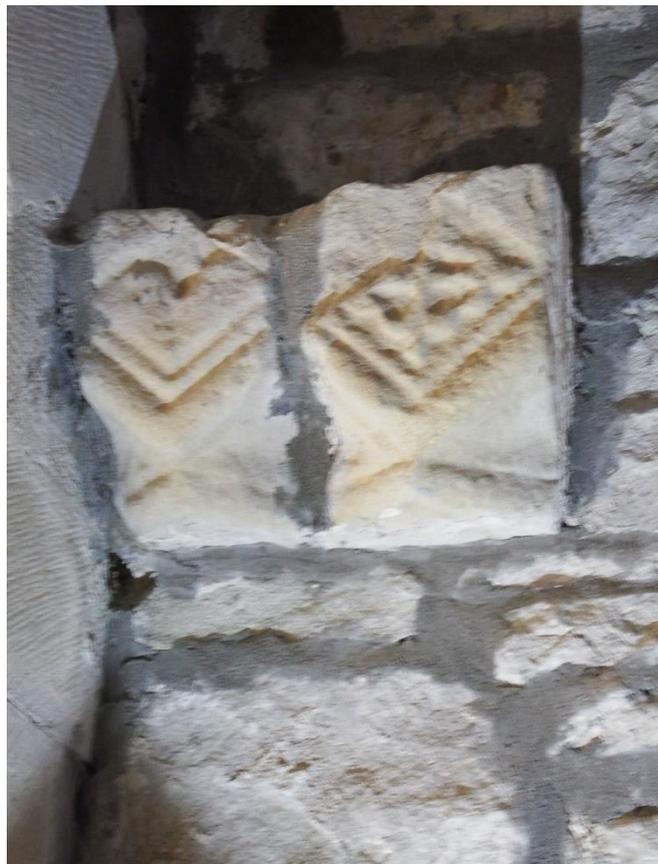
Built into the west wall of the nave, at its south end above the cross slabs, are two carved voussoirs (right), thought to be from the 12th century south door. A third simpler voussoir, with chevron, is set in a corresponding position at the north end of the wall.
