ST CHAD'S BENSHAM
QUINQUENNIAL INSPECTION REPORT 2019

Directors:
Chris Granger
Chloe Granger
Paul Crosby

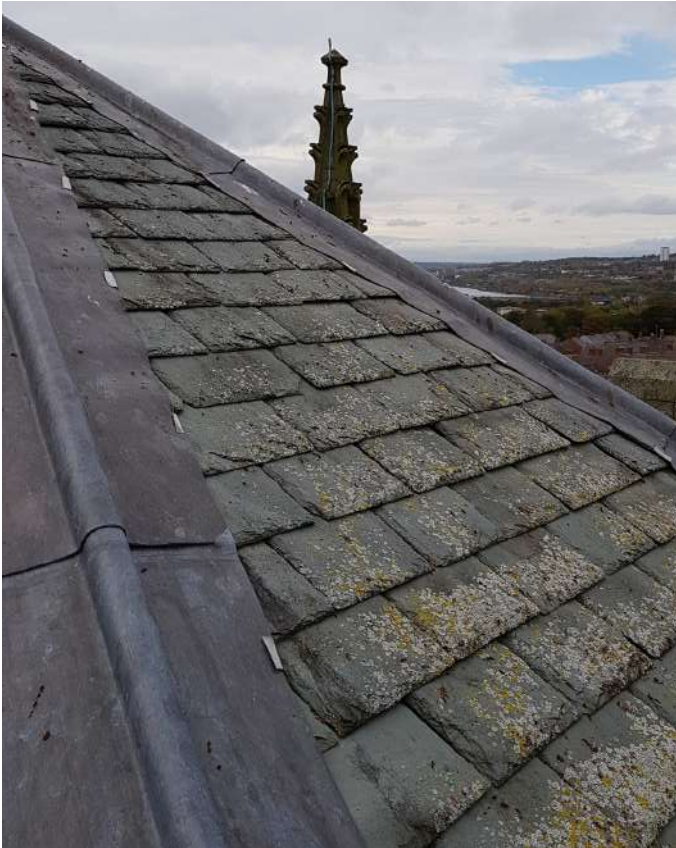
Tower roof re-roofed in 2015, in excellent condition

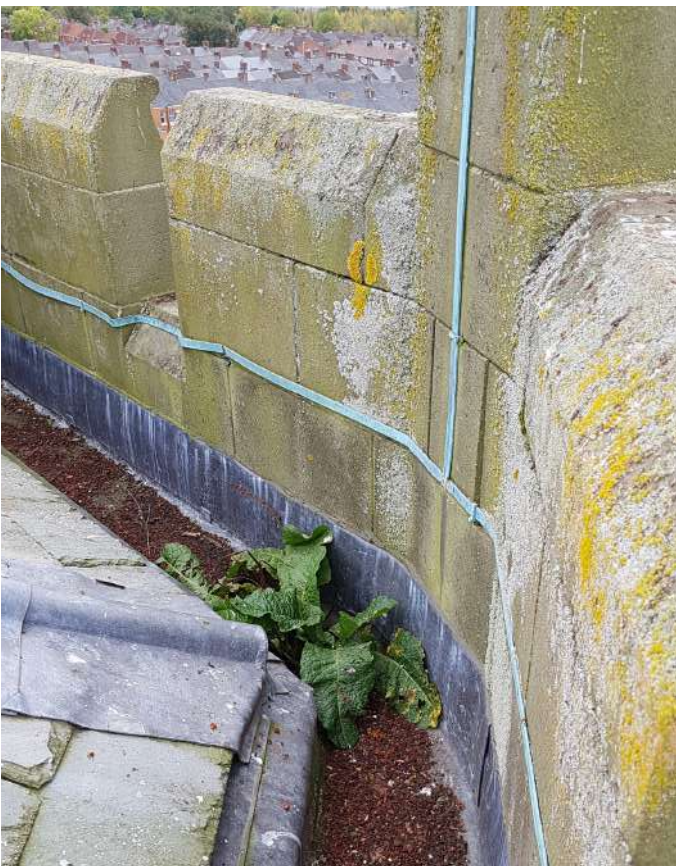
Tower - gutters full and outlets blocked with vegetation

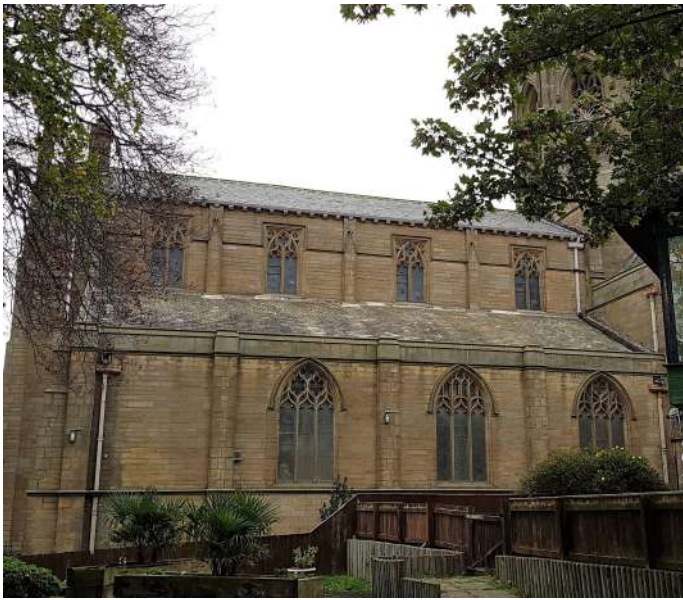
South aisle in poor condition

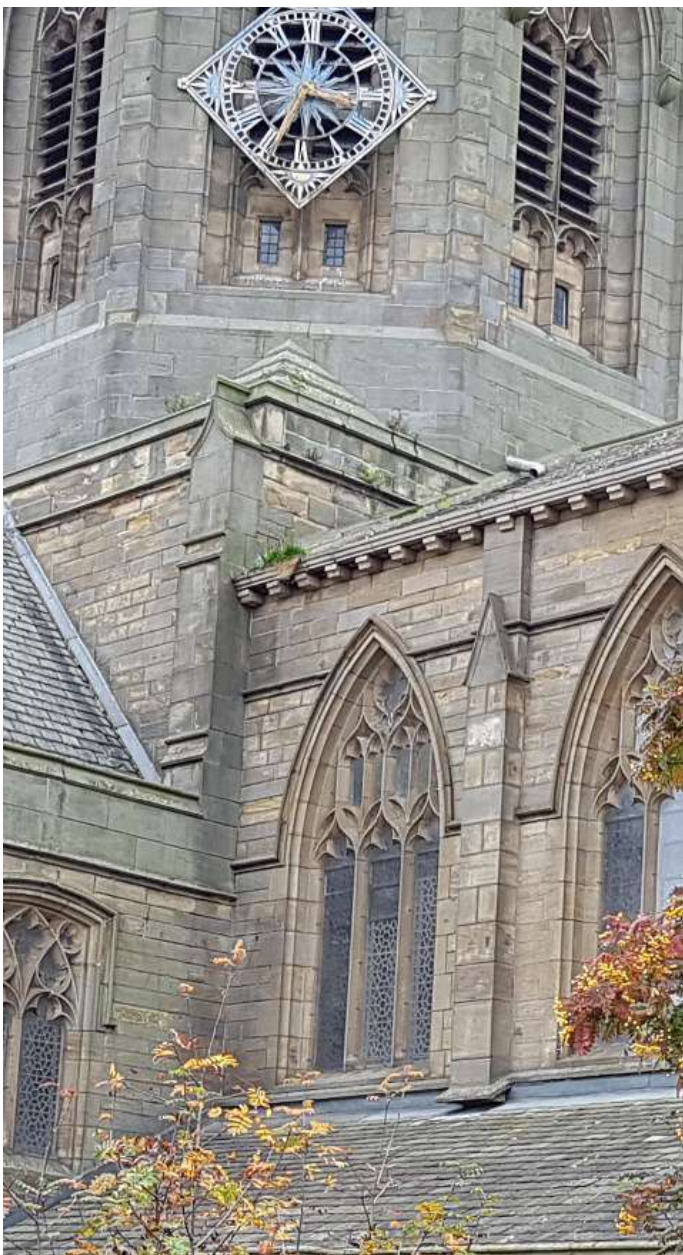
Vegetation in tower broaches, vegetation in high-level gutters. RWP discharging onto south chancel roof

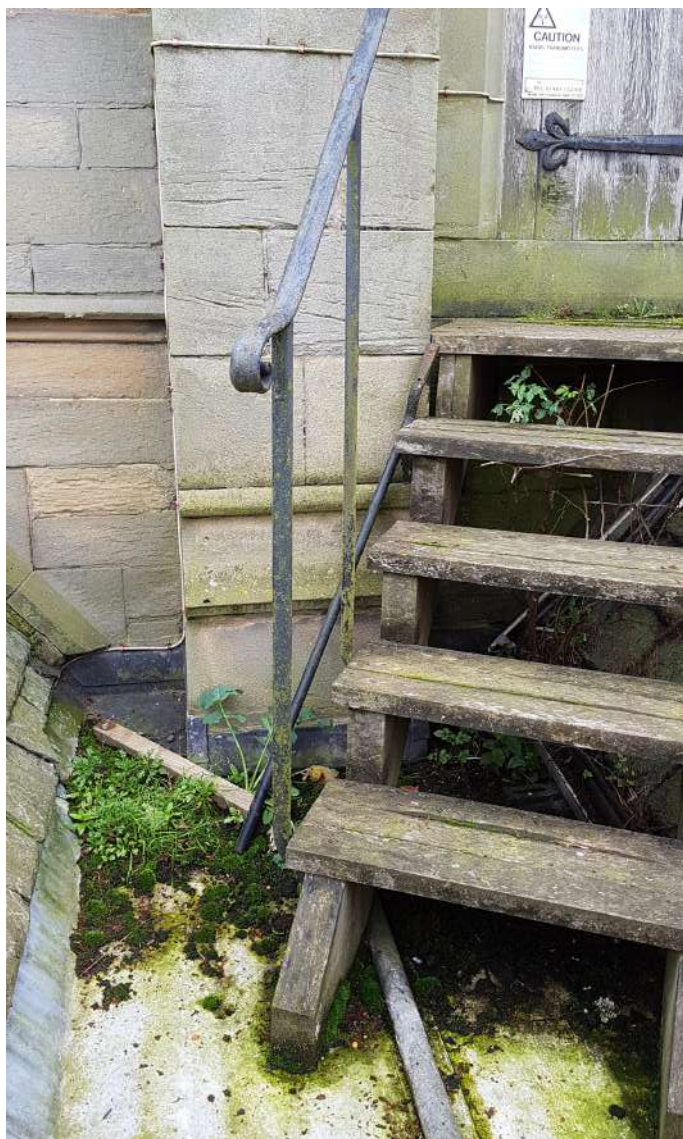
Lead roof between organ loft and north transept at end of life. Steps unsteady. Vegetation build up.

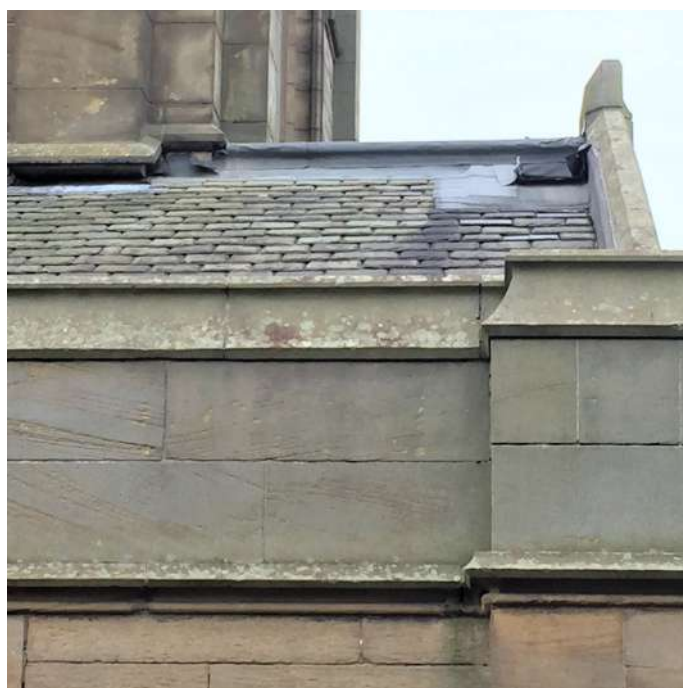
Two areas on south chancel roof where flashings have been peeled back by thieves looking for lead

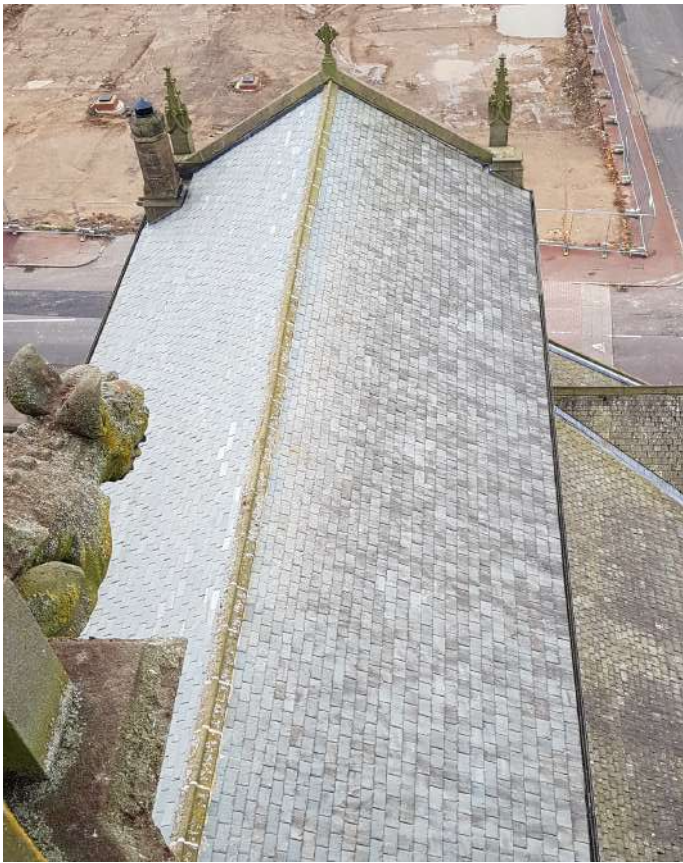
Nave roof re-roofed in 2015

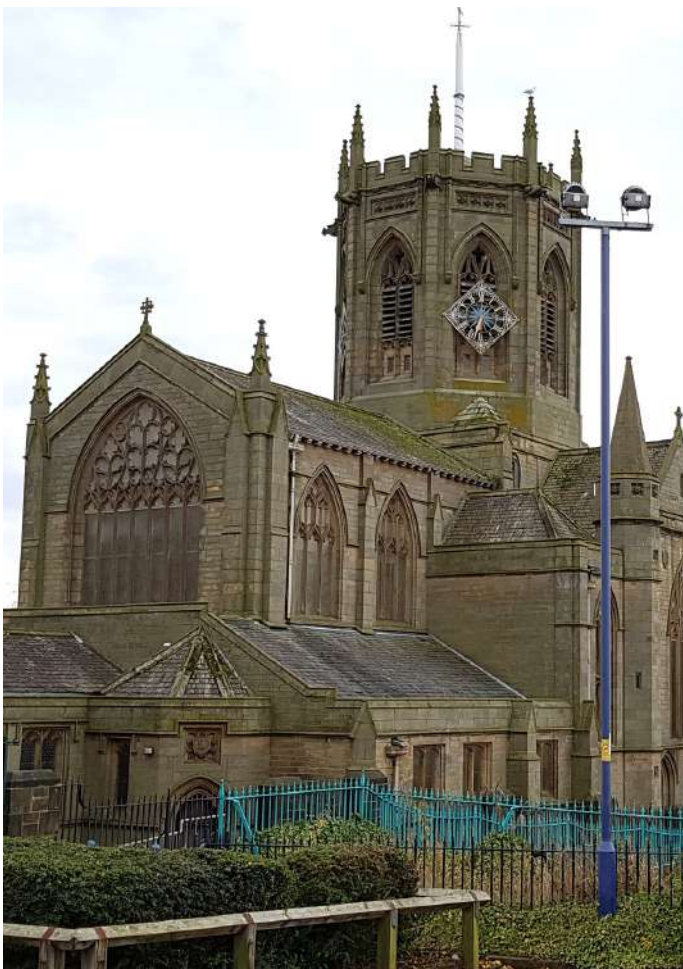
Remaining roofs generally in poor condition with many missing, cracked and broken slates - slates at end of life

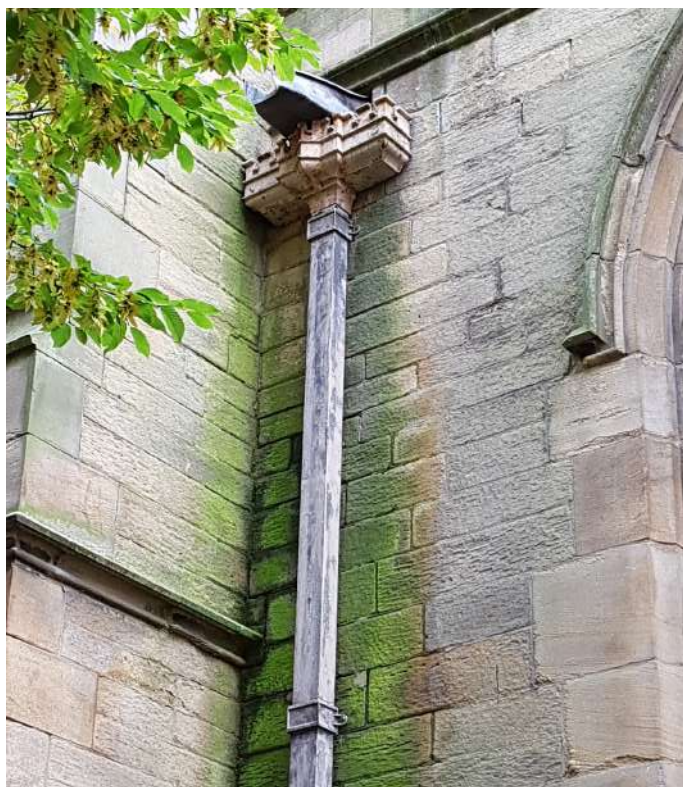
Rainwater spilling down masonry

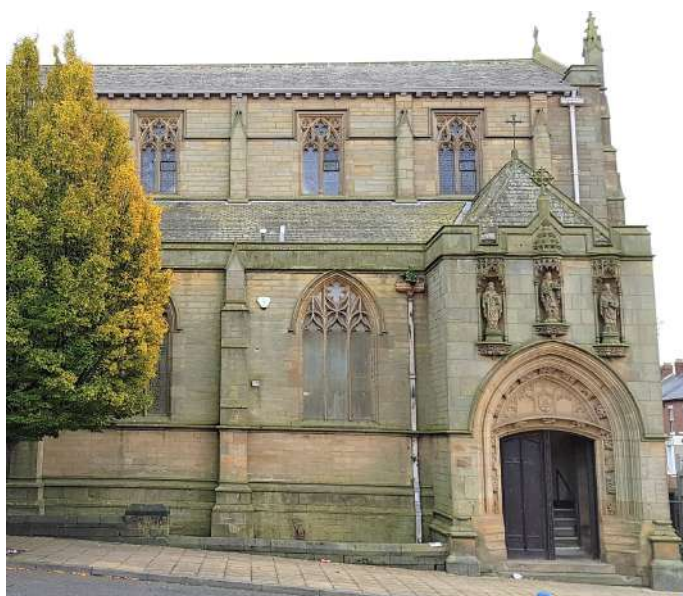
High-level nave eaves gutters, hoppers and downpipes all refurbished in 2015. Rest of rainwater goods require refurbishment during roofing works

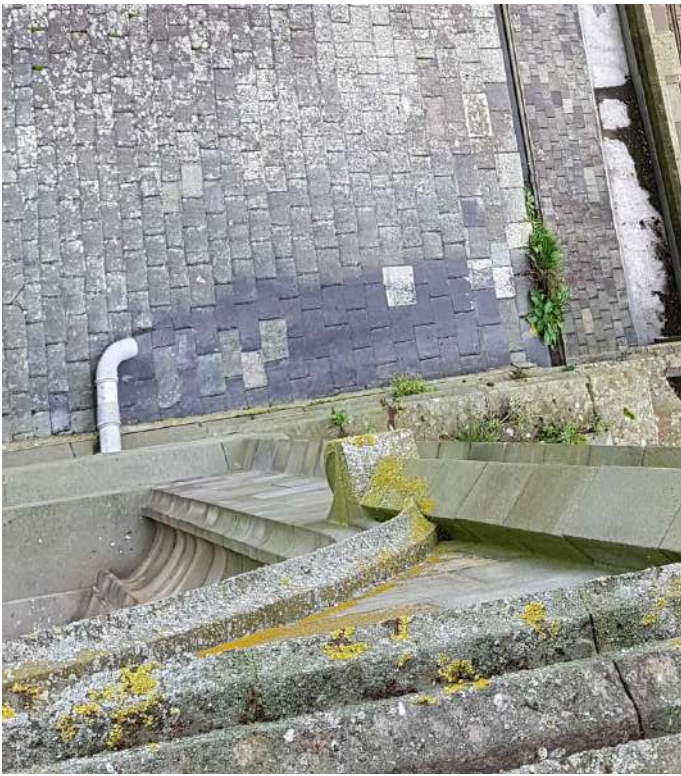
Discharge from tower onto Chancel roof - heavy vegetation directly below discharge

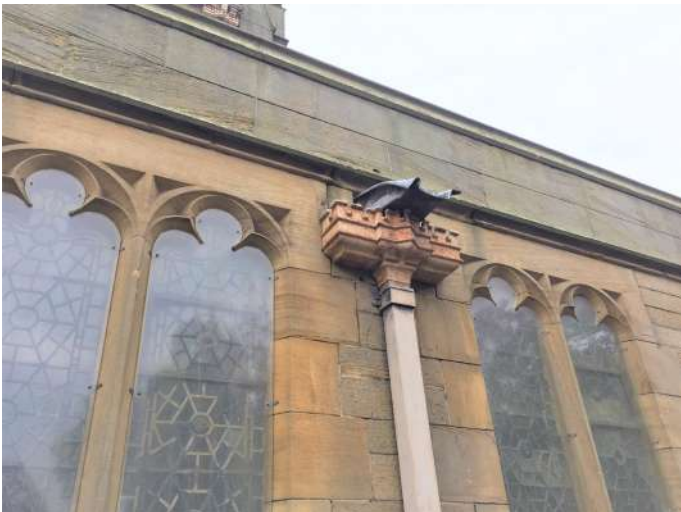
Rusting hoppers and disfigured lead chutes from thieves trying to remove/pull out

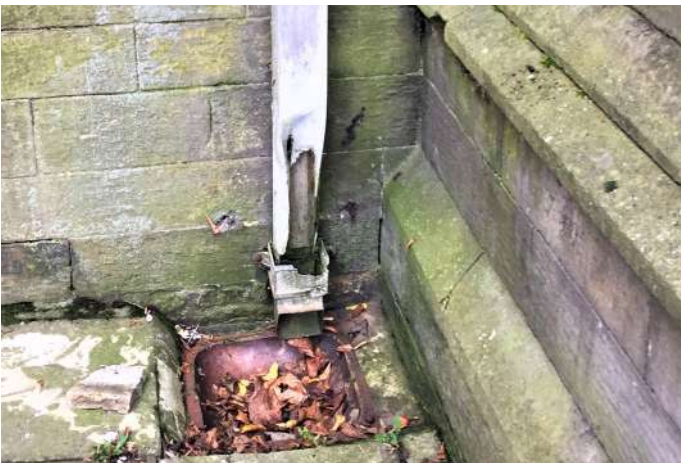
Damaged lead downpipe discharging into gully

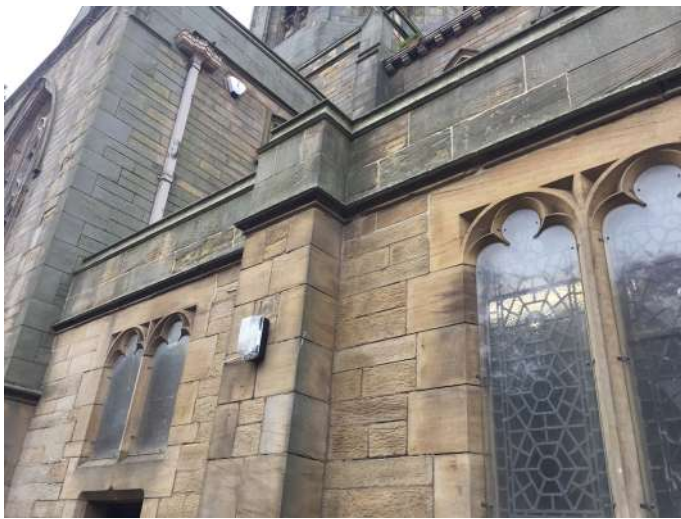
Parapet over southern garden door re-pointed (south chancel aisle)

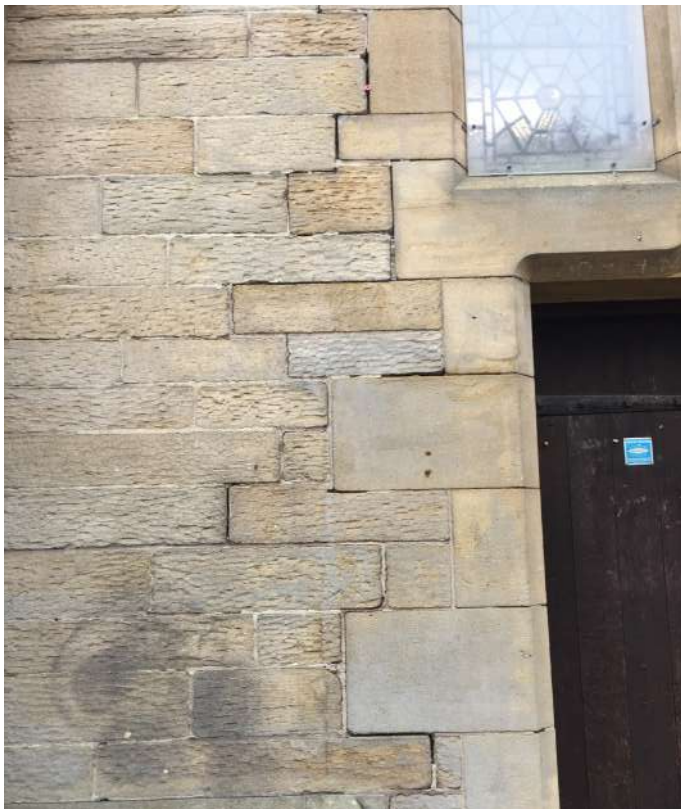
Localised cracking through joints to west of garden door

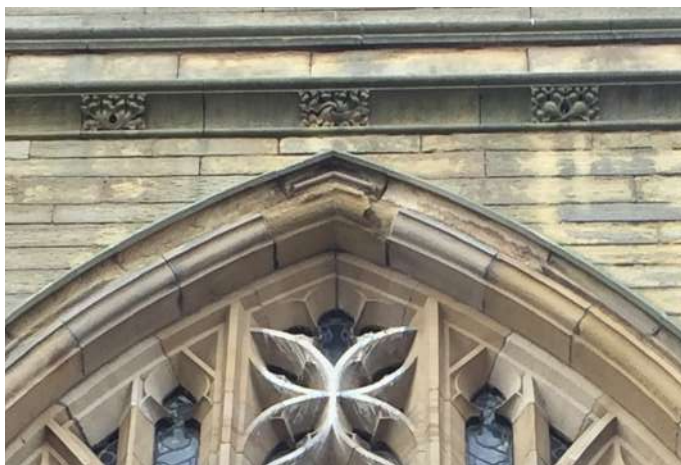
Weathering of masonry below open-jointed or inadequate stringcourses and to bottom roll of hoodmoulds where water is penetrating. Ideally all strings and hoodmoulds should be capped with lead

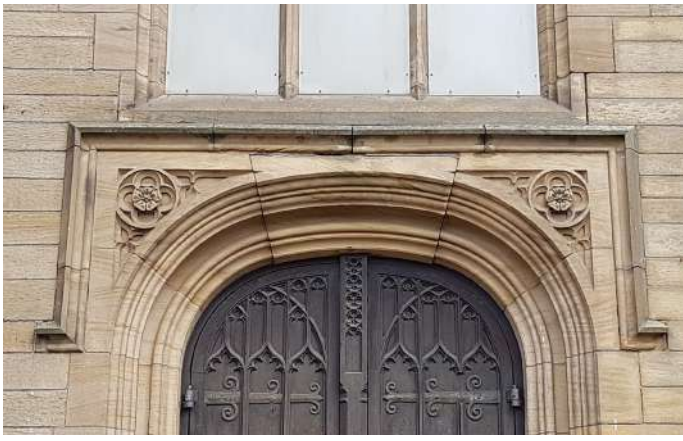
Key stone dropped over main west doorway - not progressed

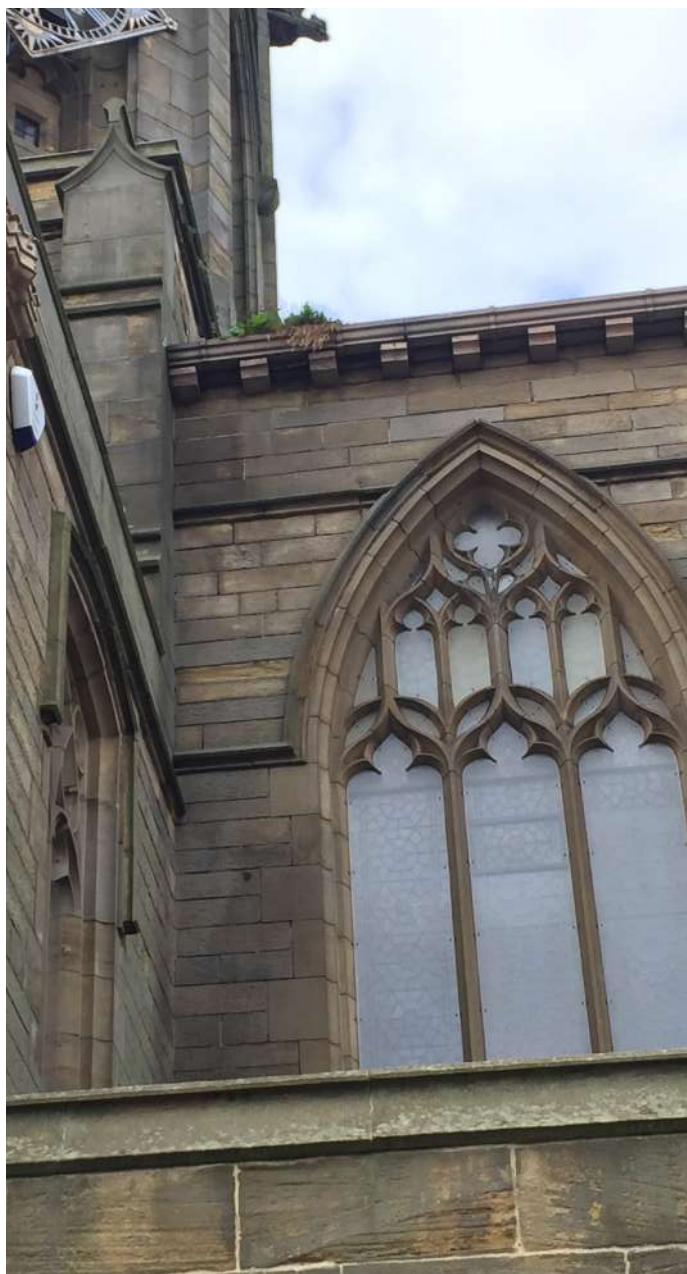
Polycarbonate sheets on exterior of windows - well fitted and neatly cut, though now clouding and would benefit from renewal in the long-term

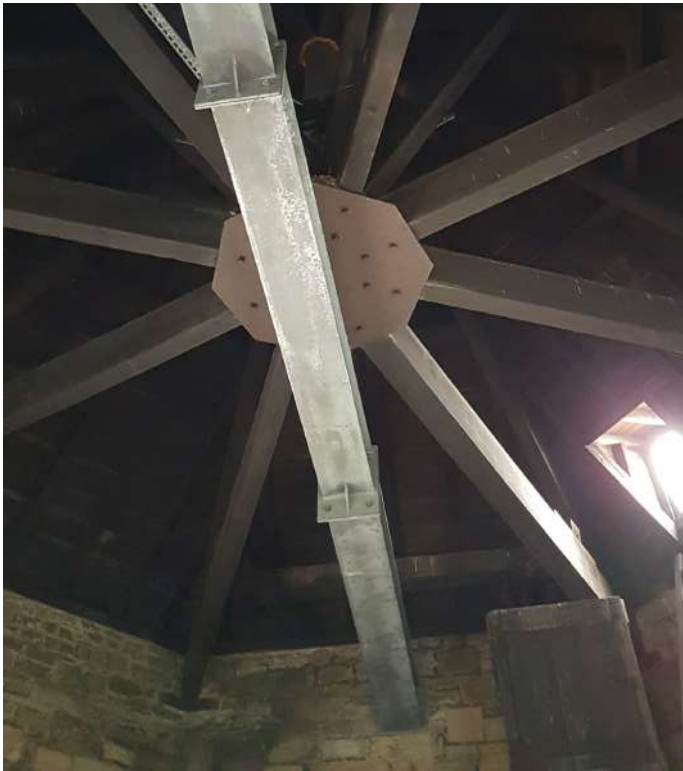
Modern steel support to roof - no movement noted

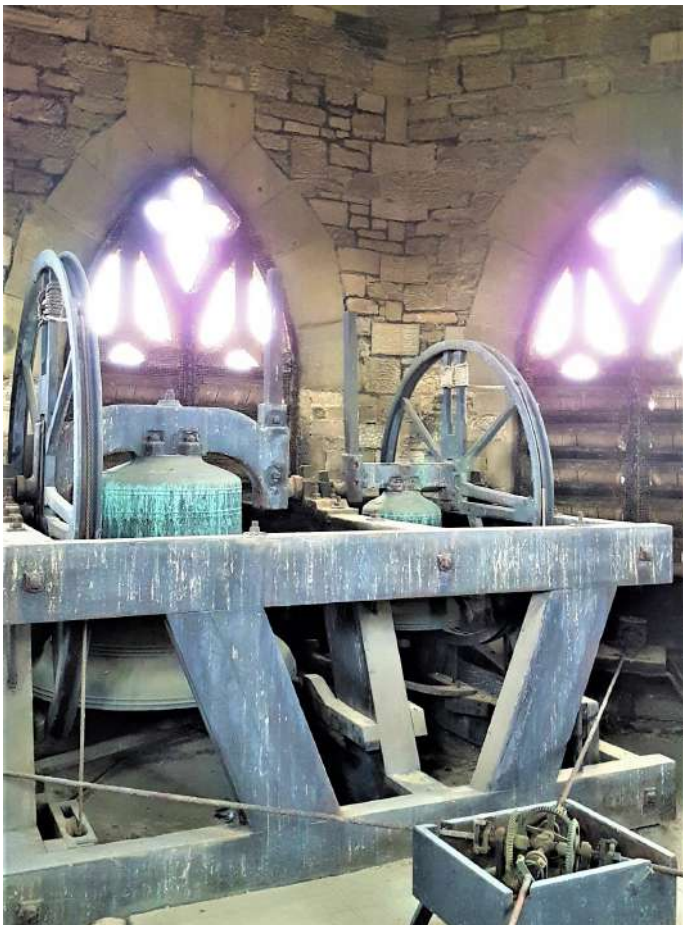
Timber bell frame on concrete floor - good condition though would benefit from a clean

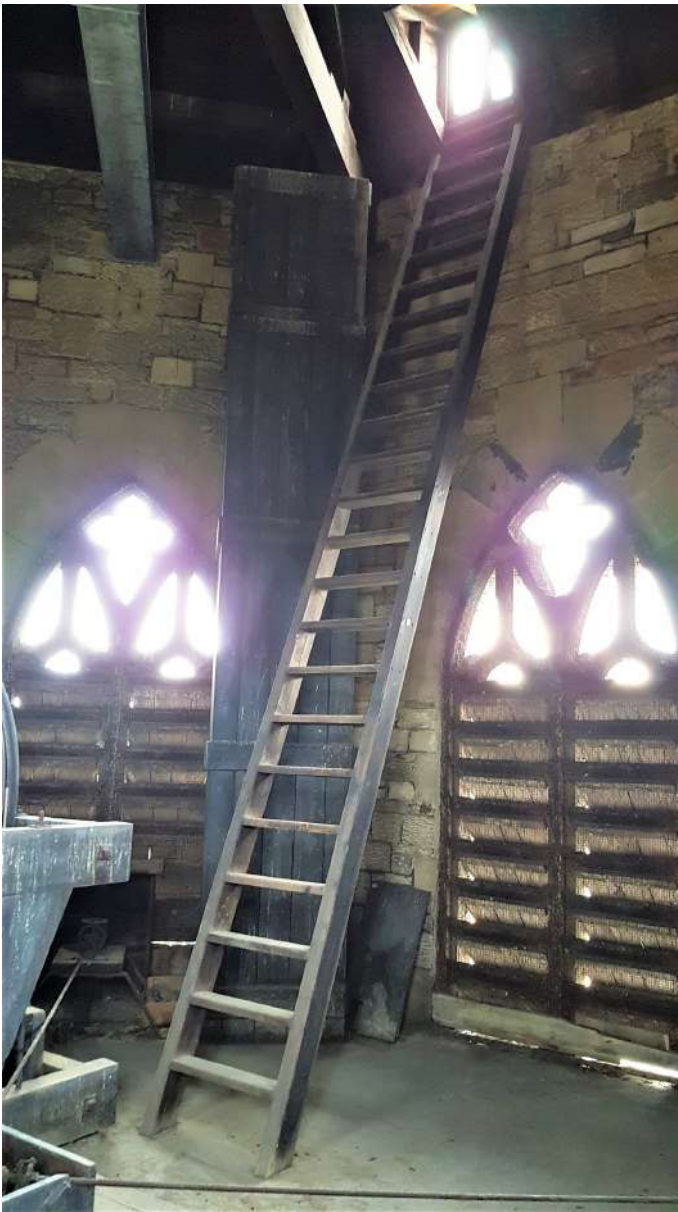
Access to tower roof. Add sign to warn users about the exit onto the parapet so they understand the risks

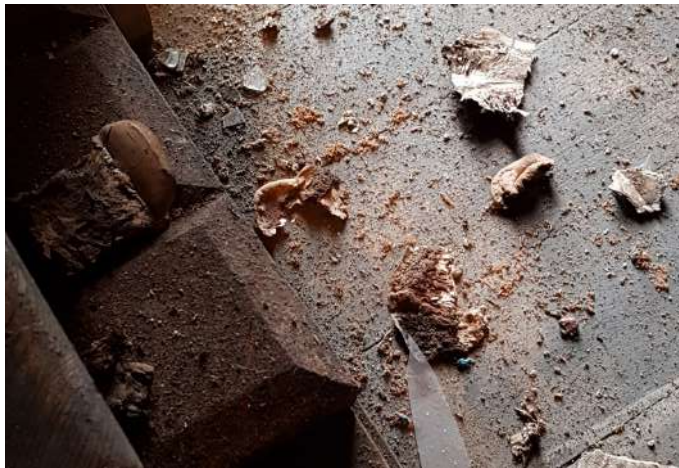
Remnants of large fungus, fallen from underside of organ loft roof (noted in last QI, located on timber soffit boarding)

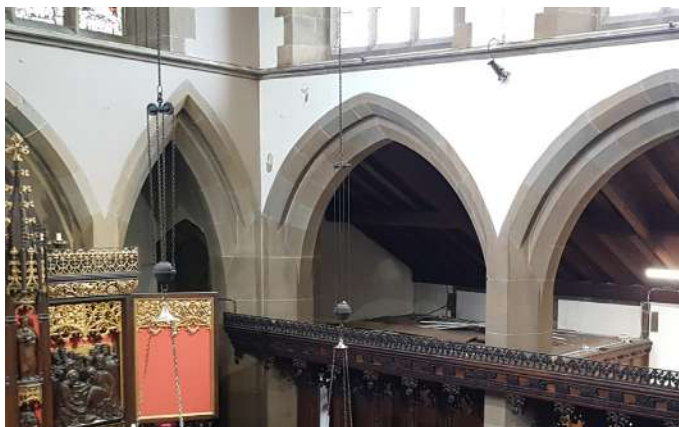
Peeling paintwork indicating damp in south-east corner of chancel (coincides with missing flashings externally)

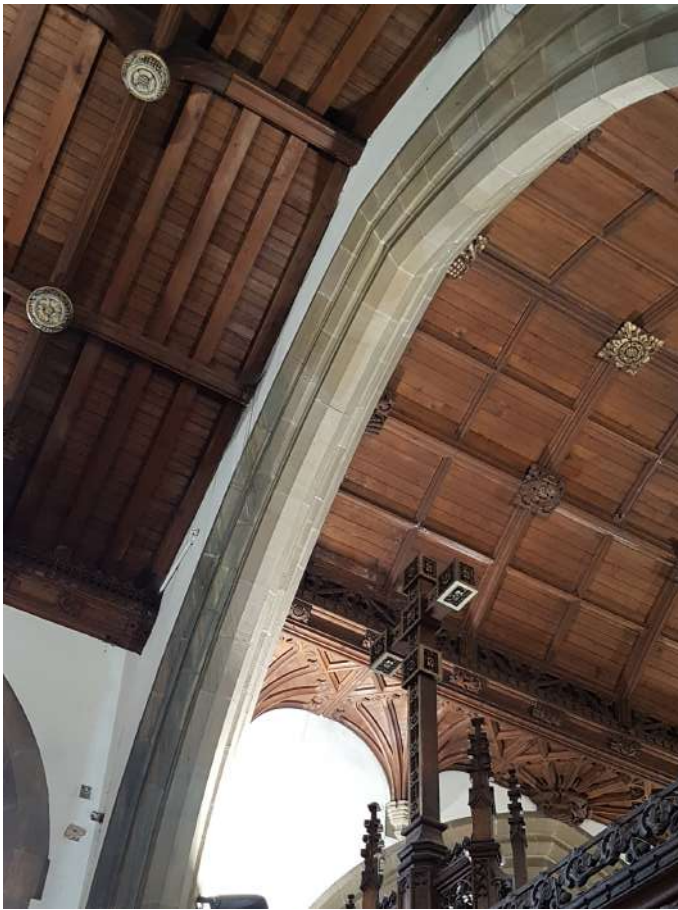
Leaks over chancel arch/crossing arches, staining from purlins - monitor

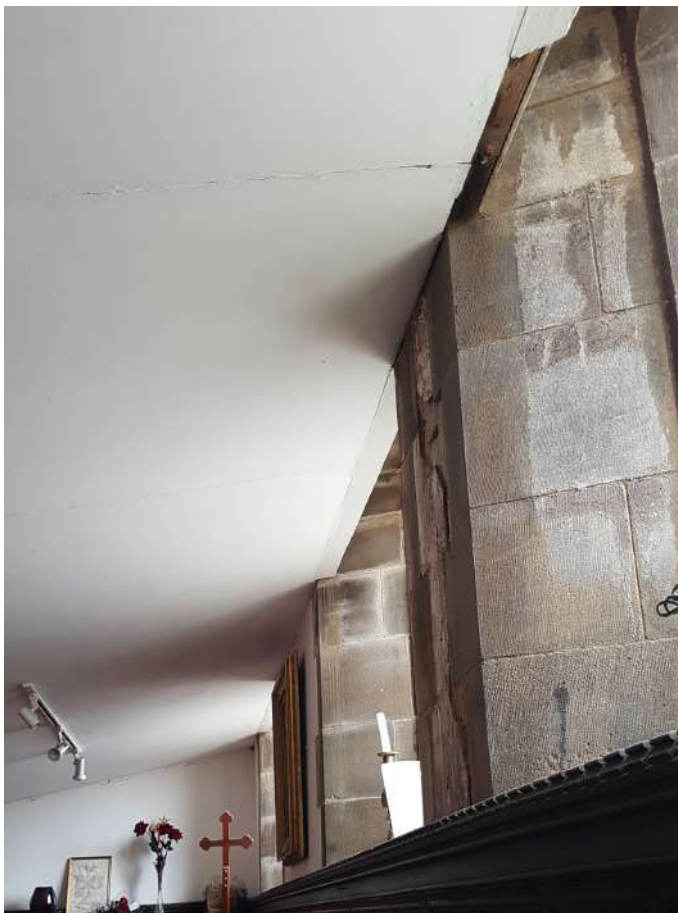
Choir vestry - damp to windows and staining from water ingress above - false ceiling and wall panelling hides issues

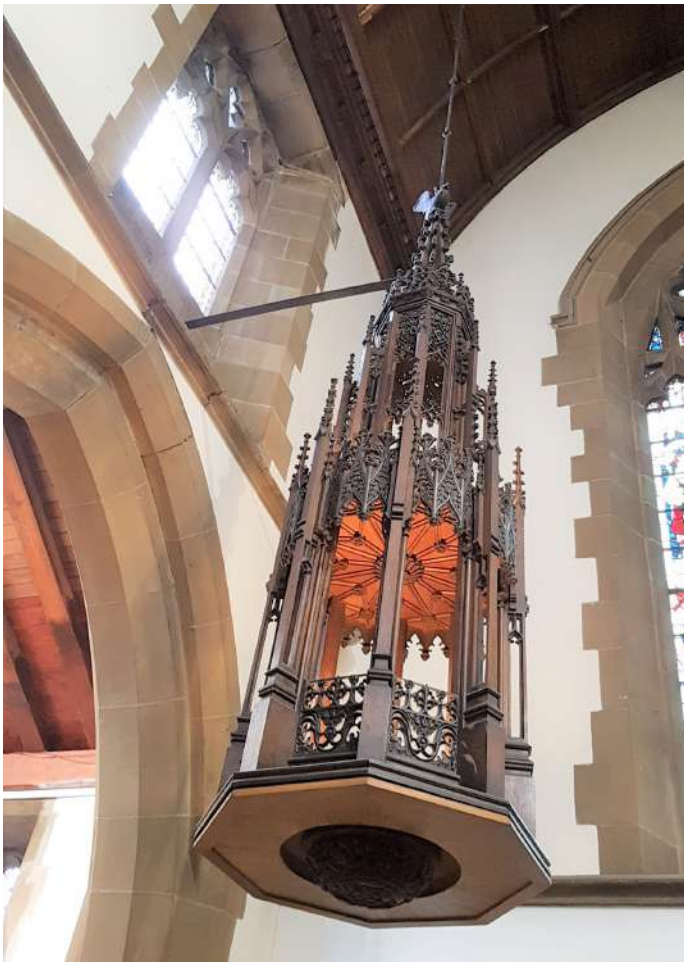
Dry-rot found and timber / gutter over repaired. Iron bracket holding the font cover has cracked the masonry at the window cill - monitor

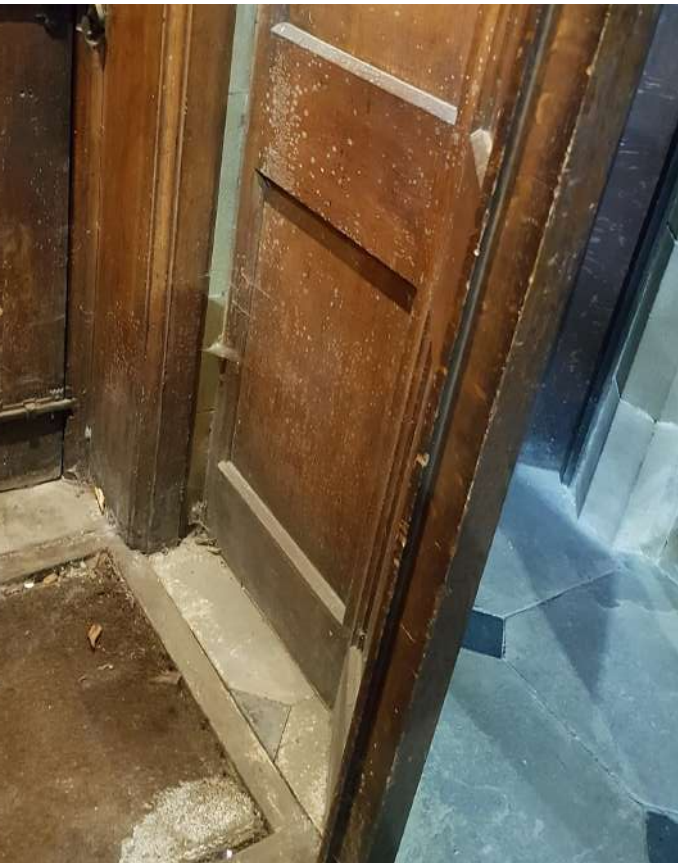
Mould to inside of north aisle draught porch, on both timber and mat

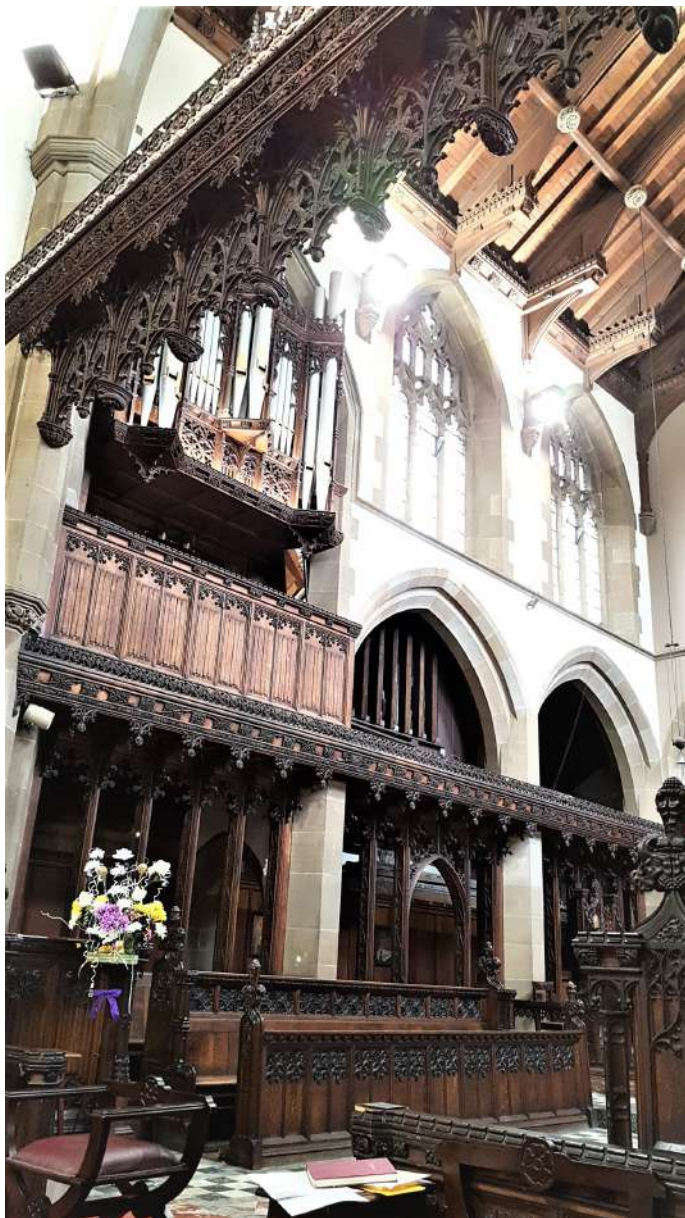
Interior panelling, carved timberwork and metalwork is exceptional and of very high significance

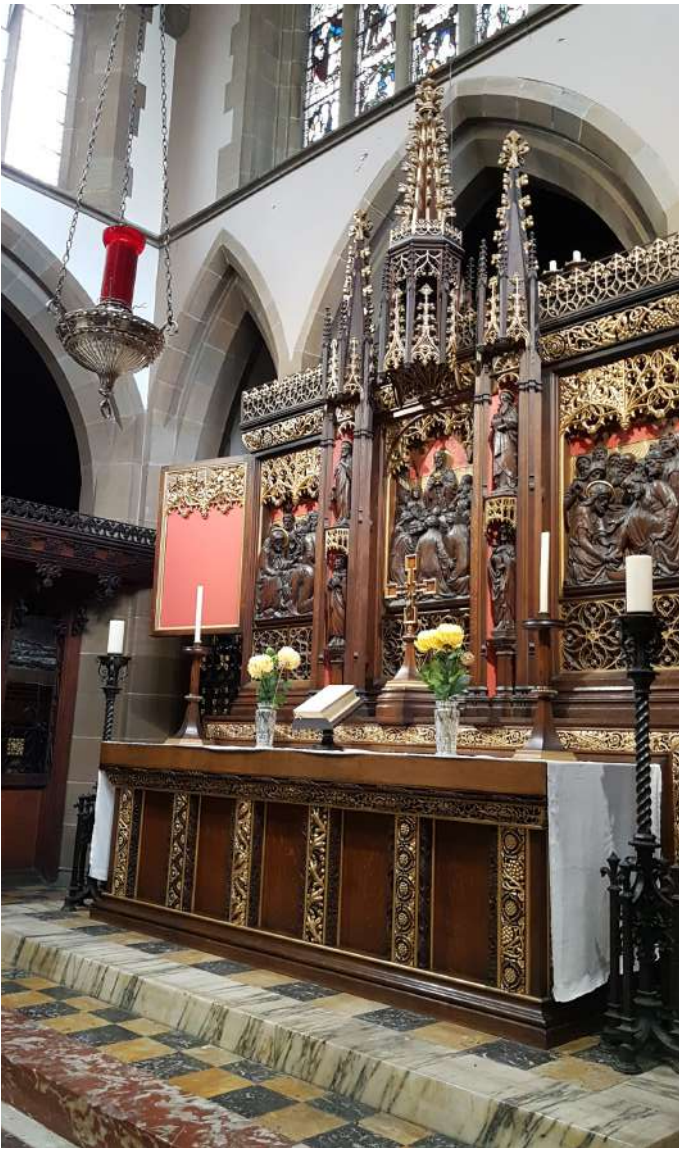
High altar and reredos

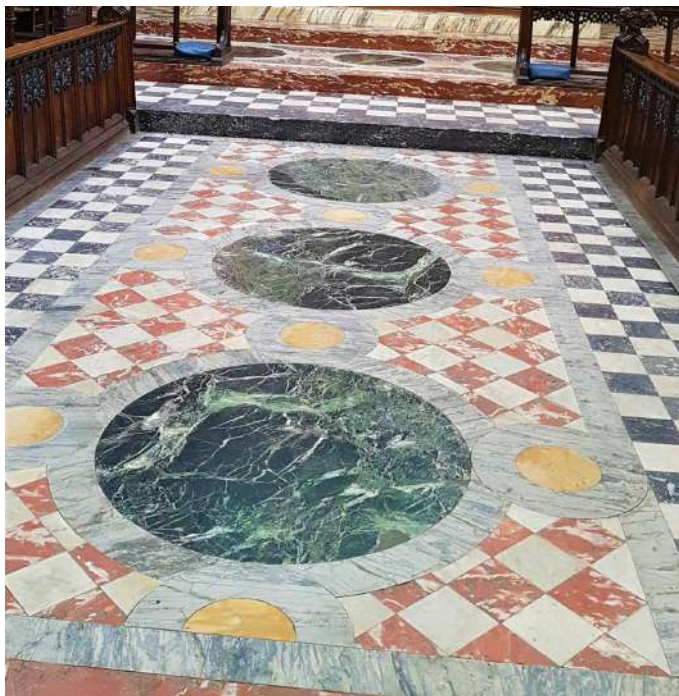
Marble floor to chancel - all interior of exceptional quality

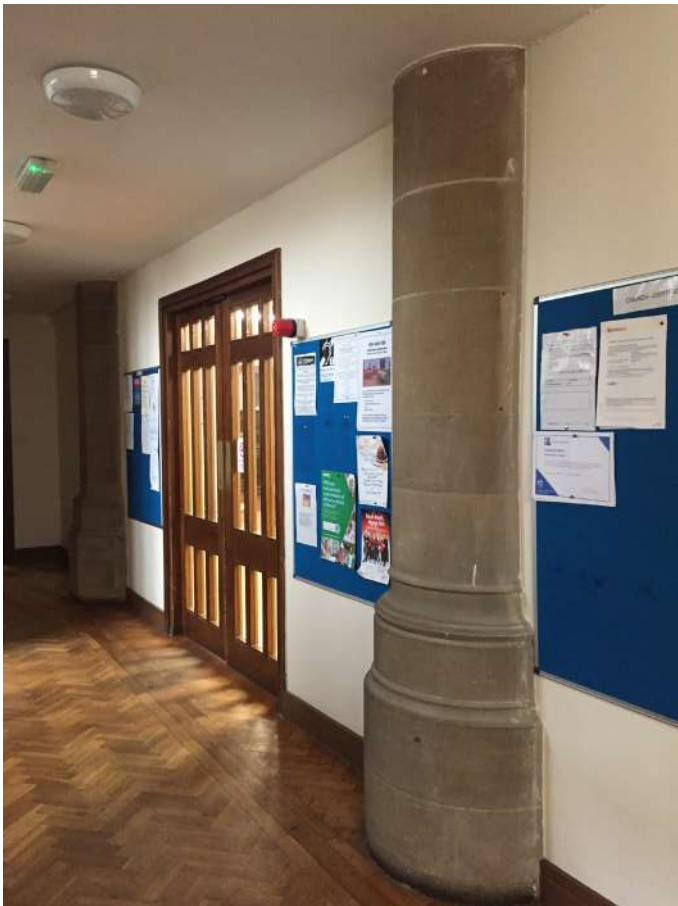
Entrance into community hall from former north aisle

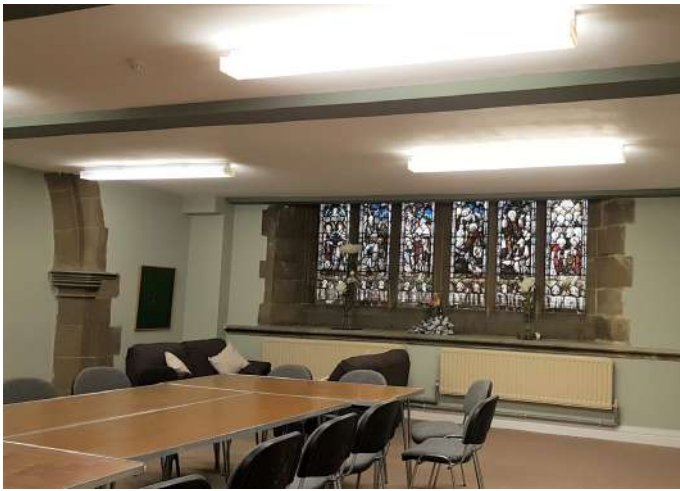
Meeting room on gallery level - ceiling cuts west window in half and creates a low-ceilinged, rather unpleasant space - consider removing the ceiling to allow appreciation of roof and west window (appropriate heating issues will have to be considered)

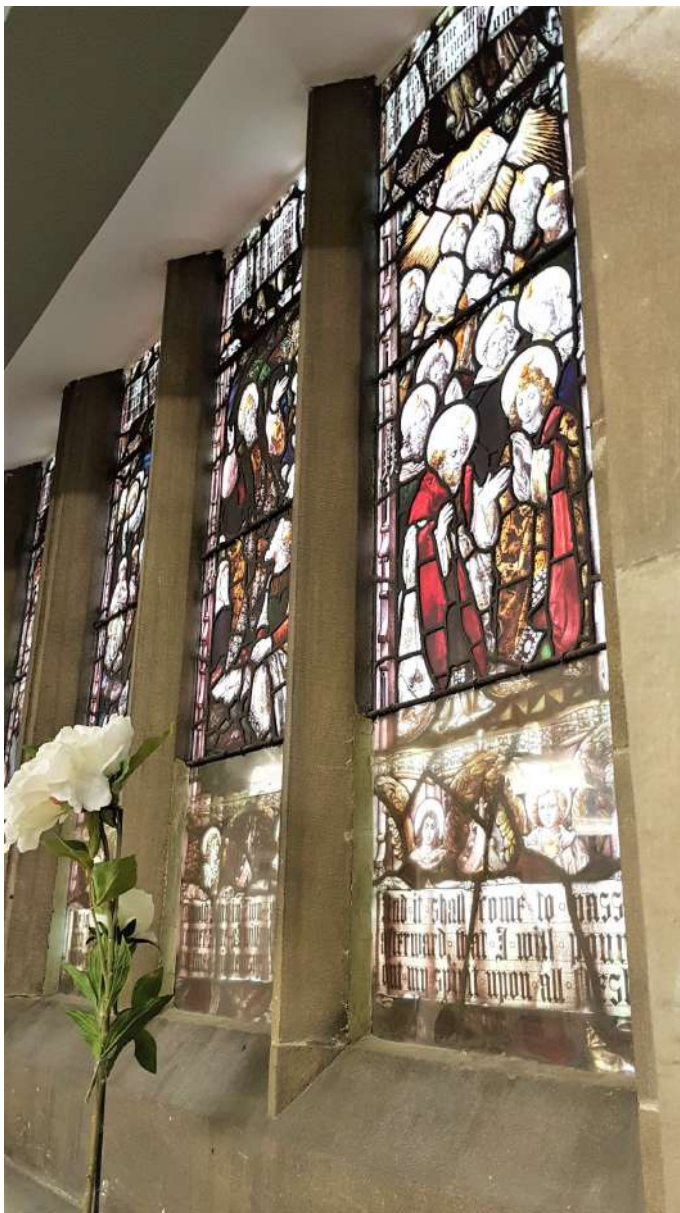
Re-pointing and minor repairs to glazing required to west window

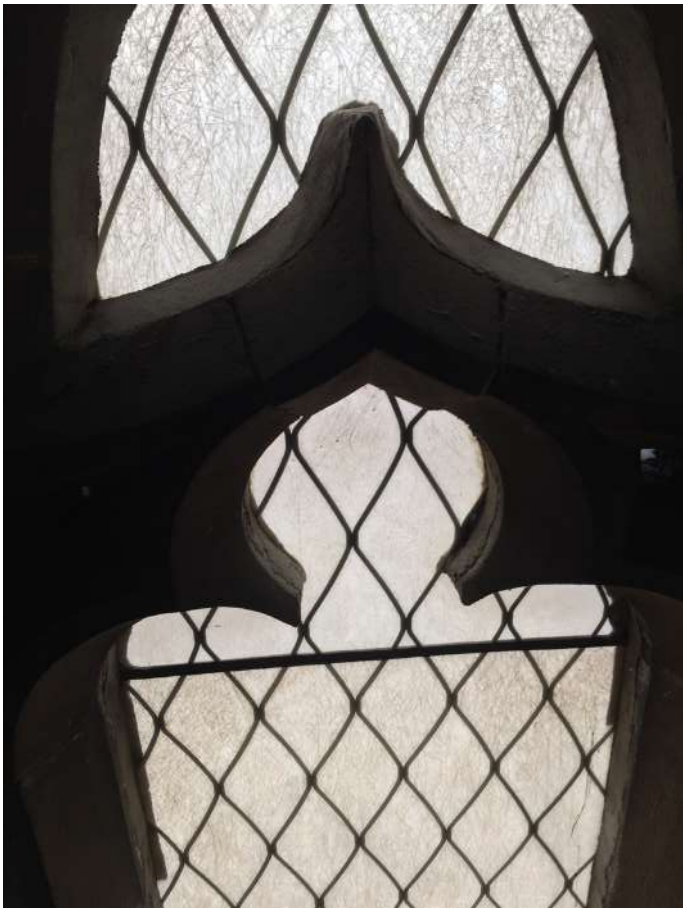
Fibreglass glazing in office - thermally very poor, room very cold and barely usable

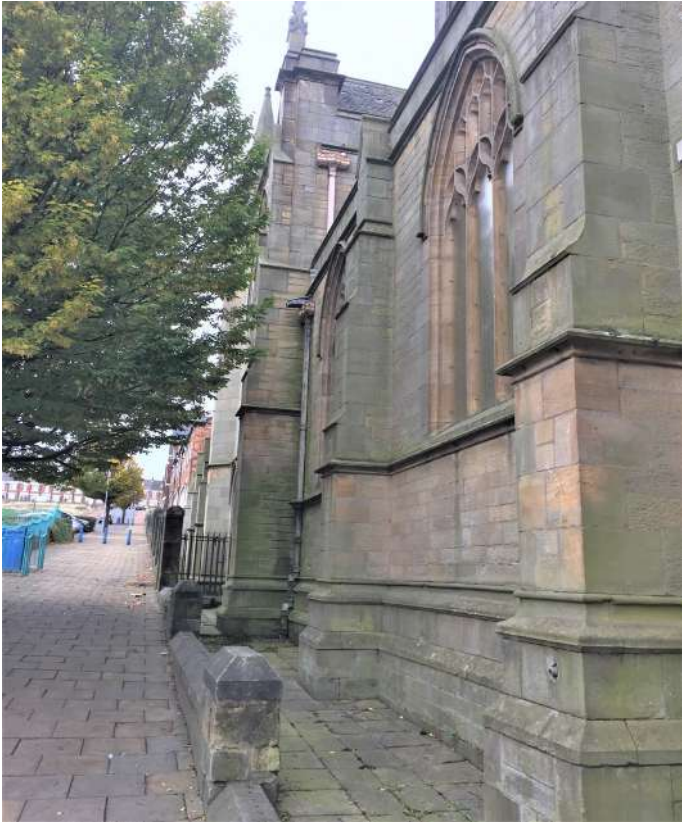
Railings missing from western end of north boundary wall. Areas behind boundary walls kept clean and tidy

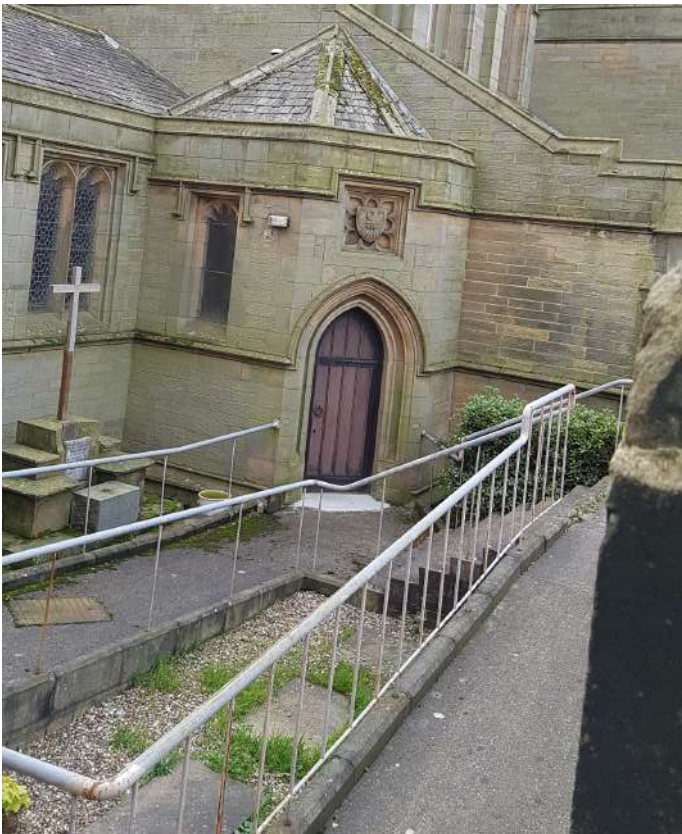
Accessible ramp down to clergy entrance at north-east end of church - not idea for access into community hall

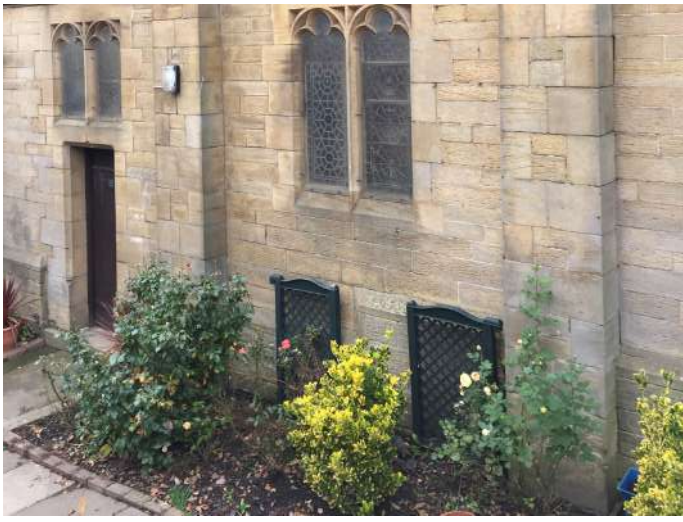
There are various gates leading to the numerous entrances around the Church. All gates are wrought iron and in similar condition to the railings.

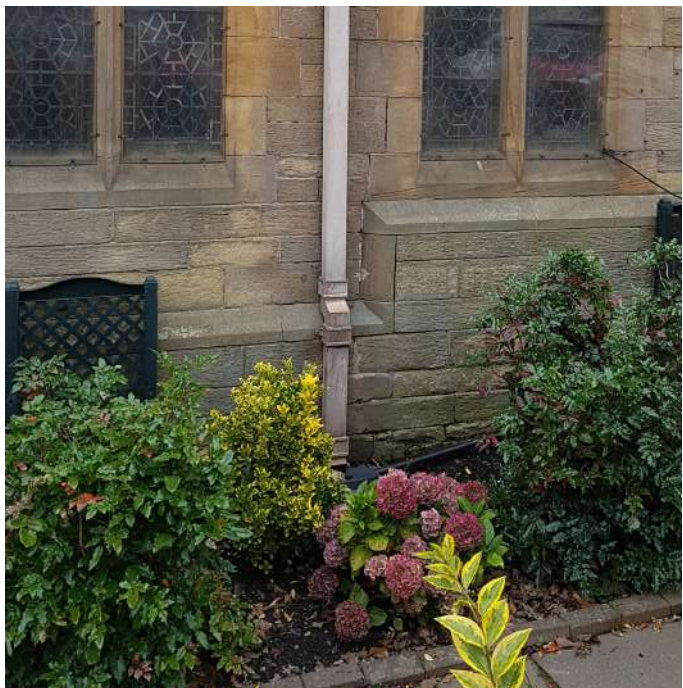
At the west end to the boundary with the main road and pavement, there is gravel and shrubbery behind the low boundary wall to either side of some narrow steps leading down to the boiler house.

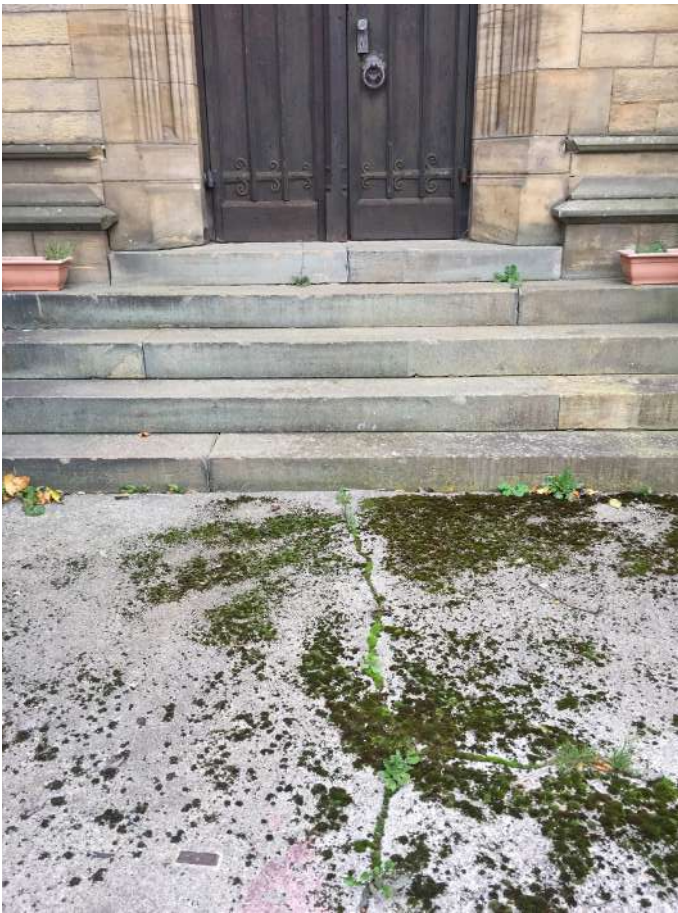
Cracked concrete to front of west door would benefit from repair and steps re-pointed to resist weed growth in gaps
