## Church of St. Gabriel Sunderland

The Care of Churches Measure 1991  
QUINQUENNIAL REPORT  
August 2018

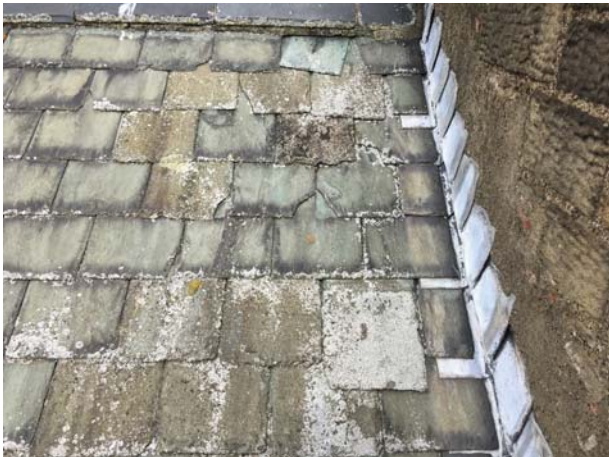
1. Small, evenly sized blue/green slates with plain black terracotta ridge tiles.
2. Slates are hard and fairly thick 'strongs' with a craggy surface, are generally intact and in a reasonable condition though there are many breakages and several slipped slates, and one missing slate over organ loft.

Photo 2:  
Slipped slate over organ

1.	Repair missing, loose and slipped slates	600
2.	Repair lead flashings above gutter and install new lead flashing to felt roof	600
3.	Replace sections of felt lined gutter	400
4.	Remove all seagull debris and vegetation from gutters	300
5.	Adapt Flower Room RWP to discharge to gully	300
6.	Clear all gullies and grille tops	200
7.	Adjust cisterns to stop overflows running	60
8.	Cut back shrubs around gullies	60
9.	Asbestos report for whole building	400
10.	Remove or treat asbestos as recommended to maintain 60min FR	?

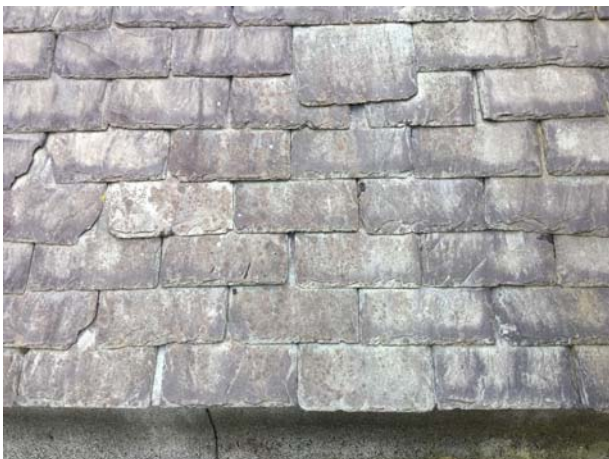
Photo 3:  
Slipped and broken slates south side of  
Nave at Transept abutment

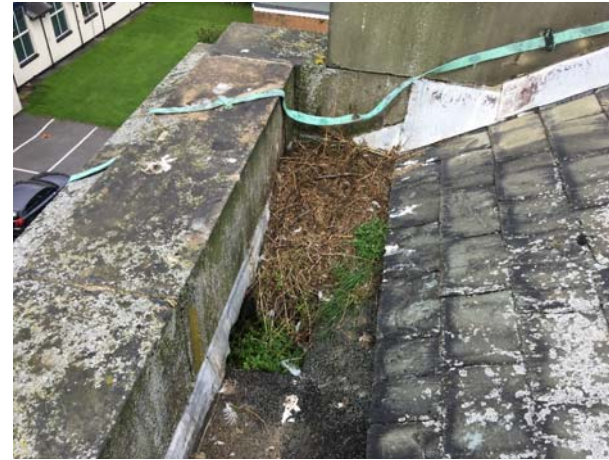
Photo 4:  
Slipped Nave south side

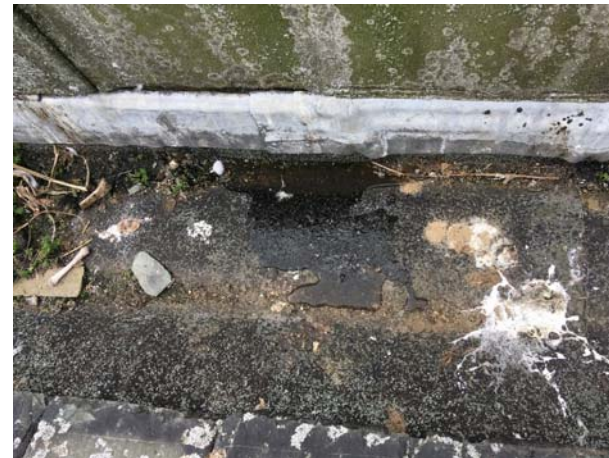
Photo 5:  
Seagull debris has blocked outlet on  
west side of North Transept

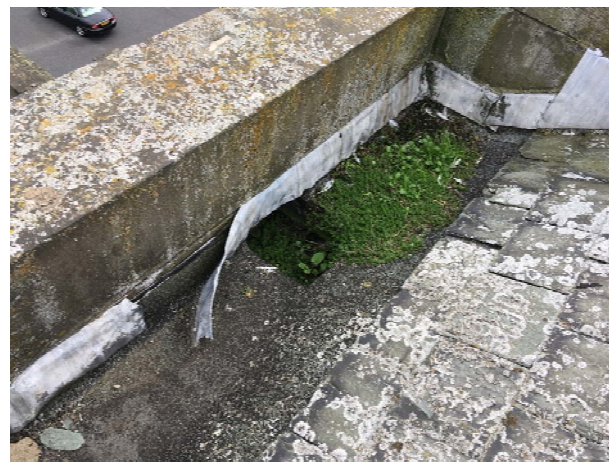
6. Flat roof over Vestry, and Choir Room replaced in mineralised felt (c2008). The gutter on west side of North Transept is spongy and squirts water when walked upon.

Photo 6:  
Spongy gutter and seagull debris on  
west side of North Transept

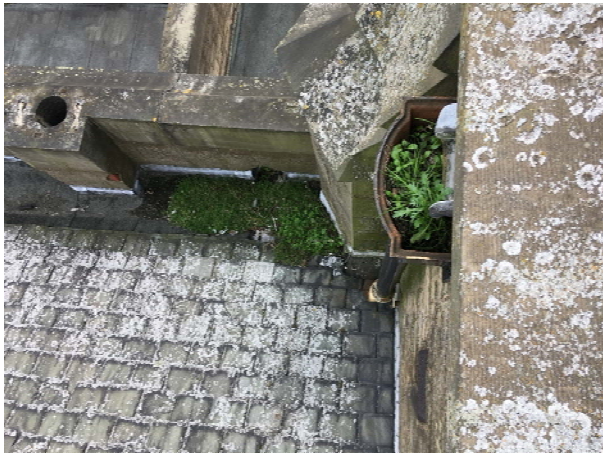
4. Code 3 lead soakers with Code 4 stepped lead cover flashings at abutments; latter is set into brickwork concealed behind cement render. This is loose in places where brick substrate is deteriorating behind, also 500mm length of flashing is loose on east face of South Transept.

Photo 7:  
Blocked outlet and loose flashing on  
east side of South Transept

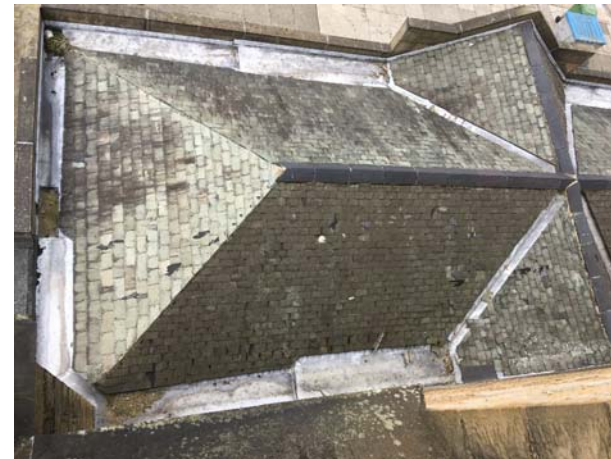
Photo 9:  
Debris and vegetation on north side of  
Nave

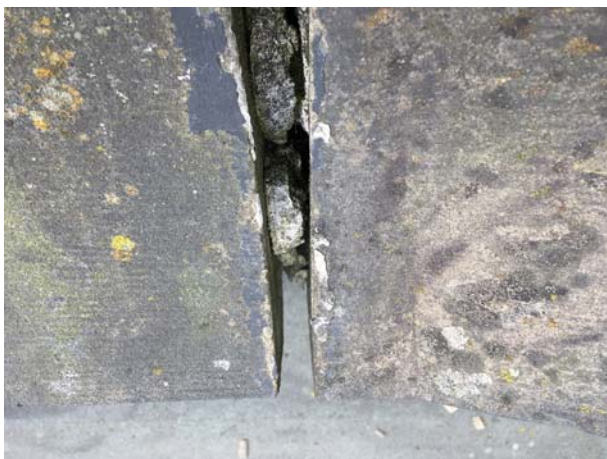
10. Narthex roof is accessible from a short ladder. Coped gable to west, mitred hips to north and south. Latter have had cement mortar applied and additional copper nails to weatherproof after theft of original lead hips. Approximately 20 broken slates and 6No. missing slates. Repeated repairs to the lead valley linings, the northeast being over-lined with *flashband*. The northeast upstand has been replaced with bitumen felt after a lead theft. Very poor condition; expected life to renewal 5 years.

Photo 12:  
Many slipped, missing and broken  
slates over Narthex

1.	Re-slate Narthex, replace gutter linings and add rooflights	26000
2.	Replace brittle bitumen felt north and south of Narthex roof	1000
3.	Repoint gaps between parapet copings	300
4.	Replace loose, missing render behind parapets	500
5.	Overhaul south Narthex doors	1200
6.	Remove corroded SVP above South Transept and dress bitumen felt down pipe	200

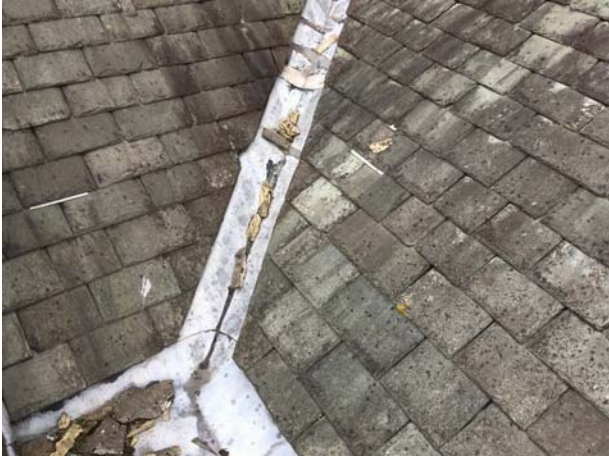
Photo13:  
Slipped and broken slates on east side  
of Narthex

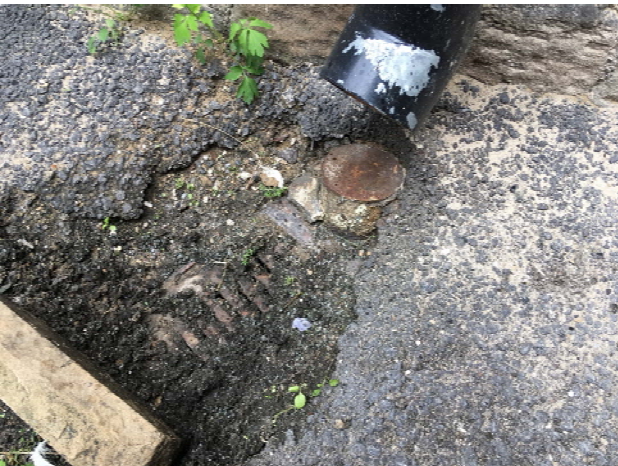
Photo 18:  
Flower Room RWP misses gully

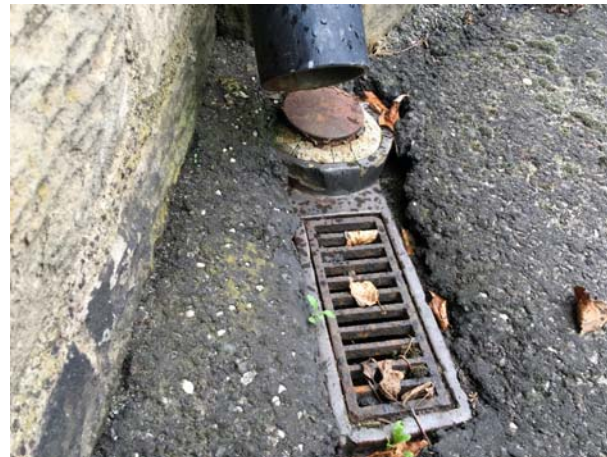
Photo 16:  
Blocked gully north side of Nave

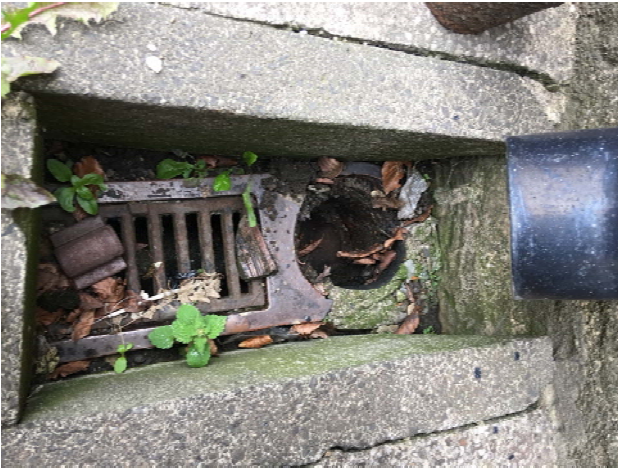
Photo 19:  
Discharge on south side runs to ground  
between macadam and gully

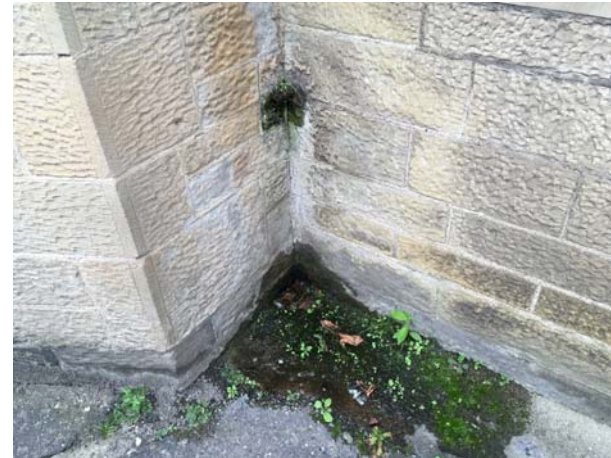
Photo 21:  
Blocked gully on south side of Nave

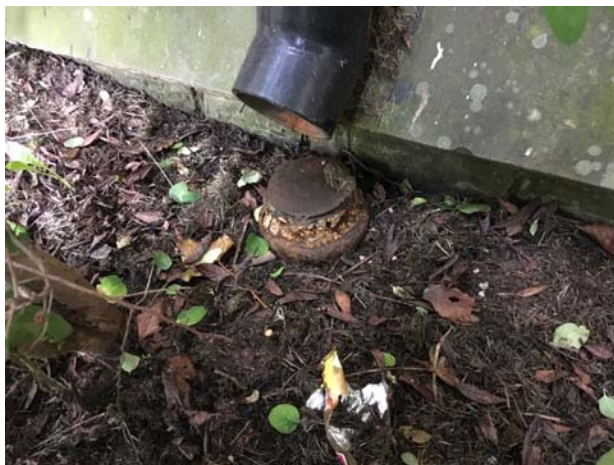
Photo 24:  
Leaking overflow south side

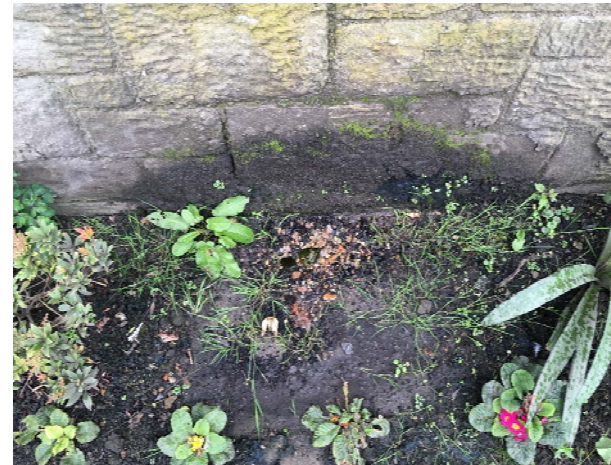
Photo 22:  
Blocked gully behind bush on south side of Nave

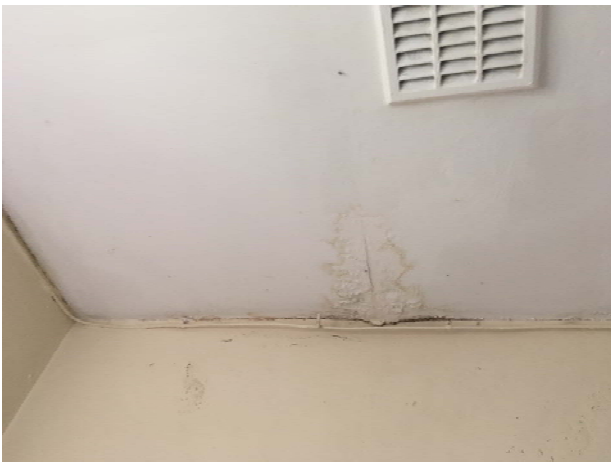
1. Small roof voids above lath and plaster finish; groined vault ceilings to Crossing, and Entrance Lobby, otherwise all roofs are exposed on the underside.
2. No access above Crossing. Plaster soffits appear in good condition.
3. Small hatches above Meeting Room & Office give access to crawl space. 150 x 50mm softwood ceiling joists act as a collar ties to 100 x 50mm rafters with sarking boards to soffits. All appear from hatch to be dry and in good condition except for isolated water staining. No insulation present above lath and plaster. Extensive cracking of lath and plaster, peeling paint in centre and water staining to south.
4. Flower Room ceiling east side is damaged by water ingress below blocked hopper.
5. Vestry ceiling east side is damaged by water ingress below blocked hopper.

Photo 27:  
Water damage on Vestry ceiling
