**QUINQUENNIAL INSPECTION REPORT
OF
ST. JOHN, THE EVANGELIST, BRANDON, COUNTY DURHAM**

QUINQUENNIAL INSPECTION AND REPORT

DATE OCTOBER 2020

David Beaumont BA (Hons) Grad Dip, RIBA, AABC

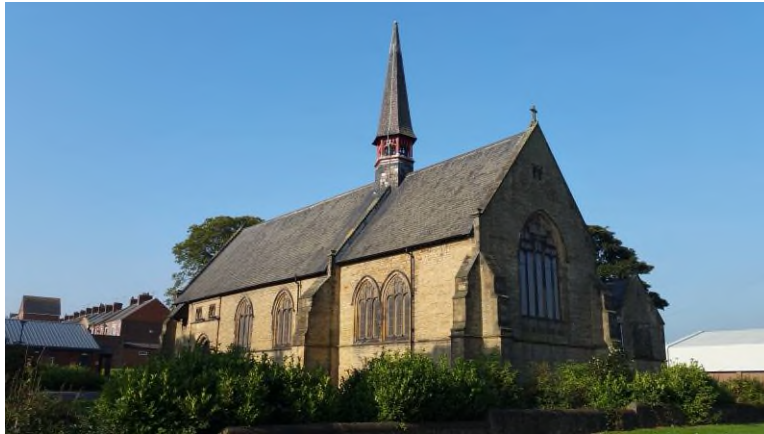
D Nave:

S side - Roll top ridge tile, bedding ok. It has got the occasional bedding piece loose. E abutment leadwork to water table looks ok. E abutment to the chancel arch same as the W, though the soakers are showing a little at the slating, but otherwise ok. Generally there is the odd slate missing up at the ridge.

N side – Same as S, in slightly better condition, the downtape comes down on this side.

Recommendation: replace missing slates and ridge bedding

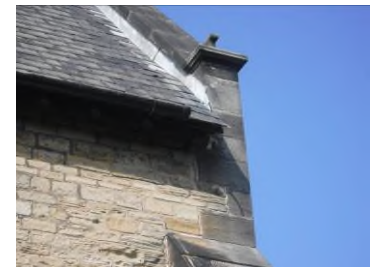
B North Aisle: Mineral felt roof, unable to be inspected from the ground.

Recommendation: have this checked when attending to gutter cleaning

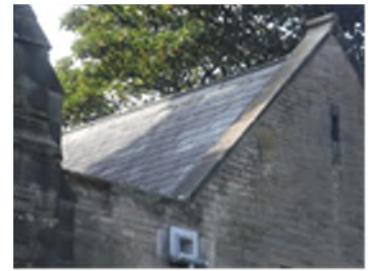
B **Clergy Vestry:** plastic membrane roof, unable to be seen.

Recommendation: have this checked when attending to gutter cleaning

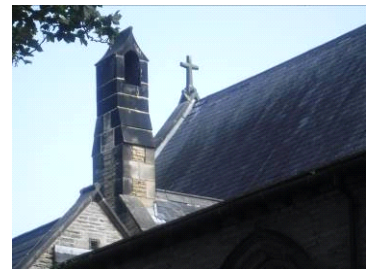
D **Chancel:**

S slope – Same ridge as nave, the bedding is poor towards the E gable, some slating coming away at the apex, flashing to the abutments- can't really see from the ground, I think they are ok, it has a major flashing abutment to the nave that looks good.

Recommendation: replace any missing slates and ridge bedding

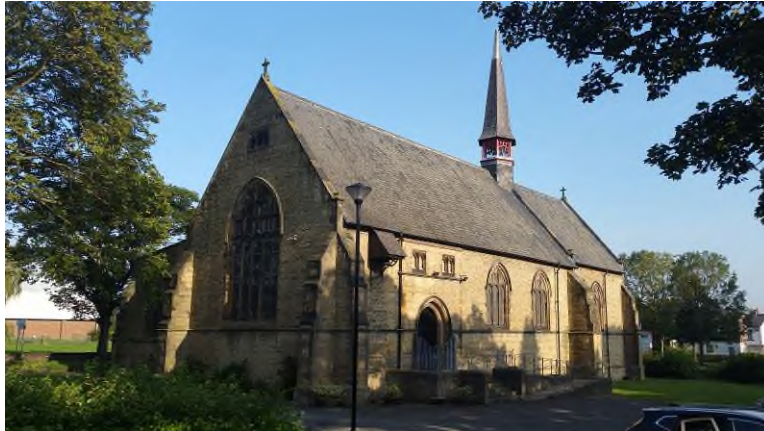
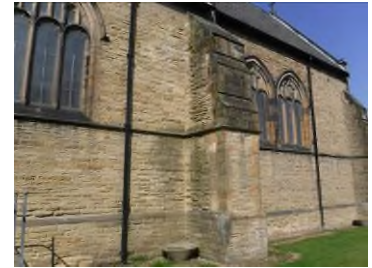
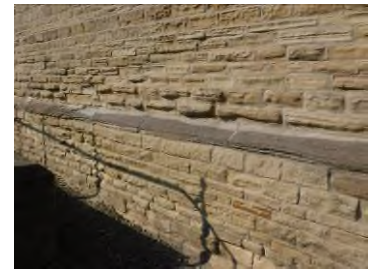
C **Nave South:**

Coursed sandstone walling wearing out a bit at low level and to the E of the entrance doorway, it has had cement pointing as is the story in most places. Below plinth stonework by the ramp is the worst effected and is salting particularly in one area and eroding out one of the plinth stones,

There is also some damp showing in the S W corner by the buttress just above an earth rod point, above this one of the string courses is eroded.

W buttress is ok apart from one stone above the first stage that has eroded out but that could just be pointed up. The E has some water staining because it is a large buttress. It is quite mighty (and original), there is water run off the top surface, looks like there are some open joints to it, be wise to be attended to, there is quite a lot of slug trails to that as well. And some water marking on the E side, generally this is ok.

Recommendation: point buttress open joints

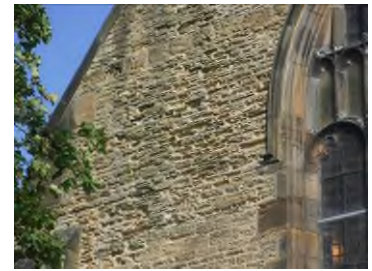
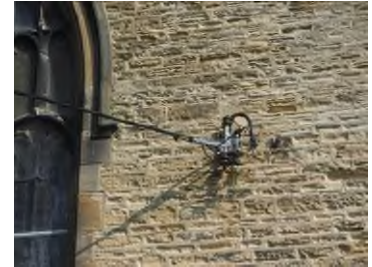
- **North Aisle:**

E side – Rebated water table looks ok, slight open joints just below it as it beds on to the top of the wall, suggestion of a crack just above the apex running through the joints and similarly something showing at the bottom not unusual and the walling is generally ok.

N side – This is made up of four bays, going from W to E. Slight wear just by the E buttress but ok. Bay 2, that is ok. Bay 3, ok. Bay 4, this contains a window and a door, is ok.

Four buttresses all in good condition, slight open joints here and there but nothing that needs attention.

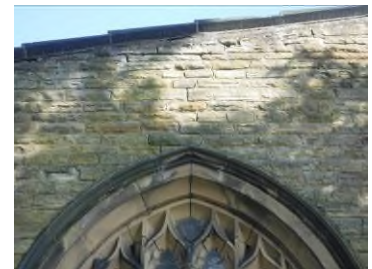
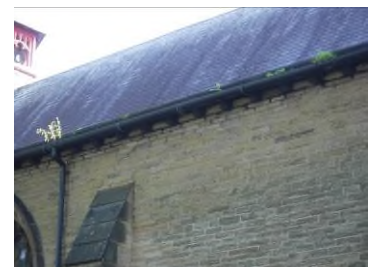
- **Choir Vestry:**

E side – Water table looks good, masonry is ok, corner quoins slight crack to one, some open joints but ok.

E side – Water table looks ok, walling is a bit dirty marked from previously water penetration through the now repaired water table, string course ok, masonry generally fine.

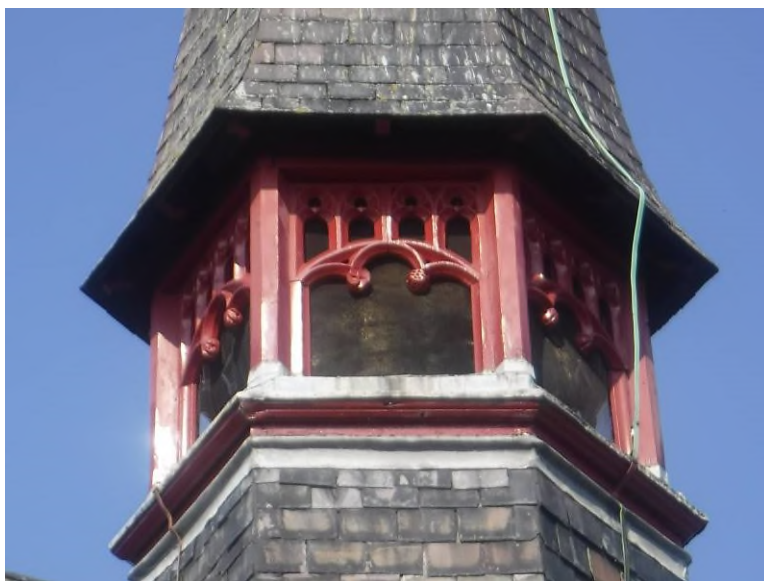
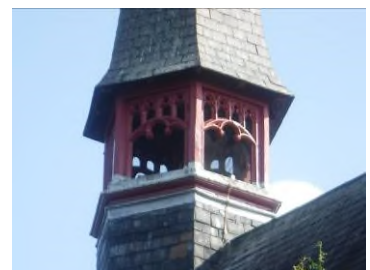
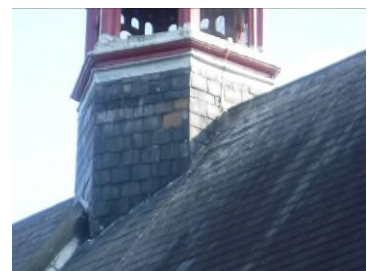
M **Fleche:**

The lead covering the tip of the spire looks to be slipping down. It may be exposing the roof structure to water ingress. Slating is generally sound to the spire, the slating to the sides is slipping in places and there is a couple of missing. The timber frame had a limited repair in 2018. Its bird mesh is missing on one side, there could well be rook nests inside, it's missing its cross and it's been down for twenty years and it kept in the former boiler room.

Recommendation: kept under close watch and create a periodic inspection, every three months and particularly after high winds. An alternative is to send a (local) steeplejack back to be absolutely sure all is well.

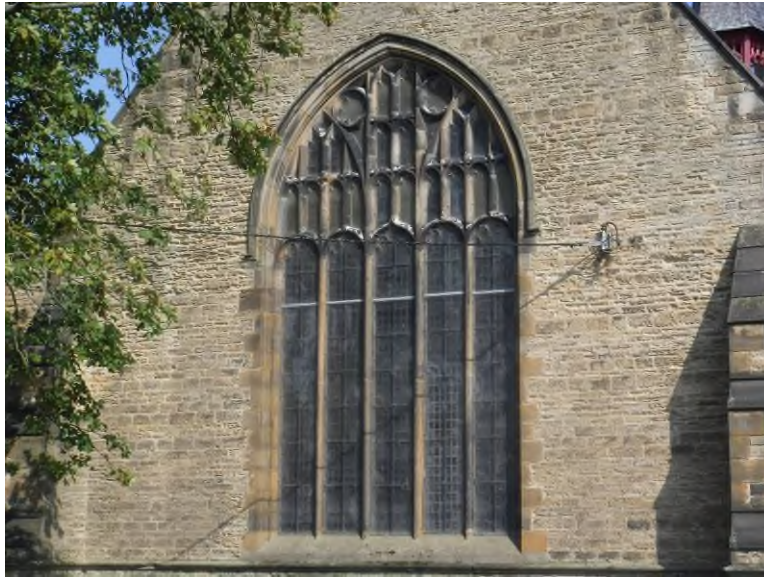
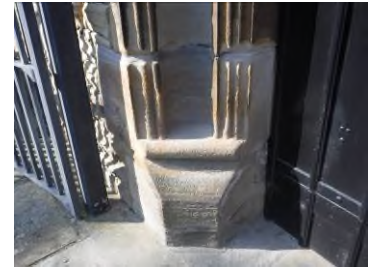
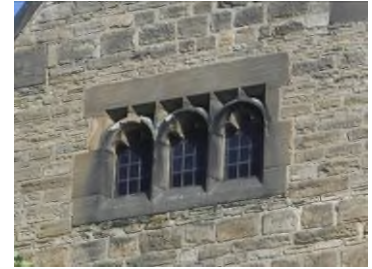
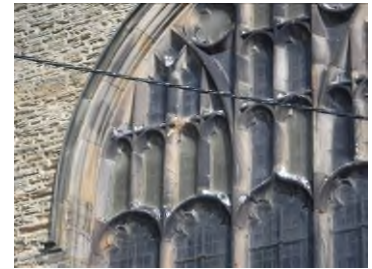
Five light window with tracery, hoodmould ok as are the jambs, the tracery has some erosion on the N side and there is cracking to the smaller units at the head of the trefoil and mullions are ok.

Recommendation: keep tracery under observation

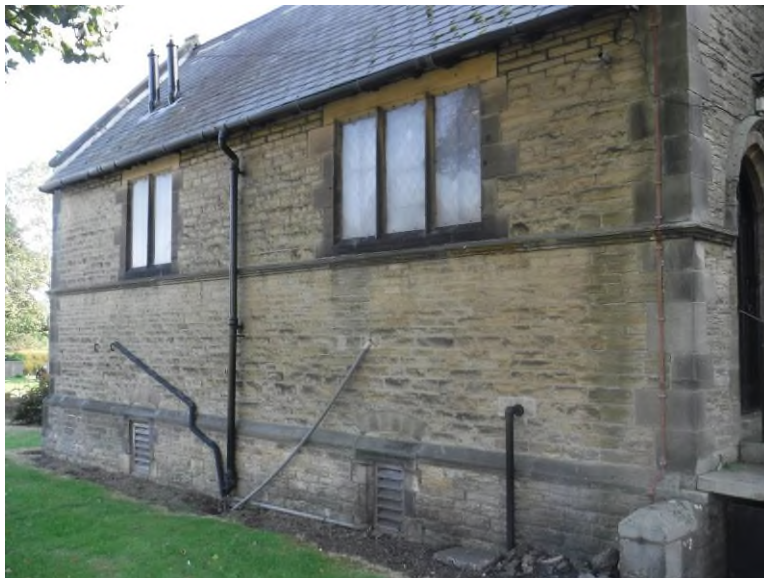
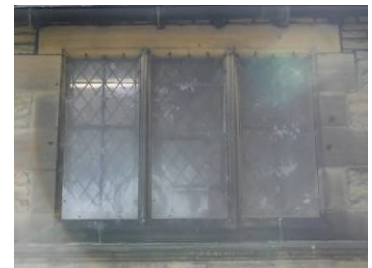
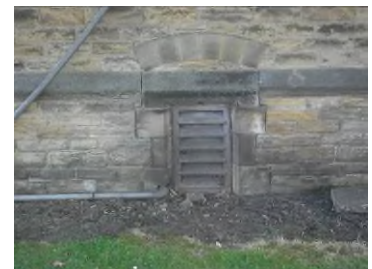
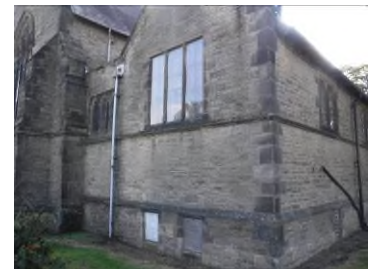
Choir Vestry:

E side – Lancet door some moulding breaking away on the hoodmould and a crack on the N side of the jamb, the door itself is a different pattern to the aisle door but in fair condition. Iron balustrade here on the steps which is sound enough though the steps could do with some pointing.

N side – Three light and two light windows of the same design with polycarbonate, hard to see through, there is a ventilator here probably not working on the triple, quite dirty. Below them are two timber louvred ventilators undecorated, down to the boiler room and these could be blocked in.

Recommendation: decorate boiler window infill

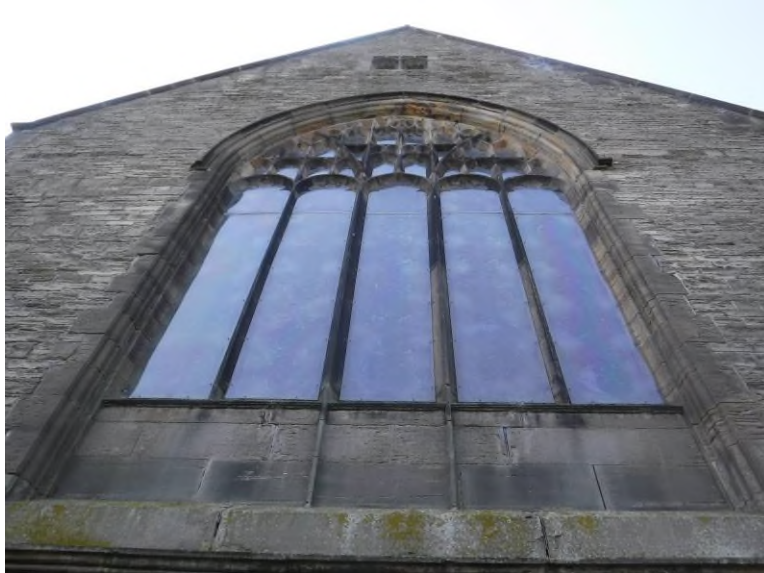
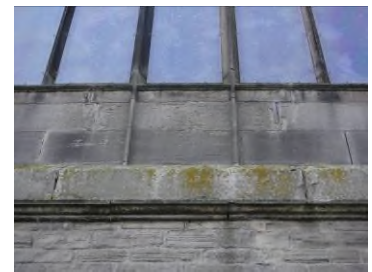
Chancel:

E side – Triple light apex window, same design as the W end, can't see it. Below that five light window same design as the W, open joint to the hoodmould and there is some water coming down that and is eroding the top of the tracery, there is a bit more erosion also to the N side, the jambs are ok, there is some slight wiggly movement but nothing major and mullions are alright though there is a chip in the base of one.

S side – Pair of three light windows, same design as the nave, there is a chip out of one of the stones by the apex on the W most, there is also an open joint at the cill of this window.

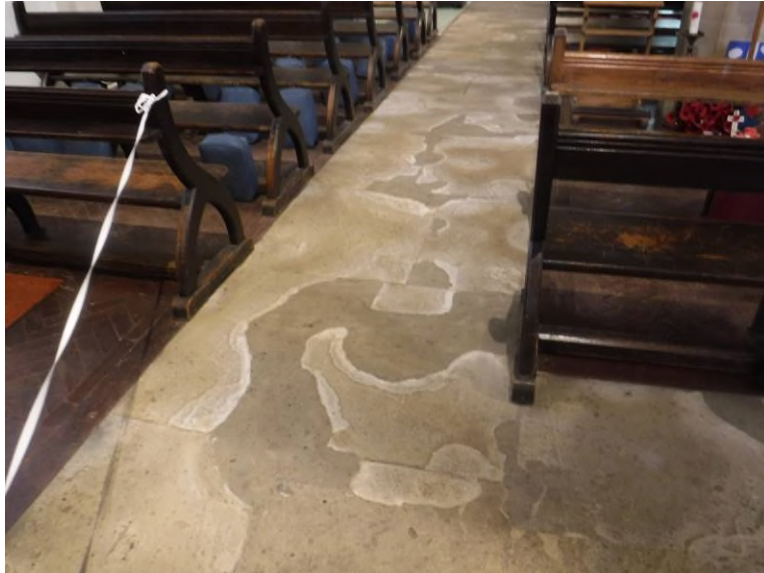
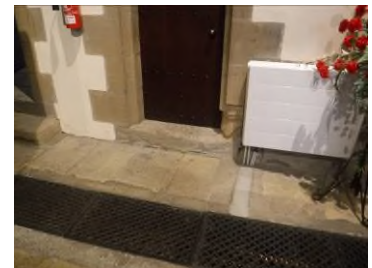
7.5.4 FLOORS, RAILS

Solid floors throughout the building. Within the nave it comprises flagstones and pewed areas in herringbone woodblock, these don't have a void underneath them, and they are fairly solid.

Some of the slabs are cracking and laminating, they have had the occasional cement patch that has broken up as well but there is little you can do about this other than not use cement next time.

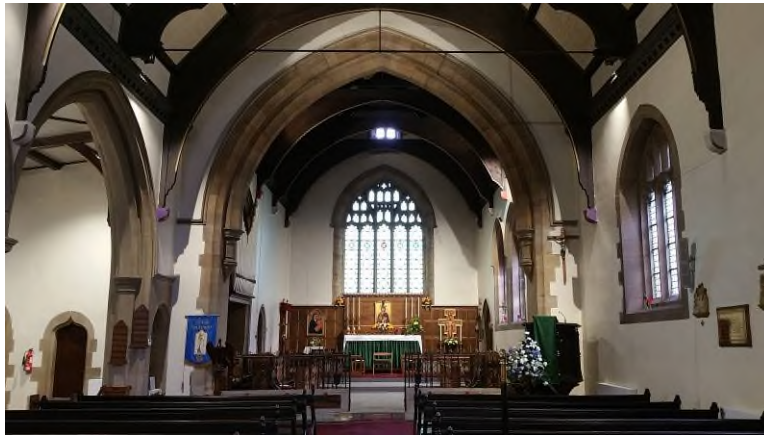
- **Chancel:**

E – Five light with tracery, grisaille glass pictorial emblems to the four Saints and a pelican in her piety, the glass is cobwebby and dirty. The masonry looks slightly weather worn up on the tracery and that is evident from dampness outside, above that is a two light window, which is heavily cobwebbed and it looks like there has been some water coming through in the past, there is water stains coming down.

N – E three light with tracery obscure and coloured rectangular glass in lead cames, the glass is dirty and buckling slightly, the saddle bars look ok, but externally the ferramenta which is hidden by the polycarbonate could do with being looked at. The masonry appears sound. W same as E both of these are no longer operating and are very cobwebby.

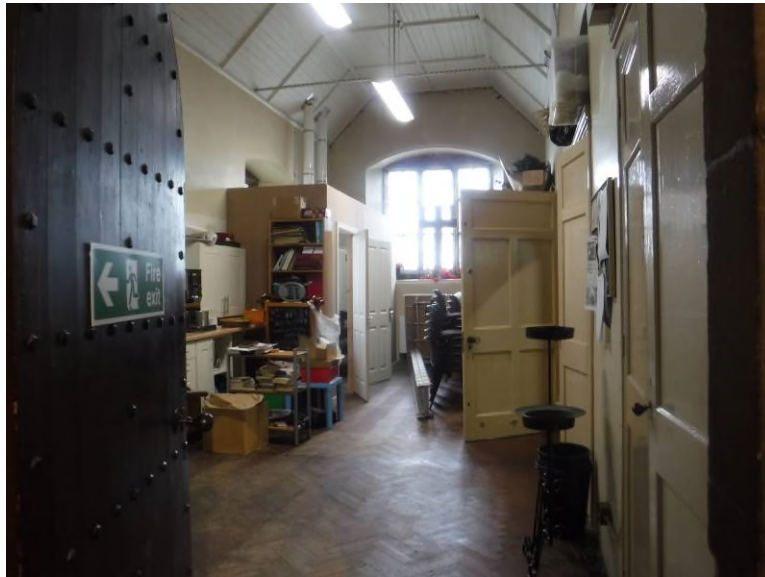
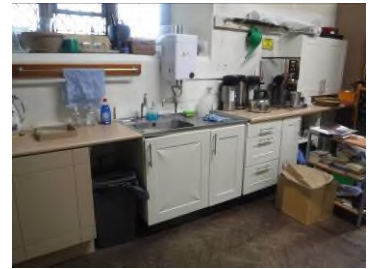
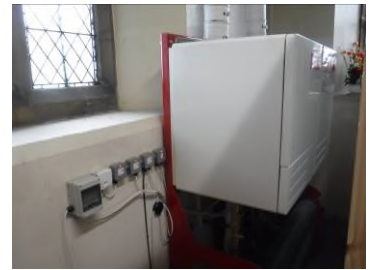
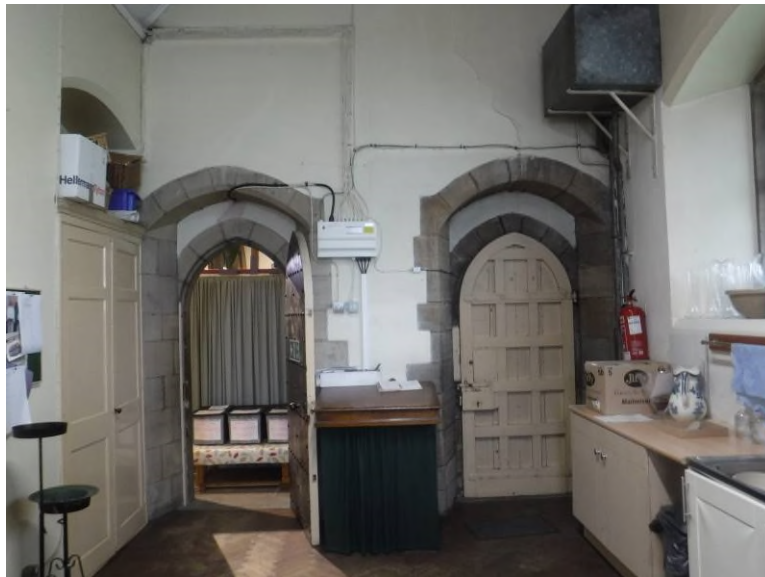
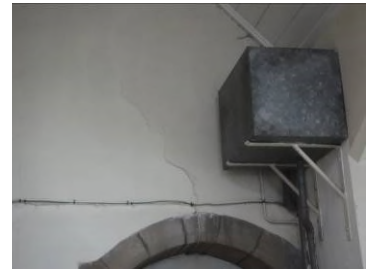
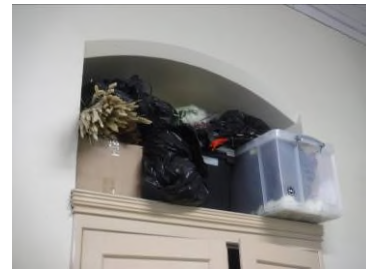
B Choir Vestry –

Fairly rudimentary sink units, tap dripping to the overhead water heater, the room has recently had partitions formed in order to house the boiler, there is also a bit of lumber in the room, there is some modern wardrobes and some built-in original wardrobes which are bursting a bit and could do with latching back better.

Recommendation: check water heater, remove lumber

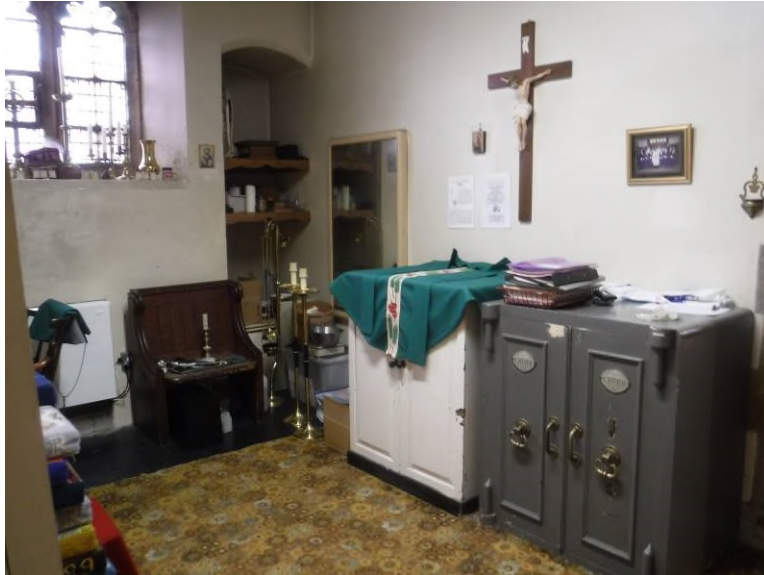
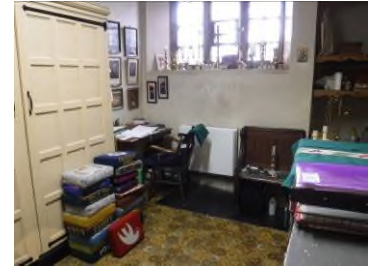
B Clergy Vestry

No latching to the robe cupboard though they used to have keys to them. The room has got one large Chubb safe, and some miscellaneous furniture, not much room for an office function in here, this room could really do with tidying up, there is a few stray kneelers in here as well.

Recommendation: remove lumber

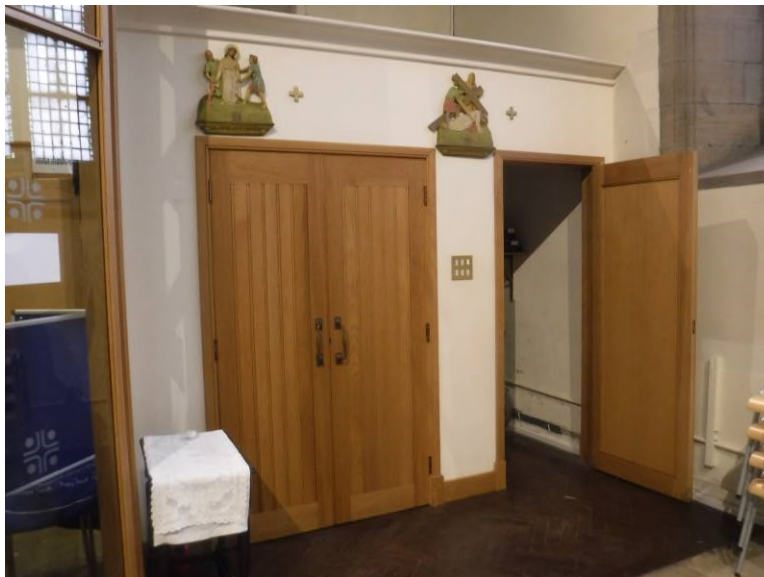
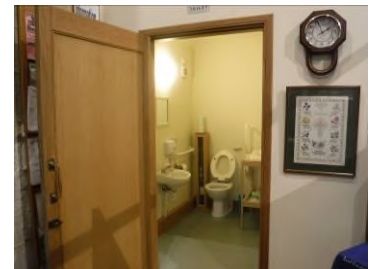
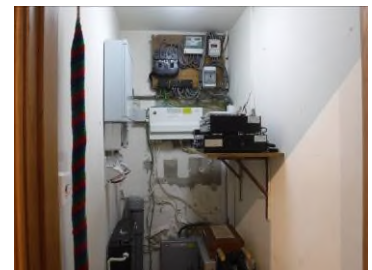
B Disabled W.C. –

It is all reasonably sound, the Triton water heater leaks when operated, behind this is an intake cupboard for the electrics and some book storage which are in oak doors and the door binds on the intake cupboard.

Recommendation: check water heater
