Diocese of Durham

CLEADON PARK
St MARK and St CUTHBERT
(4)

QUINQUENNIAL REPORT
on the architect's inspection on

25 May 2023

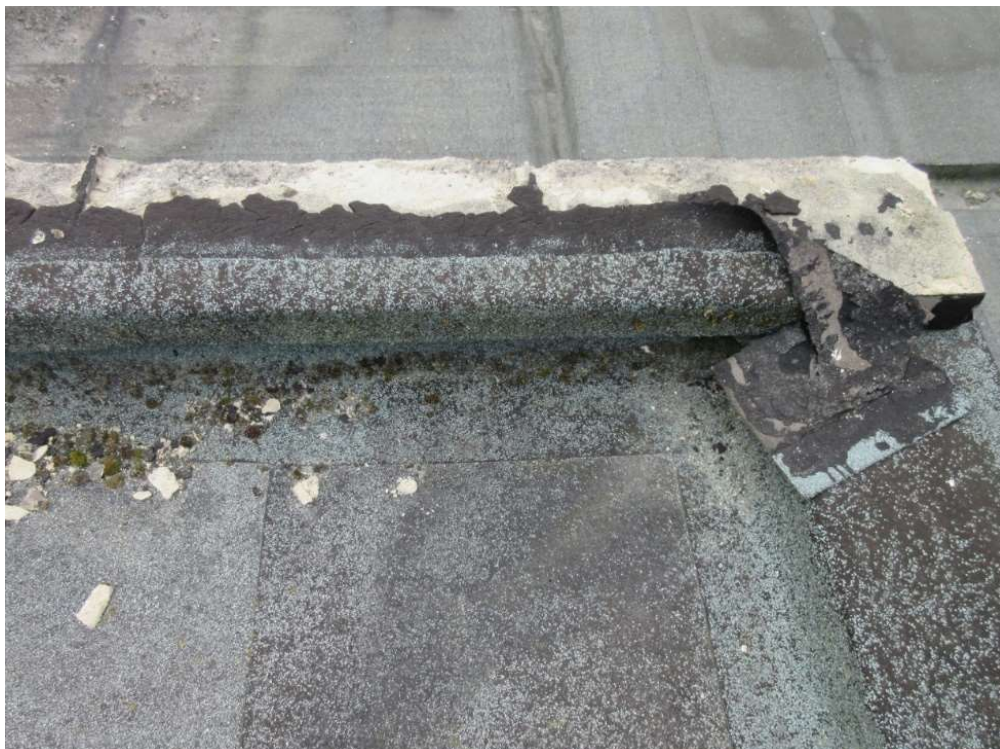
18. The intermediate rooms all have green bitumen felt carried over the parapets and copings. In fair condition except
 - badly damaged and part missing where carried over decayed copings at both roofs above the Hall.

Felt peeling off top of decaying cast stone coping on end of **stair** roof (para 28)

- Replace copings at Stair end and Meeting room over Hall with
relaying of disturbed bricks and cover with extended roofing felt 18, 28
- Seal or flash Hall roof to parapet at S corner 21
- Remove saplings against Church and Hall walls 33
- Restrain hardwood infills at Church windows 39
- Repaint outside of windows at stair, vestry, meeting room and Hall 40, 41, 42

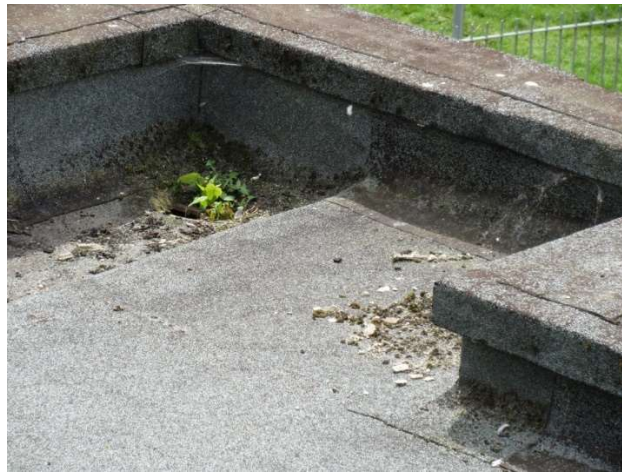
- blisters in the wide gutter over the larger Vestry and outlet cleared of plants at inspection. No known leaks at present but minor ceiling crack (para 46)

Outlet over large Vestry - Plants cleared at inspection

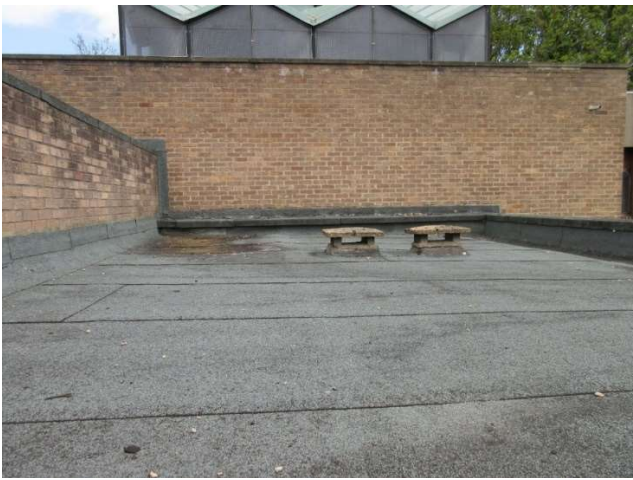
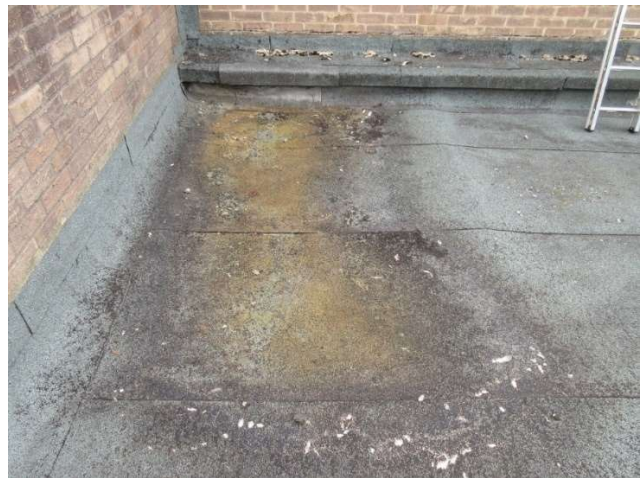
- ponded and one joint coming open over the lobby between Church and VestriesThese roofs are concrete over the **stairs** and timber over the **Vestries** where two concrete vents (disused gas fire flues?) stand on the partition.

Roof over vestries, ponded in corner over lobby, movement joint against Church wall

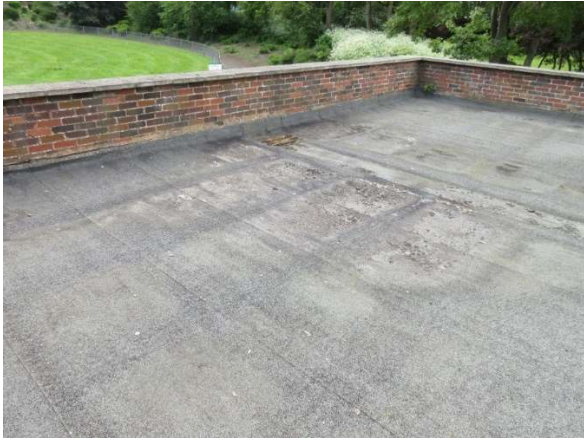
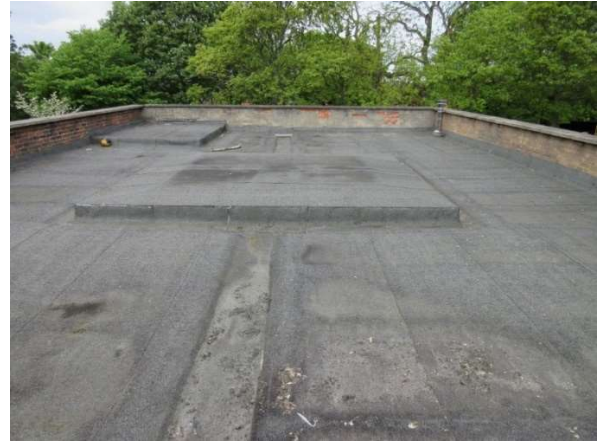
20. The felt appears waterproof despite some ponding at deflected roof deck at W and SE, at the former stair and NW of the N gutter.

Ponding at deflection of deck at Hall SE

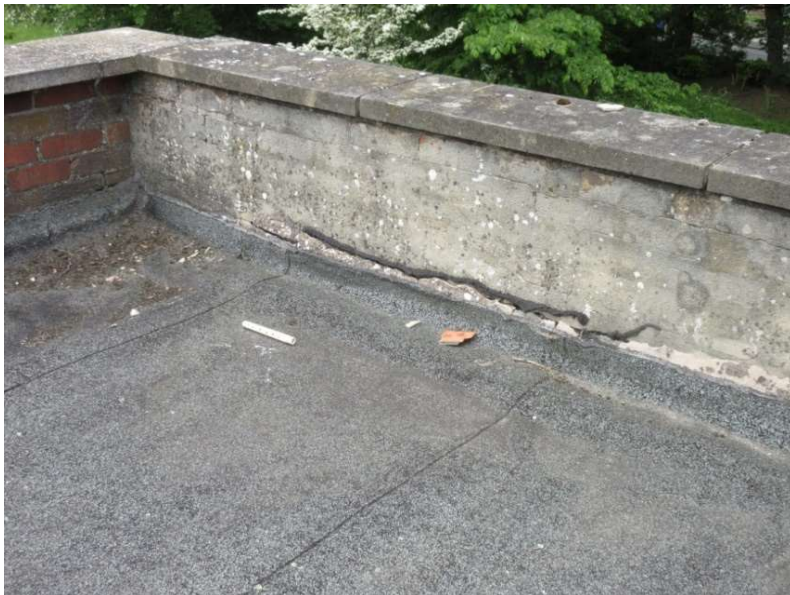
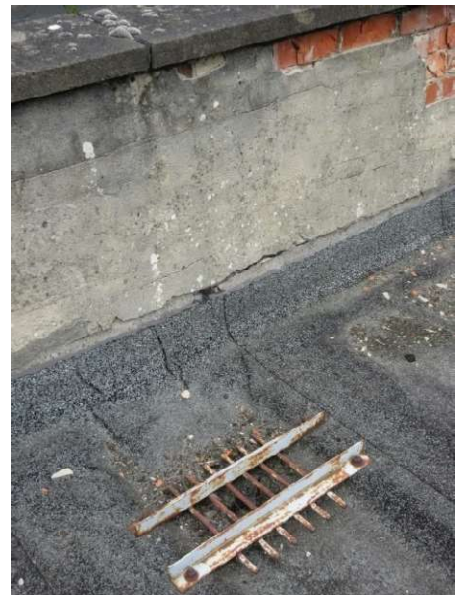
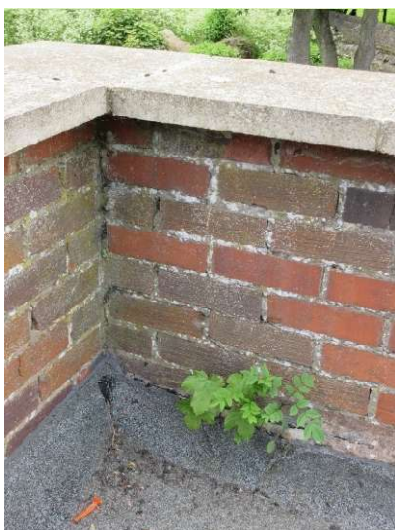
Para 21

21. Upstands mastic pointed to the brick and rendered parapets. Short lengths of upstand at the N, W and S corners are loose from the wall, open to weather and now with plant growth at S corner. Lengths of the NW render have cracked above the turn-ins. Water must get in, not yet visible inside.

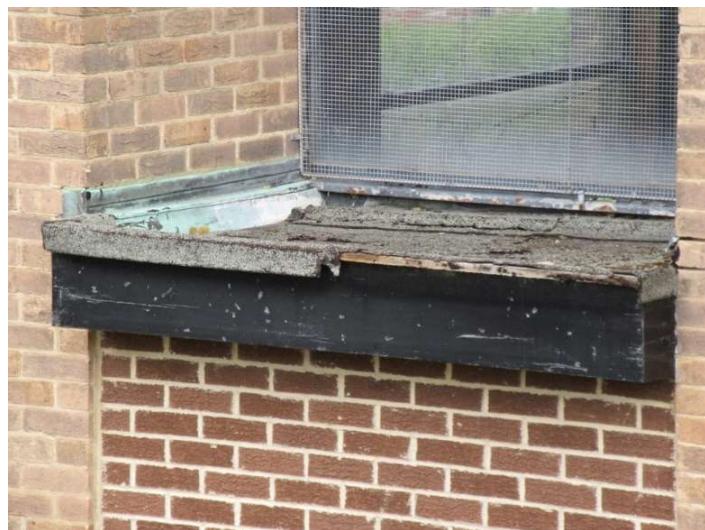
Para 24

24. Two small felt roofs in the recesses over the Church doors (and former doors) with small amounts of remaining copper. Felt begins to break down. At W roof part of the edge drip is missing. Debris and plants in both internal gutters need to be cleared.

- At Hall NW replace parapet render or rebuild inner leaf in
facing bricks with roof upstand turned in, point coping joints 21, 29
- Clean low roofs and gutters over church doors and former doors 24

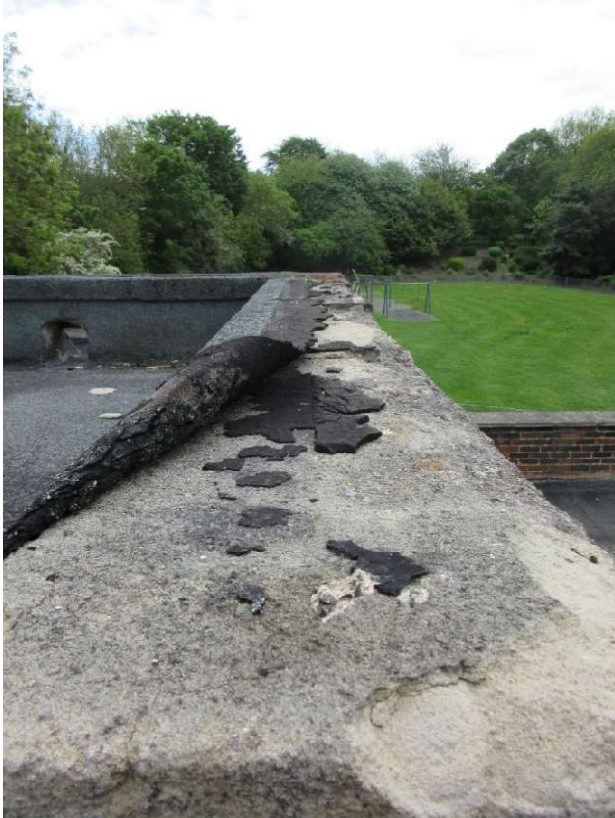
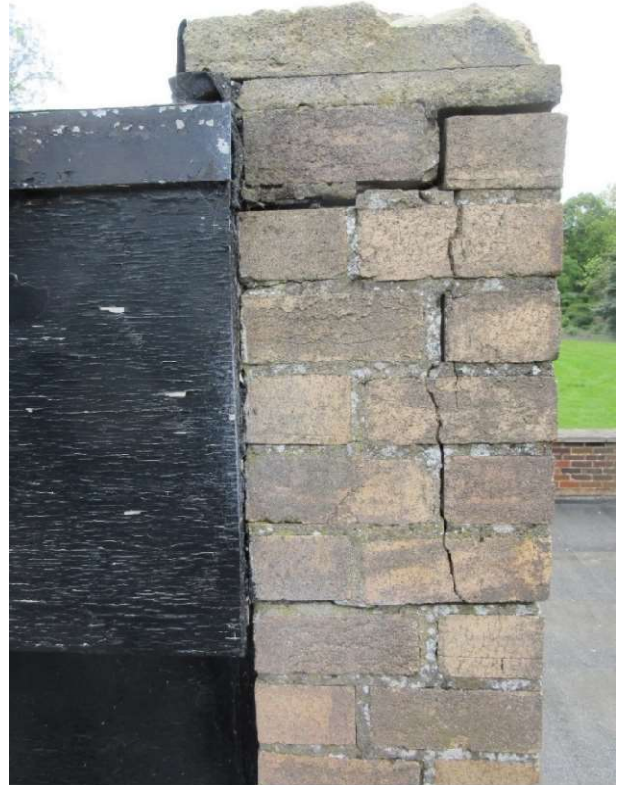
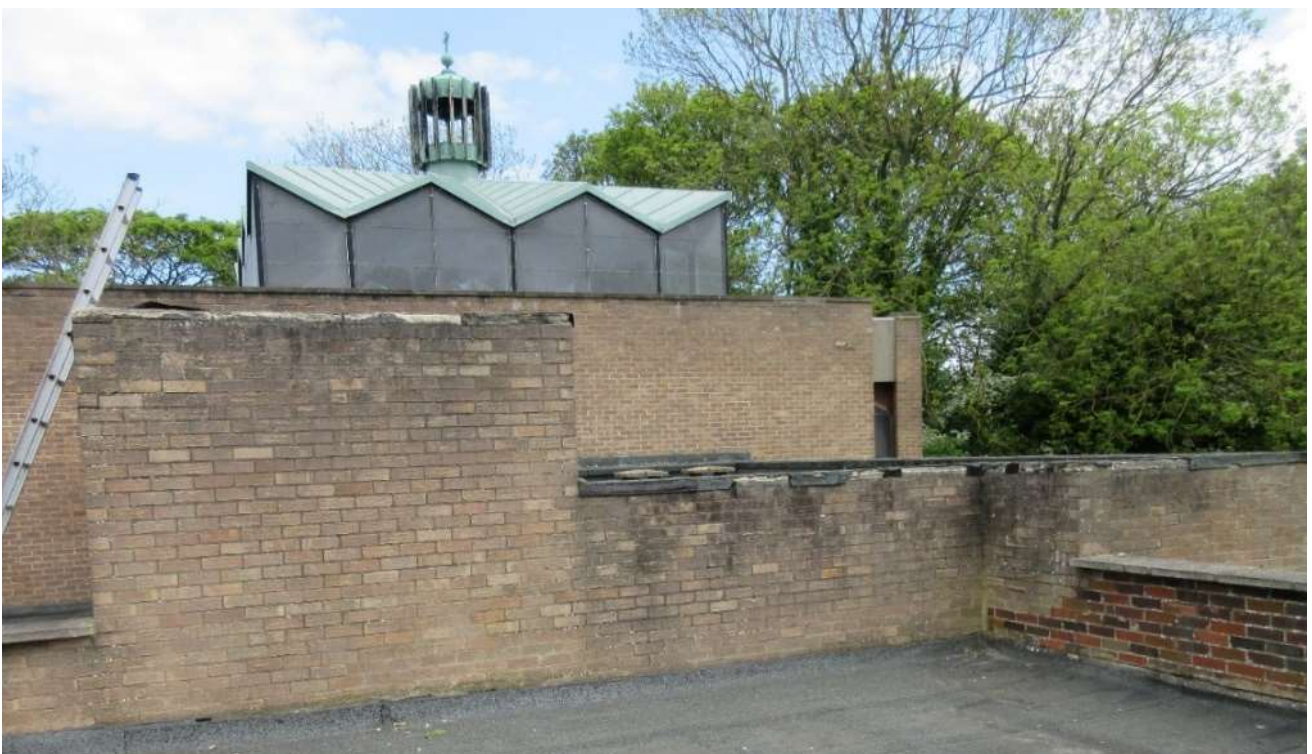
27. Cavity facing brick with galvanised twist wall ties without cavity insulation (seen before coping renewal), flush pointed and in good condition except under the Hall copings. Two full height vertical joints in both leaves of the Church NE wall were included in preparation for an intended "transept" extension.
28. Pre-cast and cast stone copings in fair condition except now felt over and some coping decay at the mid-level roofs. At a top corner of the stair enclosure joints and bricks are now cracked showing some movement since the last inspection. At least rebuilding of the damaged brickwork under new copings will be needed soon unless a plan to remodel these roofs is developed.

Details of the coping and parapet brickwork at the end of Stair (top left in photo below)

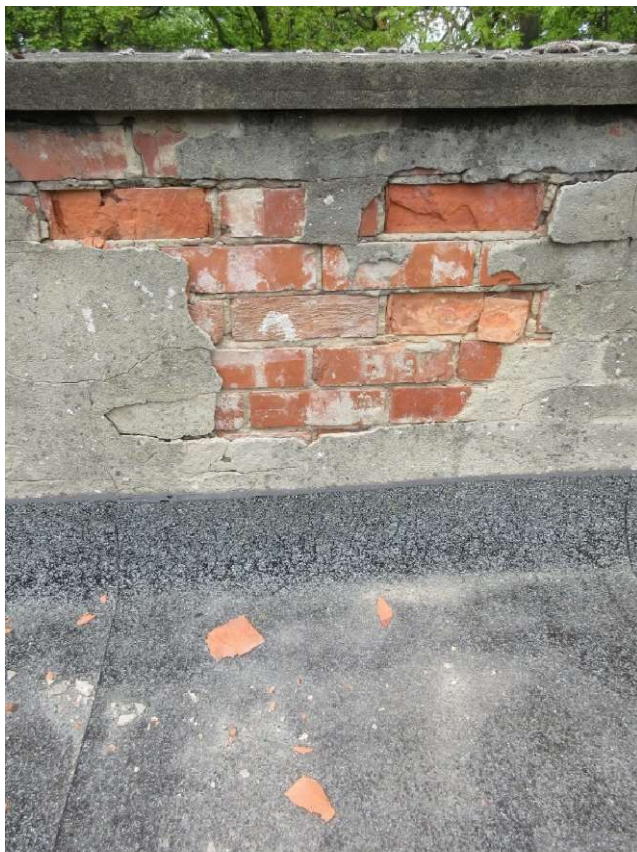
At NW the south facing render and many inner bricks (not facing brick quality) are decayed. If not covered soon by roof alteration the render should be repaired or covered with roofing material or rebuilt with facing bricks without render.

part of Hall NW parapet

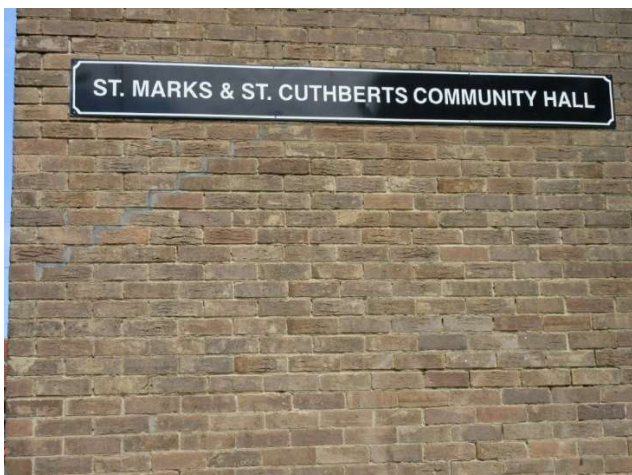
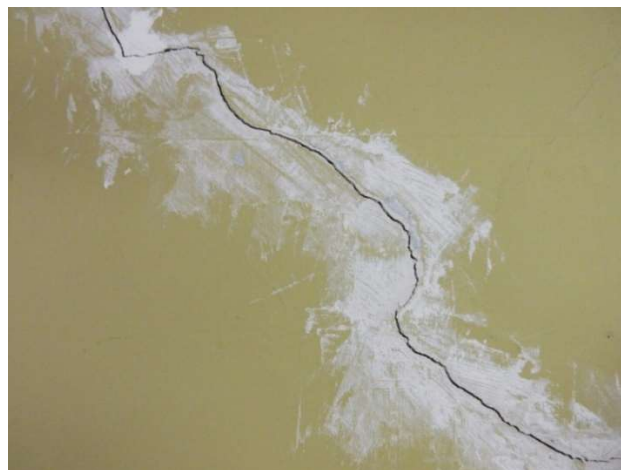
30. At the W end of the long SW wall a pointed short diagonal crack in external joints (roughly corresponding to the open crack inside) is unchanged. The cracks may have been caused by slight swelling of the parapet bricks.

Old cracks outside and inside Hall W corner

55. In Hall store a narrow diagonal crack in plaster (2mm approx.) from bottom W corner to ceiling at the partition has been roughly filled and reopened. A short pointed crack in external diagonal joints corresponds (para 30). Any similar crack in the return wall is hidden by a built-in cupboard.

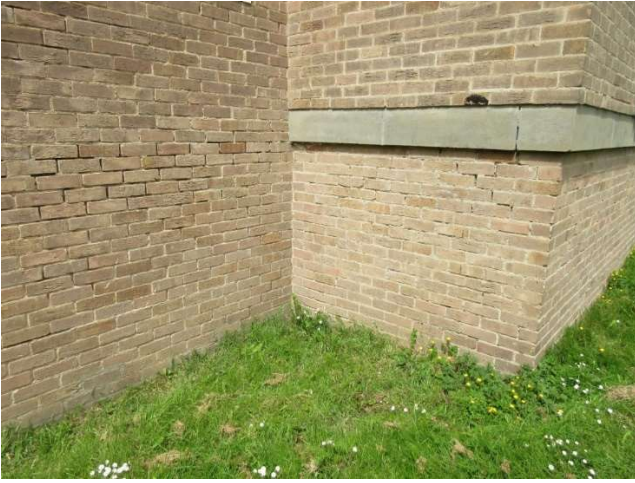
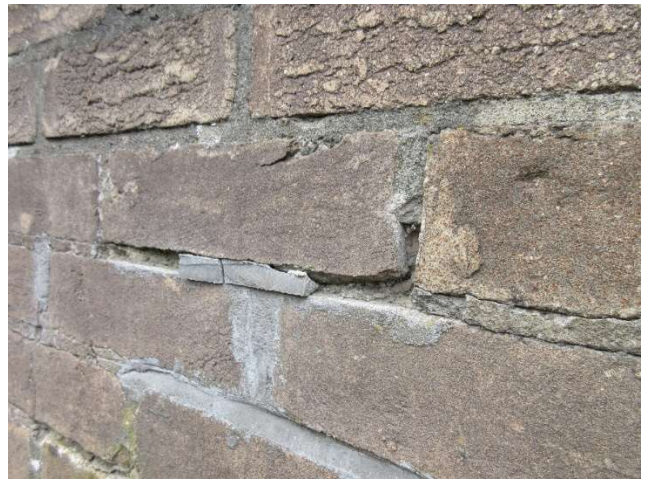
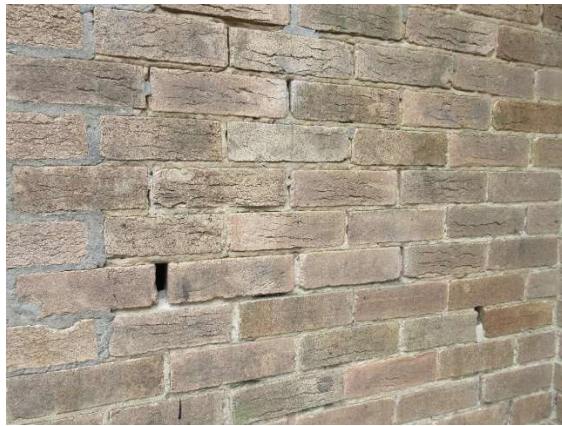
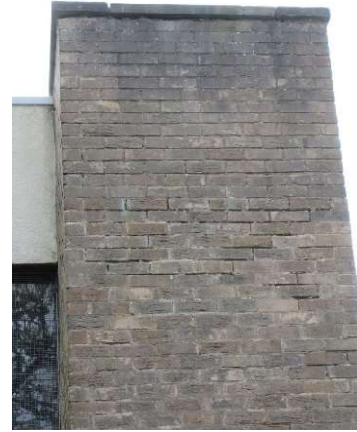
- at two panels R of the former W Church door
- at N corner of the Church lobby
- at Church high level at E side, NE corner and N end
- around large diameter NE overflow pipe through parapet
- at N end of Hall high level under open coping joints
- at S end of Hall
- at head height at S and SE of the Church (where accessible joints seem to have been picked out)

- Repoint open brick joints at Church, Hall & external retaining walls 31, 93
- Replace polycarbonate 'glazing' over stair with UV resistant type 57
- Consider same at Hall, Vestry and Meeting Room 58, 59
- Obtain new Periodic Electric Installation Test in 2026, keep report
in Log Book and review Church lighting 73 and Addendum

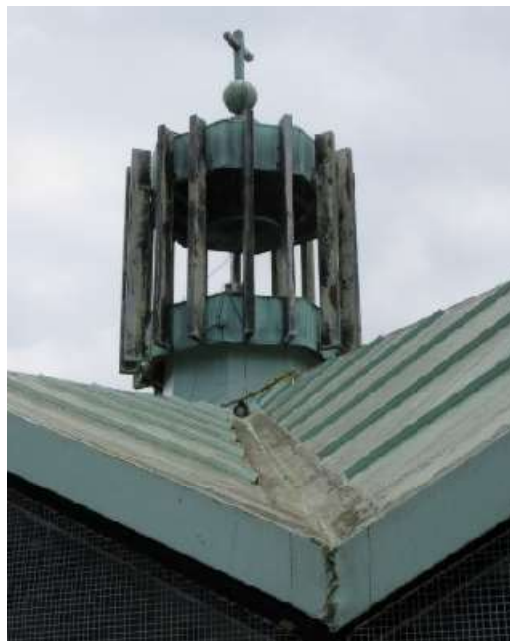
34. A single fixed bell remains in the drum on the lantern, not usable since the electric clapper was removed.
An LED light has fallen from the drum and lies on the roof.

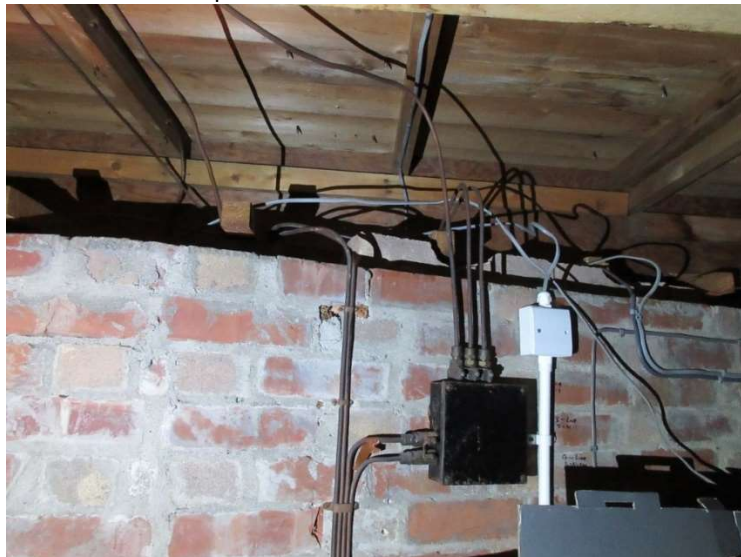
Church roof now exposed over the Store over the Church boiler room

81. The church boiler space is open to the store above which now has no ceiling protecting the underside of the church timber roof. Not known whether there is any fire barrier dividing the void under the roof. Any fire could therefore immediately reach the roof timbers (at least in part, perhaps the whole roof), risking very quick severe damage. It would be wise to replaster the upper ceiling to protect the roof.

- Restrain Church doors and windows 37
- Add door handle at Church entrance 37
- Repair and paint ceiling at Church wc 46
- Reduce fire risk by fixing new store ceiling under Church roof 43, 48, 81
- Add draught strips at Church and Hall doors 50
- Renew Gents floor 2, 63
- Review hot water in all lower wcs 84, 85
- Review access between all parts 87
