Care of Churches and Ecclesiastical Jurisdiction Measure 1991 – Quinquennial Inspection
THE CHURCH OF ST COLUMBA, DARLINGTON

Diocese: Durham
Archdeaconry: Auckland
Church Code: 613 229

Date of Inspection: 28th April 2023
Inspection undertaken by: Jamie Holden BA (Hons) RIBA RIAS
Previously Inspection: 2014 by Malcolm Cundick

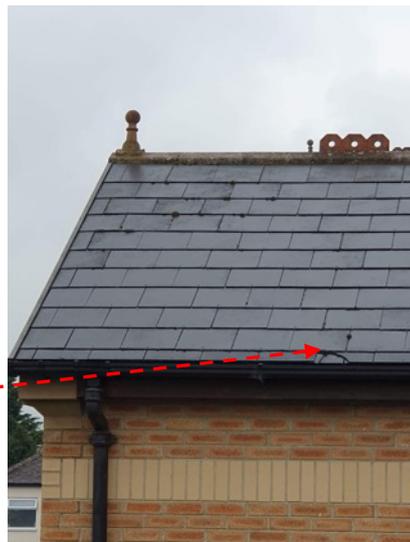
- 2.1.5 Verges are capped with aluminium trim and boxed eaves are formed in stained softwood. All are in good order.
- 2.1.6 All roof elements, including lead valleys and abutments are in good condition except for one broken slate directly above the guttering on the east slope of the lady chapel. Ideally, the slate would be replaced but it is unlikely that this defect will allow any moisture ingress. This item should be monitored and rectified as a matter of general maintenance when convenient. O

b) Cracked slate directly above the guttering

2.1.6	Broken slate on east slope of the Lady Chapel.	n/a	£ 0
3.1.3	Micro-fractures in cill bricks	n/a	£ 0

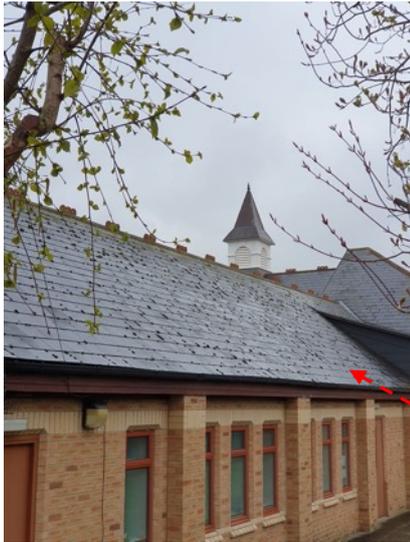
- 2.1.7 There is a notable build-up of moss growth on the north slopes in comparison to those which face southwards. This is not uncommon due north facing roofs being shaded from the sun and, as a result, remaining relatively damp for long periods creating conditions conducive for moss and lichen.

- 2.1.8 Excessive moss growth with the associated moisture retention can be damaging for some roof finishes, therefore, the moss ought to be carefully removed. However, this is not a matter that requires urgent attention. The PCC is advised to consider how the moss growth can be controlled as part of the general maintenance regime for the building with the aim of action being taken at some point during this quinquennium. 4

a) Moss growth on the north slopes needs to be monitored and controlled.

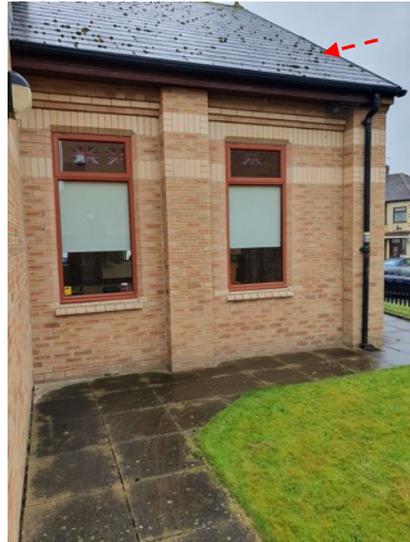
b) Moss growth on north slope of the community hall.

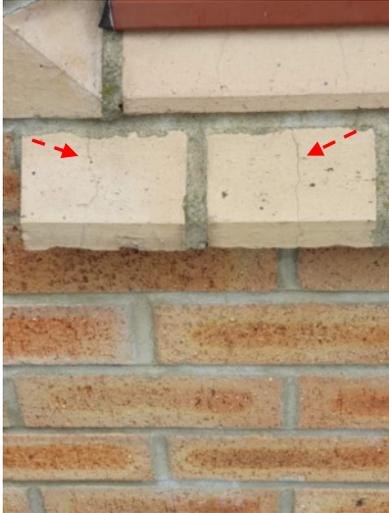
- 3.1.3 A double course of cant bricks with the smooth buff finish are used to form the cills to all window openings. Many of the cant bricks have what appears to be a very fine fracture in the surface. Any fracture in the surface of the masonry could allow moisture to penetrate with potential to damage the brick. At present there is no evidence of the brickwork suffering any adverse effects but this issue should be monitored. Overall, the masonry is in very good condition. ○

a) *Micro-fractures in the cant bricks forming cills*

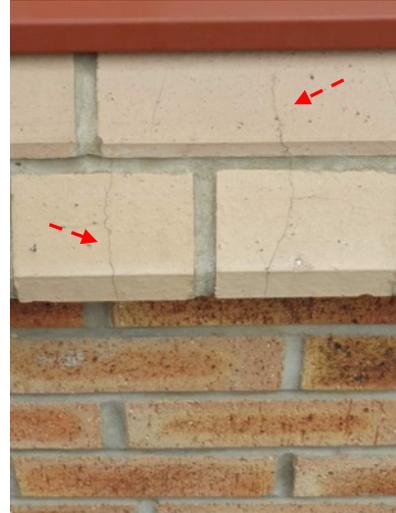
b) *Micro-fractures in the cant bricks forming cills*

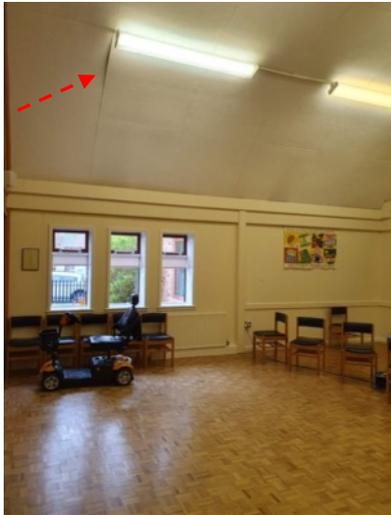
- 4.3.2 Decoration to the walls and ceiling is a simple painted finish.
- 4.3.3 A fixing to one of the ceiling panels on the south side appears to have worked loose. There does not appear to be any danger of the panel falling, however, this item should remain under observation and action taken if it worsens. ○

a) Loose ceiling panel to be monitored

4.3.3	Missing fixing from ceiling panel in the 'church hall'.	n/a	£ 0
4.5.2	Monitor cracks in the lady chapel.	n/a	£ 0
		<u>Sub-total</u>	<u>£ 0</u>
		<u>Total Estimated Cost</u>	<u>£ 500</u>

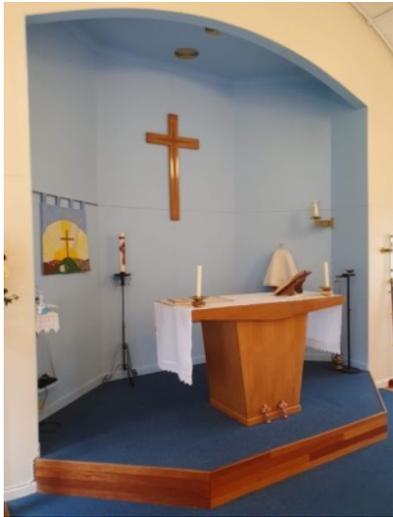
a) Large step to the sanctuary is causing access issues for some.

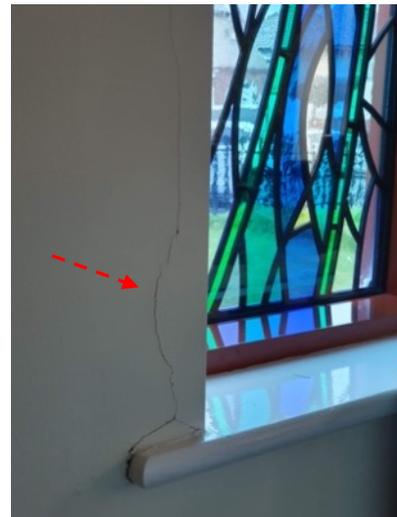
4.5.2 To the left-hand side of the decorative window and around the cill of the left-hand window in the west wall the plasterwork is cracked. There is no evidence of any corresponding external defects. The cracks may be the result of some thermal expansion in the building materials or possibly minor settlement. This is not a concern at present but the cracks should be monitored and if any significant changes are noted it should be reported. ○

b) Cracked plaster to the left-hand side of the cill

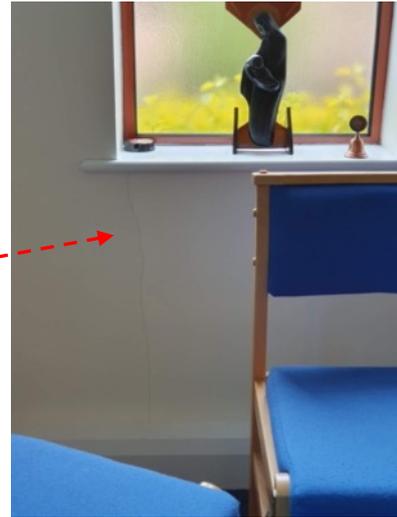
b) Plaster cracks to be monitored

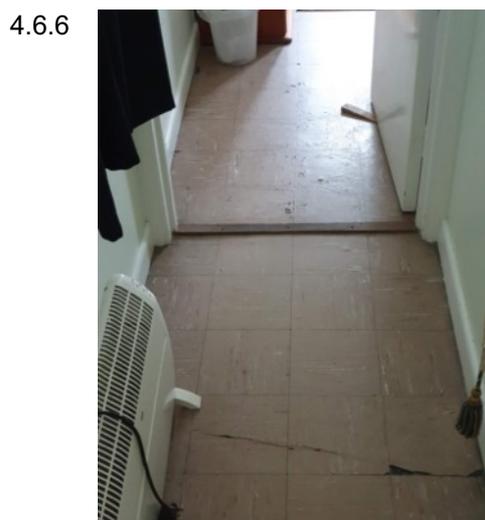
a) Vinyl flooring is worn but serviceable

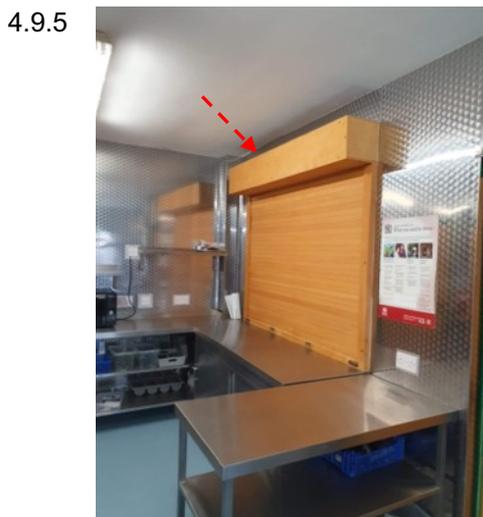
4.9.3 There is a servery hatch between the kitchen and community hall which is fitted with a timber-slatted roller shutter. The shutter appears to be manually operated. Roller shutters such as this are normally required to provide at least 30 minutes resistance and be connected to the fire alarm in such a way that it will close automatically when the alarm is triggered. The PCC/ those responsible for managing the kitchen and community facilities are advised to contact the local fire officer and seek confirmation that the current arrangement is in accordance with the required fire safety regulations. **1**

a) Does the roller shutter provide sufficient fire resistance?

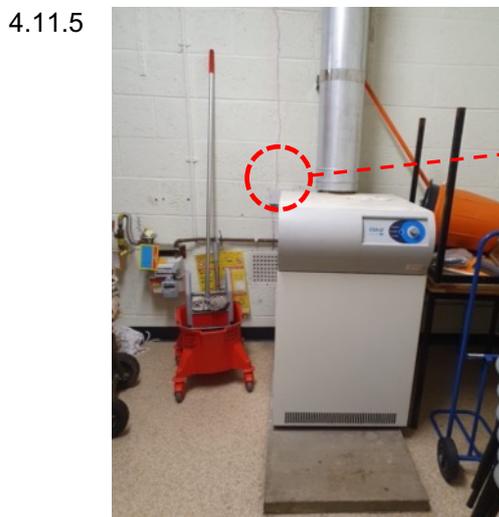
4.11.2 The fair-face blockwork walls and boarded ceiling are all painted and in good condition **2** except for a large vertical crack in the external north wall directly behind the boiler. There is no distortion in the alignment of the blockwork and no corresponding crack in the external brickwork. It is recommended that the crack is placed under observation by installing a 'monitoring gauge' or by simply drawing a horizontal line across the crack recording its width and the date monitoring commenced.

a) Boiler. Note the long vertical crack in the wall behind and to the left of the boiler

Porch Vestibule - The building structure is in excellent condition generally, however, the long vertical crack in the inner leaf of blockwork to the external wall in the boiler room ought to be monitored.

4.2.4	Ensure anybody accessing the 'storage loft' is a 'responsible person' and carries out their own risk assessment.	A	£ 0
4.11.2	Implement monitoring for the crack to masonry wall in the boiler room.	A	£ 0
	<u>Sub-total</u>		<u>£ 0</u>

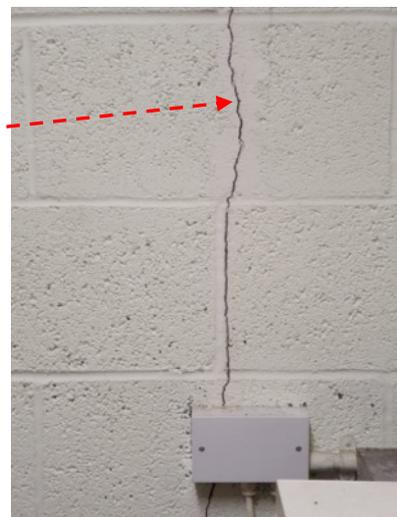
b) Crack to be monitored.
