**INSPECTION OF CHURCHES MEASURE  
DURHAM DIOCESAN CHURCH SCHEME**

**CHURCH OF ST. MATTHEW & ST. LUKE,**

**DARLINGTON**

**QUINQUENNIAL INSPECTION 2017**

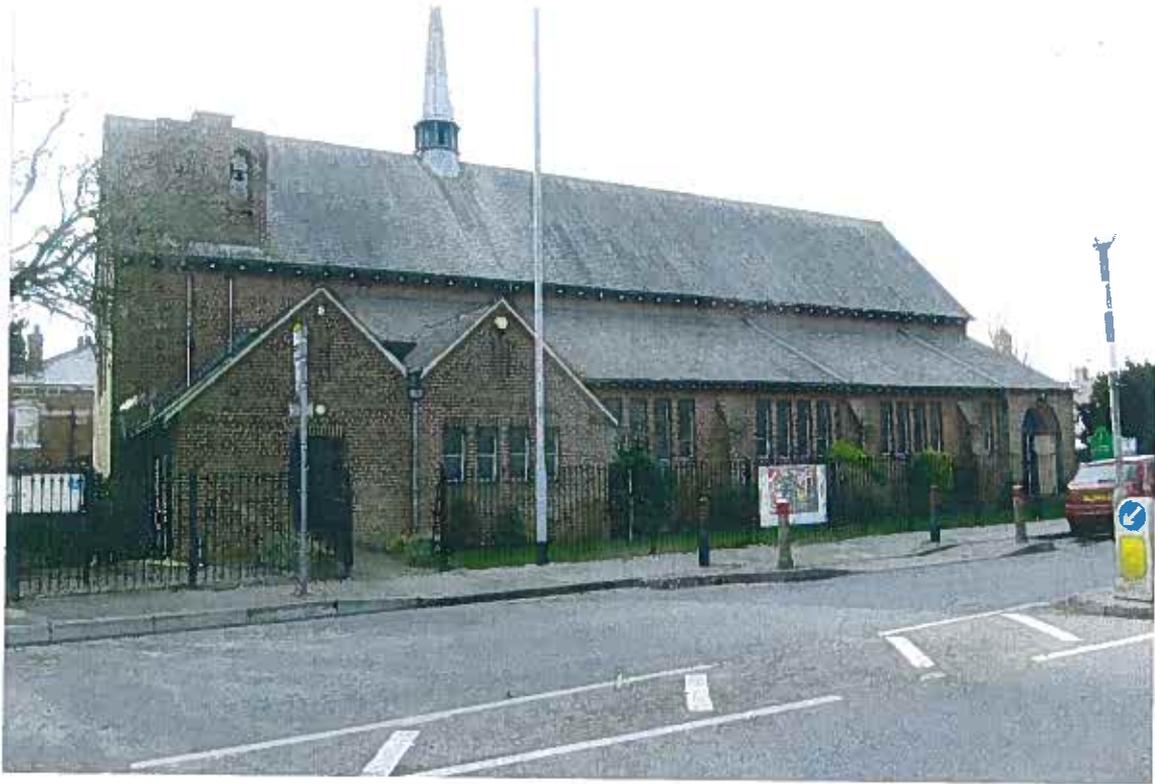
1

- P1. North Elevation
- P2. North Gables to Vestries
- P3. North Elevation from North West with North Porch.
- P4. West Gable from South West corner.
- P5. South elevation.

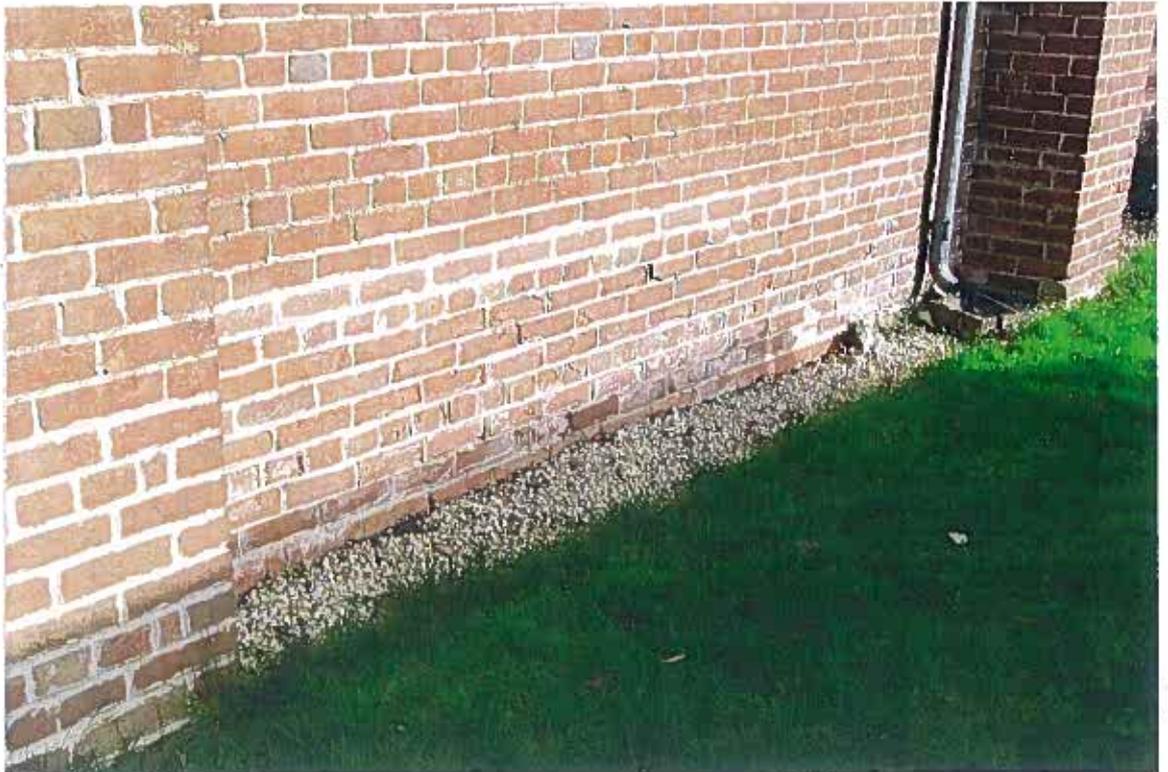
6

- 5.2.1 The facing brickwork and pointing remain predominately in a sound condition. The 1998 re-pointing of the plinth elements, particularly on the East, South and West elevations, however remains a source of concern. In this context I note from Log Book records that there was some historic debate between the Diocesan Advisory Committee's recommended specification and that promoted by my predecessor as Inspecting Architect. The specification used appears to be cement rich, is a distinct colour contrast with the existing, and is bucket handle type rather than flush. There is also evidence of some shallow chasing of joints prior to re-pointing. The condition of this pointing and impact on related brickwork has been the subject of discussions between myself and Property Wardens reference appropriate remedial pointing. Preparations are in hand to progress this work utilising a lime mortar. A number of brick faces at low level on the South elevation in particular are beginning to spall. This should be closely monitored and removal of areas of efflorescence carefully wire brushed.

- P6. Defective cement rich pointing at low level to South elevation with spalling brick faces.
- P7. Detail of cement rich pointing and spalling brick faces. Note gravel channels and clay gulleys.

- a) Install 200mm Rockwool (or similar) insulation to roof voids per item 5.14 (B).
  - b) Progress remedial re-pointing to plinth brickwork per item 5.2.1 (B).

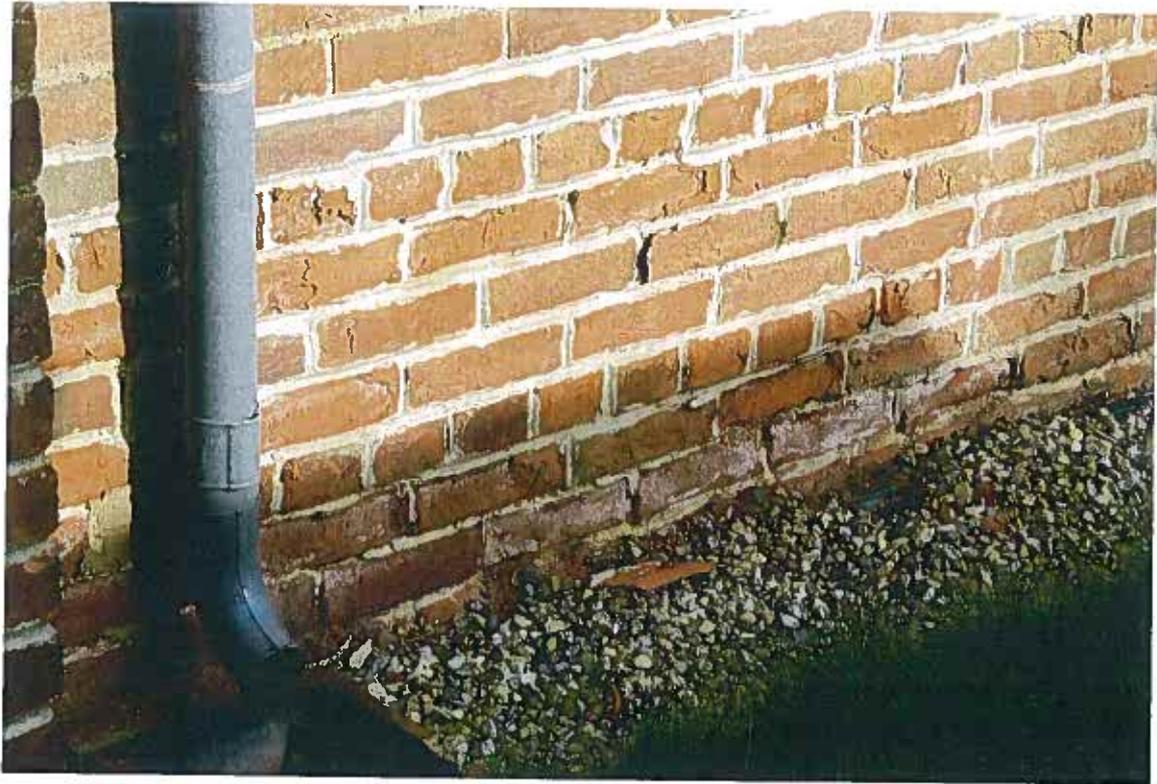
7

- 5.5.2 Gravel filled channels exist at the plinth abutment on the East, South and West elevations as apparent part protection against rising damp impact and as a surface drainage aid. These gravel margins are subject to regular and recent renewal and are being kept clear of vegetation growth, as are all drainage gulleys. There is damage to some clay outlet gulleys. Replacements are being sought.

- c) Maintain clear gravel margins and replace damaged gulleys per item 5.5.2 (B).
  - d) Progress upgrade of lightning installation to Nave and Chancel per item 6.1.9 (B).

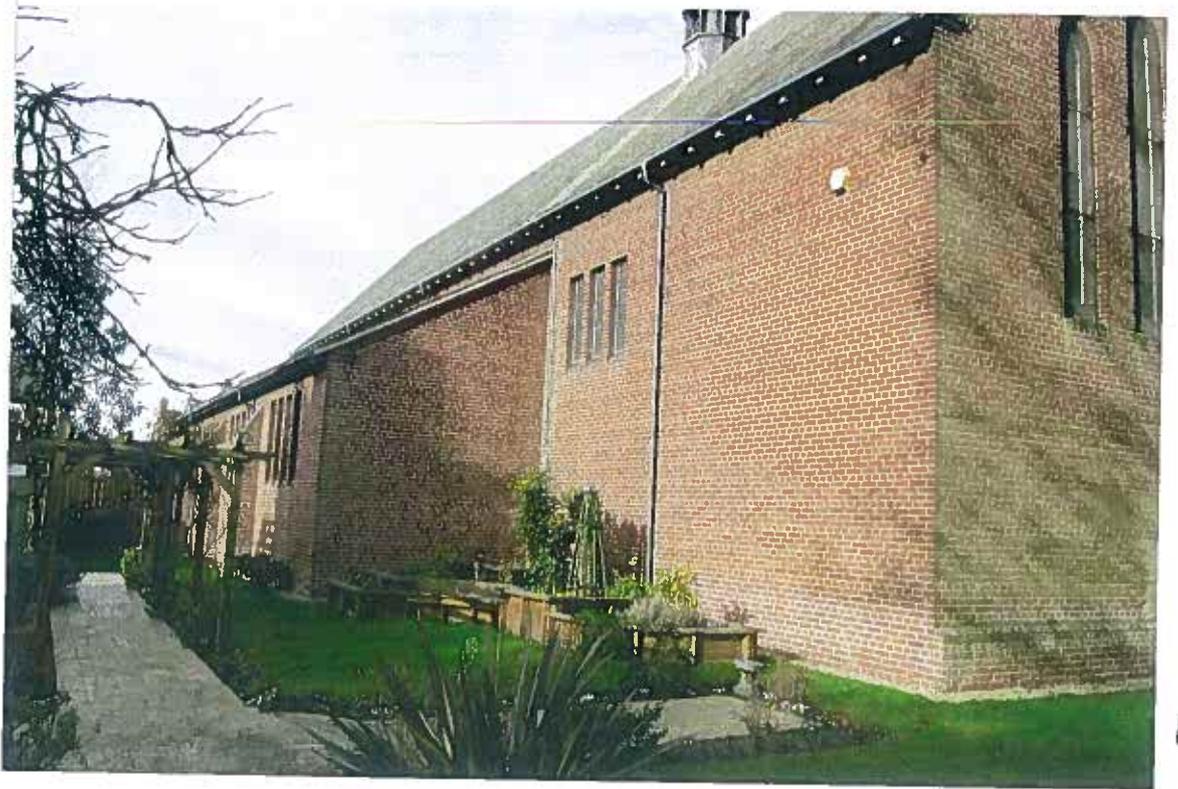
8

- P8. View from South East corner,
- P9. East Gable.
- P10. East Elevation of Vestry/Office and Accessible Toilet plus stairs down to Basement Boiler Room.

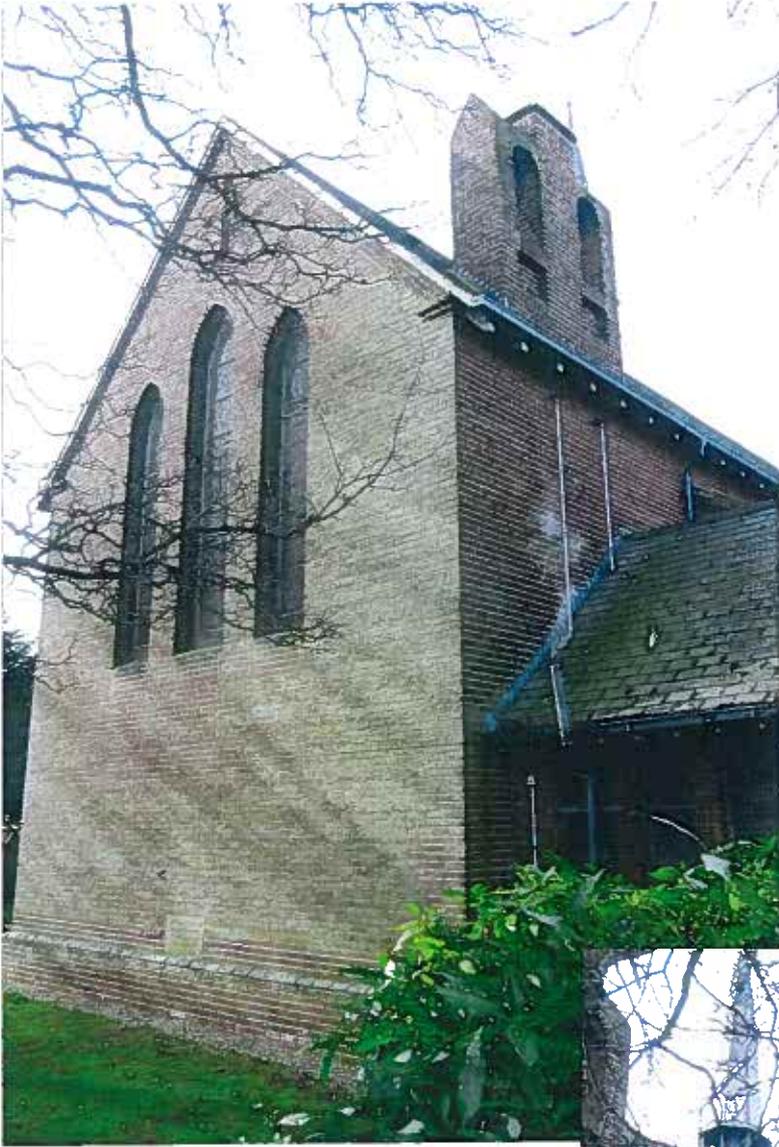
11

- P11. East Gable and Bell turret from North East corner.
- P12. Vestry elements from North East corner.
- P13. Memorial Garden from East.
- P14. Memorial Garden with pergola, raised planters and “bug hotel” from East.

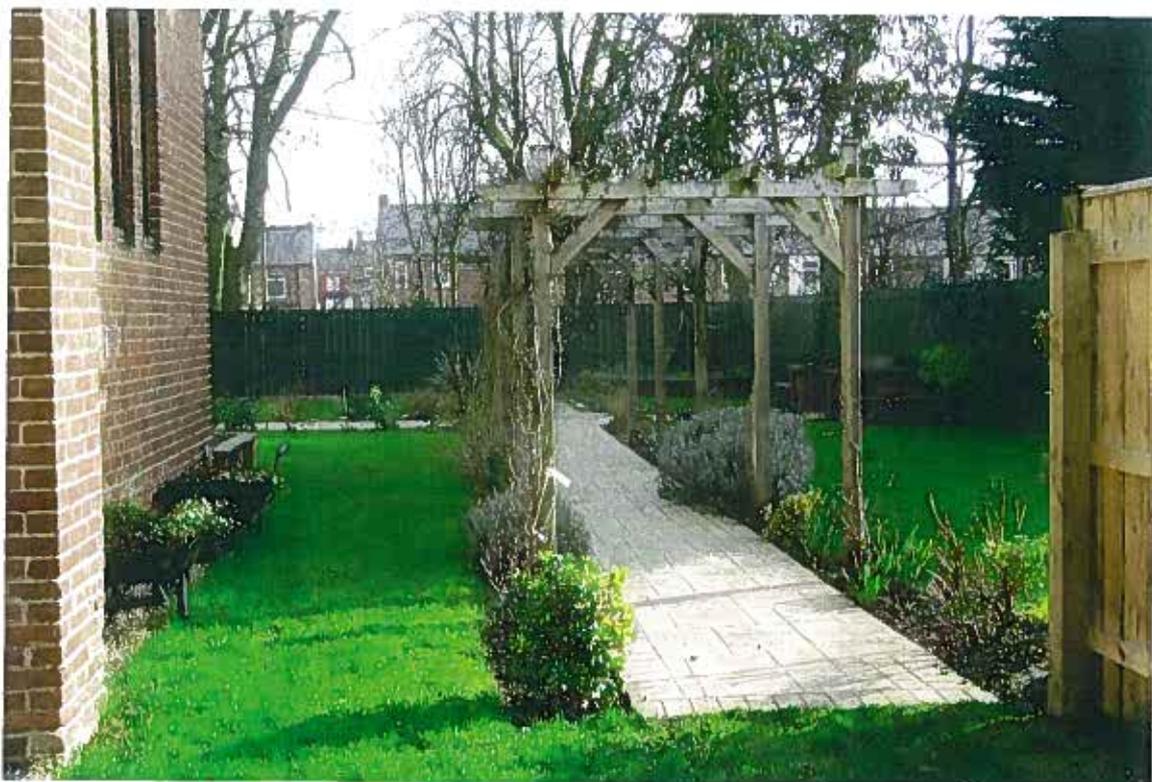
15

- P15. Memorial Garden from West.
- P16. North Aisle looking East.
- P17. Nave looking East.
- P18. South Aisle looking East.
- P19. Chancel.
- P20. Chancel detail.

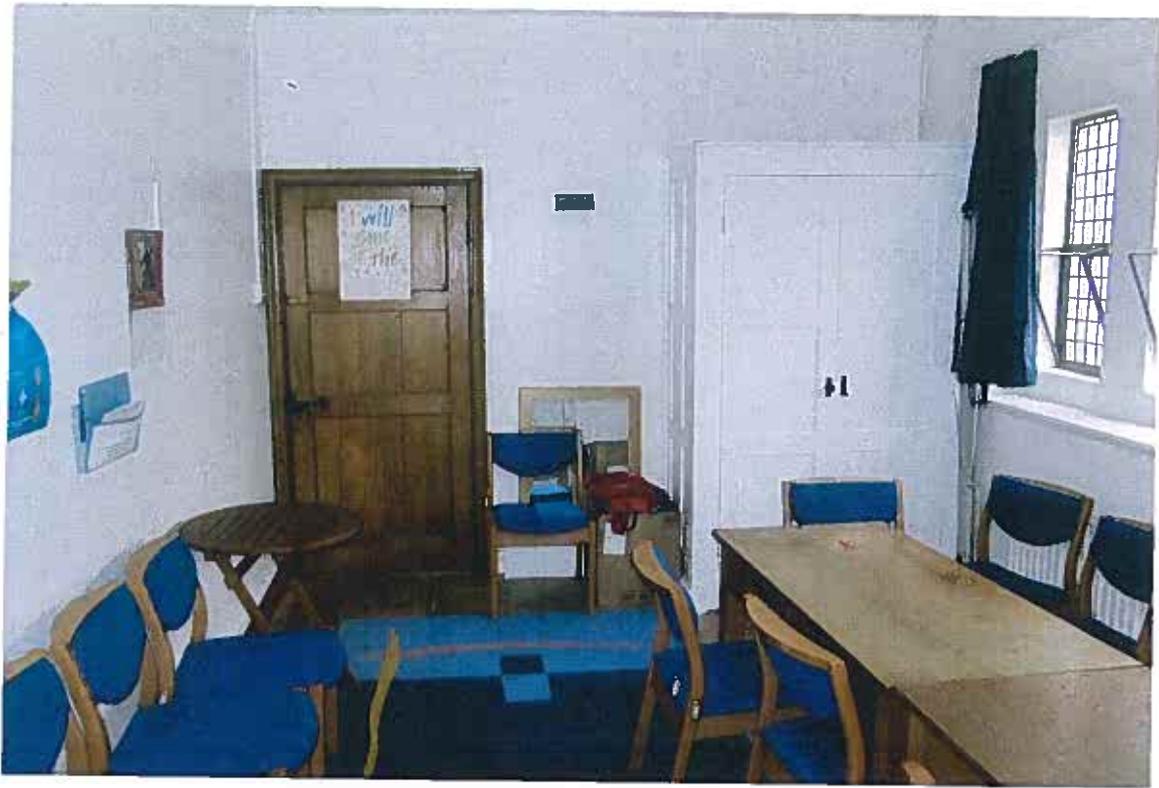
21

- P21. Choir Vestry.

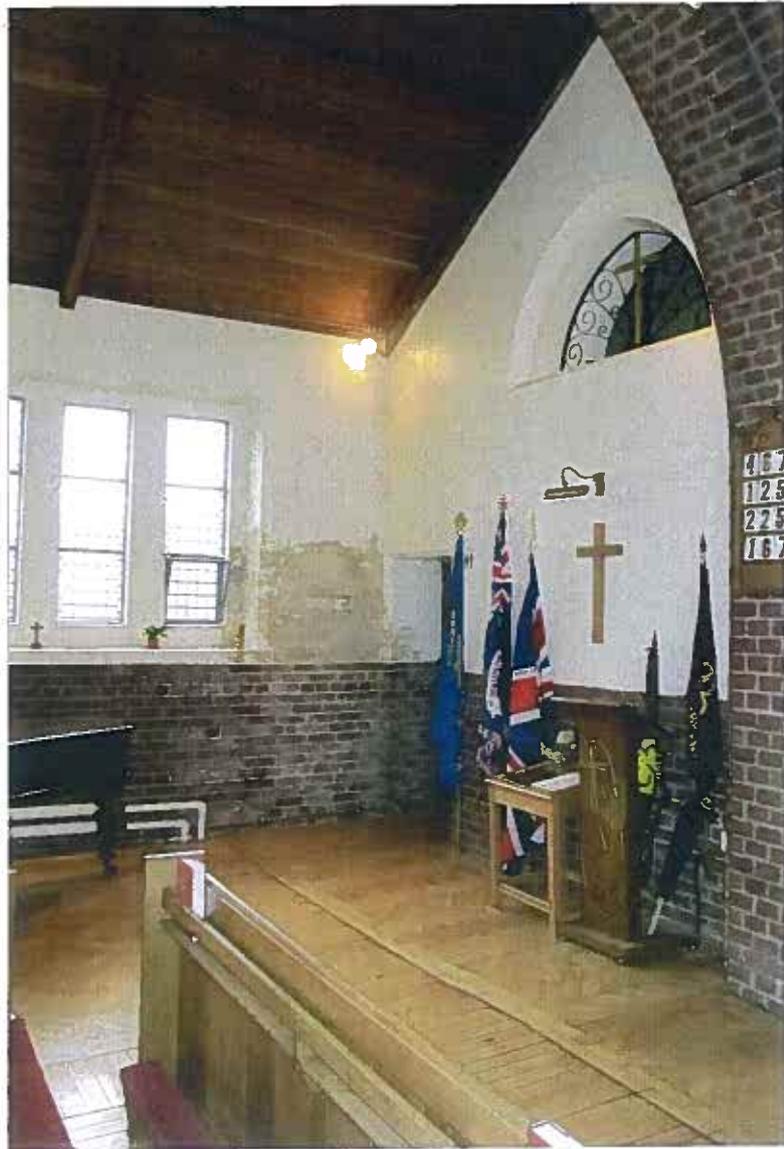
22

- 6.1.2 The walls have facing bricks to dado level with plastered walls above. The columned arcade to the side aisles are facing brick framed with plastered spandrel panels. The interior was re-decorated prior to the last Inspection. All walls are in excellent condition except for a patch in the North Aisle abutting the Choir Vestry related to gutter blockage and rainwater ingress. This is currently drying out prior to preparation and redecoration

P22. North East corner of North Aisle. Note water ingress damage to plaster.

- e) Progress upgrading of Public Address system per item 6.1.11 (B)
  - f) Progress preparation of damaged wall plaster and decoration in North East corner of North Aisle when completely dried. (B)

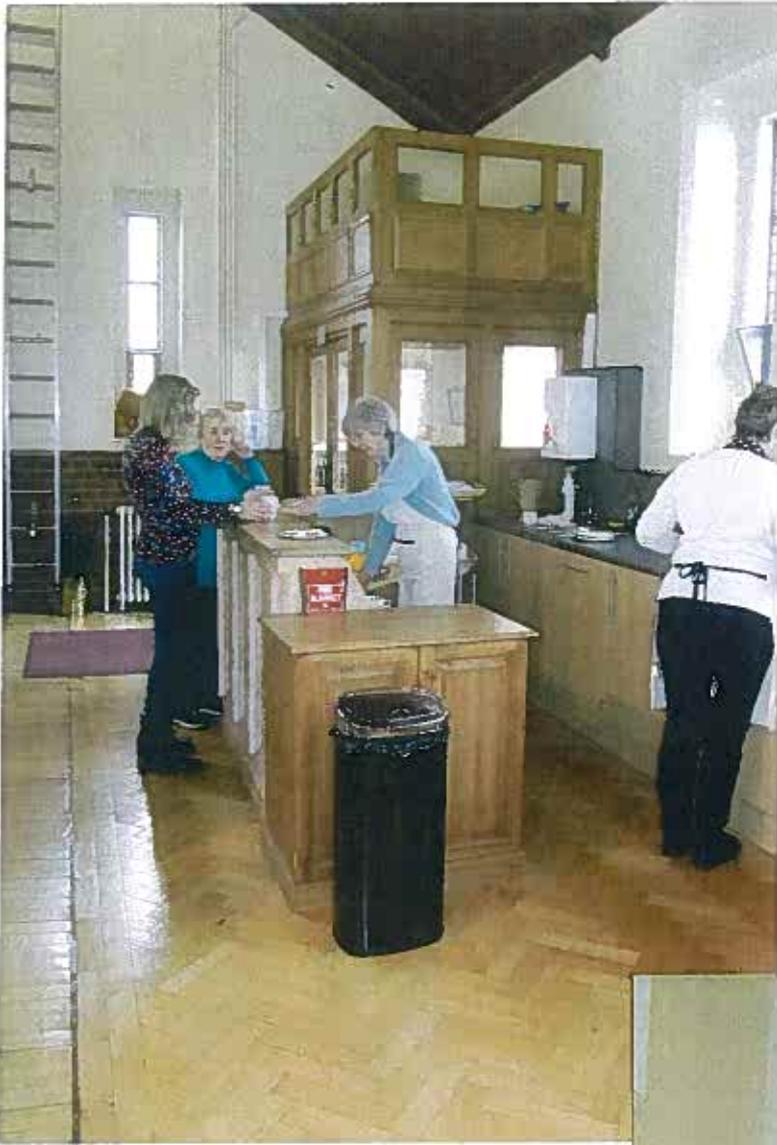
23

P23. New Kitchenette plus Served.

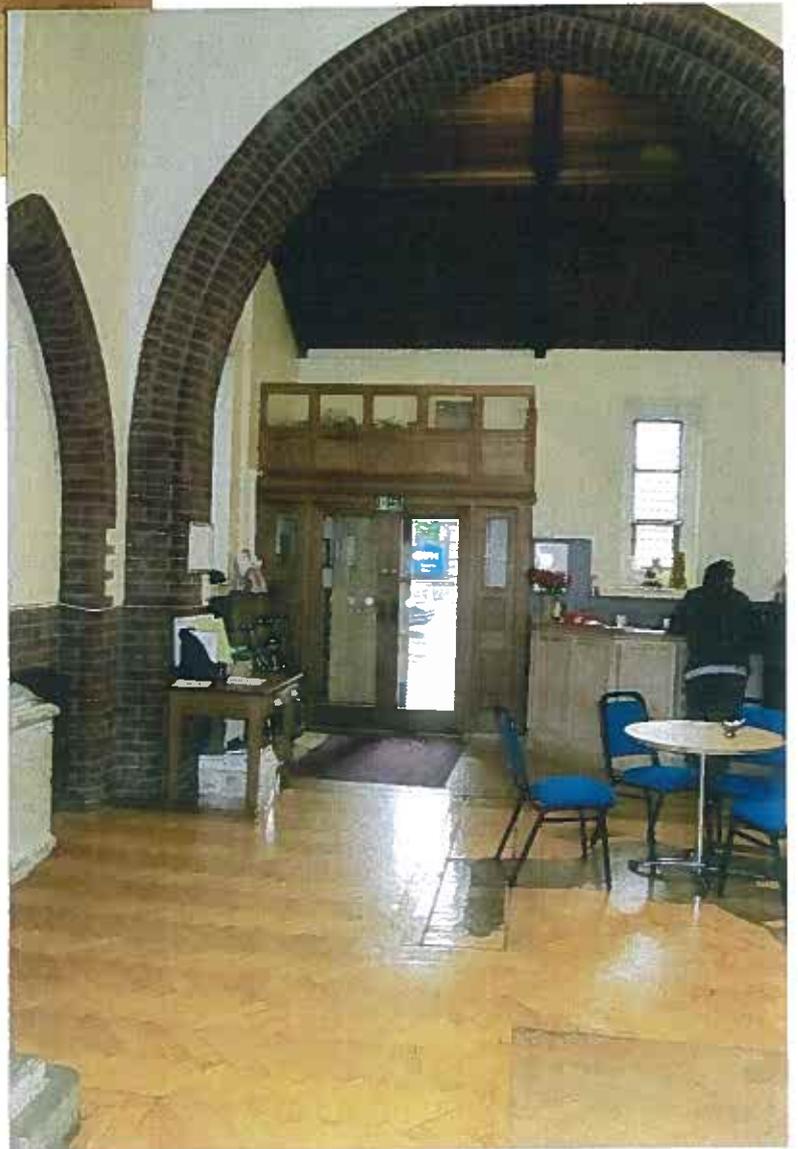
24

P24. Remodelled North Porch with glazed doors and storage over.
