## All Saints Church, Eastgate

### QUINQUENNIAL INSPECTION REPORT 2023

Prepared by: Chloe Granger ARB AABC & Andrew Bodenham MCIAT

Date: Mar 2023

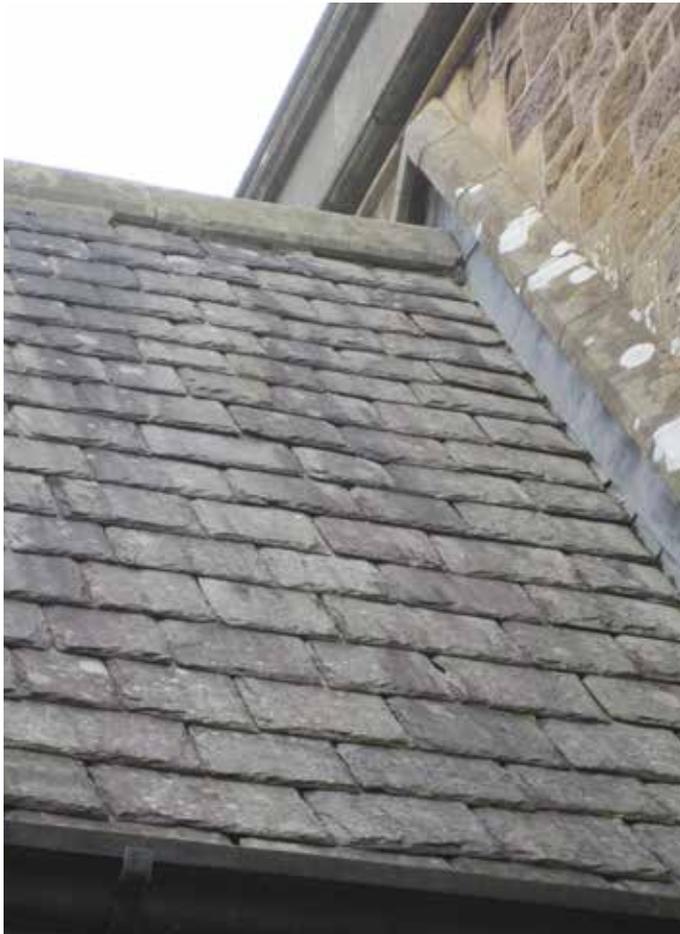
The Porch roof is in good condition with all slates intact, and lead soakers and cover flashings in good condition. The ridge stones need re-pointing / re-bedding in a lime mortar. There are short timber barge boards to the eaves of the porch gable that require repair and re-decoration.

The Porch roof is in good condition. The ridge requires re-pointing in lime mortar

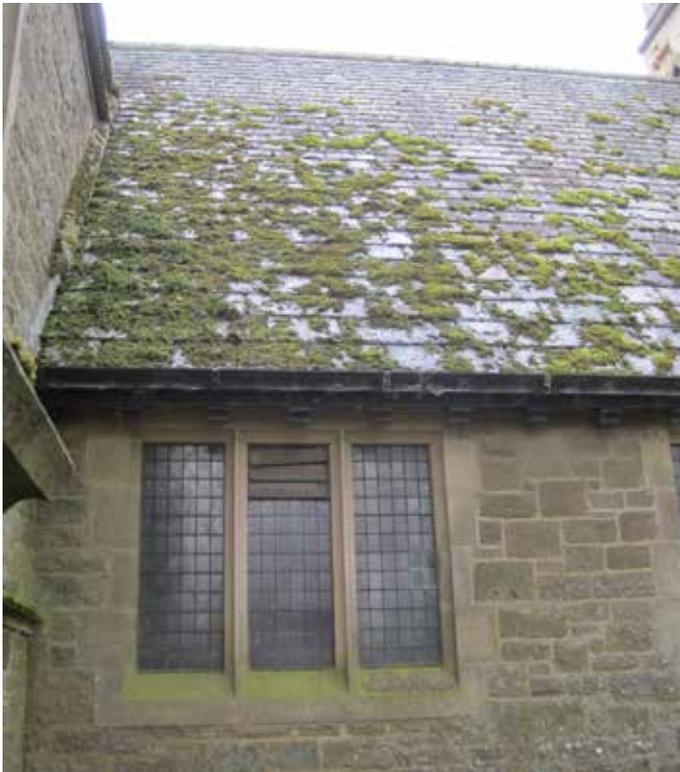
The Nave and Chancel roofs are completely intact with no slipped slates visible from ground level. The presence of moss to the north side of the roof is mainly due to the proximity of the trees to the north east which reduce the drying of the roof and encourage the growth of vegetation. Moss prevents the free-draining of the roofs and can contribute to the deterioration of slates. It is therefore important that all of the moss is cleared from the roof.

Moss build up on all roofs should be carefully cleared off. Moss prevents the slates from drying out, encouraging frost damage. It also blocks gutters and downpipes.

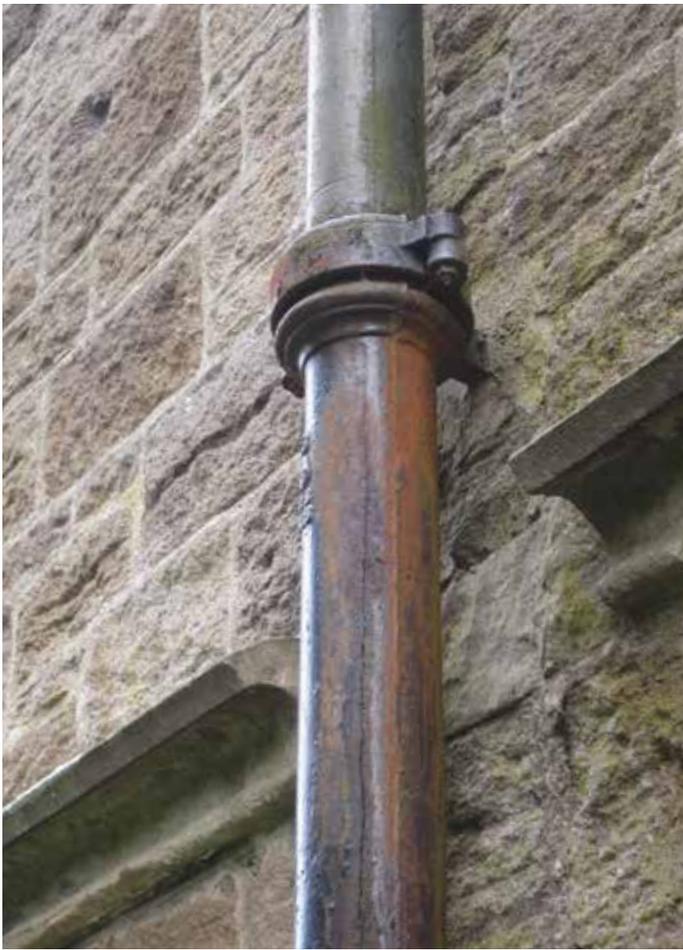
Rusting and algae on downpipes is sign of leakage from joints, suggesting that the pipe is blocked with debris.

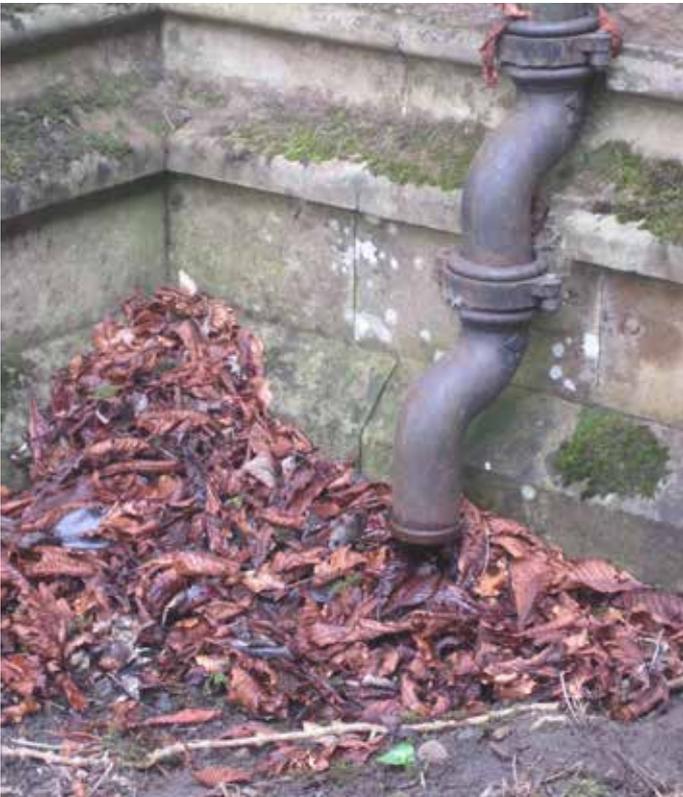
The parapet gutters discharge through the parapet via well detailed lead chutes into cast iron hoppers and down cast iron down pipes. The downpipe to the east of the Porch is a newer replacement. Although the rainwater goods area generally in good structural condition it was noted that there is vegetation in some gutters, and several joints are leaking. Downpipes are also showing signs of blockage and leaking from joints, causing staining of the walls behind. All the rainwater goods must be cleared out, and would also benefit from being re-decorated.

Rainwater goods would benefit from redecoration, as well as regular clearing out. Gullies must be cleared and kept clear

<b>2.03</b>		<b>Works recommended to be carried out during the next two years</b>	
a)	p.14	Overhaul & re-paint all rainwater goods.	£5,000
b)	p.15	Commission the Architect to carry out a high level survey of the spire, chimney, roofs, parapets and other high level structures to inform a strategic plan for future works. Price includes access.	£2,000

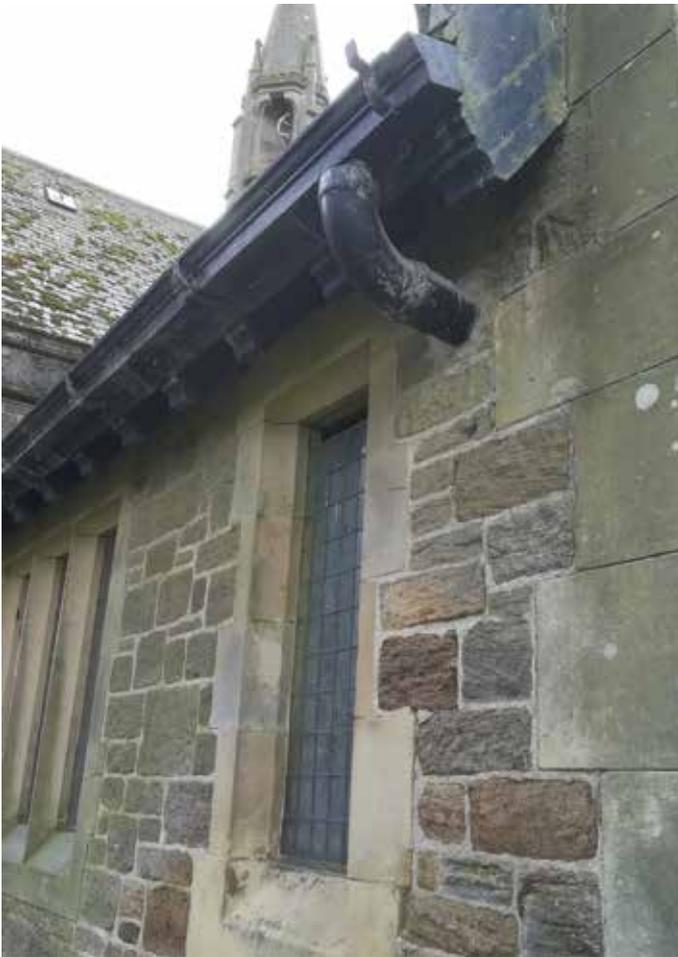
The Vestry and Porch have cast iron eaves gutters and down pipes, there is debris in the gutters and some joints are leaking. All the rainwater goods must be cleared out, and would also benefit from being re-decorated. The downpipe to the north elevation enters the wall of the Vestry and appears to exit adjacent to the Boilerhouse door. This is a poor detail, and ultimately a new conventional downpipe and new gully should be fitted.

The Vestry east gutter return into the building - a poor detail. Fit a new downpipe and gully below

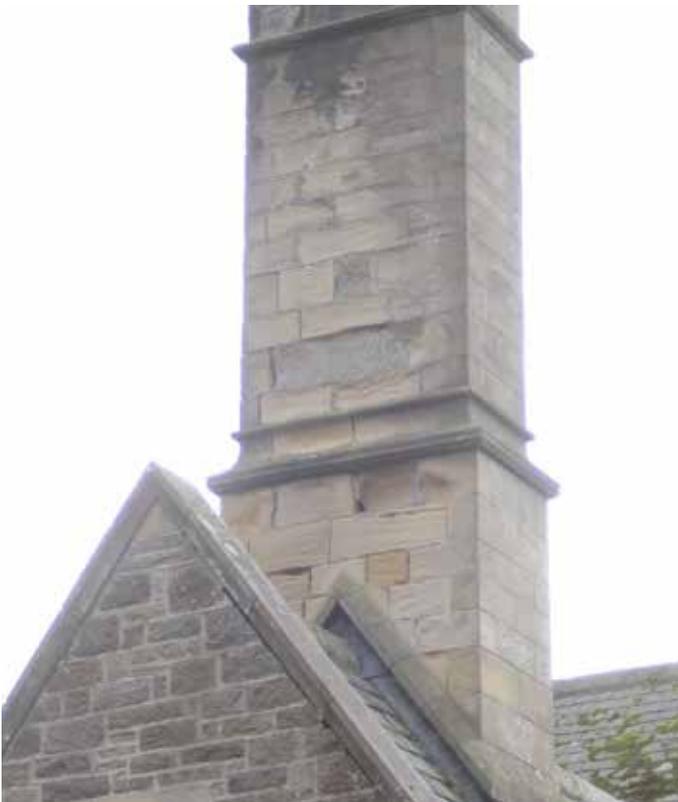
There is one chimney to the Vestry. This is very well constructed in ashlar masonry with carefully detailed drip moulds, but some of the stone blocks are heavily eroded. This appears to be due to a combination of exposure to wind and rain, the action of corrosive flue deposits acting on the stone, and the effect of cement pointing repairs. The chimney pots have been removed and it is not known whether the chimney is protected, capped or ventilated - drone photos may be of use in this location.

Some of the chimney stones are heavily eroded, and cement repairs are hastening the stone decay

d)	p.15	Vestry chimney: indent damaged stones, rake out, re-point. Apply shelter coat if necessary. Cap the flues and provide flue ventilation.	£5,000
e)	p.16	Locally patch re-point open masonry joints across all elevations.	£3,000
	p.16	Mason to re-set loose stones to the Vestry & Porch plinths in lime mortar	£400

The chimney appears to be structurally stable. In the medium term it would be advisable to re-point the chimney in lime mortar and make mortar repairs to the eroded stones. In the longer term to worst affected blocks could be replaced with new stone.

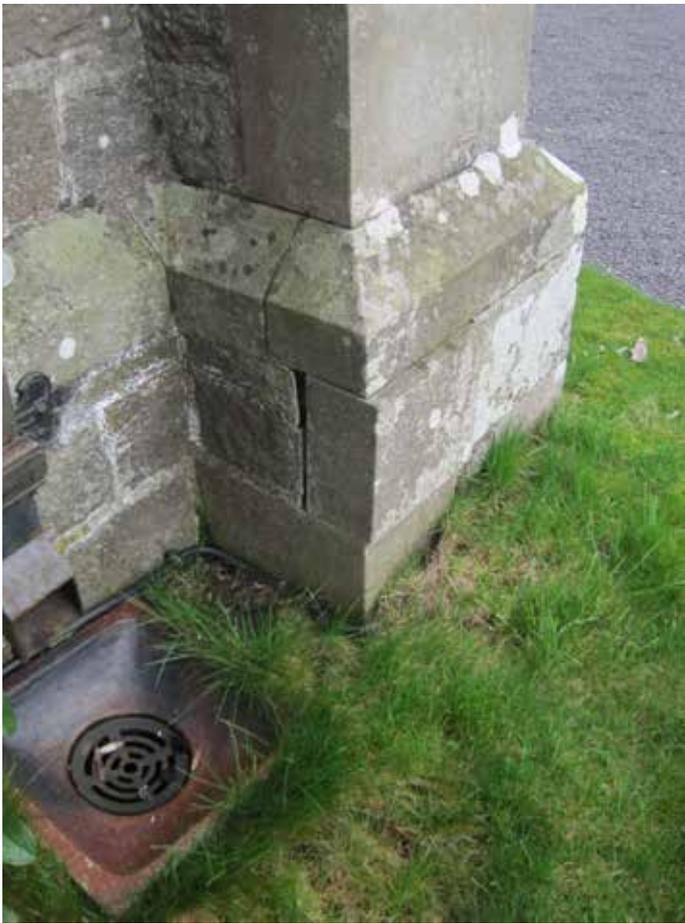
Loose stone block to the plinth of the Porch

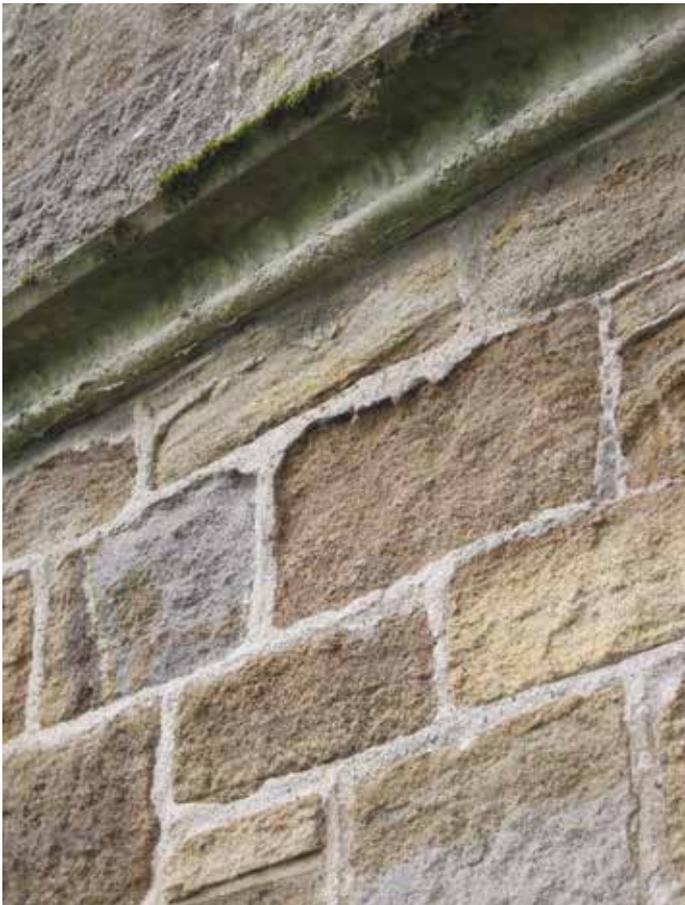
Hard and impermeable cement pointing causes accelerated decay of adjacent soft sandstone

The west wall of the Nave appears to have experienced water ingress over time. The cement pointing will trap water within the wall and prevent rapid drying of the masonry. The relatively impermeable mortar will also cause the adjacent stone to decay at an increased rate. This effect can be seen in several places on the building.

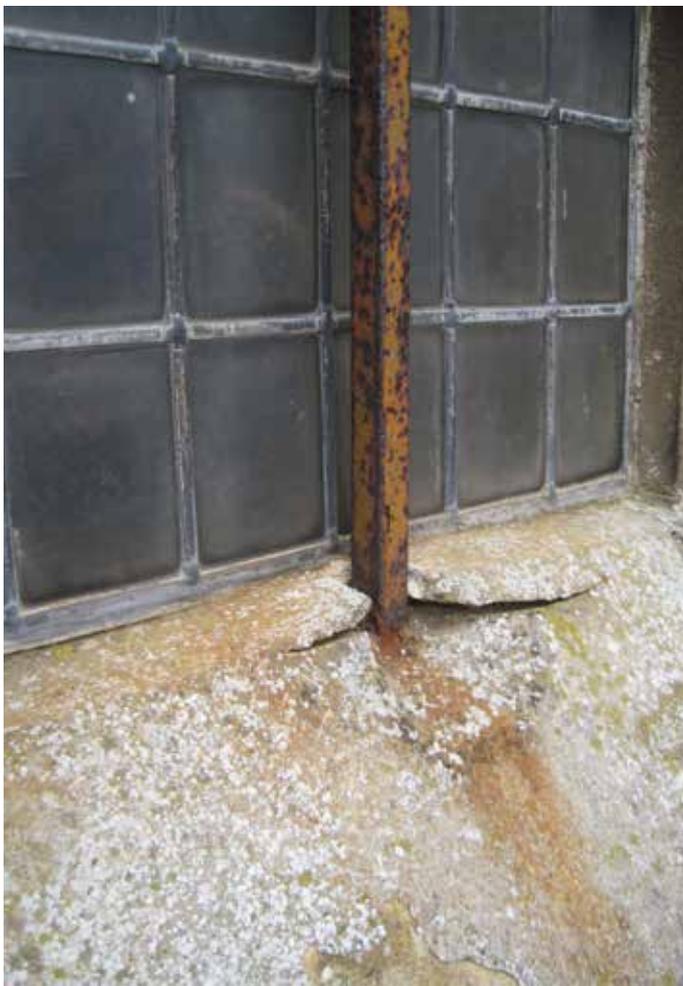
other issue of concern are the cast iron glazing bars that have begun to corrode and are causing the sandstone cills to spall.

The corroding external ferrements has split many of the window cills

f)	p.16	De-rust and re-paint ferrementa to all windows, and carry out mortar repairs to damaged stonework.	£10,000
g)	p.16	Re-build retaining walls to the boiler room steps	£2,000

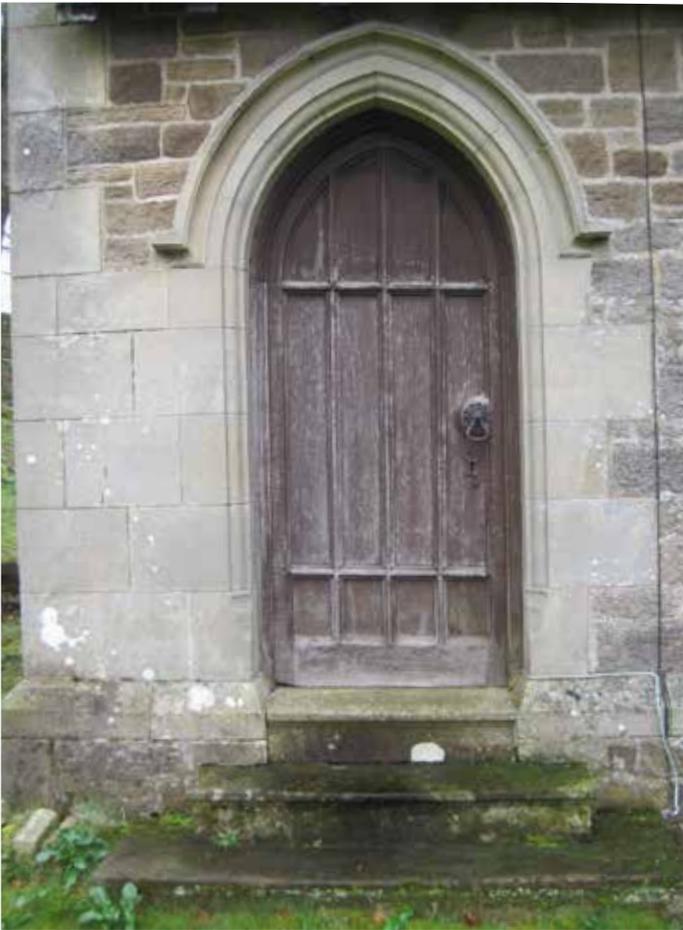
The Vestry door - the step is saturated due to a gutter leak above

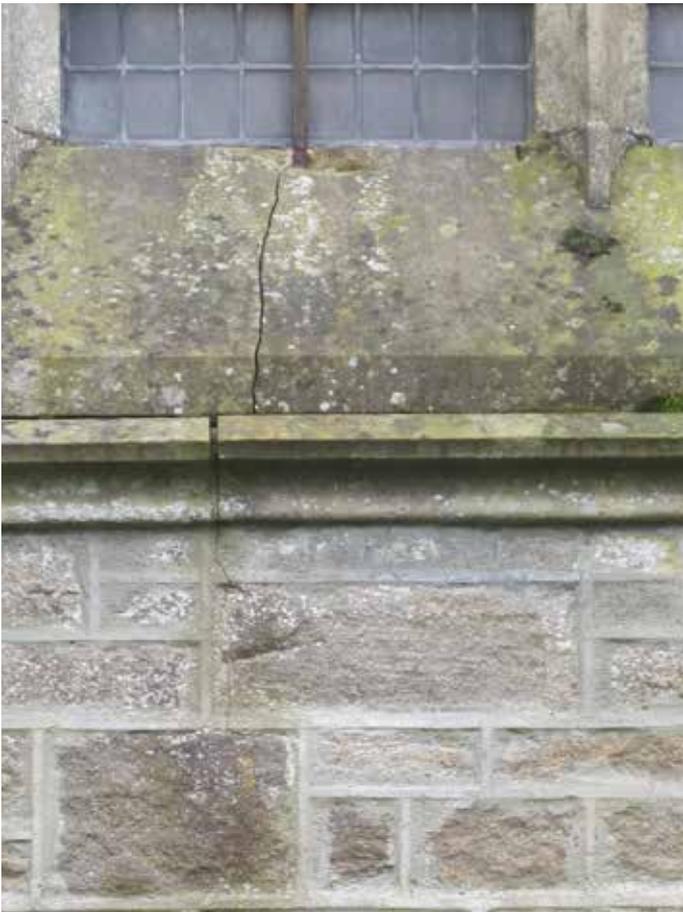
West window: cill split by corroding ferrementa, harmful and ugly cement pointing below

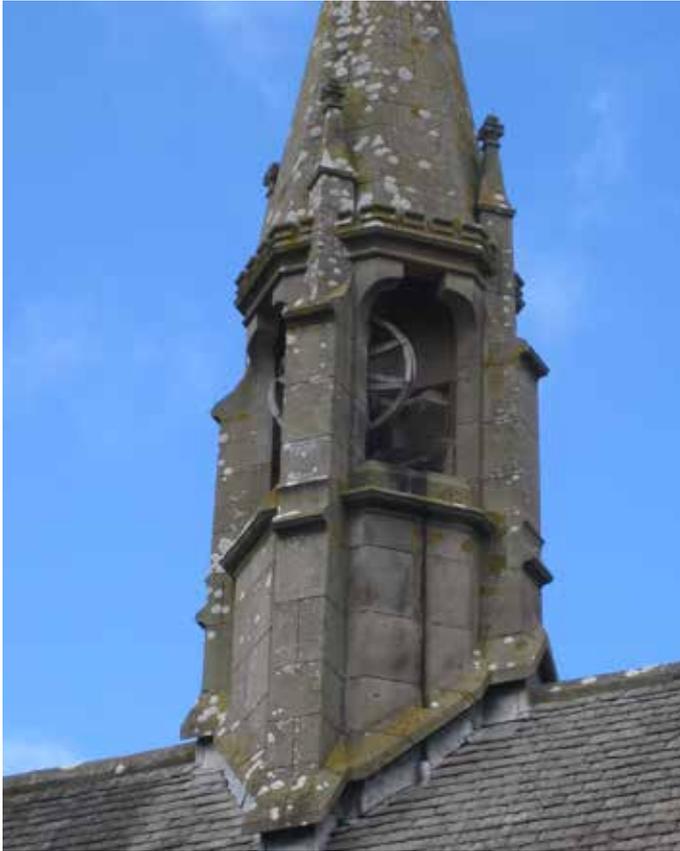
The fleche spire at the centre of the church roof is generally in good condition. There are a number of open joints in the ashlar masonry; these would benefit from re-pointing in a lime mortar. The two bells are mounted on wooden headstocks which are fitted with rope wheels. Chains are attached to the wheels which pass through the roof structure below the stone weathering skirt of the spire - this detail appears to be effectively weathertight. One of the wheels is disintegrating due to decay, and all the woodwork will be vulnerable to weathering. Only one of the bells is currently functioning, and the opportunity should be taken when access allows to undertake repairs to the bells and their associated fittings.

The fleche is very well constructed. The bell mechanisms have suffered from weathering and timber decay

a)	p.13	Rake out and re-point the bellcote spire. Overhaul the bells and put into in sound and working condition.	£10,000
b)	p.14	Employ drainage company to carry out a CCTV inspection survey of all underground drainage & report. Mark all drain locations on a plan.	£800

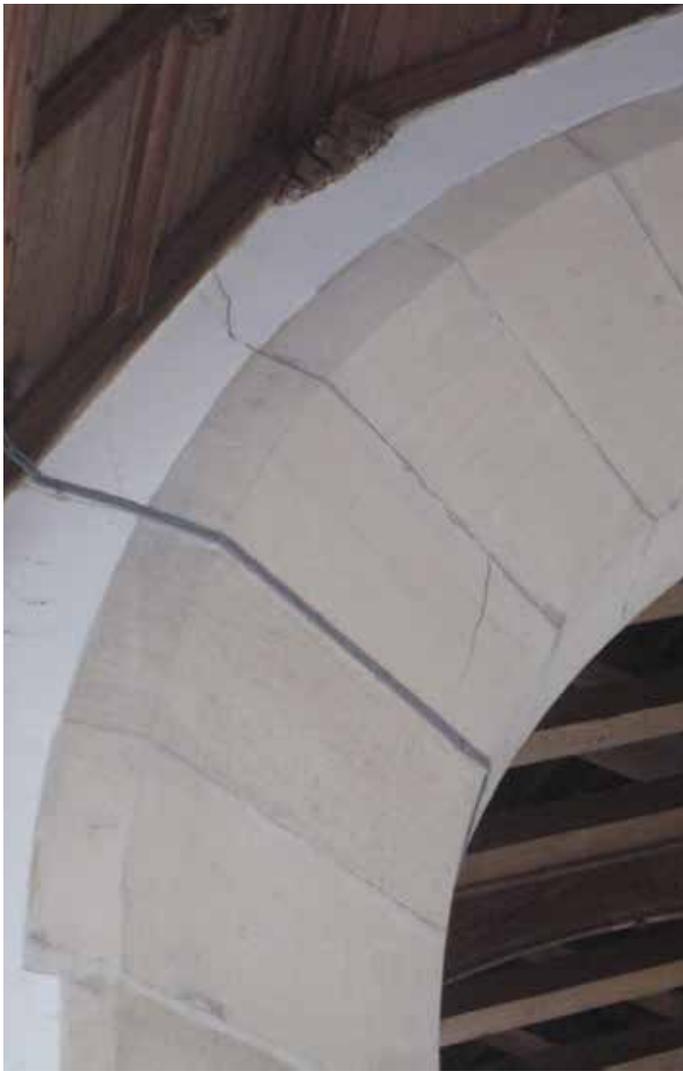
Cracking to the Chancel arch voussoir

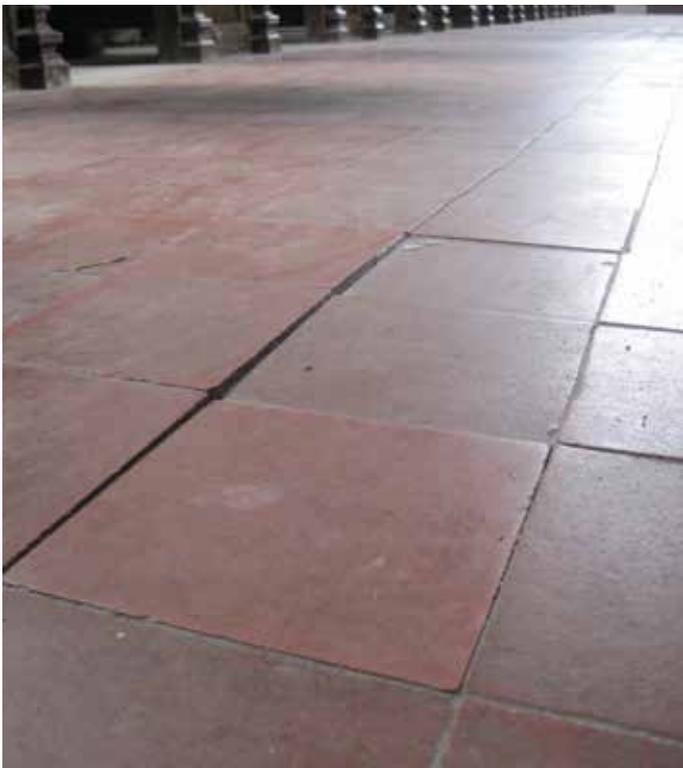
All of the tiles and timber floors are in good condition with the exception of a small number of tiles in the aisles which

Loose quarry tiles to the Nave floor

have become detached and need to be carefully lifted and re-bedded. The floors need only vacuum cleaning and occasional damp (not wet) mopping or wiping to be kept clean.

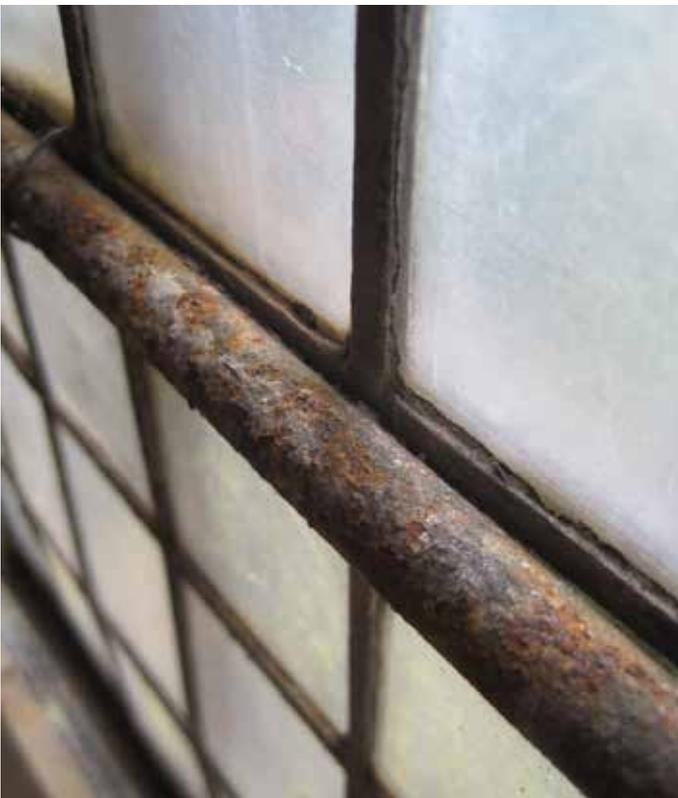
Steel saddle bars are corroding and should be cleaned off, rust-treated, and painted

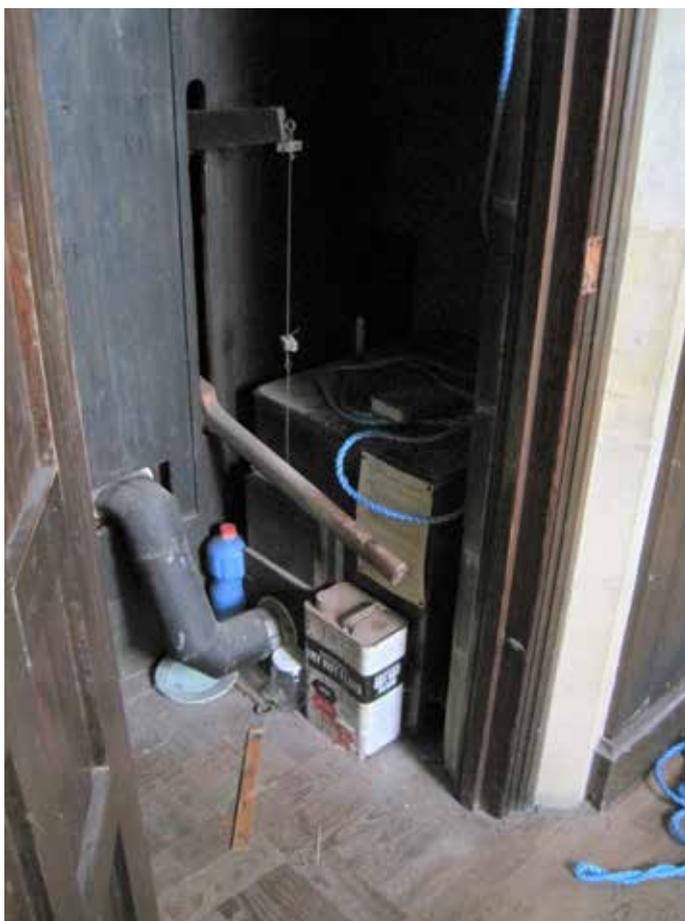
The organ loft - recommended that the organ blower be tested for asbestos

It is recommended that a non-intrusive Management Survey is undertaken in order to establish if any asbestos containing materials are present, and any recommendations for removal or management followed.

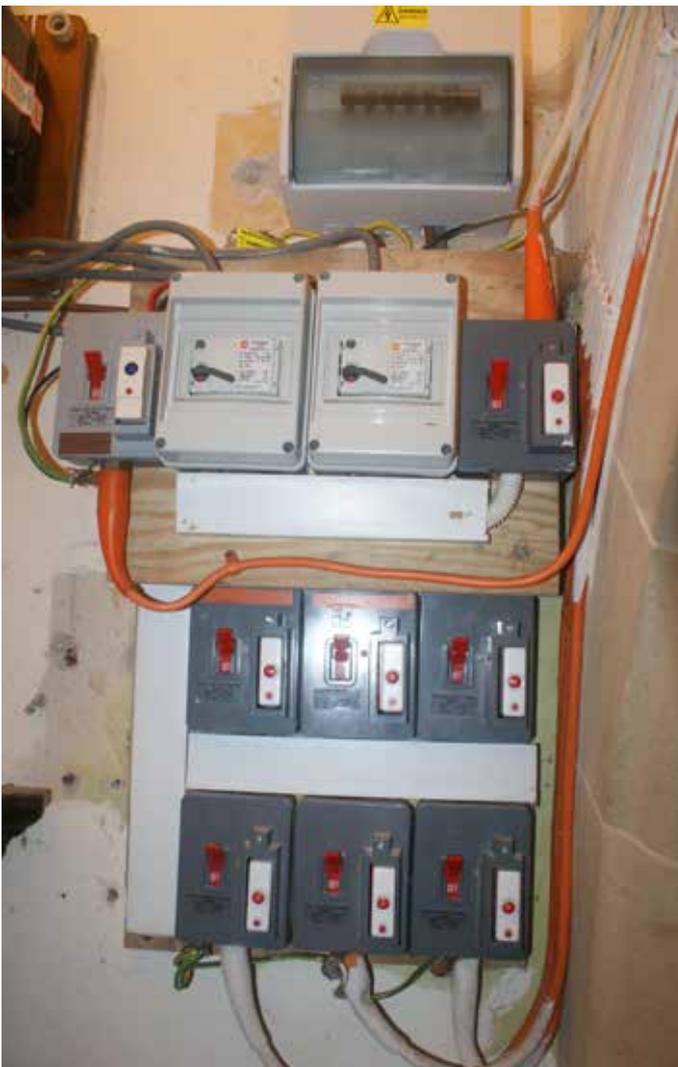
The electrical installation is tidy and appears to be in good order. Test and inspection is overdue, but in hand

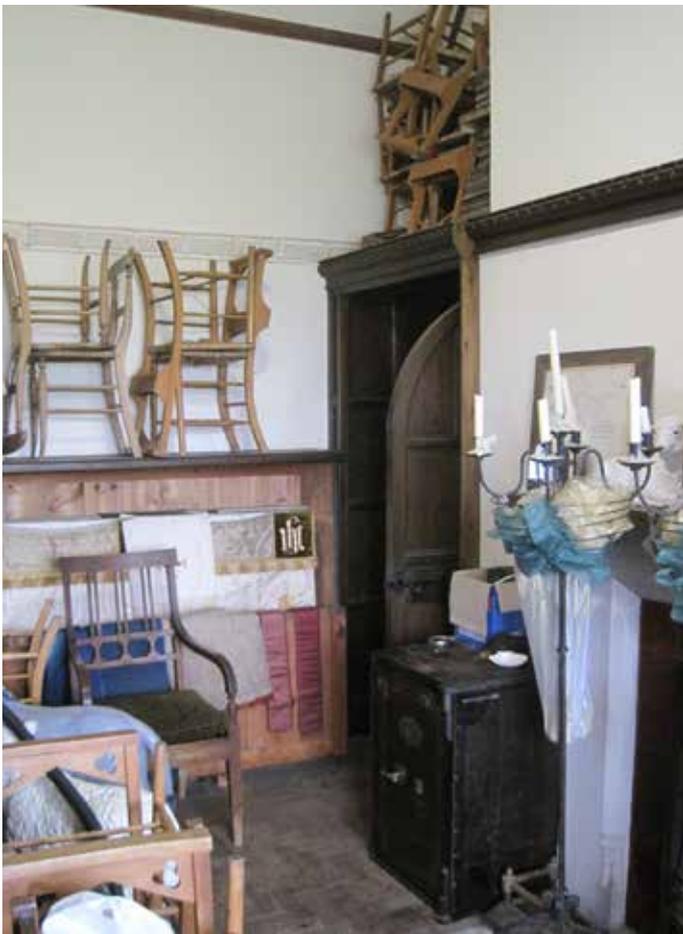
The clutter in the Vestry should be cleared

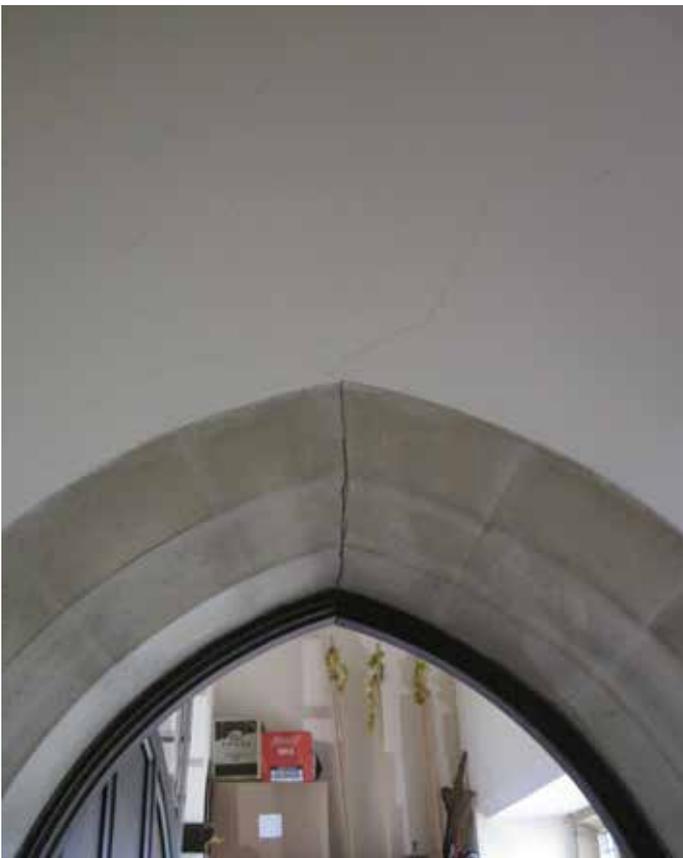
Cracking to the head of the Vestry door

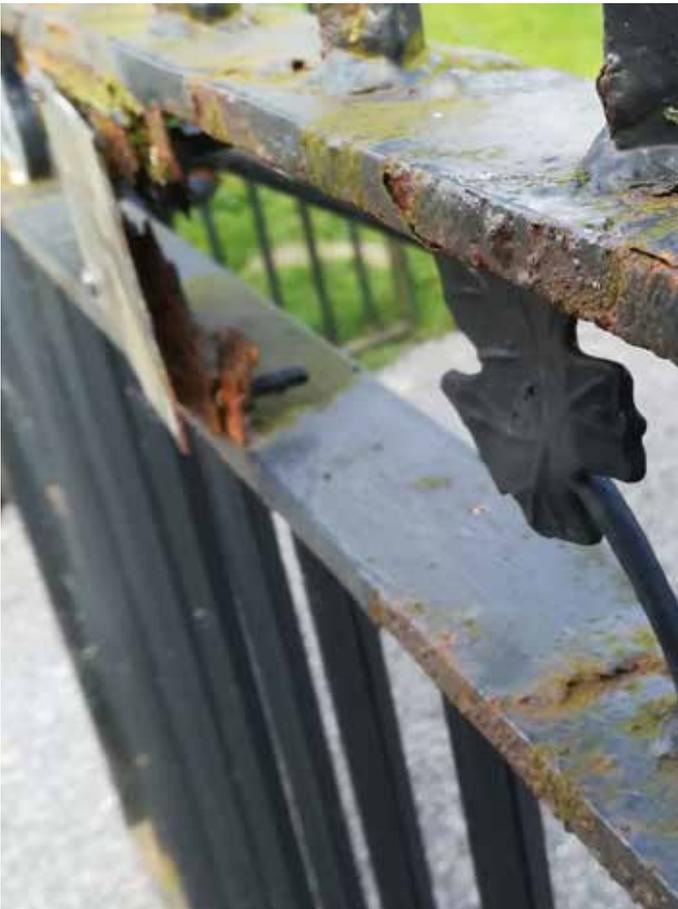
The gates will soon need repair and re-finishing

The steel gates are in deteriorating condition, with rust breaking through the paint and some sheet components rusted right through. It is recommended that the gates are repaired, blast-cleaned and re-painted.

j)	p.21	Overhaul all window louvre mechanisms, clean & lubricate	DIY / £500
k)	p.26	Repair and re-paint iron gates to west entrance	£750
l)	p.26	Remove tree close to NE corner of Vestry & grind out stump	£350

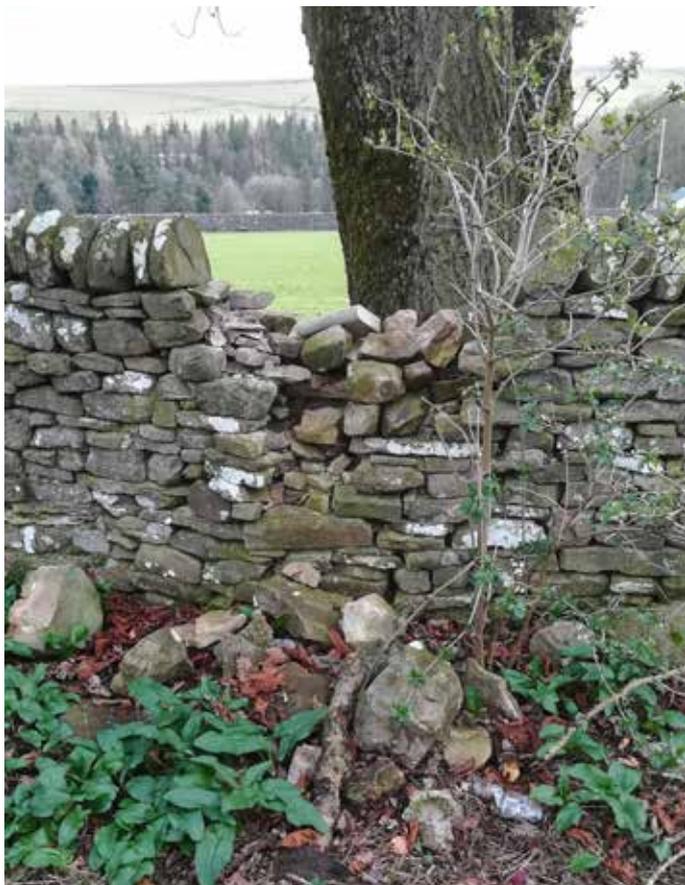
The boundaries to the churchyard consist of drystone walls to the full perimeter. The wall is traditionally capped with upright stones apart from the section to the west either side of the entrance gate which has a carved coping. The walls require some attention and rebuilding in several places, in particular where the growth of trees have disturbed the wall.

The boundary walls are susceptible to frost action and disturbance by trees.
