QUINQUENNIAL INSPECTION REPORT OF FISHBURN, ST. CATHERINE

**DIOCESE OF DURHAM
ARCHDEACONRY OF DURHAM
DEANERY OF STOCKTON
PARISH OF UPPER SKERNE**

QUINQUENNIAL INSPECTION AND REPORT

DATE December 2022

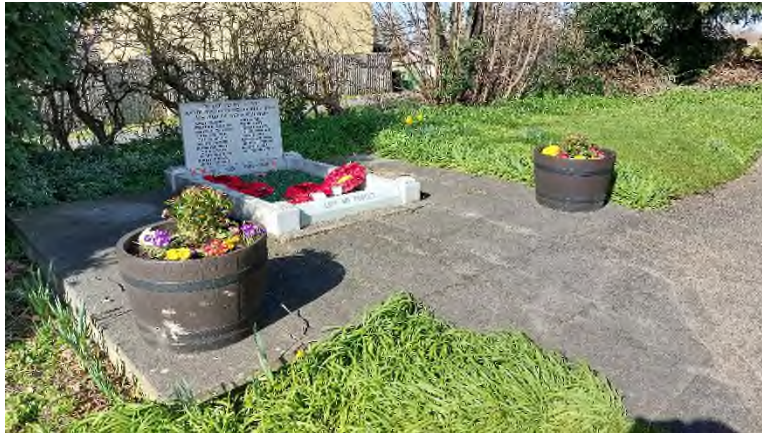
At the western end of the site. Loose paving in corner.

Recommendation: repair paving

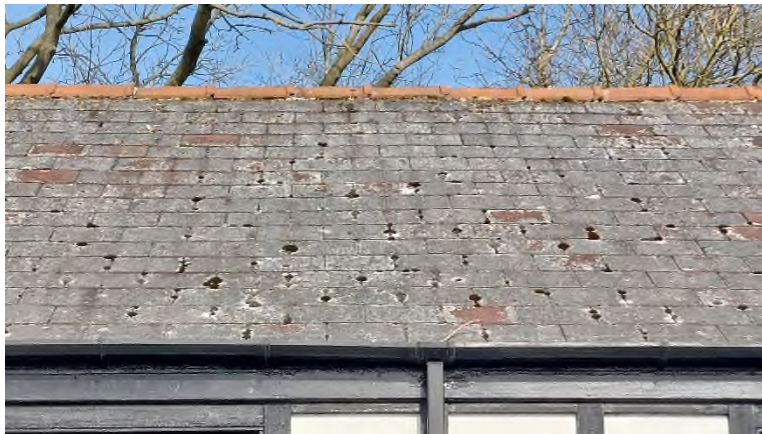
Church:

Red socketed clay dropping at the east end with the bedding generally sound, fibre board Eternit type slates in fair condition with some moss to it, significant amount on the north side.

B Church Recommendation: Reset nave ridge, point up ridges where bedding missing, clear off moss,

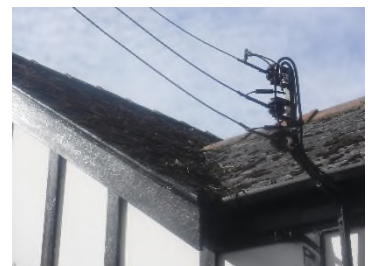
Same construction as the church, some bedding missing from the ridge tile socket joint, a lot of leaf build-up in the valley so unable to really see what is there. Very mossy.

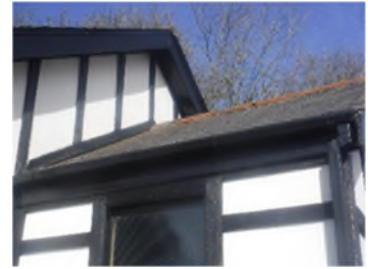
Same construction as the church roof, some of the bedding to the ridge is loose and the sockets are slightly open as last QI. Little change. The slating appears ok.

All the roofs have timber bargeboards and timber verges, these are in poor decorative condition. The barge board feet of the south west corner has been repaired.

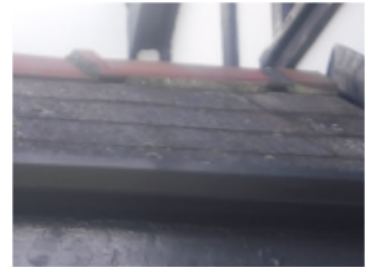
Same details as church but has more bedding missing at the ridge. Slating looks ok. The timber board abutting the church has been repaired as has the verge board. The bargeboard has been replaced.

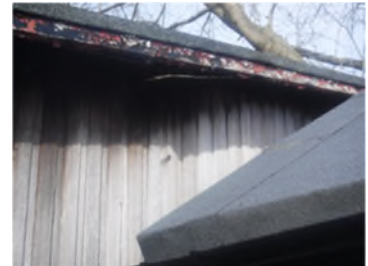
New mineral felt pitched roof which is covered in moss though appears there is no leaking to it, only the south side is easily inspected, there is a lot of tree debris on its surface. Fascia board decoration poor.

D Hall Recommendation: remove moss and twigs, redecorate fascia

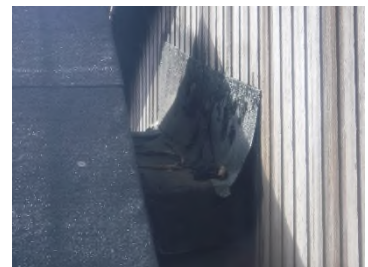
New mineral felt roof covering but the link not renewed.

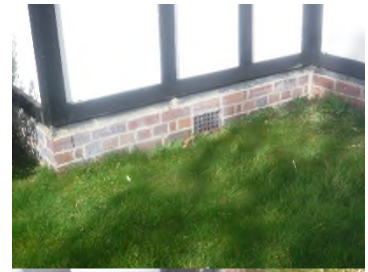
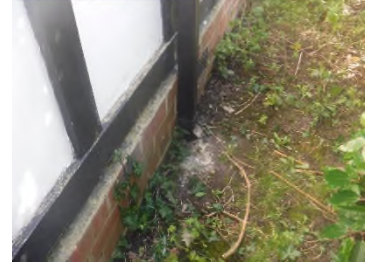
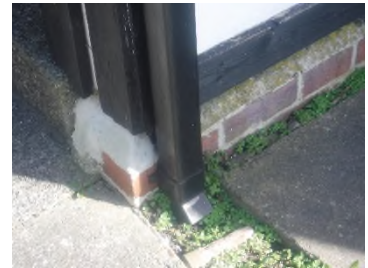
All these downpipes do go down to the ground there appears to be no underground drainage system.

Recommendation: check records for an underground system, replace warped gutter on nave, repair gutter joints, repair downpipe joints, redecorate down pipes.

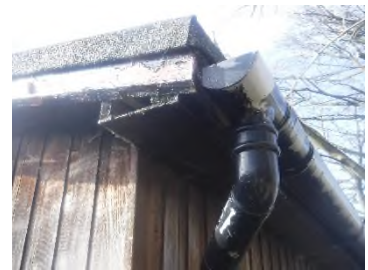
Downpipes discharge direct to the ground.

Recommendation: Clear gutters and redecorate.

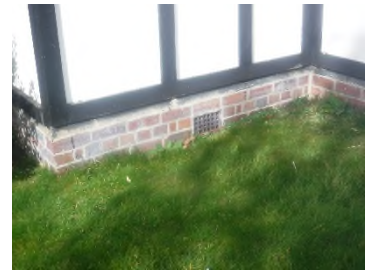
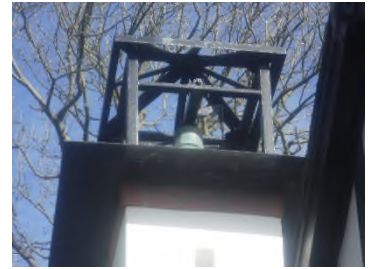
Timber stud walls with fibre board covered with timber cover beads on recently repointed brick plinth. They have been repaired at various times in their lives. They are currently sound.

There's a large, rendered tower structure at the west end which has now been decorated. On top is a steel structure providing a roof for the bell and the roof is now lost.

Recommendation: replace bell roof, ease bell.

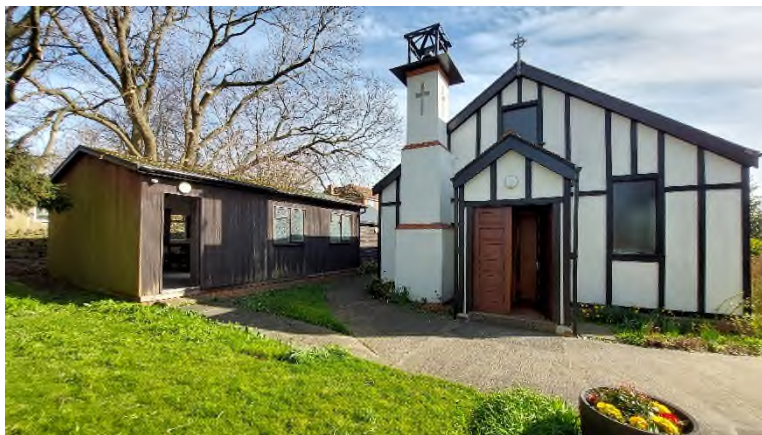
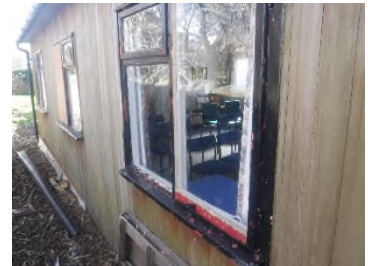
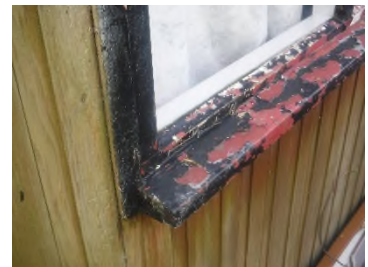
Hall:

The walls to the hall are cedar boarding and these are in good condition, though have lost their decoration on the north and west side because of algae build-up. The north side fascia/bargeboard members etc. need repair and decoration.

Recommendation: Sweep down the walls, remove algae, repair fascia, redecorate

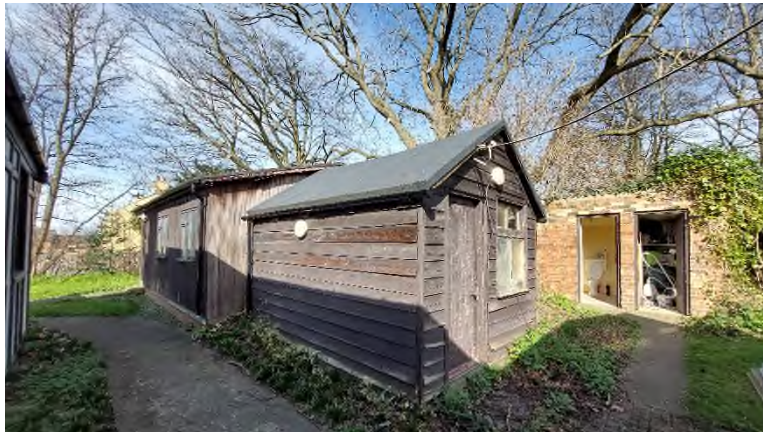
W.C. Block:

This is a separate brick built structure providing a W.C. and a storage area. It has a mono-pitched corrugated roof falling towards the neighbour land. There is no gutter to it.

The building itself sits partially into the neighbour land.

Inside the walls are plastered and painted and in fair condition, the floors are concrete.

A rather basic W.C. but serviceable with pan and wash basin. Wash basin is slightly loose on the wall. The electric don't appear to be working for the heater, perhaps the fused spur has gone.

The doors to both rooms are flush doors and in terrible decorative condition, and easily kicked in because their bottom panels have been patched over.

Recommendation: Remove ivy, decorate exposed timber, repoint open joints, fix water heater, replace doors.

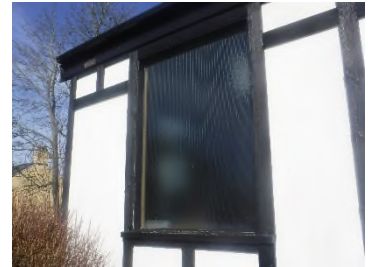
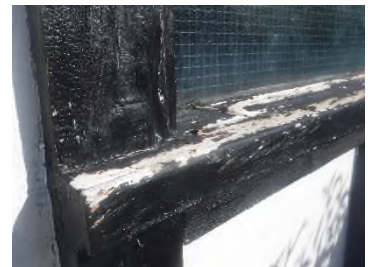
Whilst the windows themselves are serviceable (though they are non-opening) they do no credit to the building and if funds allowed their replacement in clear glass would improve the aesthetics of the church and improve mission.

Pair of double doors slightly catching at the lock, decoration failing.

Flush door locked at time of inspection, door handle loose and decoration coming away.

Recommendation: ease, repair and decorate doors, consider window replacement

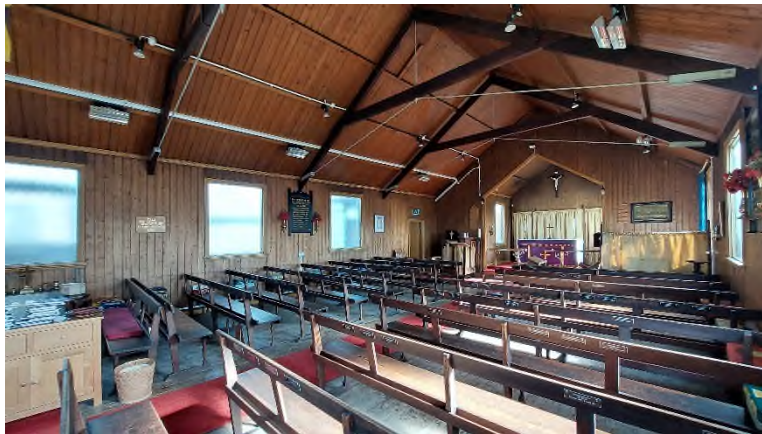
The trusses appear sound

Recommendation: none

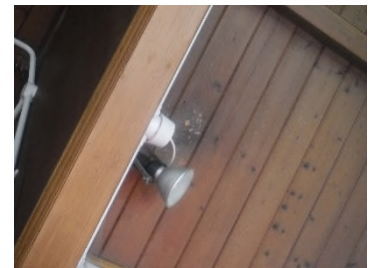
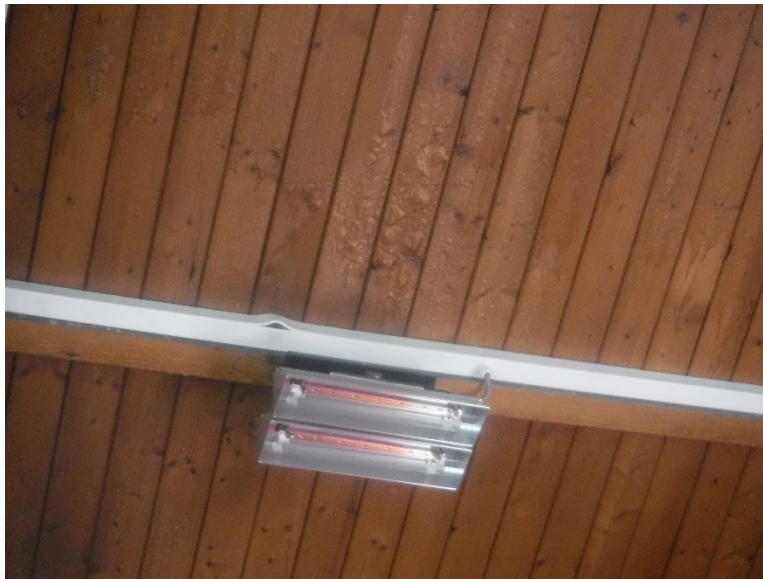
Boarded ceiling with decoration breaking down

T&G boarded roof with three timber trusses with steel tie rods, no water marking, and good condition. Bubbling to the varnish is caused by the heaters and former lamps,

Recommendation: Consider renewing ceiling decoration.

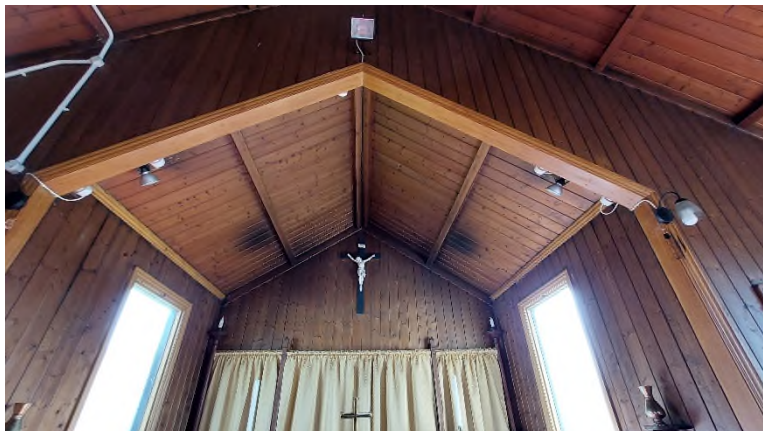
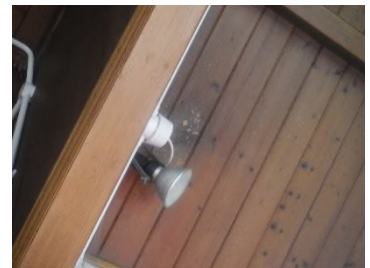
Chancel:

Open boarded ceiling, some paint blistering at a spotlight.

Recommendation: Consider renewing ceiling decoration.

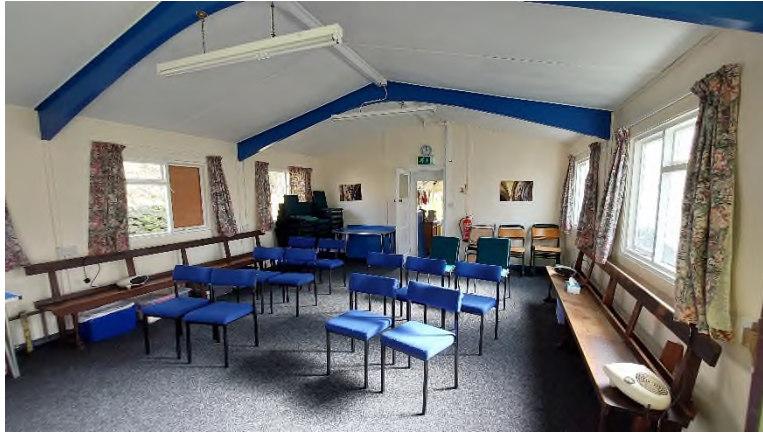
- **Hall:**

Open trussed roof with board panels with cover strips, slight rippling to one of the boards over the doorway.

Recommendation: none

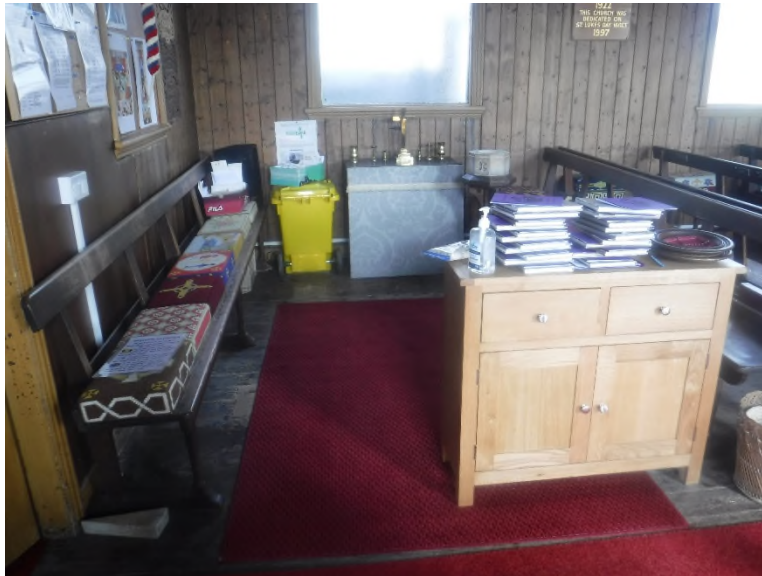
Nave:

Timber boarded floor, decoration has worn off now, in reasonable condition.

Recommendation: none

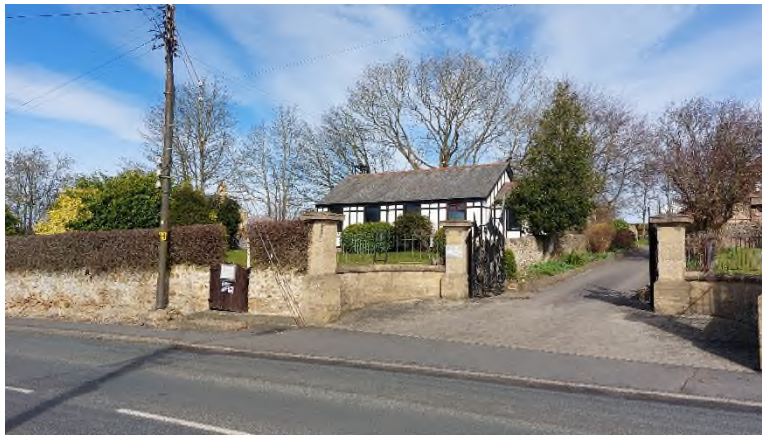
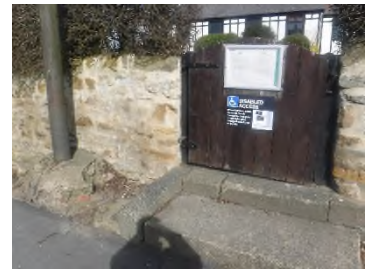
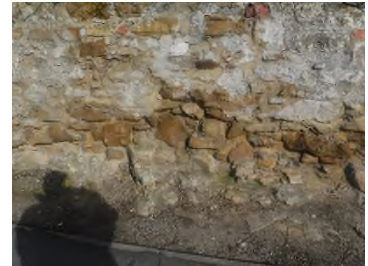
E **South Boundary:**

Random rubble sandstone wall topped with hedge, open joints to the walling at low level. Entrance gate where there are two steps in concrete slightly broken up but they will do. Decoration coming away from the fence posts.

Internally the graveyard is higher than the outside road by about half the height of the wall. Large cast iron power pole has a rather poor cement base to it but is serviceable.

Recommendation: Repoint open joints, consolidate the gate post fixing.

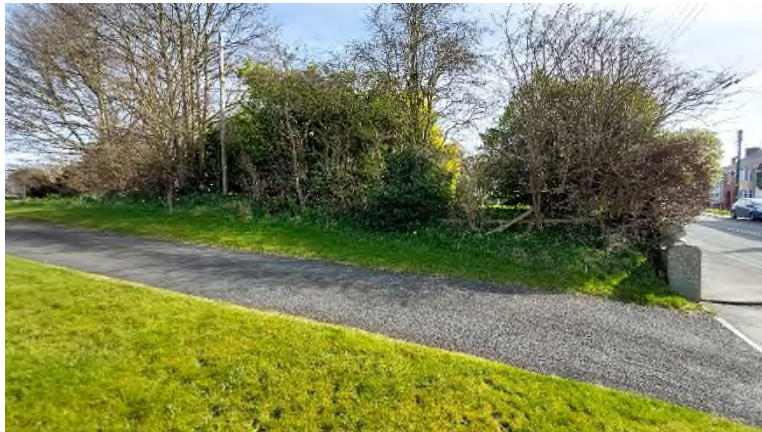
E West Boundary:

This looks onto private land, the churchyard is higher than the adjoining drive, and there is no fencing to it just shrubs. In the north west corner is a very large Sycamore tree which rather dominates the hall building, there's also an Ash tree but that is on the adjoining land both of those are dropping small twigs. Ash is known to be a brittle tree and it may be that a limb might come down onto the hall and kitchen.

There's also a Sycamore tree beyond the larger one which is in poor condition probably just a windblown sapling but now leaning towards the neighbour land and I suspect that this could be a problem in the future. These have been trimmed but will continue to threaten the building and structures.

Recommendation: keep tree growth under control.

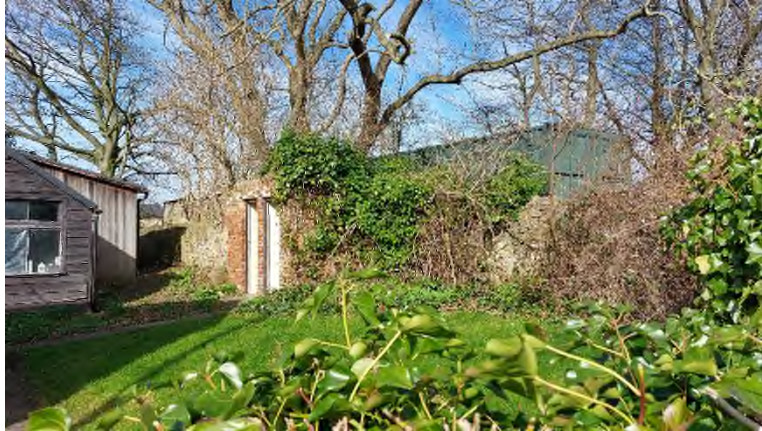
E North Boundary:

Mostly enclosed by a neighbour land which is overgrown, so not possible to inspect the neighbour side of the wall well, though it is obvious that there are open joints. Can see the W.C. roof doesn't have any drainage to it just drips on the back and there's an area of stonework which looks very poor adjoining the railings. There's a large sea container looking like a very permanent installation, close to the north wall and this is covered in ivy it's unable to be inspected.

Recommendation: Point up accessible open joints to rear of wall.

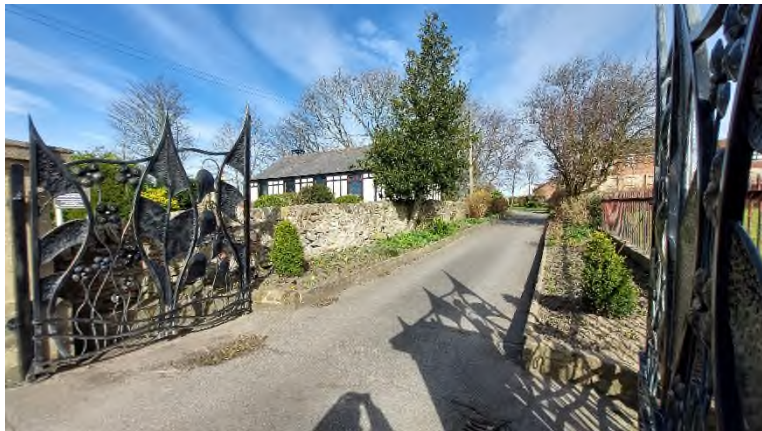
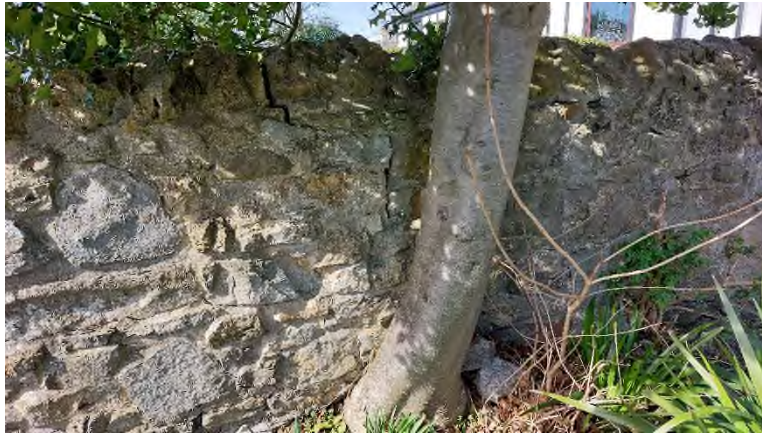
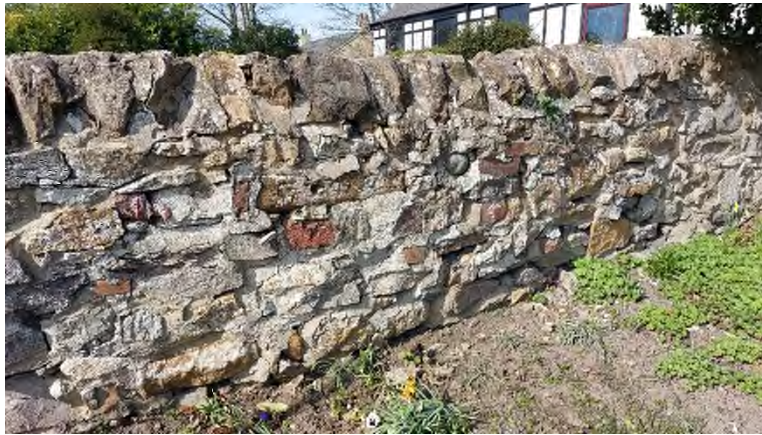
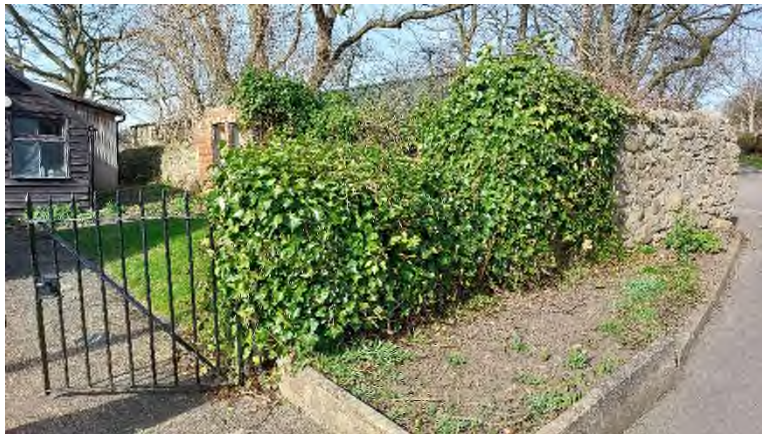
E East Boundary:

Poor quality random stonework wall, heavily restored in cement a lot of open joints to the cemetery path side, slight cracking at the northern end.

Holly tree is causing cracking to the wall and will only get worse and so it needs removal or the wall rebuilding to suit the tree growth.

Original cast iron gate providing access to the rear of the building and disabled access, decoration is coming away and the gate lock needs easing slightly and the handle adjusting to it better.

Recommendation: Repoint open joints, redecorate and ease gate.

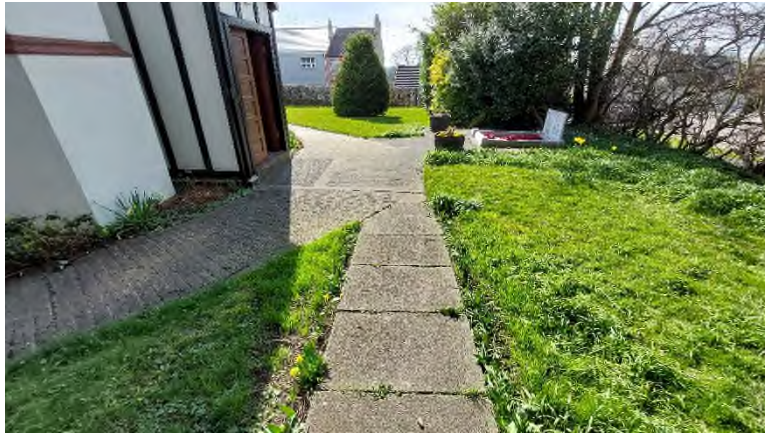
D **General:**

Within the boundary walls the area is mostly laid to grass with the principal path in concrete, in good condition. There is a secondary path to the hall in concrete paving slabs, slightly undulating and leading to a stone step up into the hall.

At the rear of the church the concrete paving is slightly slippery and there are some cracks and open parts to it by the disabled entrance gate.

There's a rough area of land on the north side at the back of the hall used for dumping garden waste. There are two loose bins outside the vestry.

Recommendation: Remove algae and point up cracks in paving.
