## **QUINQUENNIAL REPORT**

*For the Parish Church of  
St John, Gateshead Fell*

***Report Date: July 2024***

Inspecting Architect:  
Becky Smith BA(Hons), MArch, ARB

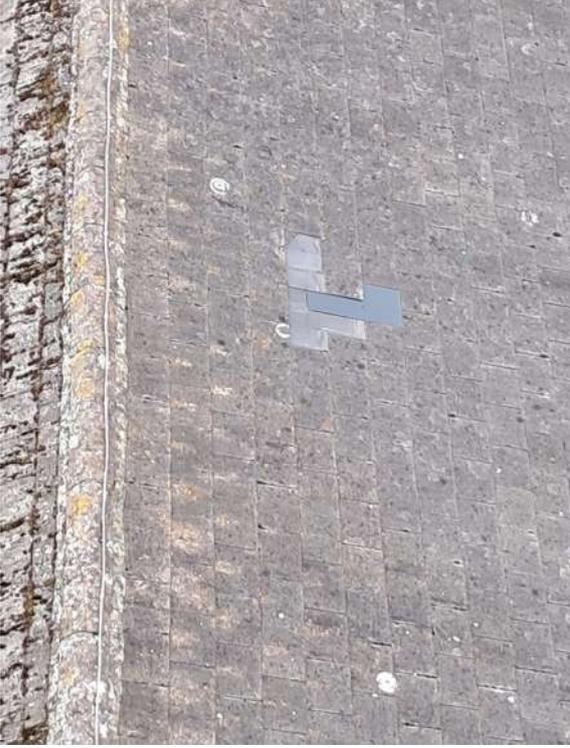
Missing slates to South Nave roof.

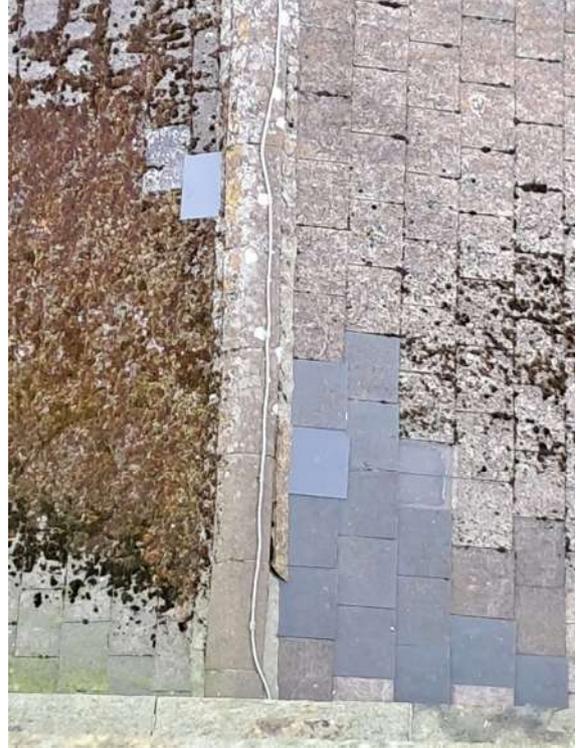
Missing pointing to ridge of Nave.

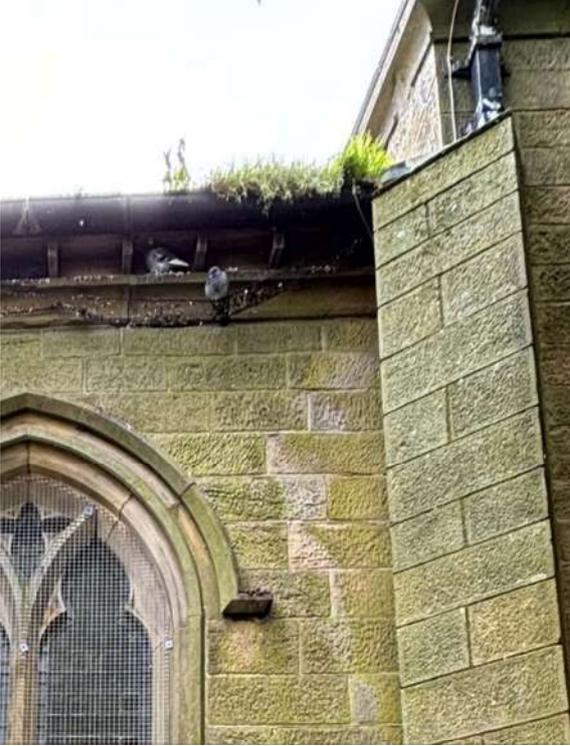
Vegetation growth and pigeon nesting below.

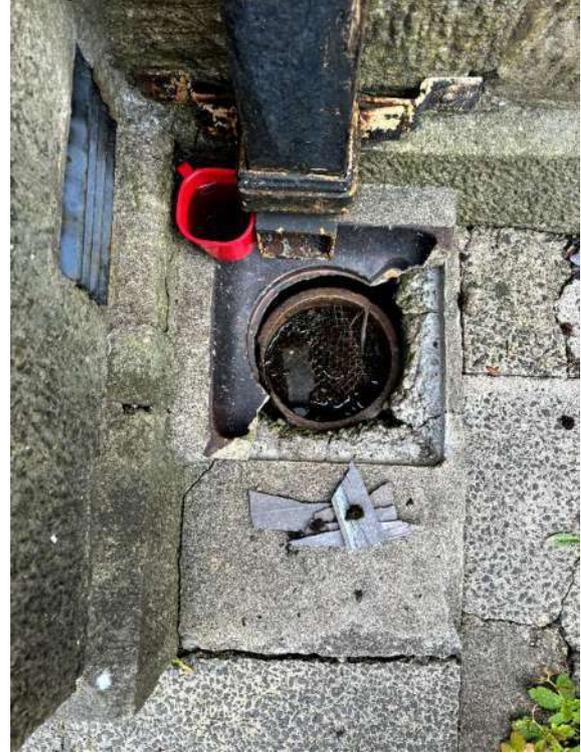
Gully is cracked allowing water to seep into the ground & all are blocked.

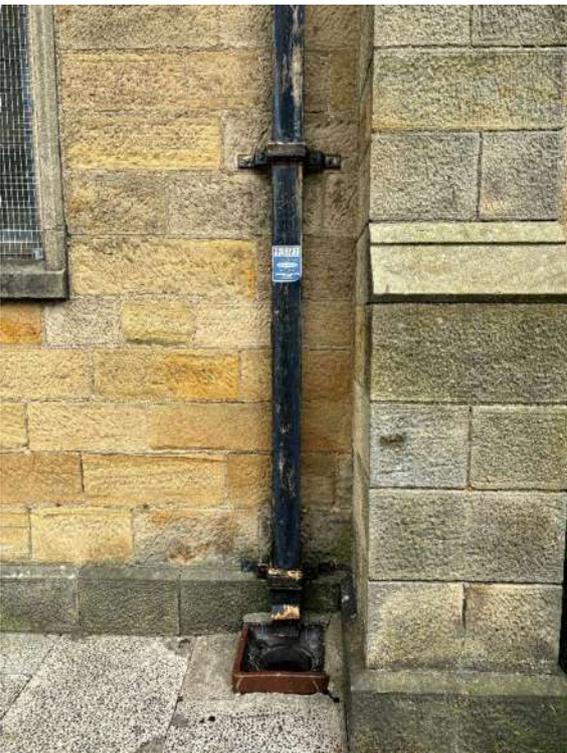
Vegetation growth, rust and poor decoration to gutters.

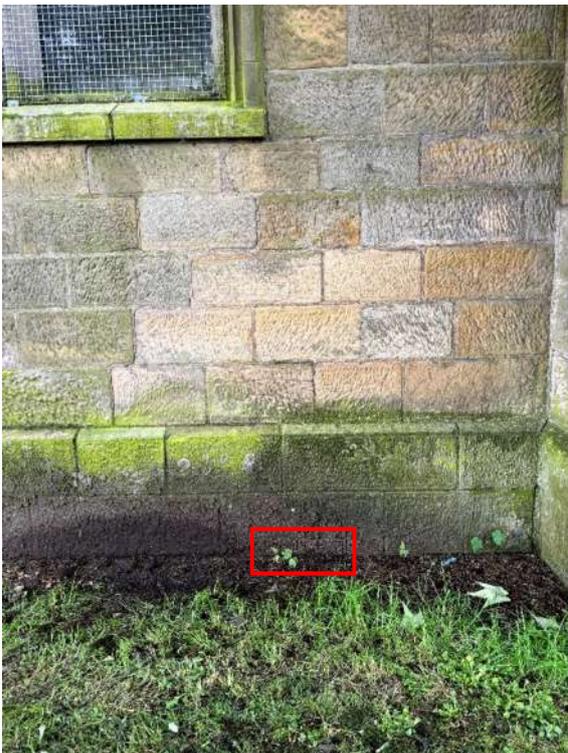
Vent positioned very low into the ground within this bay. Damp evident.

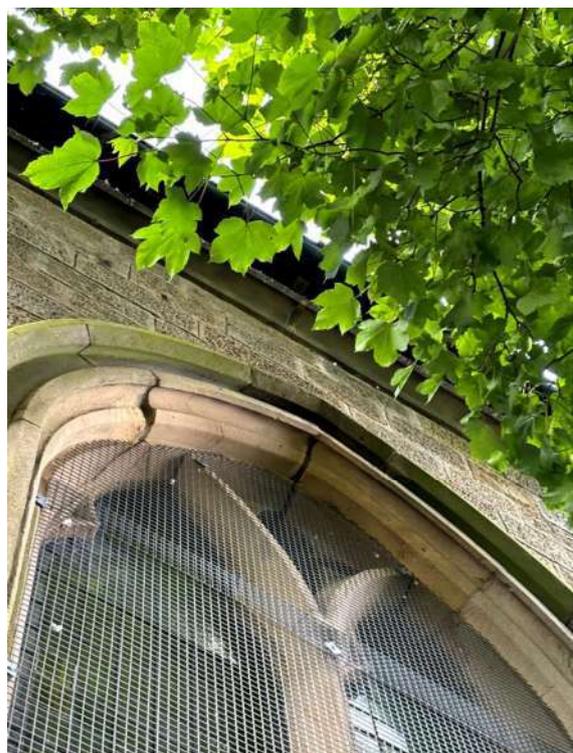
Crack to stone surround of W.09.

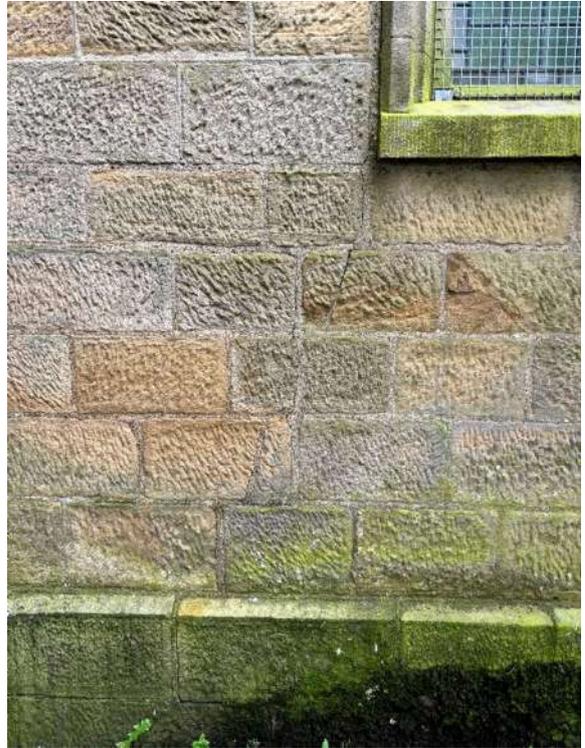
Wider left hand joint to window, historic crack reopening with new crack appearing.

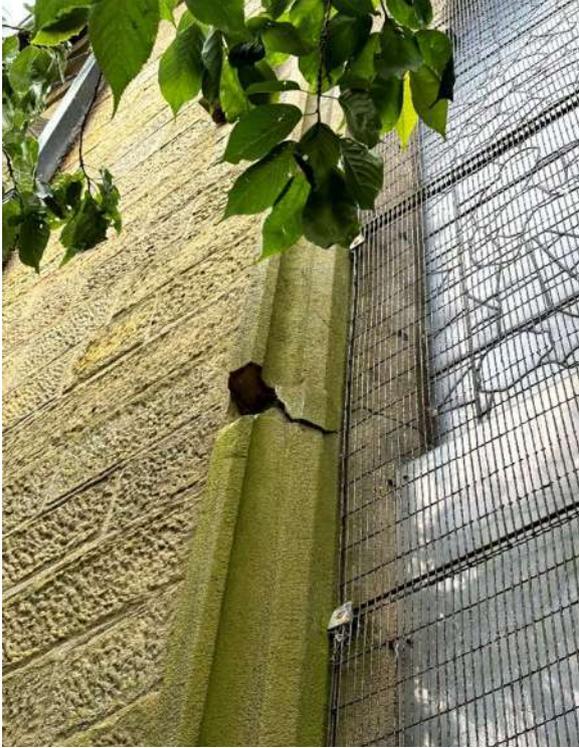
Crack to stone surround of W.11 and missing section of stone.

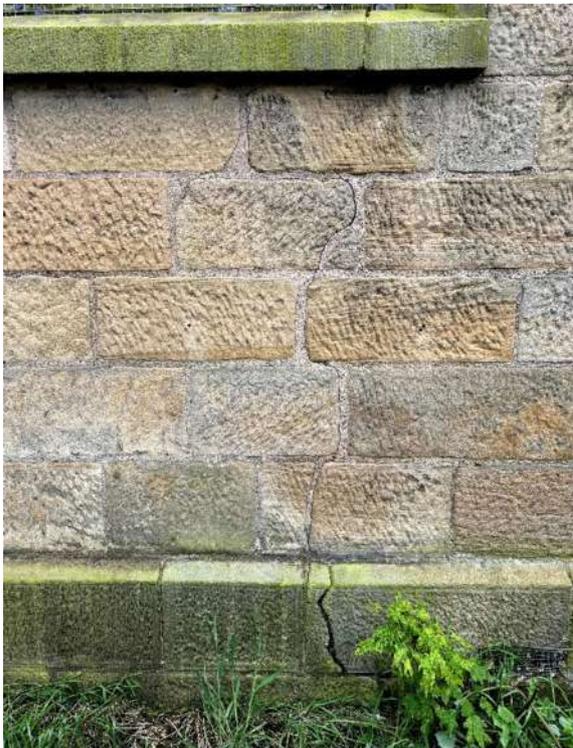
Previously repointed historic crack is reopening with new crack to base.

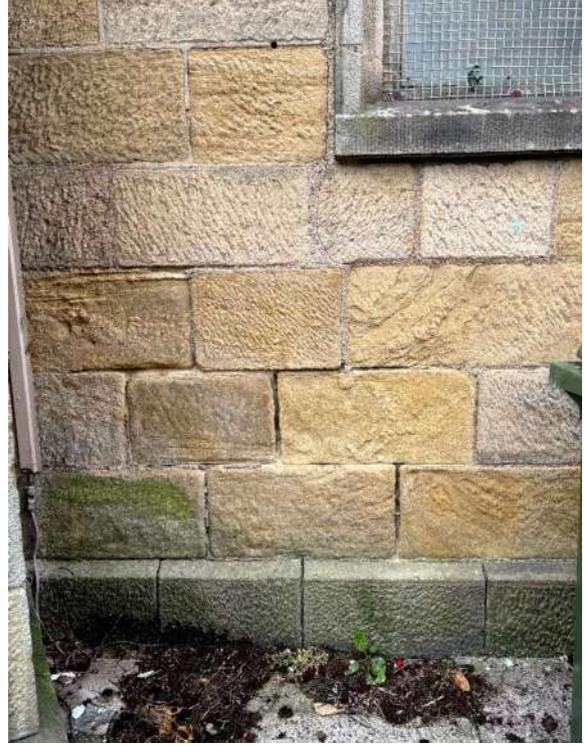
Loss of pointing to lower left side of window and crack to window reopening.

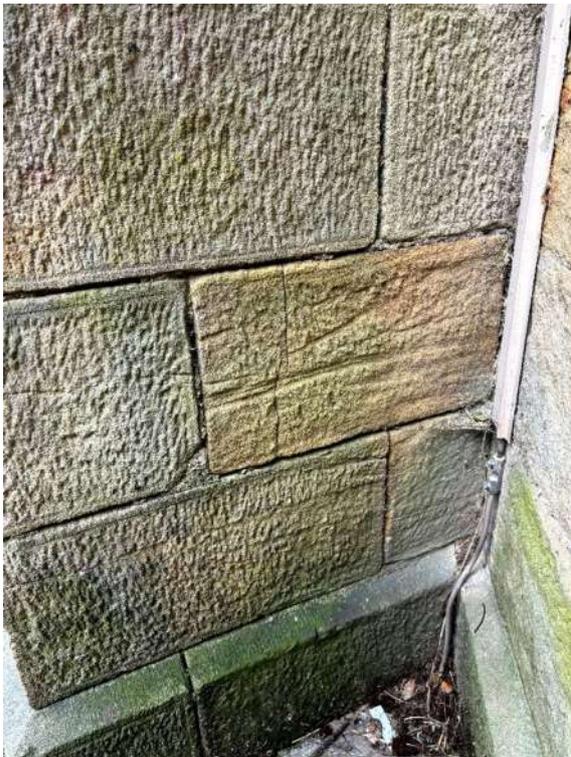
Loss of pointing and crack to buttress.

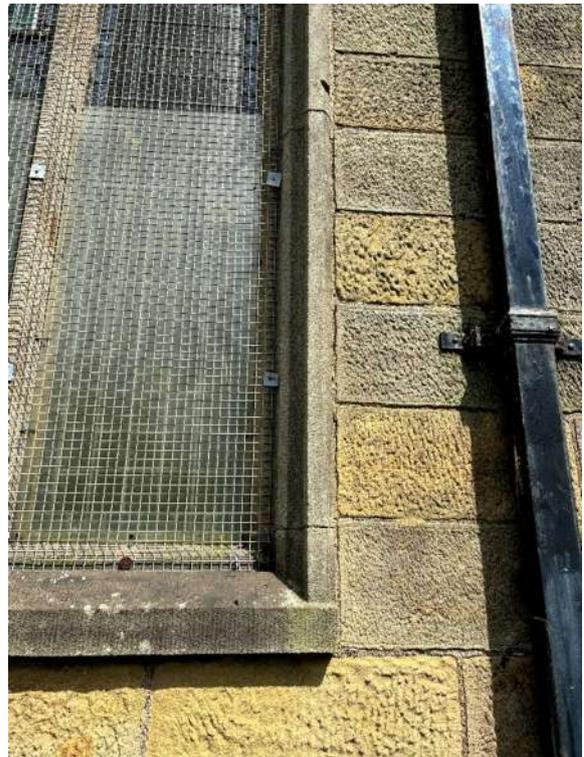
Crack to right side of window.

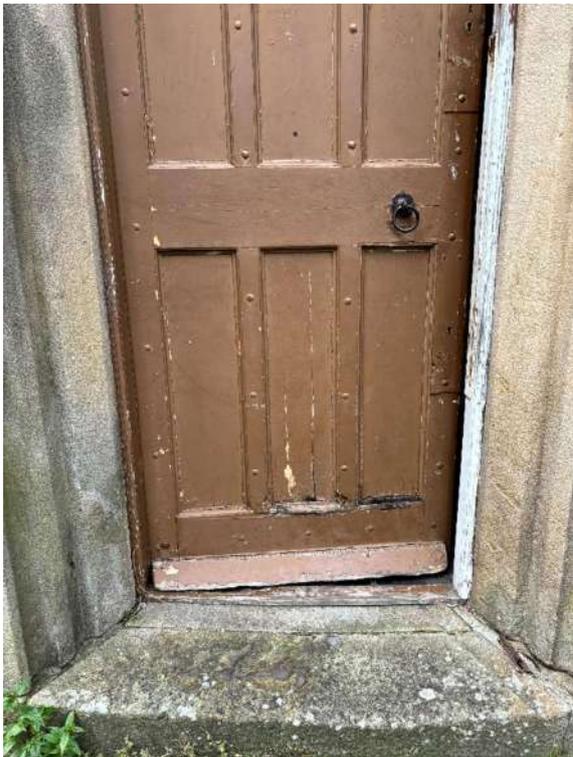
Stone step weathering and cracks to sides of step visible.

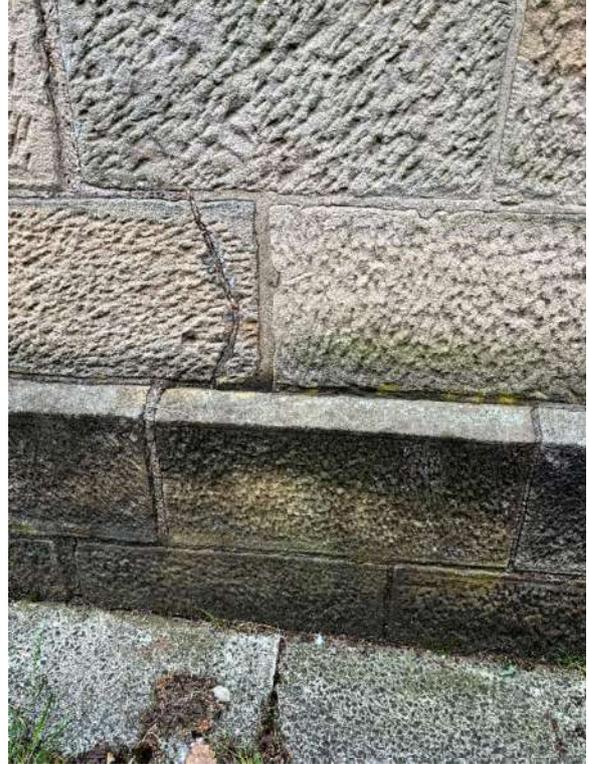
Previously repointed crack to base appears to be reopening.

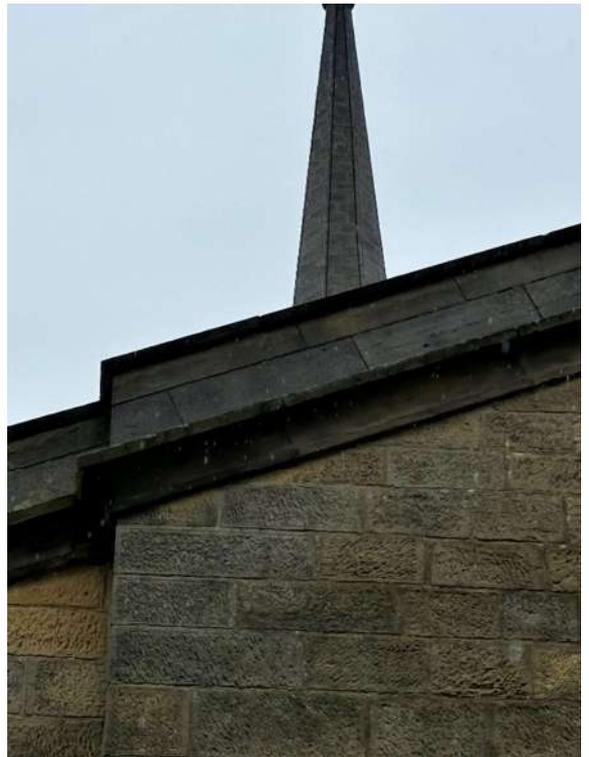
Loss of pointing to water tabling and string course with crack visible to last left stone.

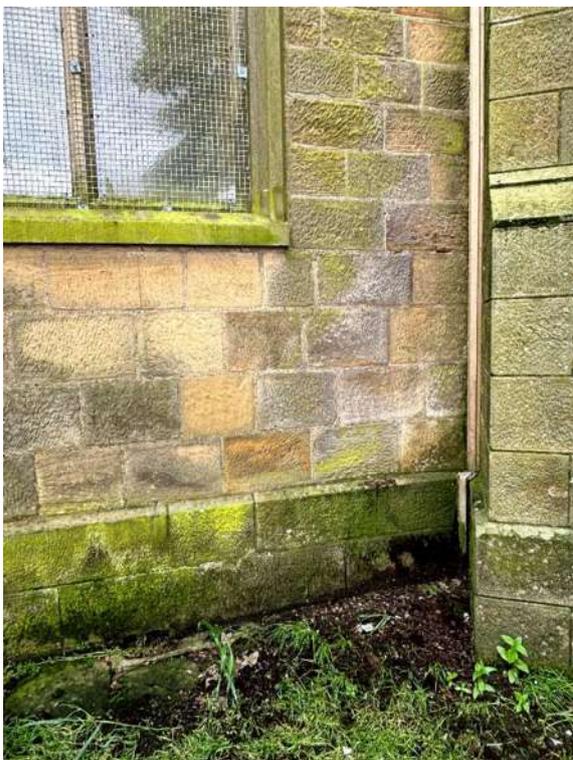
Damp to base of elevation.

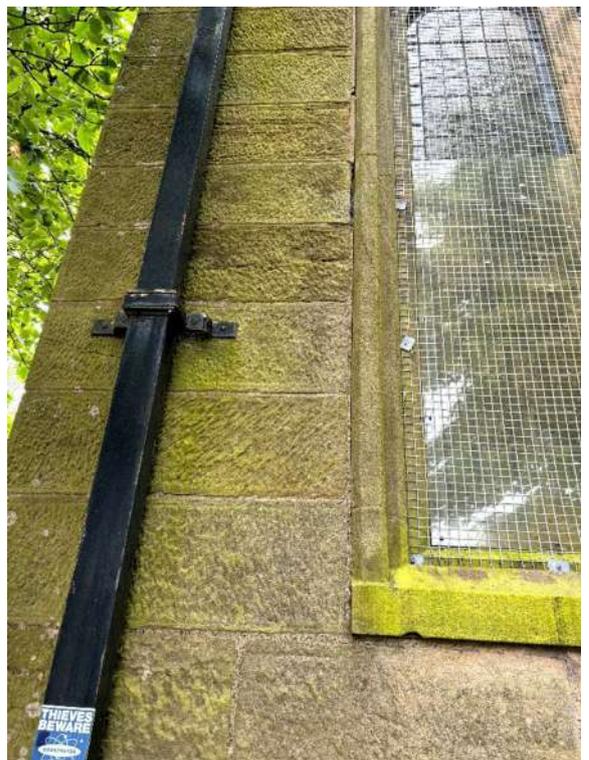
Cracking to left side of window.

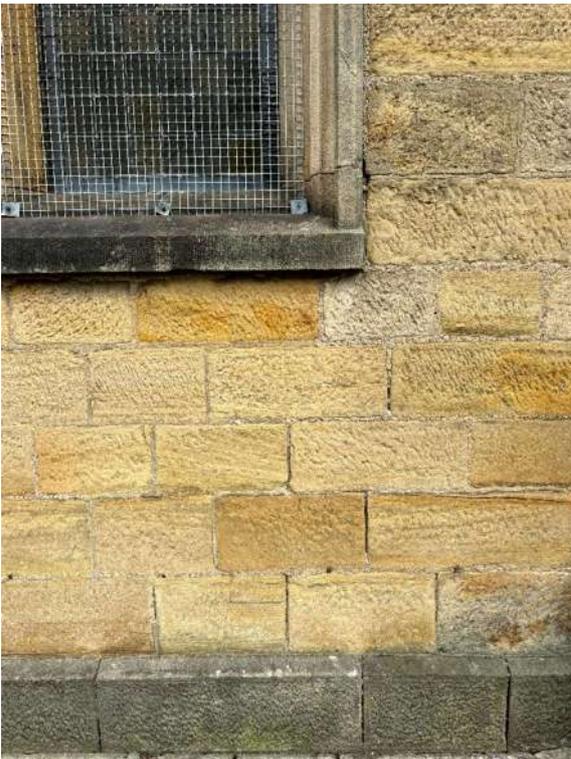
Mortar hard under window – showing areas where pointing is missing.

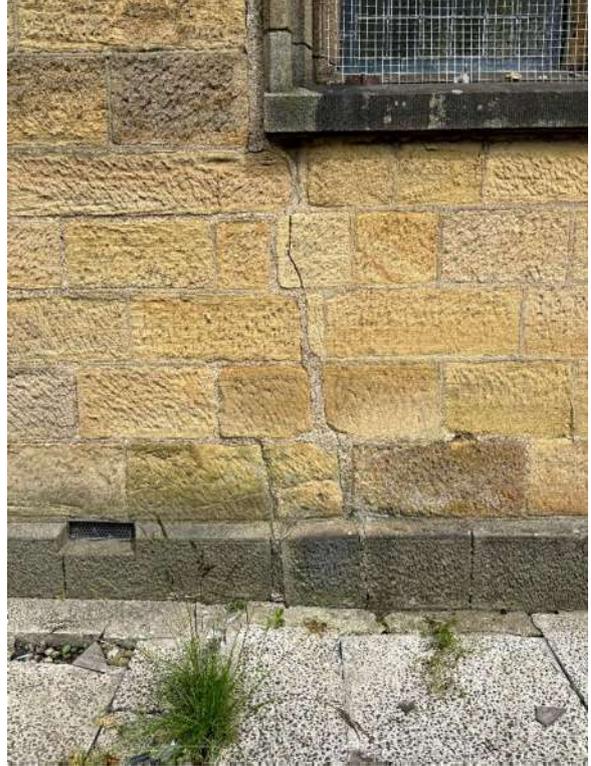
Evidence of historic cracks opening with new hairline cracking appearing.

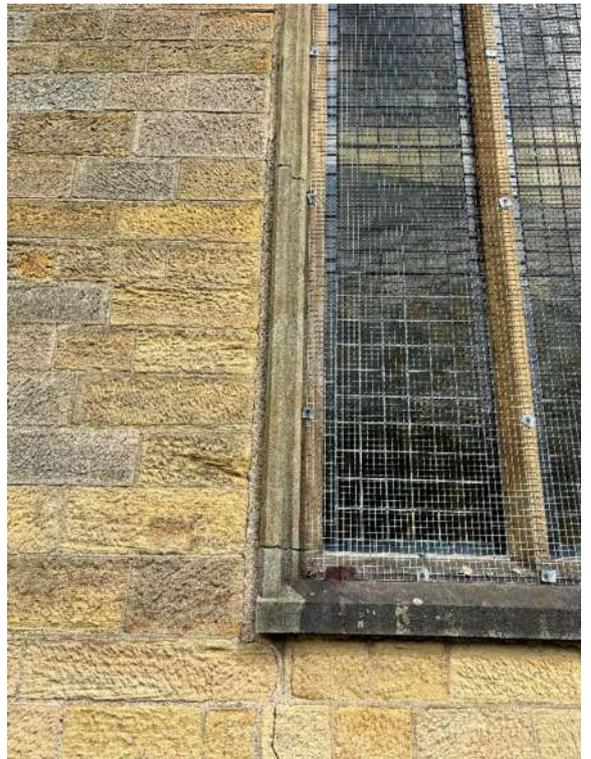
Wider joints to left hand side pointing.

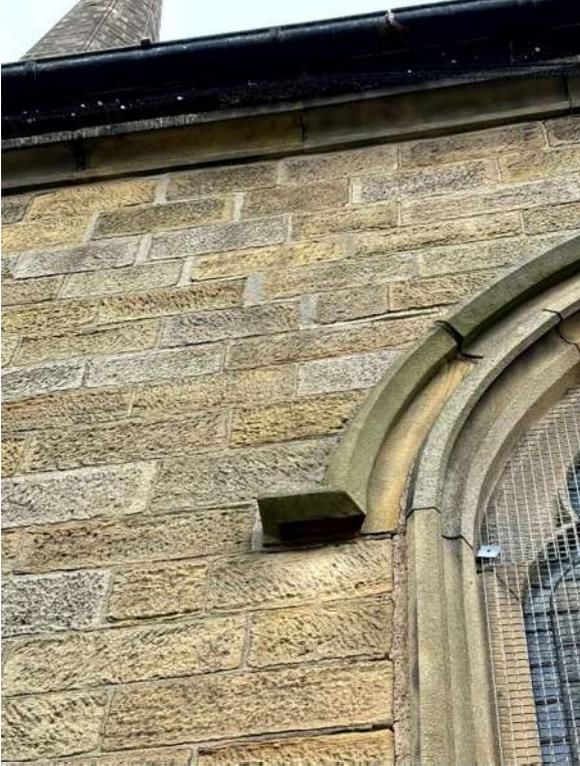
Crack to left side continues under top of window and surround.

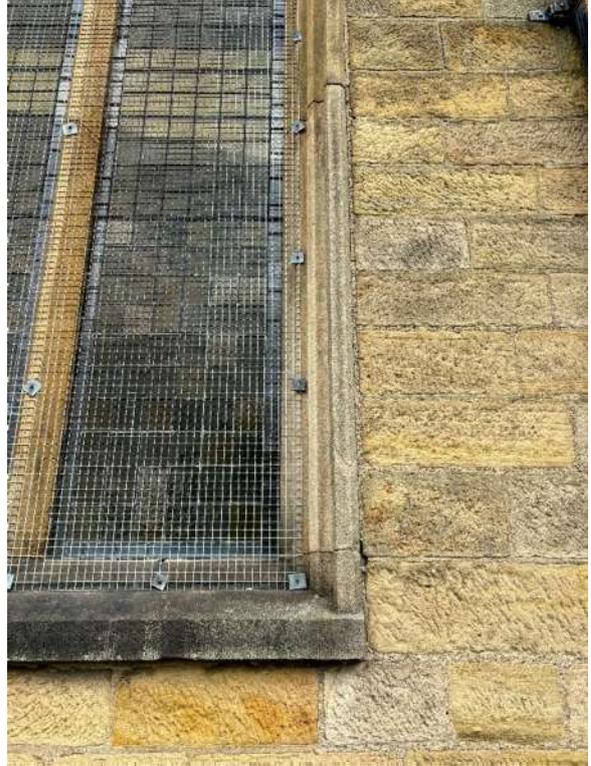
Crack to right hand side of window.

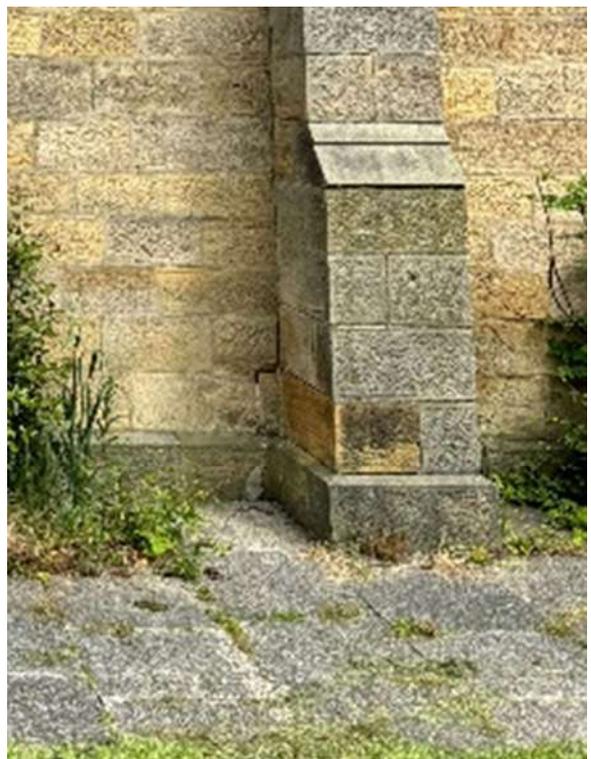
Crack reopening to lower right side.

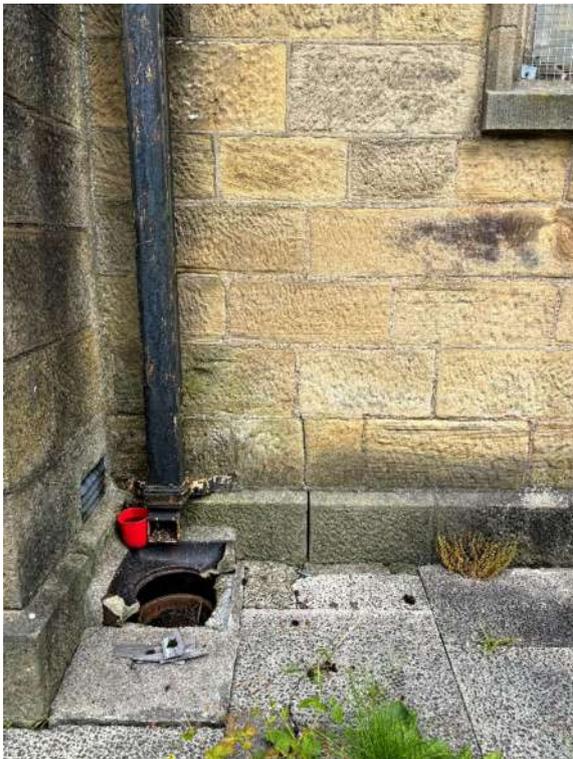
Crack visible to stonework next to cracked area of drain.

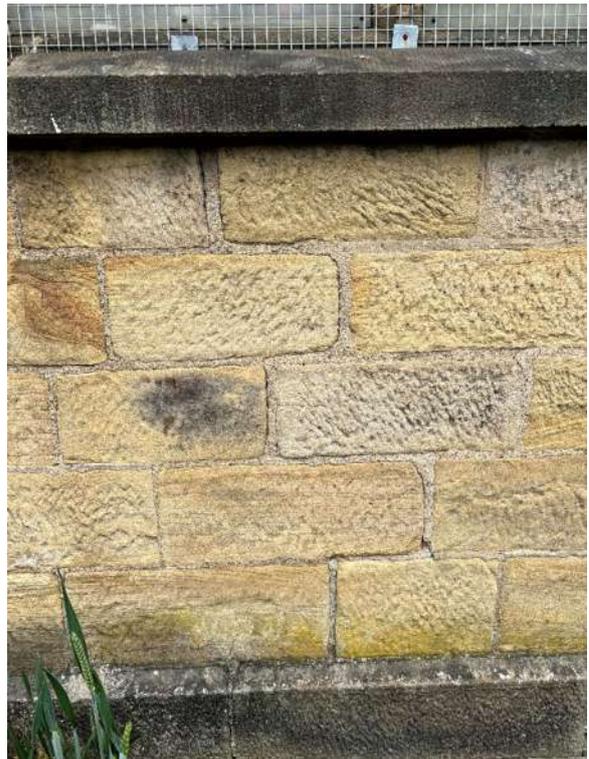
Previously repointed crack starting to reopen.

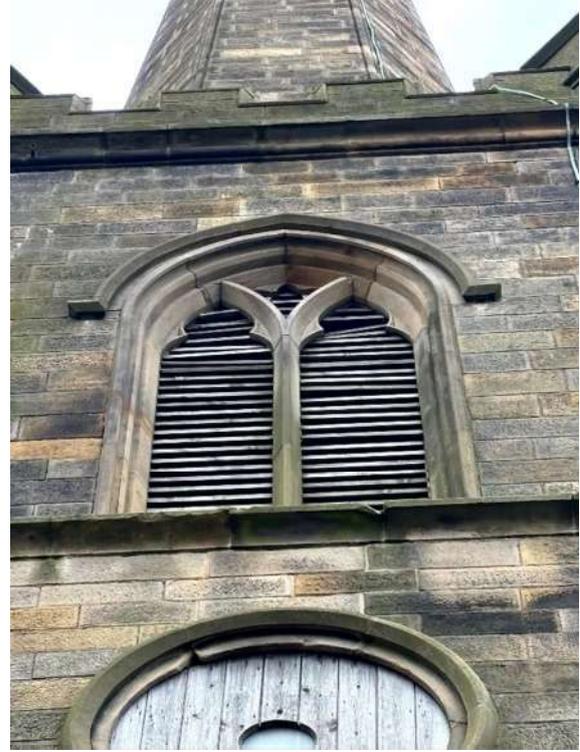
Broken timber louvres, crack to stone ledge and crack to surround of circular opening.

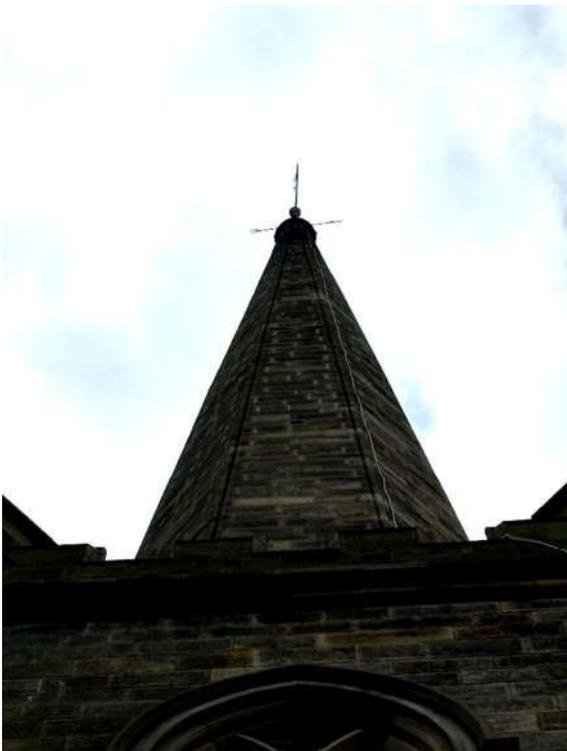
Some cracking to stones of spire.

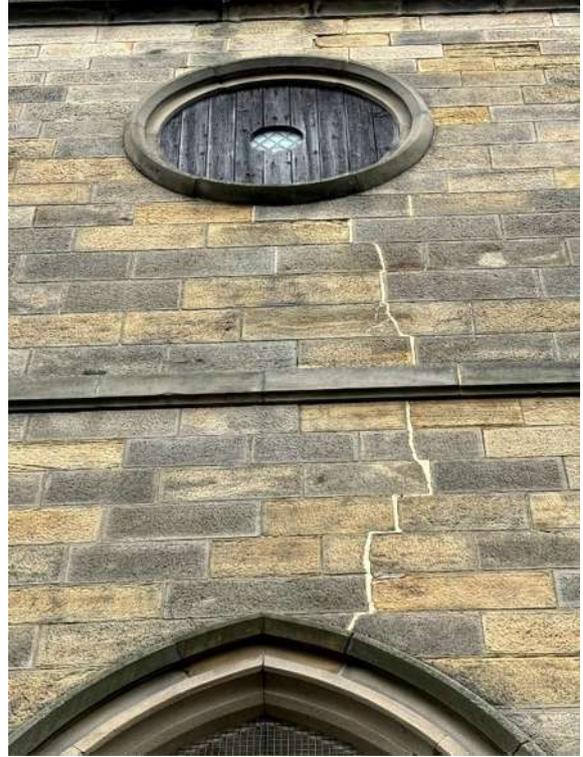
Historic crack starting to reopening above window.

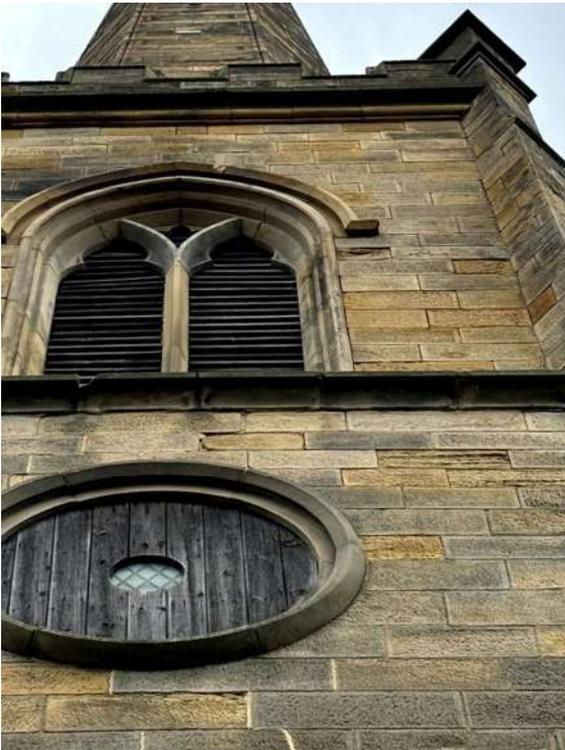
Loss of pointing above circular opening and to right side of window.

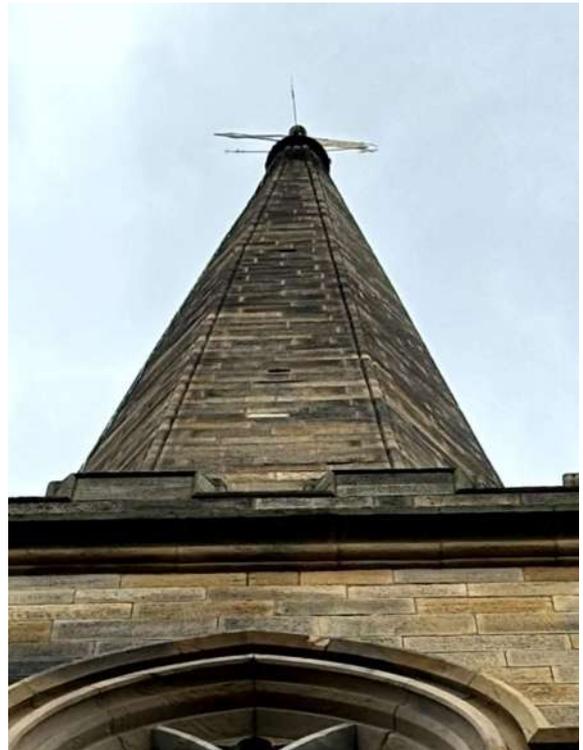
Some cracking visible to spire.

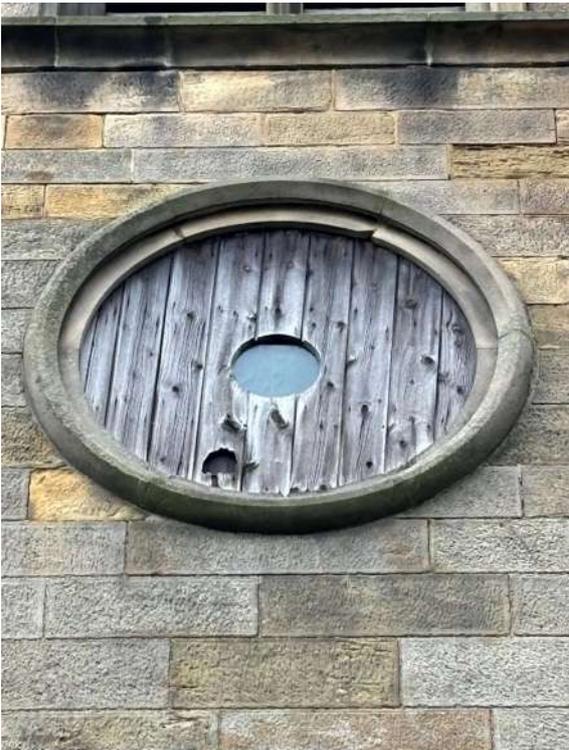
Damage to timber infill of circular opening.

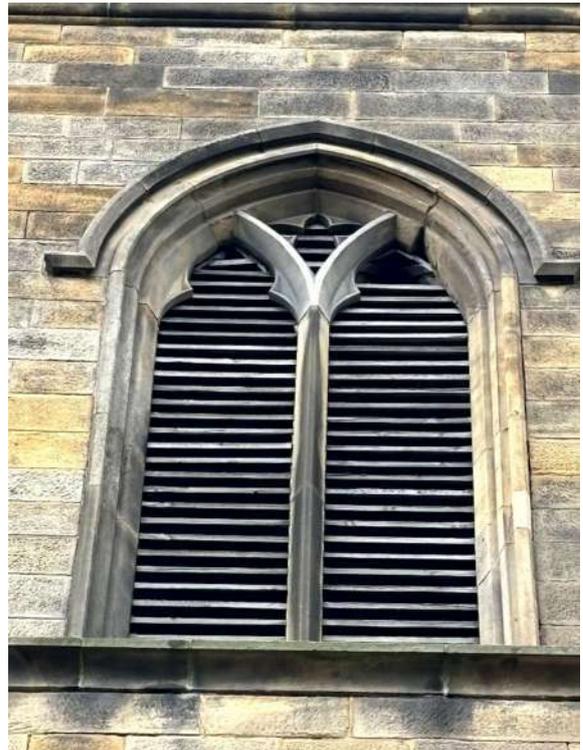
Broken timber louvres.

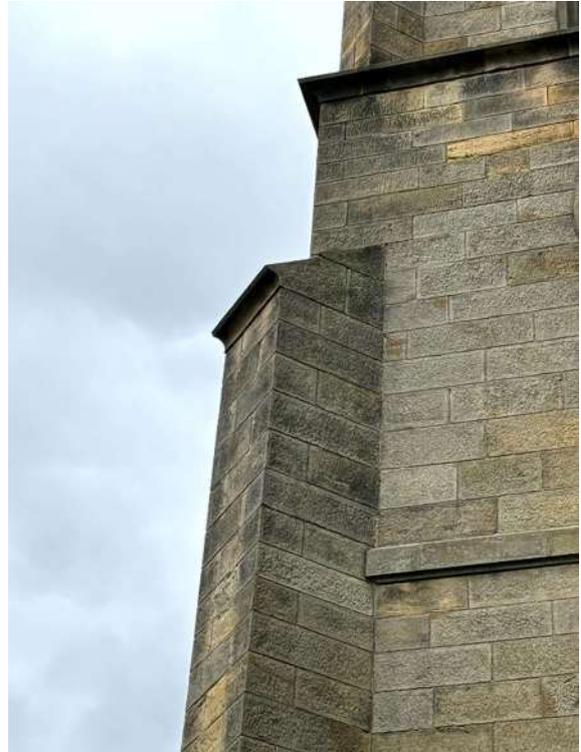
Loss of pointing to buttress.

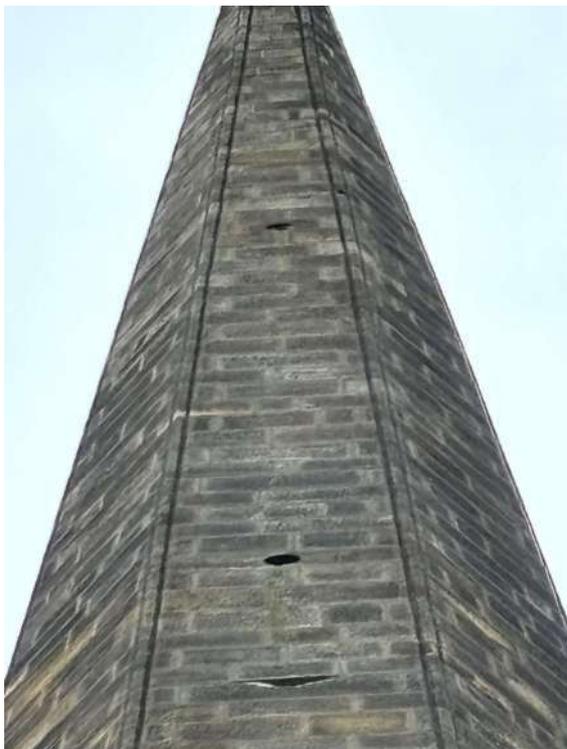
Cracks to spire visible.

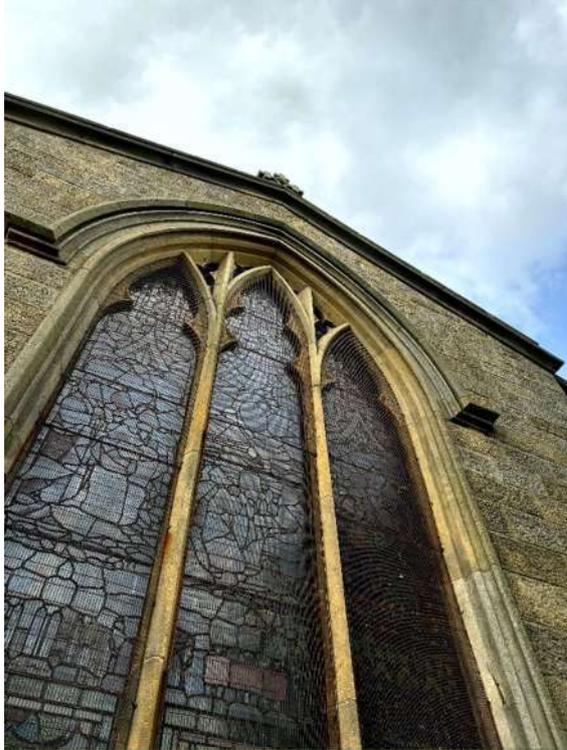
Rust visible to window guarding.

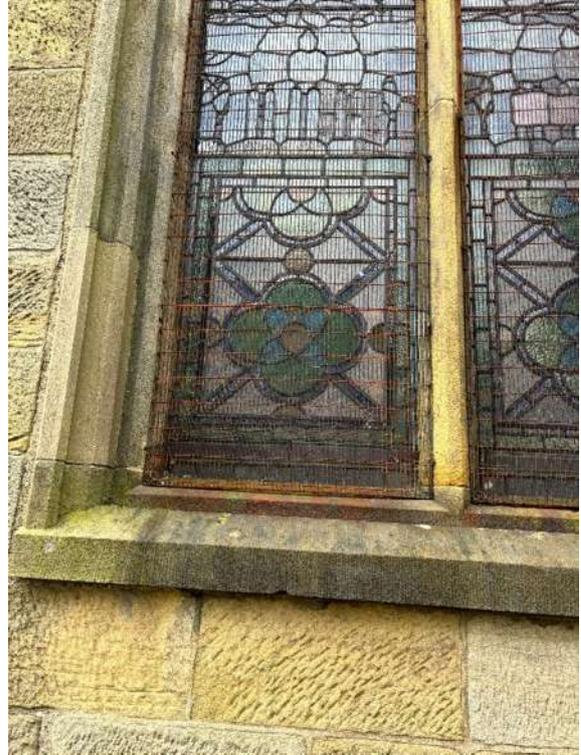
Rust from window guards starting to run off onto stone surround.

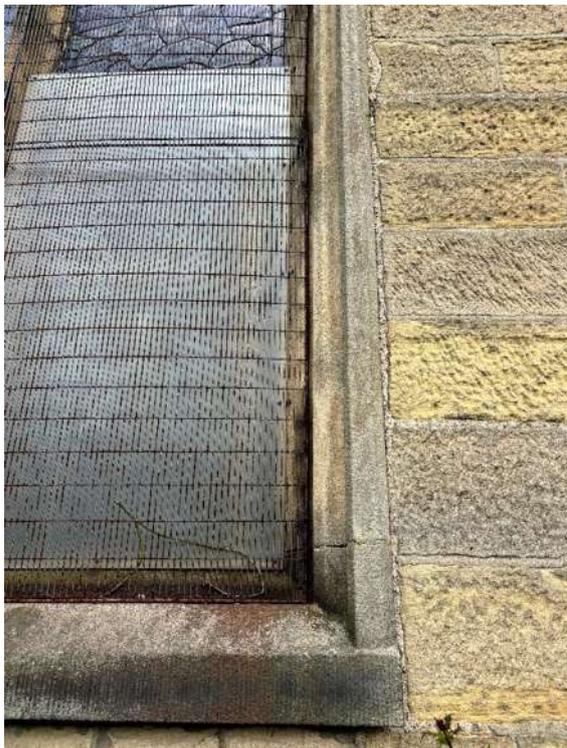
Rust from window guards starting to run off onto stone surround.

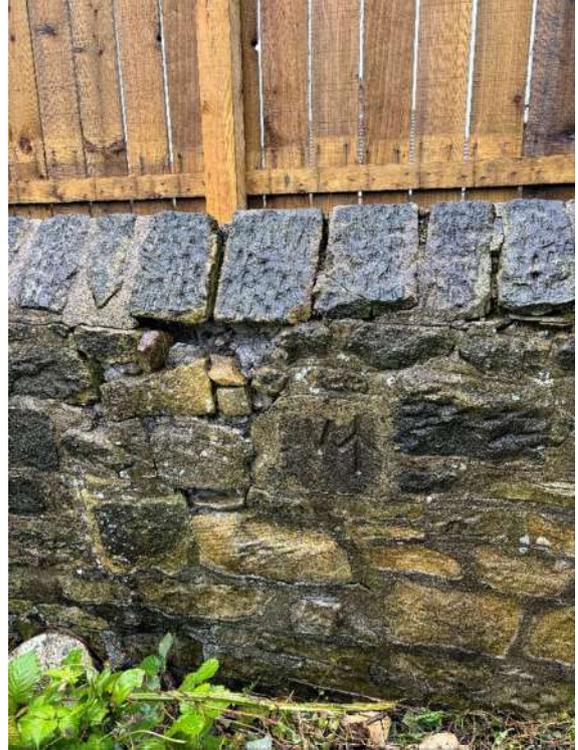
West Wall: Areas of missing stones / cracking.

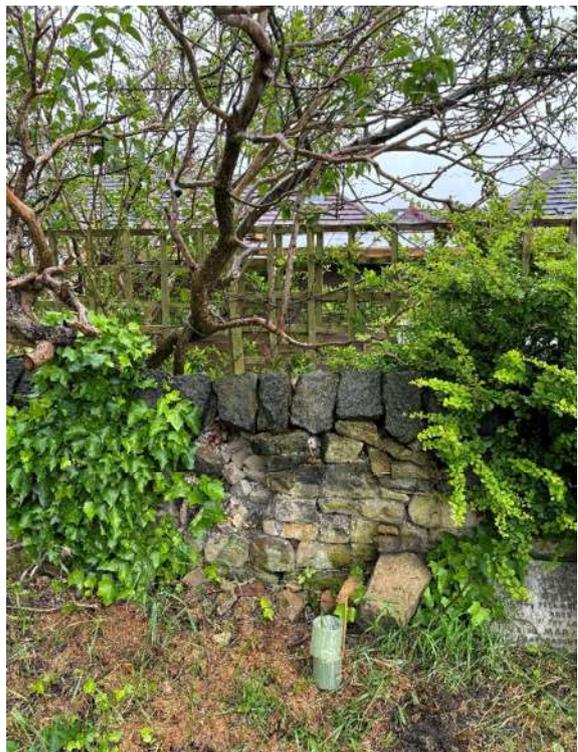
Example of loose/fallen stone to East Wall.

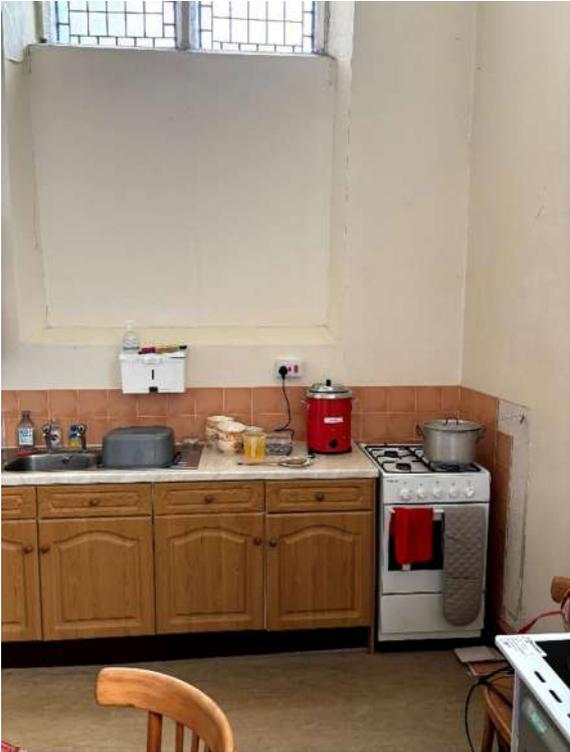
Kitchen overview – missing tiles to wall.

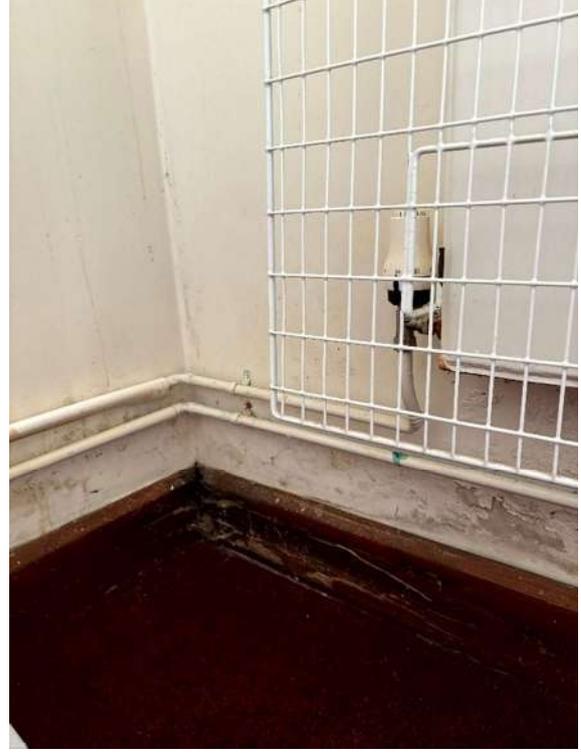
Rotting to skirting board below window W.01.

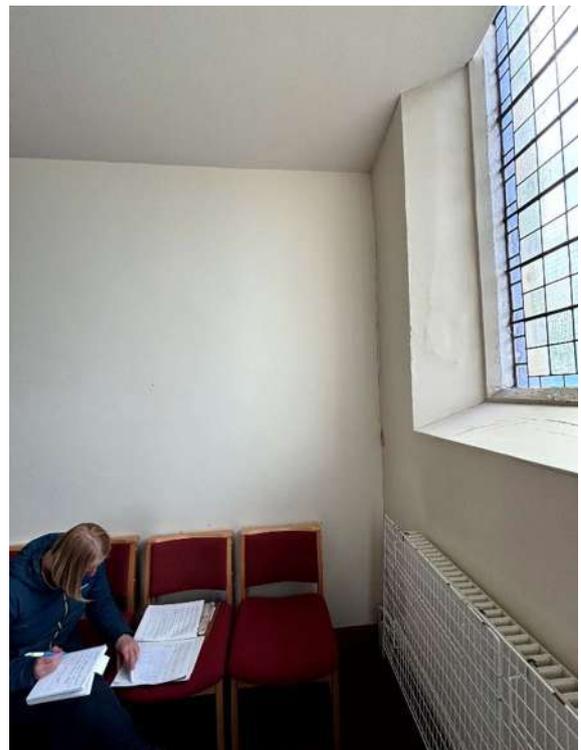
Some cracking to internal surround of window W.02.

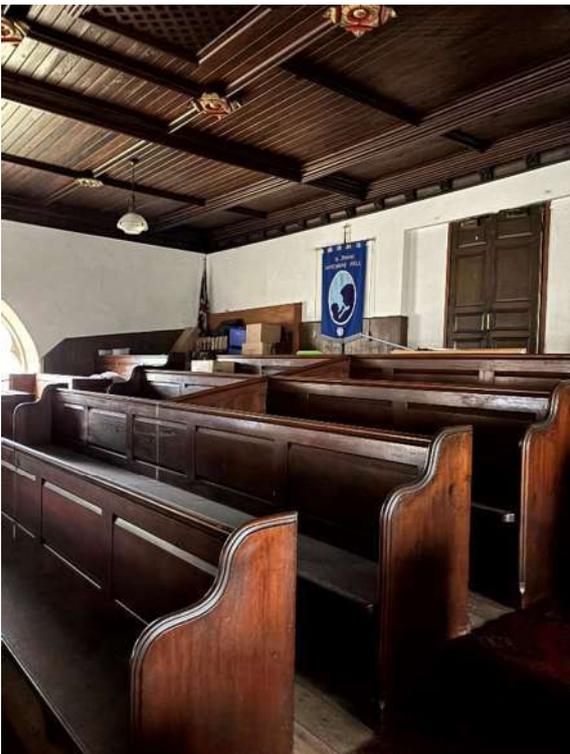
Overview of gallery space, some areas of flaking paint to walls.

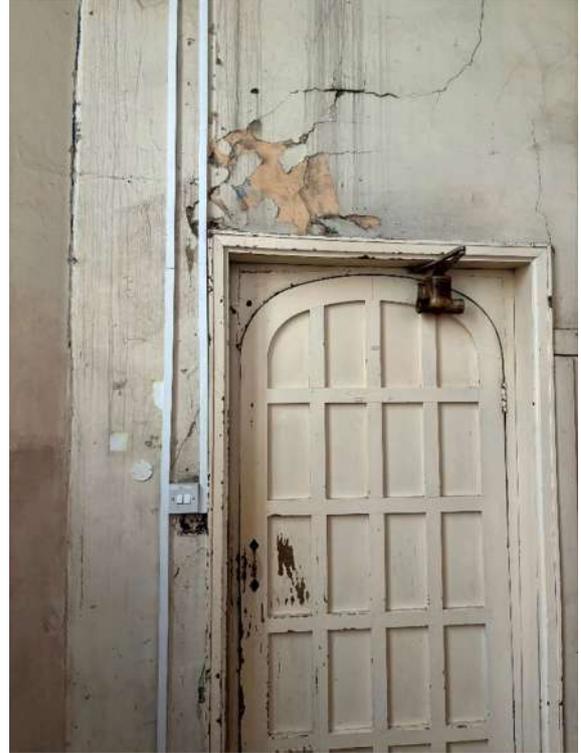
Significant cracking and flaking of paint to surround of internal door.

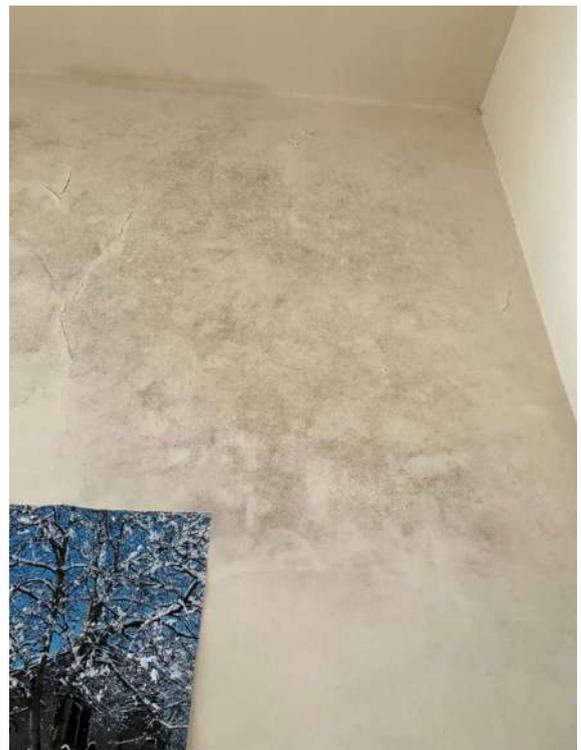
Mould visible to walls and cracking of paint.
