**Quinquennial Inspection**

**Church of St Helen,  
Low Fell**

**For  
St Helen Parish Council  
February 2022**

Church: Church of St Helen, Low Fell.  
Archdeaconry: Durham  
Diocese: Durham.  
Deanery: Gateshead  
Date of inspection: 11 January 2022  
Weather: Dry and sunny

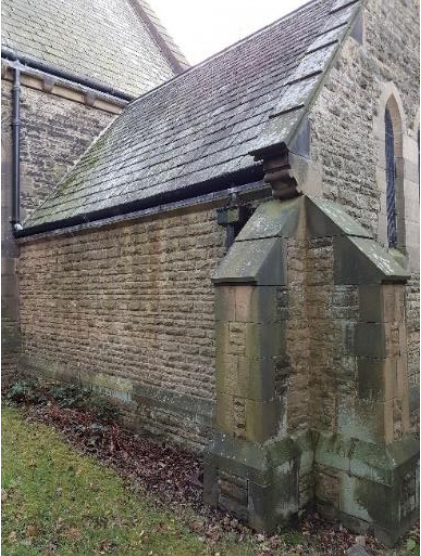
1.2	<p>The church roof is finished in Westmoreland green slates in traditional reducing courses. The roof has been reslated/overhauled in recent years and is generally in good order. The hips are formed with lead rolls, all of which seem in good order. Original ridge tiles have been rebedded. The valleys are all lead lined and sound. The original gutters were lead lined gutters to wall head. Presumably the original gutters did not have adequate capacity and the roof was re-aligned to accommodate cast iron ogee gutters sitting on the original.</p>

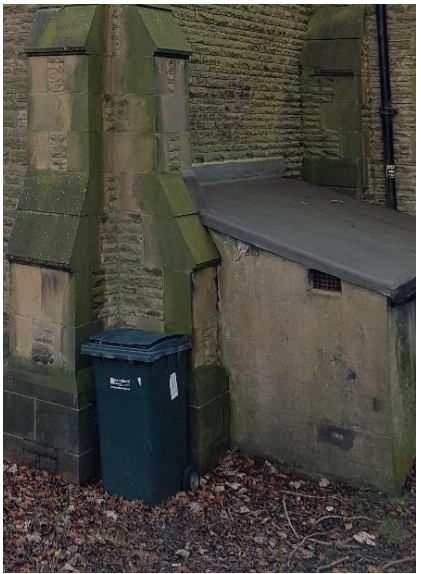
<p>1.3</p>	<p>The organ pump house has a shallow pitched roof finished with asphalt. Appears generally sound.</p>

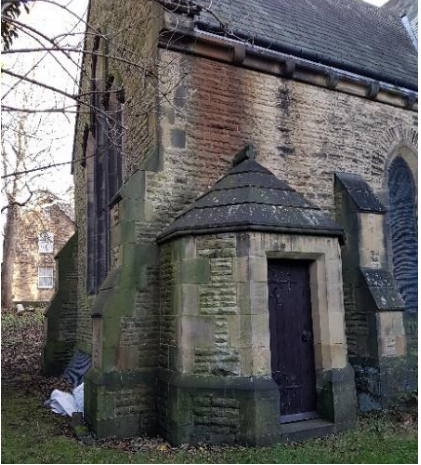
<p>1.4</p>	<p>The canopy over the 'Joicey door' is constructed in corbelled stonework with exposed 'vault' internally. There is daylight showing through internally, though it should be stressed this is minor.</p>	<p>Monitor the stonework and wait till there is sufficient repointing required elsewhere to warrant issuing instructions to a contractor Point up fine joints using a lime putty for the fine joints.</p>	<p>E</p>

1.1, 1.4, 3.1.	Monitor pointing	<i>More info needed</i>

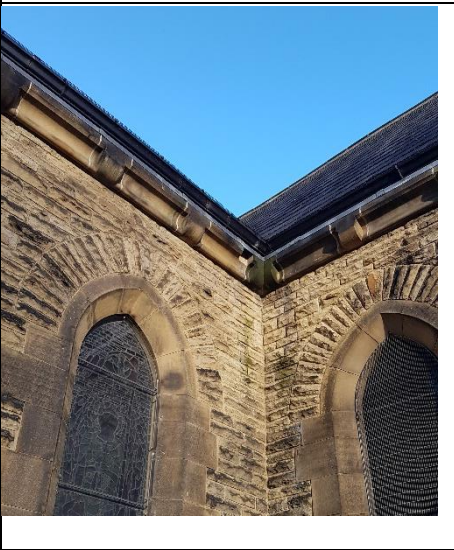
<b>2.0</b>	<b>Rainwater goods and other external pipes.</b>			
2.1	<p>Generally these are all relatively new cast iron ogee gutters with round rainwater pipes connected via hoppers with short lengths of lead sleeves. The gutters sit over the original lead lined stone gutters (presumably replacing the latter as they could not accommodate the flow). All operating satisfactorily apart from at the junction of the south transept and nave. There is evidence of an original (or intended new outlet) when it was lead lined.</p> <p>The new cast iron rainwater goods are protect5ed with 'smart water'</p>	<p>Adapt the junction of the gutters, install a hopper and new rainwater pipe discharging to a new gully connecting to a new soakaway.</p>	C

2.1	Install improved roof drainage to south nave/transept junction including below ground drainage	£3000
3.3	Check on stability of gable kneeler	<i>More info needed</i>

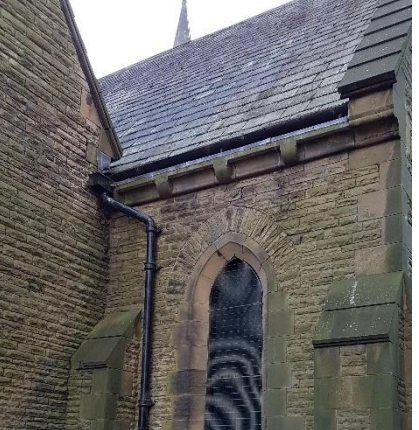
<p>3.3</p>	<p>A potentially dislodged coping stone kneeler to the sacristy roof was pointed out by the parish.</p>	<p>Check on stability of the kneeler and stabilise if necessary.</p>	<p>C</p>

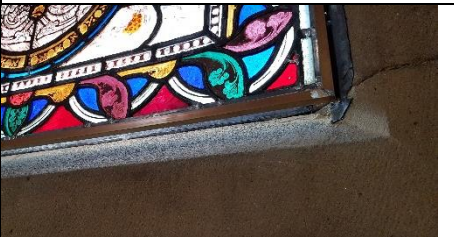
4.1	<p>Windows are all protected externally with either mesh grilles or in more recent repairs with polycarbonate.</p>			
4.2	<p>The windows to the chancel were undergoing restoration at the time of the QI. One had been restored and re-instated set in a brass frame, complete with polycarbonate to original glass line and providing a ventilation gap. The other stained glass had been removed and was being restored in a workshop. Between the on site inspection and writing up the QI, the stained glass had been re-installed and was now complete.</p>	<p>Complete the conservation work to the stained glass panels</p>	B

4.2	Complete the chancel stained glass conservation	<i>More info needed</i>
10.2	Electrician to check on rusting spire conduits as part of periodic inspection	£0
<b>C</b>	<b>Requires attention within 18-24 months</b>

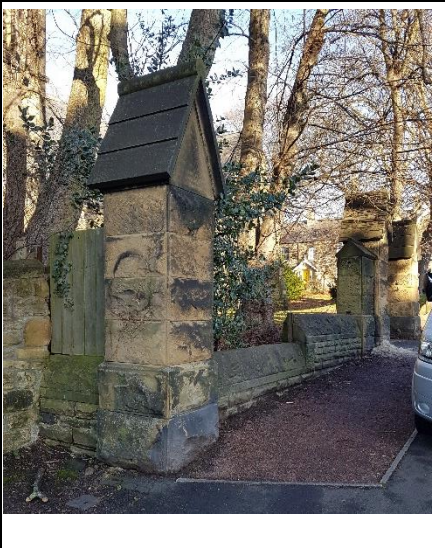
<p>6.2</p>	<p>South boundary: The wall is complete along with two gate posts and corner posts. The former are leaning slightly but not to cause a concern at this stage. One coping is broken at a 'step' in the wall.</p>

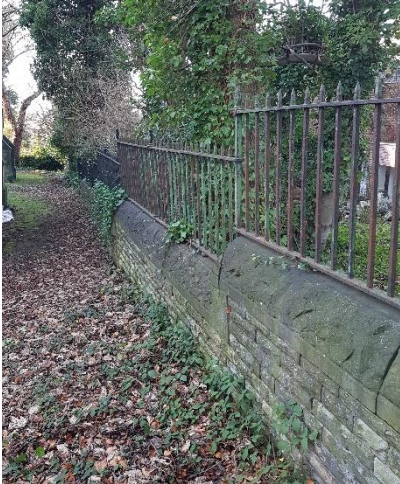
<p>6.4</p>	<p>North boundary:                  This has the best surviving original boundary treatment. The wall and railings are intact. However, historic action of the tree growth (in neighbour's property) has distorted the walling which in turn has distressed the railings. The copings have cracked at 'steps' in the walling. Surviving gate to the Joicey home to the north. Whilst the distortion of walling and railings is unfortunate, it is still stable, however, there will be continuing pressure from the trees.</p>	<p>Discuss responsibility and/or liability of damage caused by the neighbour's tree.</p>	<p>A</p>

<b>SUMMARY OF COSTS</b>		
<b>A</b>	<b>Urgent, requiring immediate attention.</b>	
6.4	Commission arborologist for condition of boundary trees	£1200
8.3	Investigate foul drainage	£1500

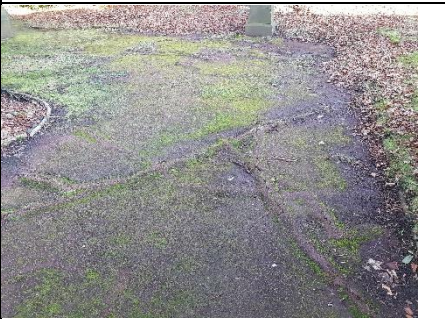
<p>6.7</p>	<p>Tarmac foot paths to south side of church. Heavy moss has established, presumably thriving from the shade of the trees. The tree root pattern is clearly visible distorting the tarmac. This will need attention soon , as it will be a trip hazard if/when the tarmac breaks down. There is a gully at the east end of the path.</p>	<p>The tarmac should be replaced with correct falls to the existing gully.</p>	<p>C</p>

5.1	Consider access at the main entrance for DDA compliance	£8000
6.7	Repairs to tarmac footpaths	£7000
10.1	Repair mural stair window	£750
12.5	Organ repairs	£1993
<b>D</b>	<b>Requires attention within the quinquennial period</b>

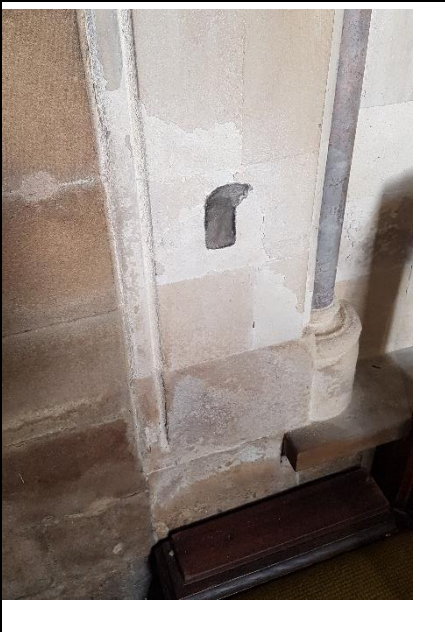
<p>8.2</p>	<p>The Chancel has a carved limestone plinth with marble spindles/columns. Evidence of very minor low level erosion presumably from damp penetration.</p>	<p>Monitor as a part of general maintenance, and review at next QI</p>	<p>M</p>

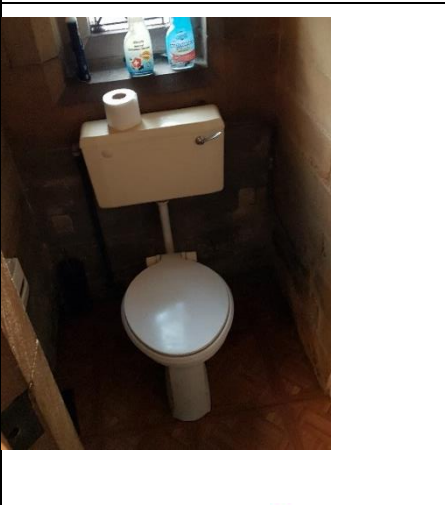
<p>8.3</p>	<p>WC/Utility room. Evidence of damp in the walls.</p>	<p>It is understood the foul drain from the wc discharges to the basement via a lead pipe and its final discharge is unknown. This should be investigated to ensure the drainage is effective. Consideration given to providing a DDA compliant WC for congregation use.</p>	<p>A</p>

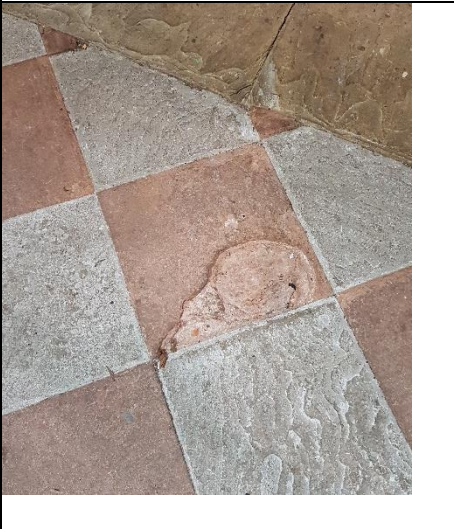
<p><b>9.0</b></p>	<p><b>Floors</b> A chequerboard pattern of red and white sandstone flags to entrance lobby, rear and front of nave along with the main processional route. Sandstone flags to east and west aisles.</p>			
<p>9.1</p>	<p>Main entrance. The flags are slightly worn but still perfectly serviceable.</p>			
<p>9.2</p>	<p>Signs of flags delaminating. These have created 3 no. deep pockets which may become a trip hazard. However, they may have been in this state for some time.</p>	<p>Monitor as a part of general maintenance, and review at next QI</p>	<p>M</p>

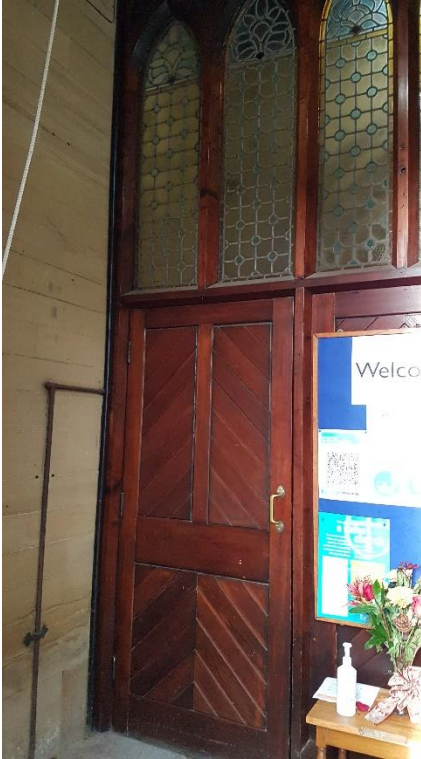
10.4	Upper Spire Chamber, accessed via an old timber ladder. This is not fixed and is a health and safety risk. Consequently the chamber was not inspected. This was also noted in the previous QI.	Replace the ladder with a metal ladder securely fixed to the wall, and inspect chamber at earliest opportunity.	A	
<b>11.0</b>	<b>Internal Doors</b>			
11.1	The lobby is divided with a glazed screen with stained/leaded Lobby screen and solid timber construction. 2 no doors. Parish advise that general access is very awkward particularly for funerals.	The Parish has ambitions the screen could be adapted for improved access	D

10.4	Install a safe ladder access to the upper spire chamber	£2000
12.6	Check on insurance for fixtures and fittings	<i>More info needed</i>
<b>B</b>	<b>Requires attention within 12 months</b>
