INSPECTION AND REPAIR OF CHURCHES

QUINQUENNIAL REPORT on

CHRIST CHURCH

HAMSTERLEY

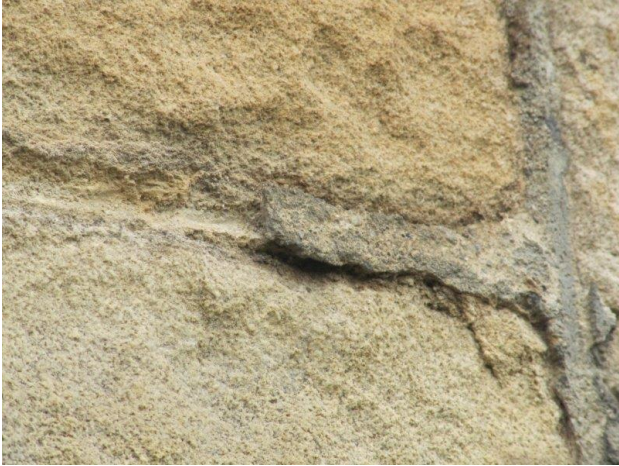
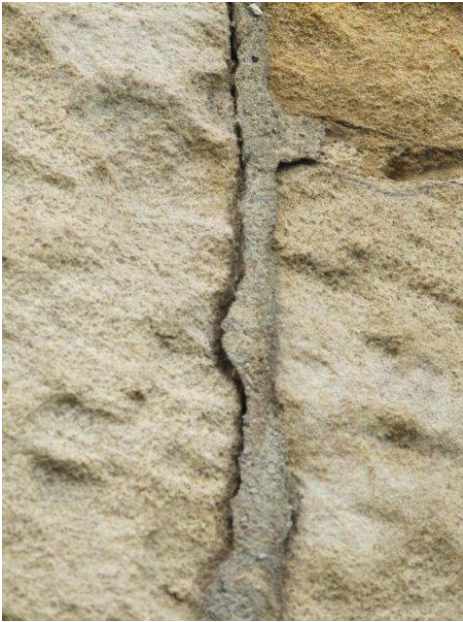
Typical issues with failing mortar experienced around the church

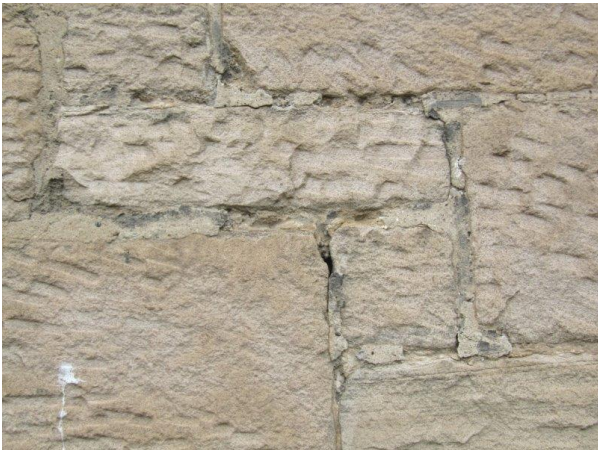
Typical issues with failing mortar

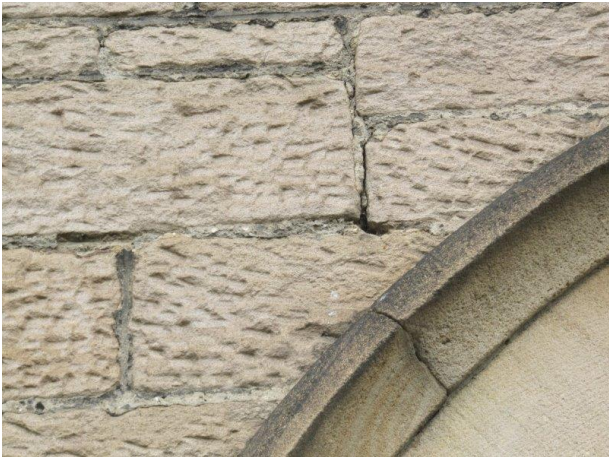
Open joints on the South Elevation

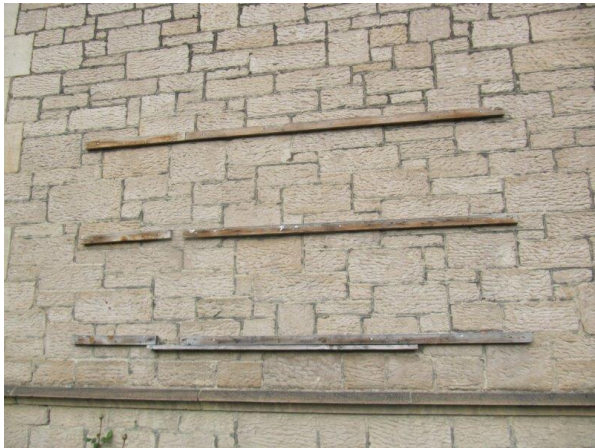
Battens fixed to the South Elevation which should be removed if they no longer serve a purpose

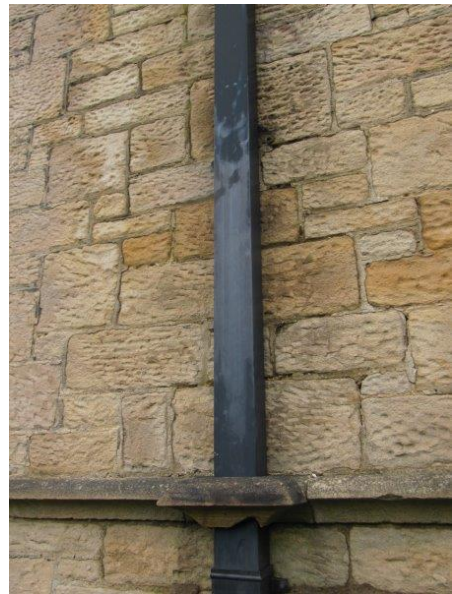
Open/hungry joints behind a downpipe on the South elevation

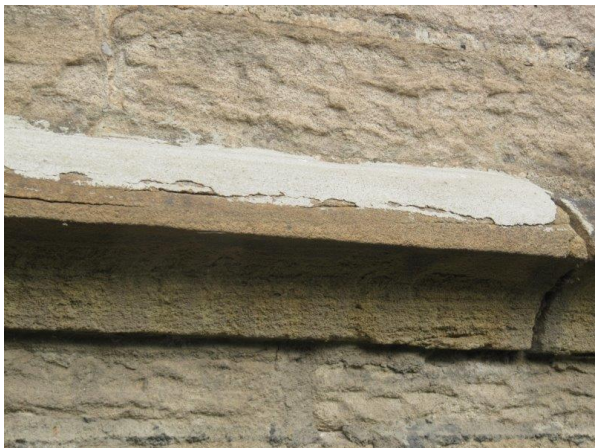
Previous mortar repair to string course on South Elevation

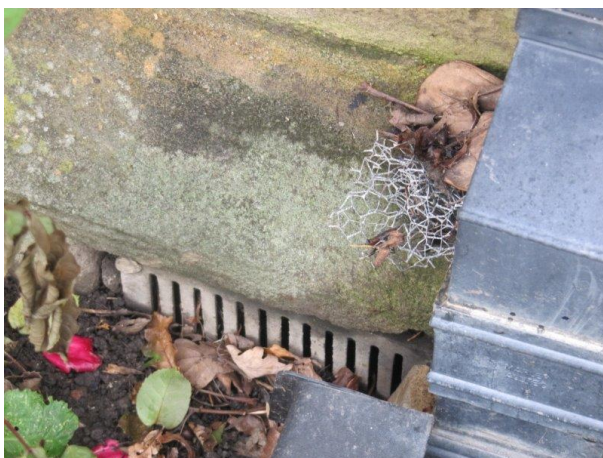
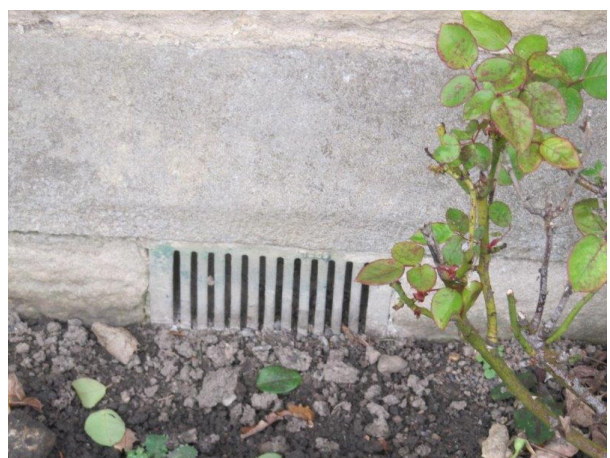
Vents on the South wall are becoming partial covered by soil from the planting bed. Each should be checked to ensure the soil is below the level of the vents and there is no material within the vent ducts. Plants should be kept clear of the vents.

Soil levels close to or covering vents on the South elevation

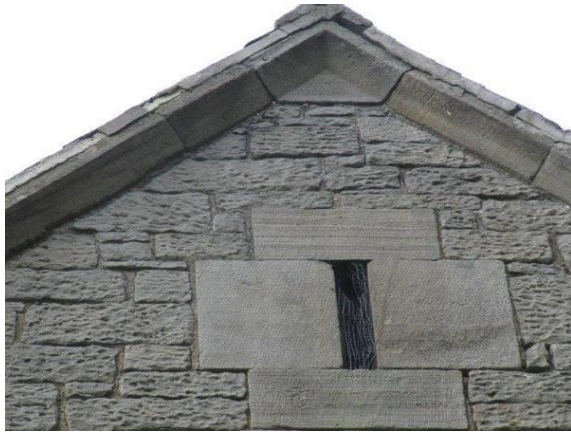
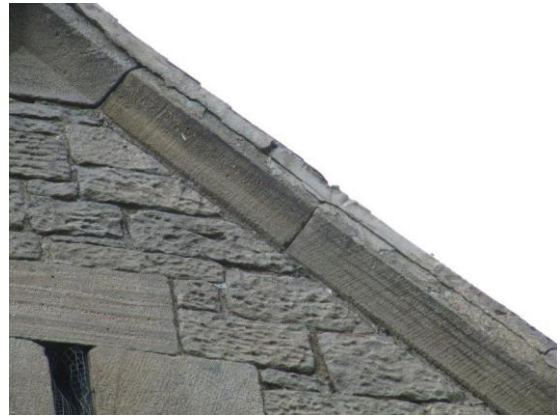
Hungry joints to the Gable of the east Elevation and failing mortar to verge

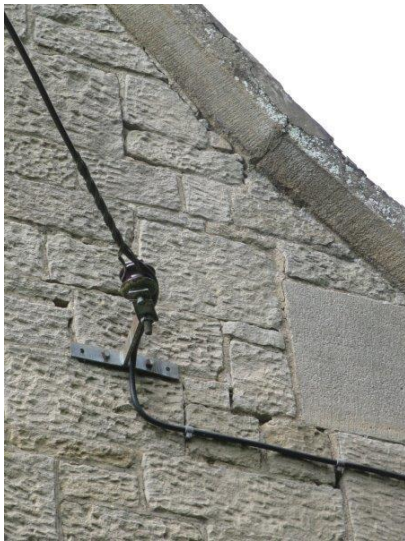
Hungry joints to the Gable

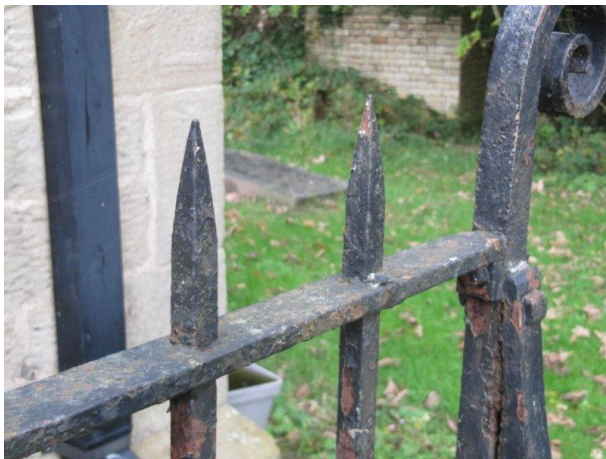
Sharp spikes to railings around the boiler house steps

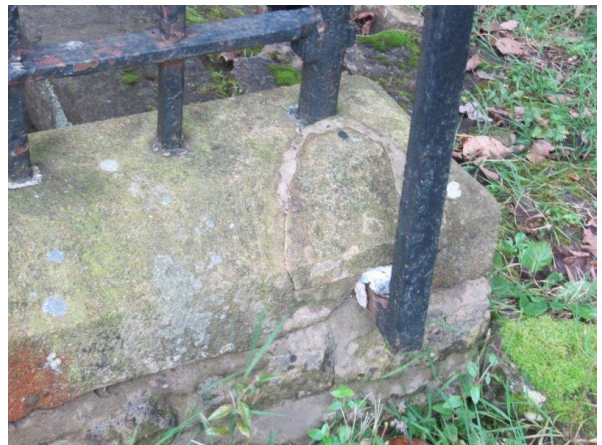
Previous mortar repair in the same area

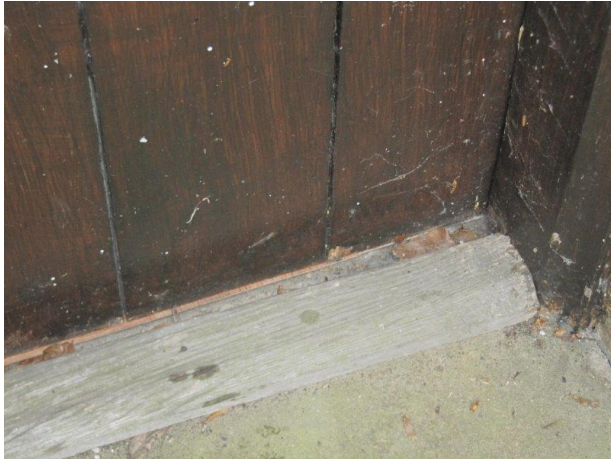
The step to the vestry door is slippery and should be cleaned to prevent slips and the loose 'threshold' fixed for kept more firmly in place

Loose threshold/weather board to vestry door

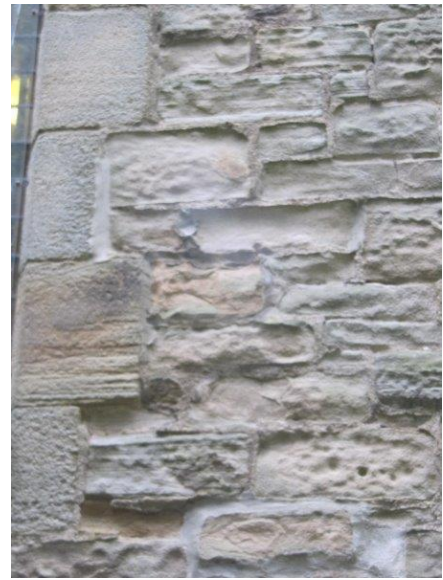
Weathered stonework to North Elevation of Vestry

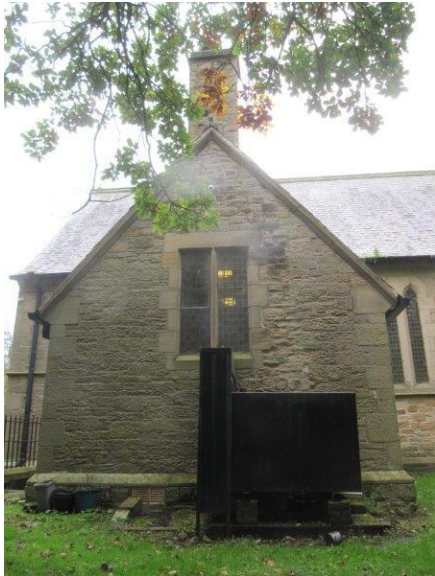
Oil tank location in close proximity to the Vestry

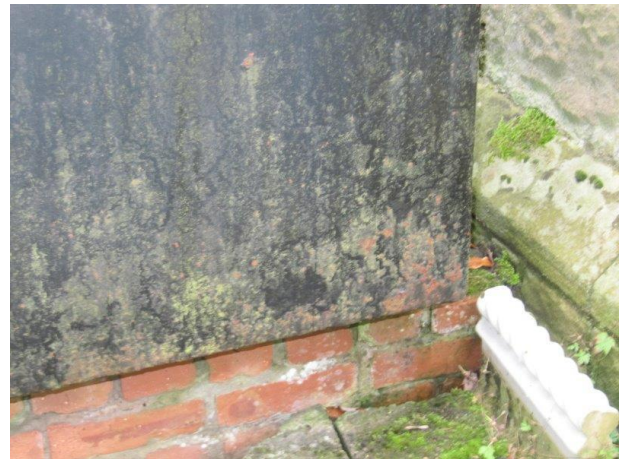
One area of concern is the oil tank. It is a single skin metal tank and rust is visible towards the base of the tank. This should really be a bunded fireproof tank in this location and urgent advice should be sought as to the exact condition of the tank and likely life expectancy. It would be prudent to plan for its replacement in the near future to avoid any issues should it fail. When the tank is replaced masonry repairs to the area behind and above the tank should be programmed in as access is restricted when the tank is in situ.

Rusting base to the oil tank

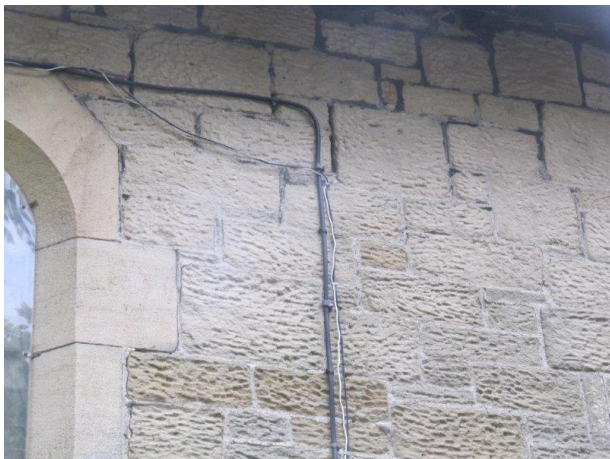
Cracking to the side to the Eastern window on the North Elevation

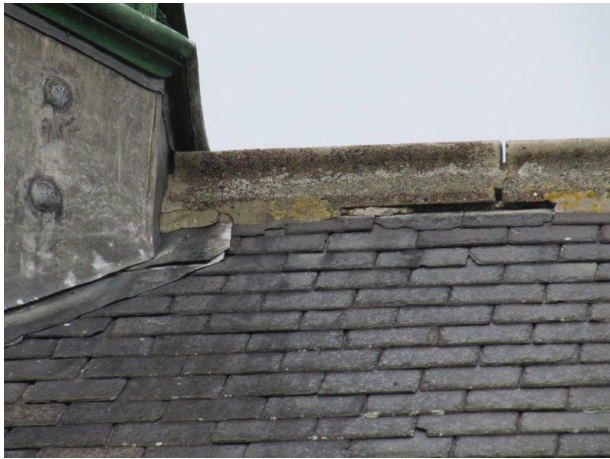
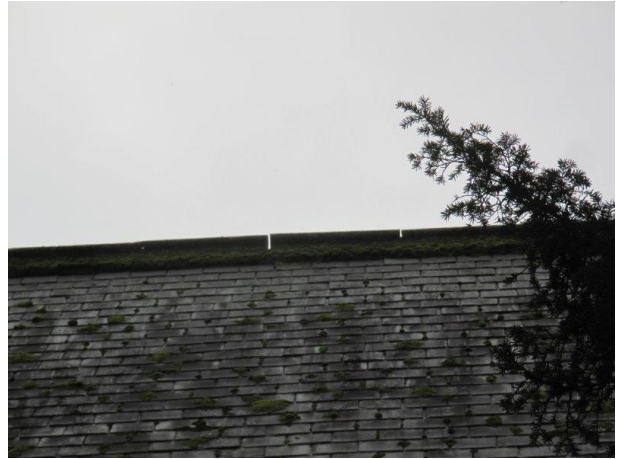
Open joints and failed bedding to main ridge

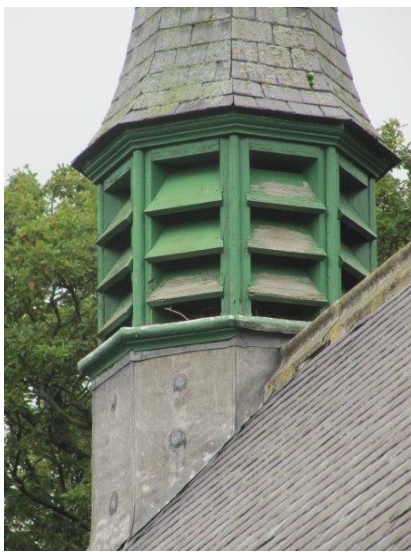
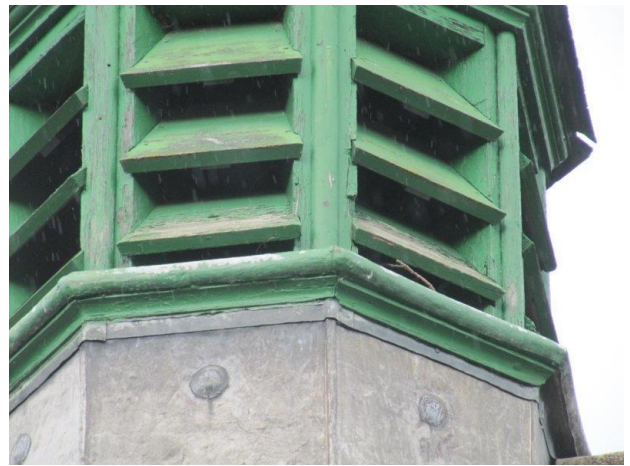
Bare wood visible to louvres on the fleche

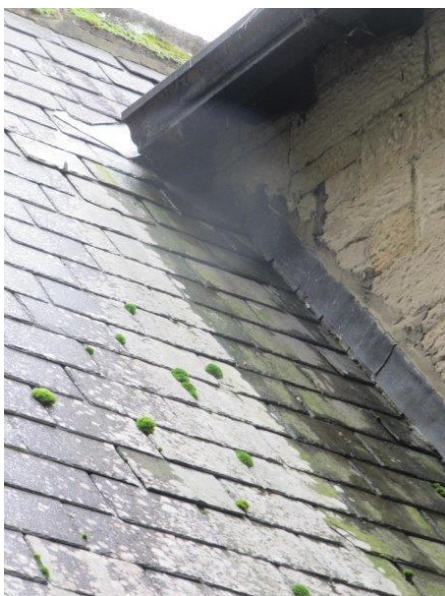
Dampness on the vestry roof from the gutter/roof over

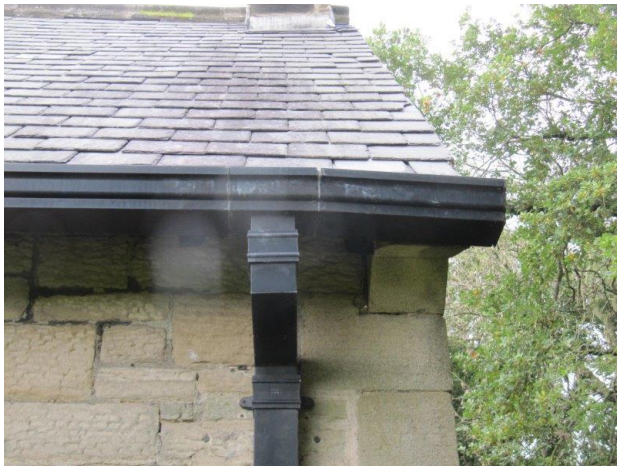
North end of the vestry gutter is poorly supported

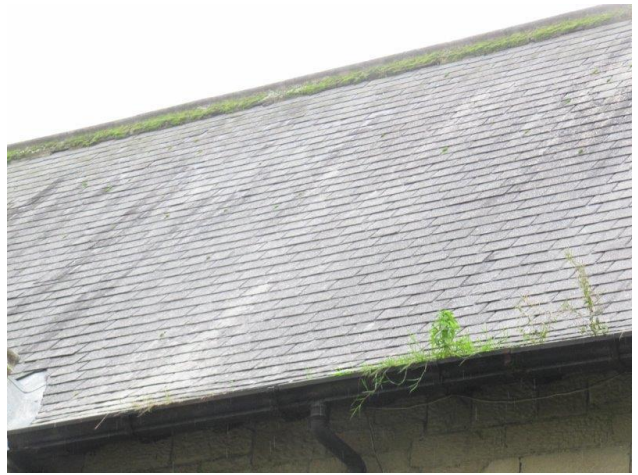
Vegetation to northern gutters

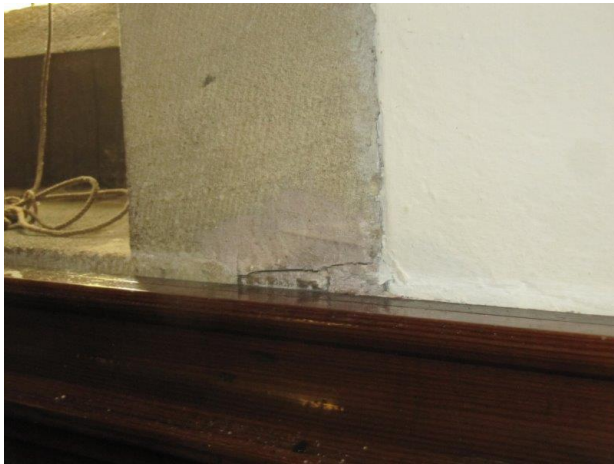
Cracked stone to window on south wall

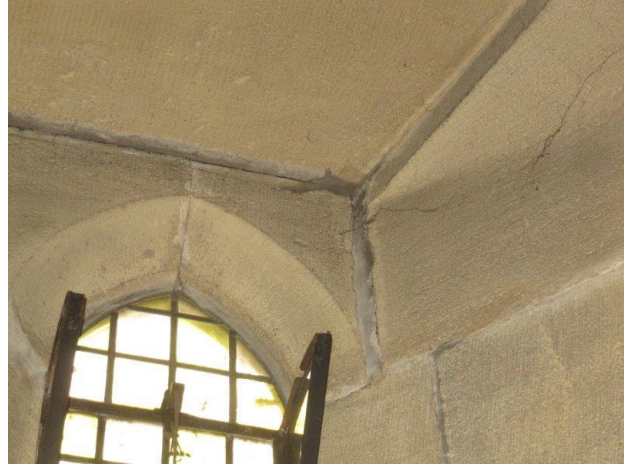
Cracking reopening to reveal of Nave windows

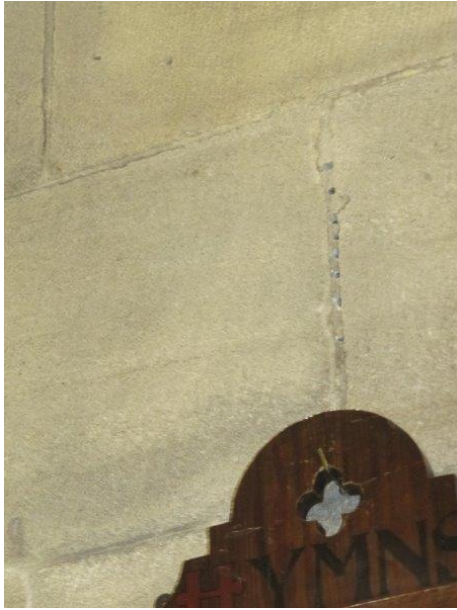
Holes left in joints from previous fixings to hymn board

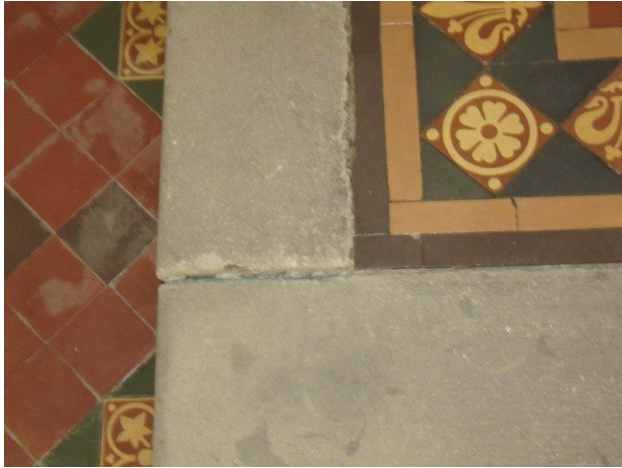
Hungry joints to altar dais

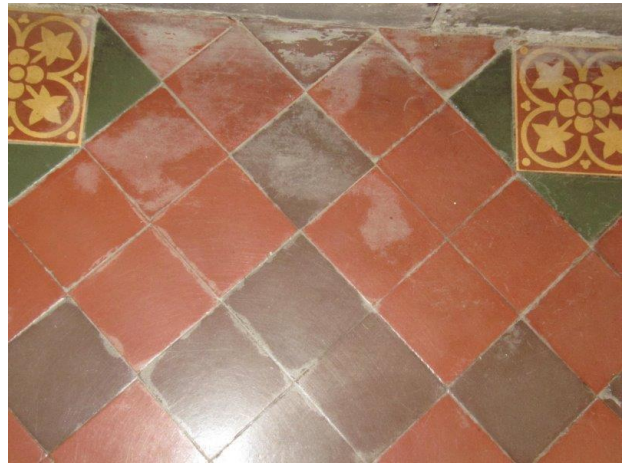
The tiles near the altar are showing signs of salt or other staining. These should be sensitively cleaned and the area monitored for signs of the issue reoccurring.

Salts/discolouration to tiles near the altar dais

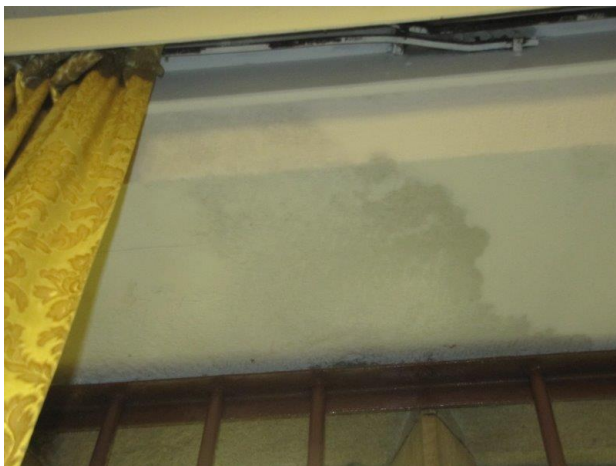
Damp staining over Vestry window

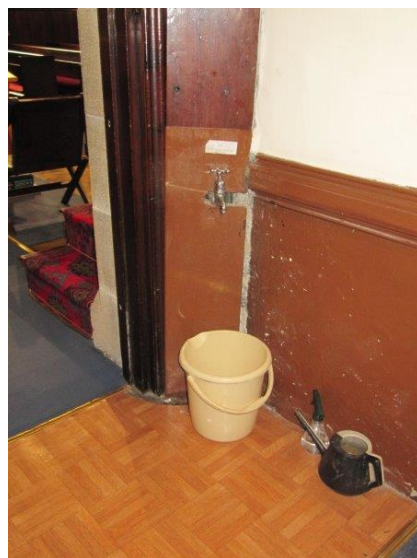
Tap in the vestry with bucket below

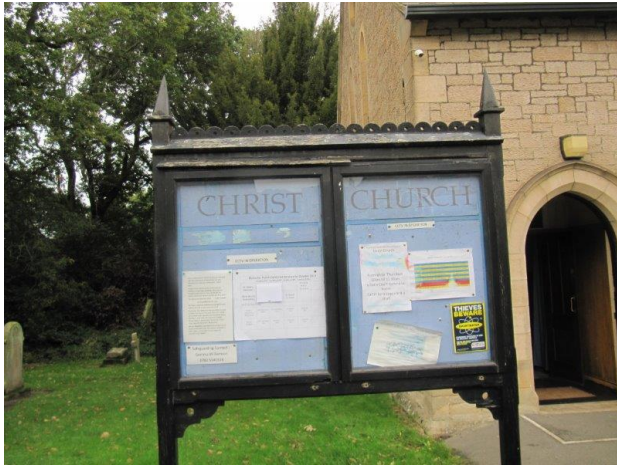
Externally the main noticeboard is in need of repair or replacement.

Loss of detailing and decorative finish to noticeboard

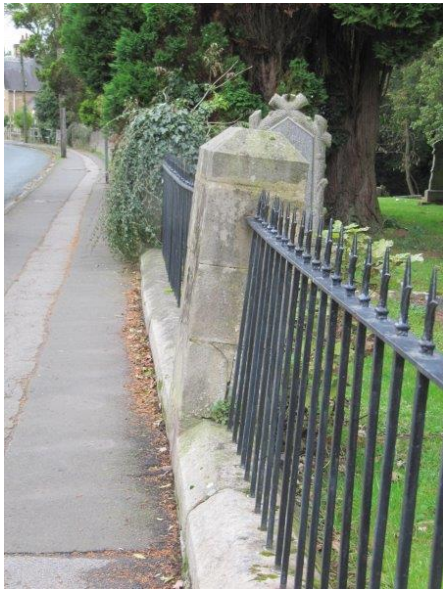
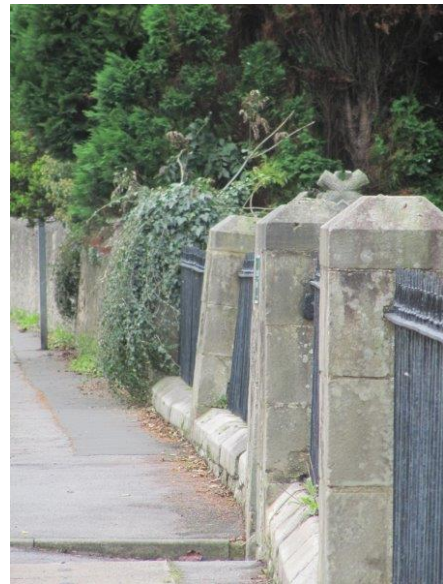
Leaning pier and distorted railing to Southern boundary

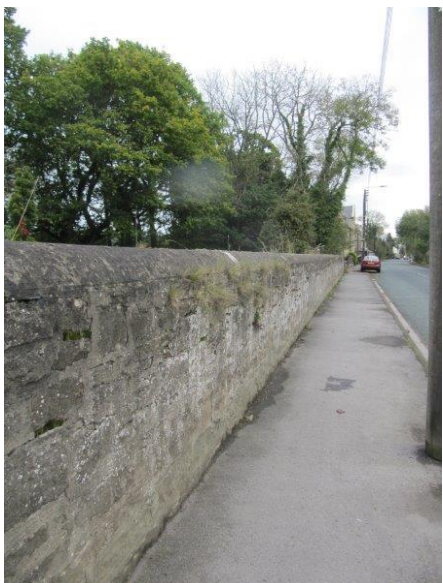
Eastern end of the southern boundary alongside the pavement

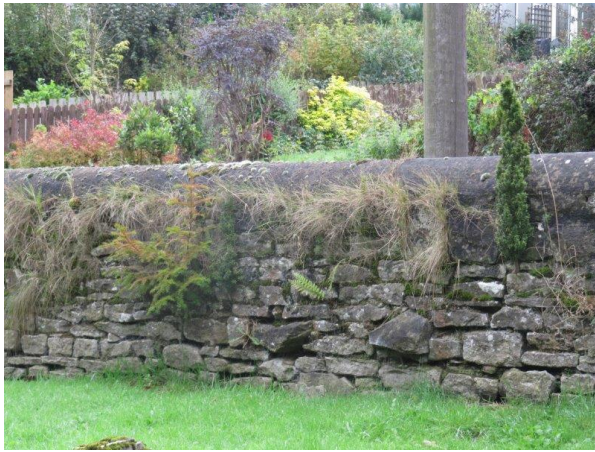
Grass, saplings, open joints and dislodged stonework to the inner face of the Southern Boundary

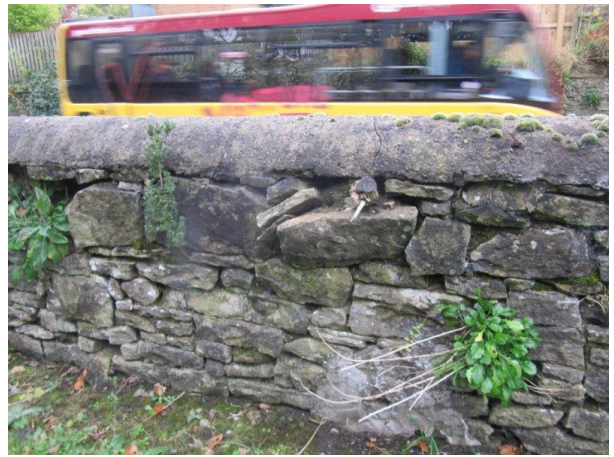
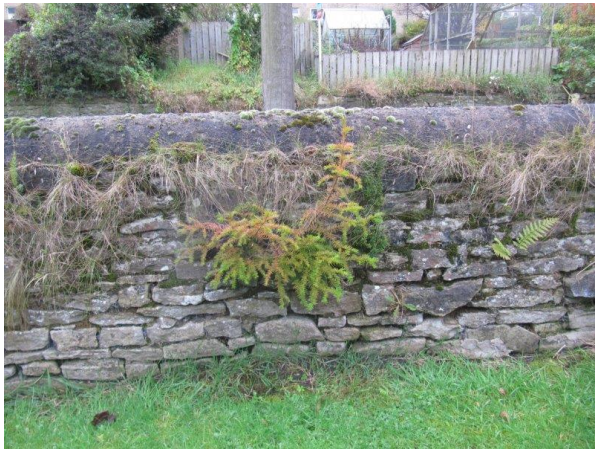
Grass, saplings, open joints and dislodged stonework to the inner face of the Southern Boundary

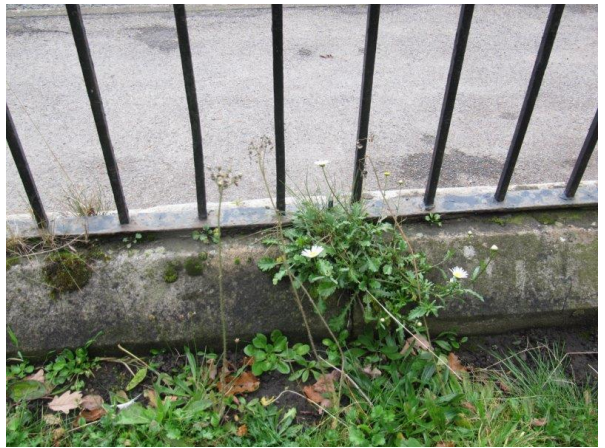
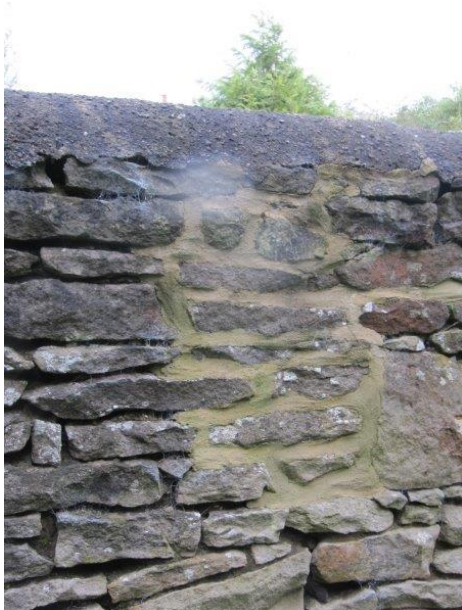
Small areas of pointing carried out to the Western end of the Southern boundary
