## St Aidan, Hartlepool

### Quinquennial Report

**7<sup>th</sup> November 2023**

Archdeaconry of Aukland  
Deanery of Hartlepool  
Grade II listed – Blaydon Conservation Area

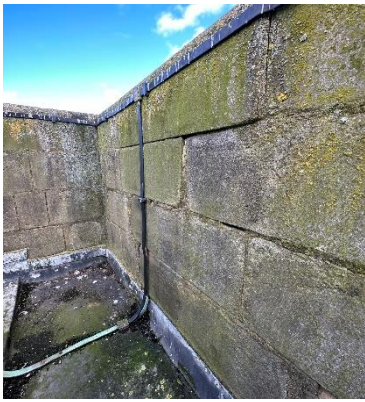
Figure 1 - NE corner

6.1.1 The southwest and southeast corners of the parapet had cracking at the corner stones reported at the last inspection. The issue is also visible on the northeast corner and it is unknown if this is a progressive issue. There are some open joints to the coping, these should be pointed to allow for closer monitoring. The previous QI also reports the east and north walls have a slight curved line. The step in the parapet stones to the SW corner current measures 15mm.

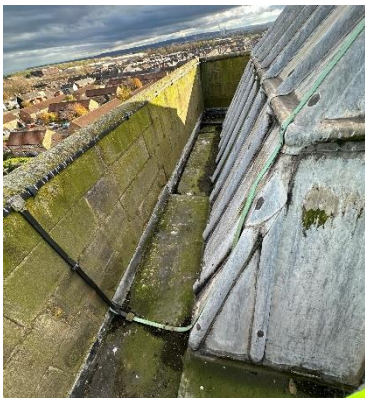
Figure 4 - tower lead gutter

6.1 **The tower:** Flag pole now removed. Lead work to roof is generally ok. The lead has seen various repairs in the past, but currently appears sound. Flashing to the north parapet has also been repaired. The lead gutters are moss covered but have no defects, there are a number of patched areas which will need monitoring.

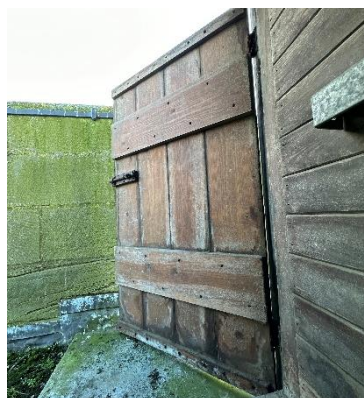
Figure 5 - Tower roof and hatch

6.1.3 The access door decoration is breaking down and the door itself is catching badly in the frame. Very difficult to open and currently a safety concern if closed whilst on the roof.

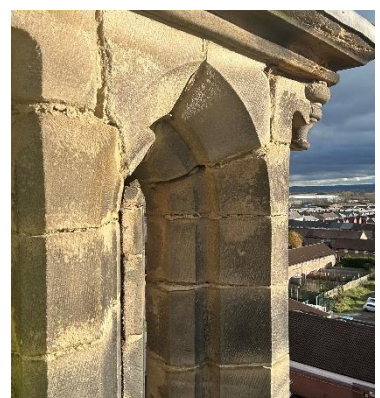
Figure 6 - lantern to SW corner

6.1.2 The lantern to the SW corner is held secure by a central rod. Three of the shafts are missing and there are several open joints which require re-pointing. Minor erosion to the face of the stone.

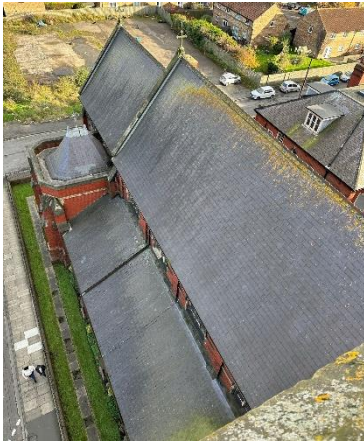
Figure 7- Roof from tower

- Viewed from a distance with binoculars only. Ridge looks ok, as does the slating. East abutment looks ok. There is a large chimney within the roof that has back gutters in lead, they seem ok from what can be seen – as does the chimney itself. It is unknown if this chimney is capped.

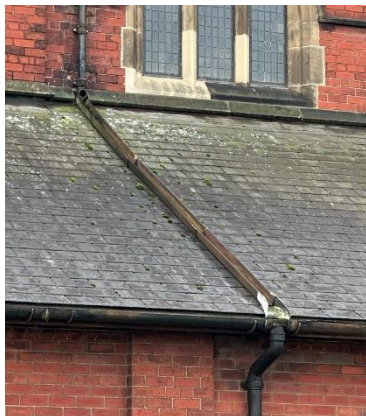
Figure 9 – Channels on N Aisle roof

7.3 Aisle - The aisle gutters and downpipes and fascias are similarly losing their decoration. The gutter brackets particularly. They lead down to gullies which are ok, there is a plastic sheet covering one of these. The Nave downpipes discharge into channels on the aisle roof, these are rusted and out of alignment.

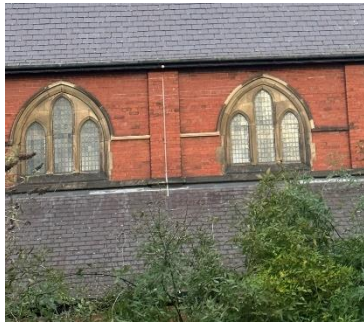
Figure 10 - erosion to mullions

8.1.1 **Nave** - The mortar joints are eroded, though appear similar to the last inspection. Stonework to the three light clerestory has been repaired in the past, repairs are good, though there is now some erosion to the bottom of the mullions, one is particularly eroded. Erosion to the pointing perhaps at the buttresses more than anywhere else but looks ok for the moment.

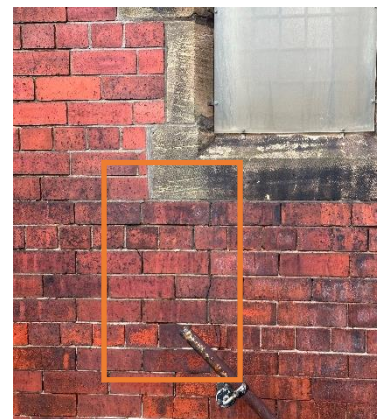
8.4.1 **Vestry:** There are open joints to the right hand side, also to the mid stone and the water table at the apex. The pointing and brickwork are ok though it has some splashes of paint by the handrail to the boiler room. Boiler room lintel is heavily eroded. Window is has some minor erosion to the cill and cracked brickwork to the bottom left hand side of the cill.

Figure 12 - crack to E Vestry window

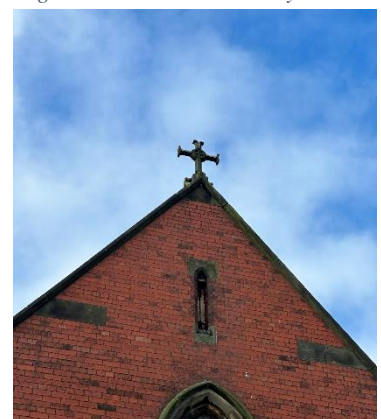
- Open joints to the water tabling remain, the previous inspection noted they suspected this was just to the overhanging edges- not to the width of the stone covering the wall. The cross appears sound though could not be inspected closely. The brickwork is generally ok, though polluted and there is an area of joint erosion on the north and south sides below the string course.
- The string course is beginning to break on the south side. The buttresses seem ok. The windows have seen cement repair to the ashlar stone in the past and this will only deteriorate in future, though holding up currently. The apex window has a short piece of boarding which is eroding.

Figure 13 – E gable open joints

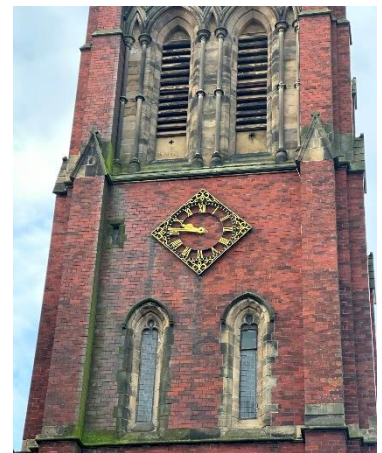
Figure 14 - east tower and clock & louvres

- Stage 4 – the shafts to the belfry windows have been clipped back in copper straps. The louvres have some lamination and this should be monitored. The lightning conductor tape comes down on this side.
- Stage 3 – heavy algae growth on the brickwork as water runs out of the spout from the tower. This stage has two lancets within it which seem ok, though there is some slight erosion to the northern, at the arch. There is also a small lancet to the south of the clock which appears ok. The reconditioned clock faces look ok.
- Stage 2 – ok though there is a loss of the string course at the return at the buttress to both the top and bottom of this stage.
- Stage 1 – ok.

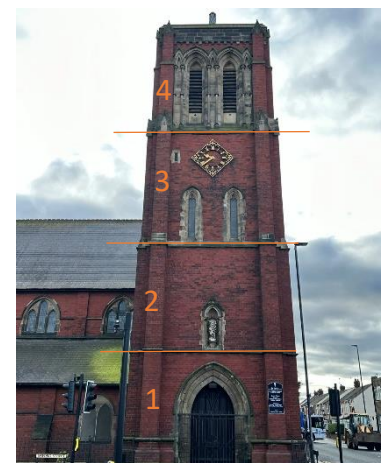
Figure 15 – north tower

- Stage 4 – diagonal crack in parapet that was reported in the last inspection is barely visible from ground level. The belfry window stonework is generally ok though there is some erosion to the eastern side halfway up, old cement appears to be delaminating here, to a lesser extent to the west. The louvres look ok. Slight open joint at the sill and erosion of stringcourse below. Caps to the buttresses look ok.

- Stage 3 – the lancets have been repaired here in cement, some of which is coming away. The east lancet cill is eroding slightly.
- Stage 2 – statue within the niche above the doorway is heavily polluted. Some holes to area above this suggest previous fixings here.

- Stage 1 – the arch has been heavily restored in the past with black mortar which is a little unsightly. There is some erosion to the stonework at lower level, only showing a marginal progression from the last inspection report.

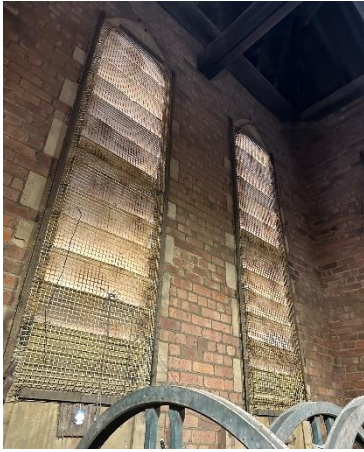
Figure 16 - internal louvres

10.1.1 Upper level – Rust remains on the upper steel stair guarding, which is a health and safety concern, a long vertical ladder with some guarding gives access onto an upper platform at the roof access hatch (see section 6.1 for details of the condition). The roof structure appears dry and clean. The louvres have sandstone slats and there is some lamination to them, their condition should therefore be monitored closely and regularly given their exposed position and pedestrianized area below. These are backed with wire mesh which is rusting but presently sound. The brickwork is generally sound but there are some open joints in the brickwork on the east elevation and to the corners.

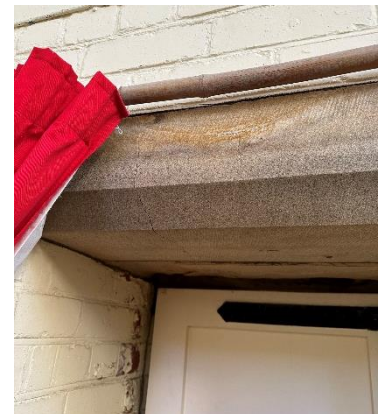
10.4.3 There is a door giving access to the roof area between the nave and the tower. The door needs decoration. The lintel is also cracked, as this was not noted on the last inspection this should be monitored closely.

Figure 17 - crack to lintel (10.4.3)

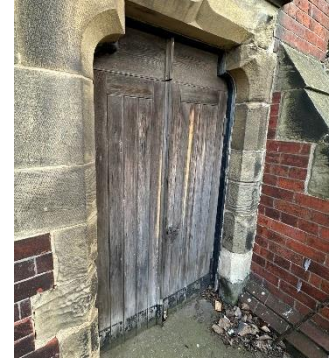
Figure 18 – west doors

- 11.1 Entrance door is a pair of large double timber doors with cast iron hinges. Painted and in servicable condition, handles beginning to rust.
- 11.2 Vestry southeast door – A steel plated timber door, weatherbound to the base, decoration is very poor.
- 11.3 West porch – softwood framed ledged and braced doors, pleasant but no decoration.
- 11.4 S Aisle windows are guarded by a mesh, padlocked and hinged and the window stonework. Guarding bending to the mid window and the padlocks are rusted.
- 11.5 The polycarbonate to the glazing has yellowed now and is very dusty.
- 11.6 Vestry no mesh to the polycarbonate glazing here but there is on the aisle.
- 11.7 E gable - The guarding to the windows is rusting.

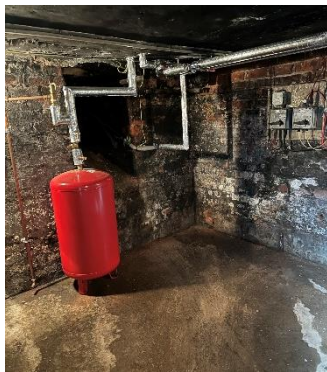
Figure 20 – boiler room

- 12.1 Below the Clergy Vestry. Concrete roof, some cracking in it but not defective and appears as though condition has not changed since the last report.

- 12.2 Walls are brickwork, they have been lime-washed in the past and painted black though most of it is missing now. There is a lot of salting to the walls, mostly at the north side and the west.

- 12.3 The floor is concrete and has some water ingress but surprisingly dry following heavy periods of rain. This reportedly occurs at the eastern end (the former coal chute) and leaks through the wall and possibly comes up through the floor in heavy rains. It finds its way diagonally across the floor to the gully. This should be kept in mind with any future use of the room.

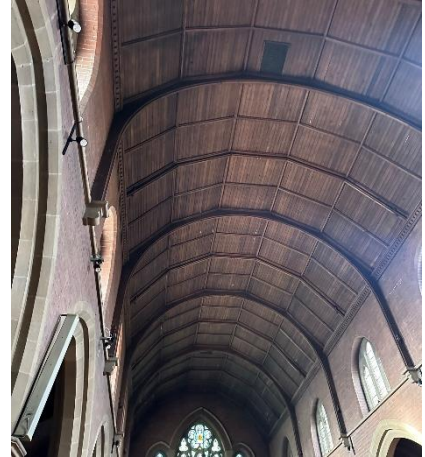
Figure 21 – North ceiling

13.1 Minor water staining to the boarding of the nave, worst to the west. There is staining throughout the building, though this has been reported as historical.

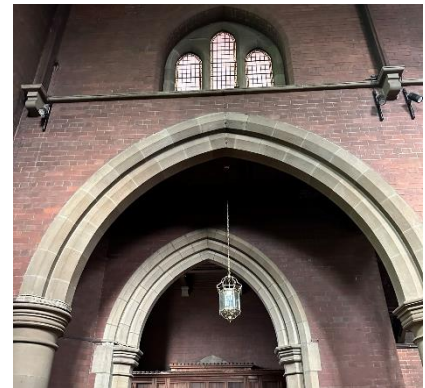
- 13.2.2 North – high level salting at clerestory. Clerestory lights remain dirty in some places. One has a ventilator but is not openable. Below the string course the arcade brickwork is ok. The ashlar arches are chamfered. They have marks at the apex of former cabling and a slight crack to the penultimate arch to the east, minor settlement of the eastern arch. There is some minor damp to the western most column at the base.

Figure 22- arcade as item 13.2.2

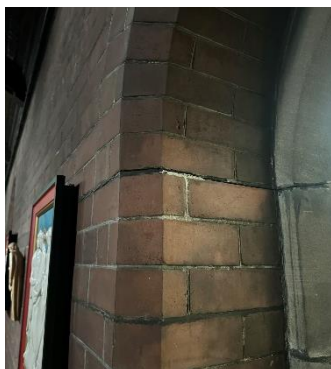
Figure 23 – crack to LHS of E

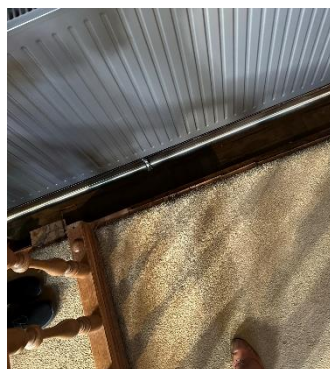
Figure 24 – unfinished edging

- 14.1.1 Historical staining to the boarded roof. Walls look a little sooty and there is some loss to the dirty face of the mortar that makes the joints white, which could be confused for efflorescence. Slight crack above the second window. Window ashlar is sound, though there are some open joints, and cracking tot her LHS of the easternmost opening. At the eastern end there is a crack at the Lady Chapel approximately 2mm, unchanged since the last inspection, potentially heave. At the lower part of the walls the the new stainless steel heating pipes run to the side of the raised platform. The platform now has an unfinished edge which would benefit from an edging to match the front.

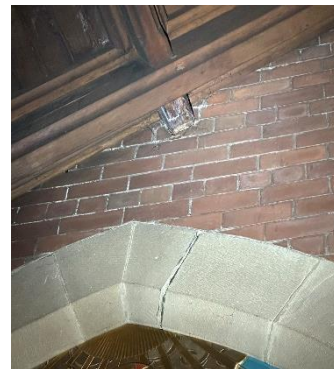
Figure 25 – purlin and crack to lady chapel

- 14.1.2 East wall above the Lady Chapel – the purlin seating remains open. It is unknown if the previous recommendation in the last QI was carried out to check for the presence of rot, if this has not been completed it should be done now. The arch below has an open joint, which remains approx. 8mm therefore doesn't look to have moved. Repointing would assist with monitoring any future movement.
- 14.1.3 At the west end of the arcade is the entrance porch, the adjoining wall is ok with minor staining.

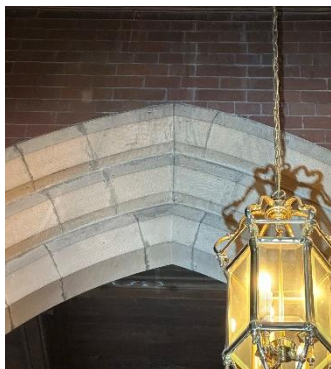
Figure 26 – crack to apex

- 15.1.1 Salting at high level within the arcade. The crack at the apex of the arch on the nave side remains approx. 2mm. The ceiling has some historic water staining, this is the floor of the ringing chamber. There is a pleasant timber partition forming a draught lobby, though its decoration is beginning to look aged and the doors do not close effectively.
- 15.1.2 North wall at high level appears ok.
- 15.1.3 East wall has some salting at high level.
- 15.1.4 South wall contains the arch, crack also visible on this side which wasn't reported at the last inspection and should therefore be monitored.
- 15.1.5 West wall ok, features a large window that has some cobwebs to it, otherwise ok.

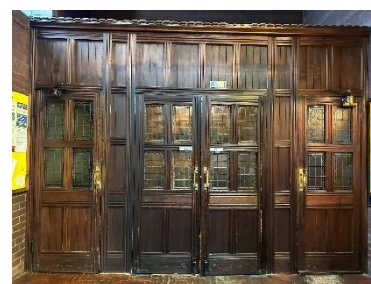
Figure 27 – entrance screen

- 16.1.1 The main entrance door still catches on carpet slightly, as the floor is a little uneven with some erosion at the threshold. The timberwork itself enclosing the space is ok. To the east is a small secondary draught lobby now full of lumber and unopenable, matched on the other side with a marginally less cluttered cleaning store.
- 16.1.2 The entrance double door is twisted and allowing draughts through the gap to the base.

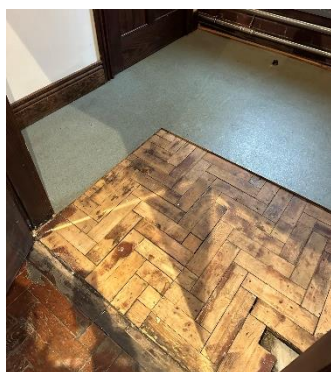
Figure 28 – floor WC lobby

- 17.1.2 Disabled WC – the baby change takes up the transfer space for a wheelchair. It would also benefit from a PIR sensor operated light.
- 17.1.3 WC lobby – some slight open joints to the right-hand lancet top and the glass is dirty, some erosion of the cill but not of concern. Peculiar positioning of two cabinets on cill – are these fixed? Vinyl flooring cut short and parquet beneath requires some finishing, a number of blocks are missing, this floor needs to be made safe and accessible.

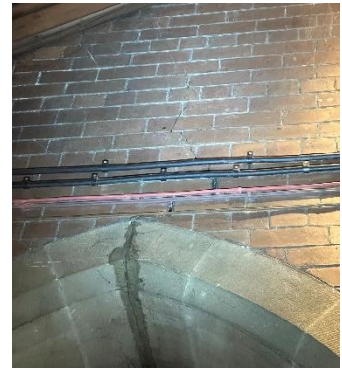
- 17.1.5 The West wall has a crack emanating from the top of the lancet to eight courses above. There looks to have been many repairs to this area in the past, judging by black mortar to the stonework. A corresponding crack is present at the bottom LHS of the cill, the brickwork below is quite shattered. These should all be re-pointed and monitored for any further action, the previous QI reports that this may be a response to the compression loading of the tower. Still no movement visible externally here. Behind the radiator, salts are drawn from the wall behind through the mortar, this could be brushed off. There is quite a lot of damp in the flower vestry which could do with ventilating.

Figure 29 – crack above w lancet

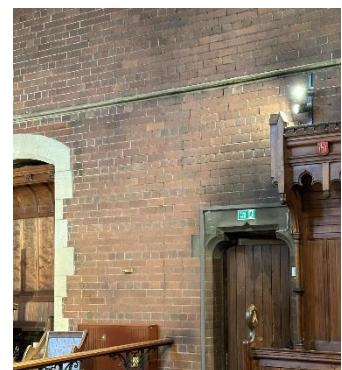
- 18.6 Flooring – carpeted at the low level and marble steps up to tiled area then marble steps to marble inlay. The two highest red marble steps have seen significant cracking, which the previous report suggests could be due to heave, but the cracking doesn't follow a significant

Figure 32 – cracking to S

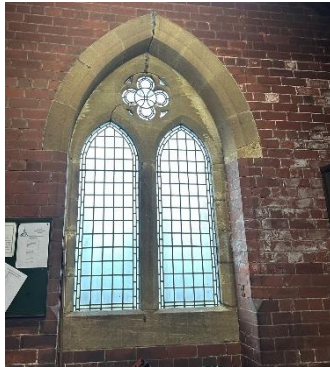
Figure 33 – cracking to E lancet

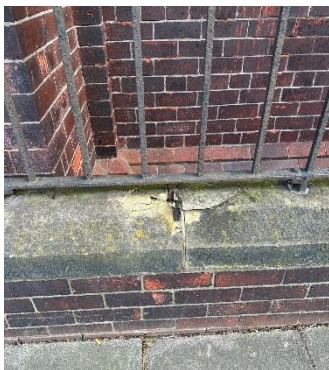
*Figure 37 – cracking to W wall*

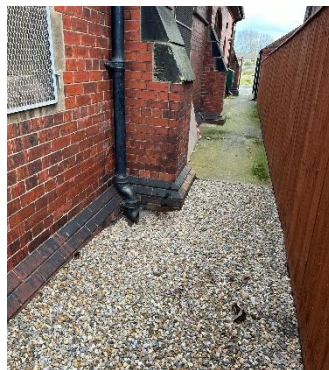
28.5 On the north side, the area in front of the aisle has been relandscaped in grass and gravel and this has much improved the drainage at the base of the walls.

*Figure 38 – new fence and gravel*

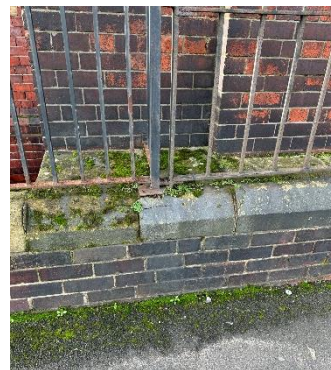
*Figure 39 – raised areas*
