CHURCH OF SAINT ANDREW HAUGHTON-LE-SKERNE

The Diocese of Durham
Listed Building Grade I
Haughton Conservation Area

Report on Quinquennial Inspection 2021

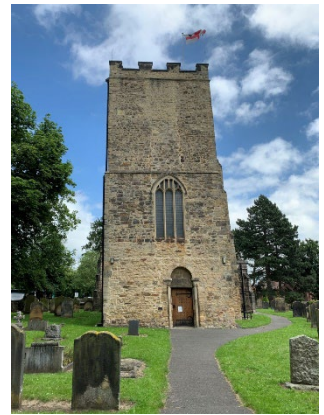
The wall is rubble with dressed quoins and there are a number of areas of cracking which have been pointed in 2012.

On this elevation there are a number of cracks which have been re-pointed and consequently should be monitored.

Around the doorway arch within the recess there is a crack to the right hand side and a ferrous fixing which appears to be the source of some more damage to the stonework below. This should be removed and repaired.

- 2.2.1.3. **Recommendations:**
- C • Coping stones need repointing.
 - D • Monitor the pointed up crack on the right hand side of the recess of the doorway arch.
 - C • Remove the cement pointing to the right and left of the doorway and re-point/repair with a lime mortar.
 - D • Remove ferrous fixings and repair stone in arch.
 - E • Replace light fittings with more visually acceptable alternatives.

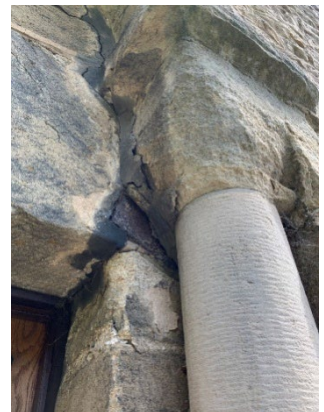
There is a large amount of erosion to the stones to the left and right of the doorway and this has been repaired with cement pointing. It would be advisable to remove the cement pointing and re-point and repair with a lime mortar around the doorway.

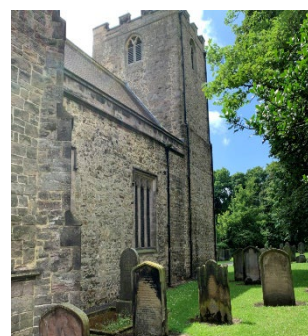
This is also rubble, and it has had quite a lot of cement strap pointing in the past, although this is desirable to remove, it appears to be in reasonable condition at the moment, though there is a crack to the east of the quoin stones at the corner between the north and west. The coping at the top of this stage though well weathered appears to be in reasonable condition although the pointing should be checked.

- 2.2.2.3. **Recommendation:**
- D • Lower Stage of North Side of Tower: The pointing at the stage should be checked. Check the pointing at the top of this stage
 - M • Upper Stage of North side of Tower: check three ferrous tie bar ends

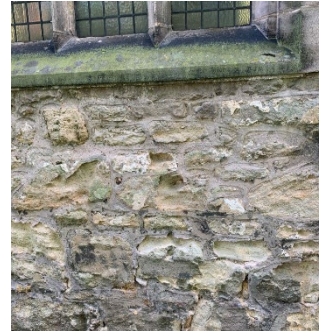
This face is a mixture of rubble and semi dressed stone. One area to the west appears to have been rebuilt quite substantially and a historic crack between it and the body of the Tower is visible. This has been repointed. Along this wall are two square headed traceried windows and between them are the remnants of an old doorway into the Nave which has been blocked up.

Below the western most windows are a number of eroded stones which appear to be suffering because of the very hard cementitious mortar which has been used around them. Some stone replacement should be considered within the quinquennium.

| D | • Stones should be replaced below the western most windows. |

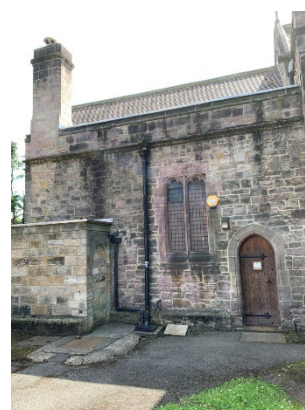
There are a number of rainwater outlets/ shoes, there are a number of rather ugly plastic downpipes. The design of the area around the gulley ought to be reviewed to avoid dampness to the base of the vestry wall.

- D • The design around the gulley to be reviewed to avoid dampness to the base of vestry wall.
- B • Check SS roof – dampness noted to the East of hopper

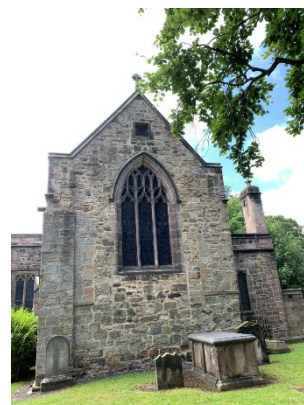
2.2.8.2. **Condition:**
Pointing at the upper areas of the east end of the Chancel is required to the north and south of the lancet window and near the square window above. Also pointing under the coping of the gable. At low levels there are a number of eroded stones which require replacement.

- 2.2.8.3. **Recommendations:**
- C
- Pointing required to the north and south of the lancet window (located at upper areas of the east end of the Chancel) and under the coping of the gable. Eroded stones require replacing at the low levels.

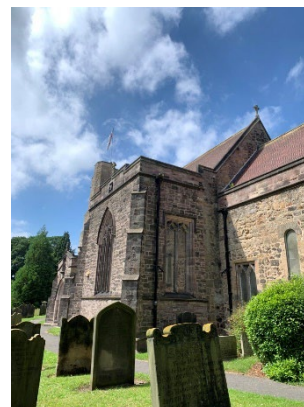
The shoes on the downpipes don't appear to be long enough and so the water isn't being directed to the gulley properly. This ought to be rectified.

- D**
 - Downpipe shoes to be replaced to ensure water is being directed to the gulley.

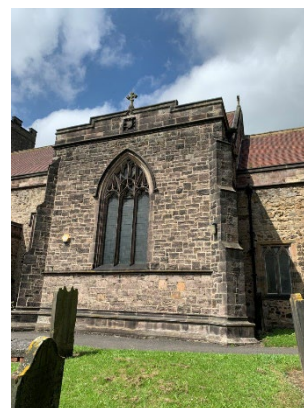
There are cracks to the pointing to the left and right of the window that require re-pointing. Some pointing is also required at plinth level.

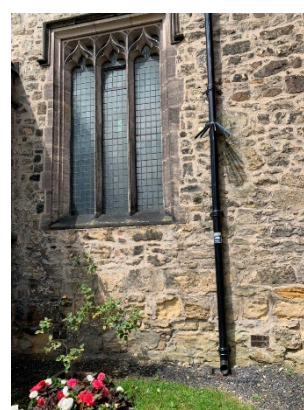
Masonry bees are evident to the west end of parapet – pointing required.

There is substantial decay at low level and also inappropriate cement mortar.

- D
 - Pointing required to the west end of parapet.
- D
 - Replace eroded stone and repoint around lower levels with lime mortar.

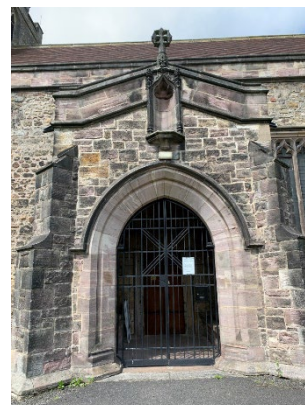
2.2.17.2. **Condition:**
Cross may have crack at base.
Poor cement pointing. Movement in arch.

2.2.17.3. **Recommendations:**
C • Check cross base.
D • Point open joints to hood mould.

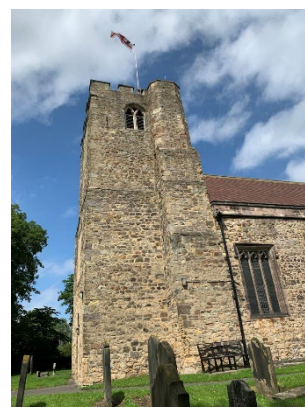
2.3.2.2. **Upper stage of South Face:**
Condition:
There is one window and a tie bar. All this appears to be fine although some of the coping has eroded.

2.3.2.3. **Recommendations:**
D • Decorate tie bar

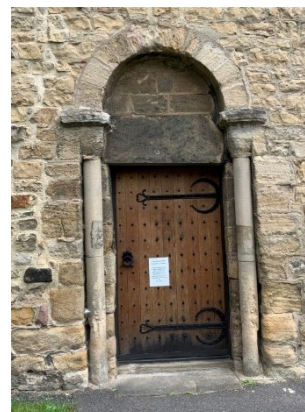
2.4.1.2. **Condition:**
The south and vestry doors are varnished and are in reasonable condition. The west door is in oak and has been overhauled in 2004. The ironwork will need a thorough rubbing down and decoration.

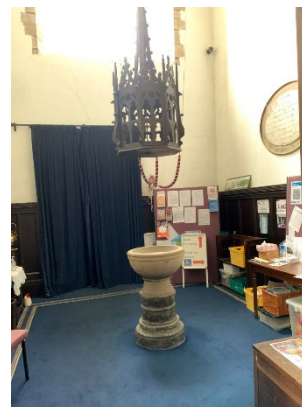
3.1.1.2. **Condition:**
Above, on the ceiling there is a hatch and three bell pulls come through for the ringing of the bells. Note that there appears to be a spider's nest up in the corner of the ceiling and the west and south walls which should be removed.

A crack runs across the south west corner of the ceiling.

- E • A spider's nest should be removed from the corner of the ceiling and the west and south walls.
- C • Cracks above the doorway arch toward the window sill and above the arch apex should be monitored regularly.
- M • Other cracks should be noted and monitored.
- B • The door to the bell tower is binding badly at the bottom and should be eased.
- C • Access to the upper levels should be improved. Handrail and lighting to spiral stair, step and handrail down to sounding chamber
- B • Repair broken glass to stair window.

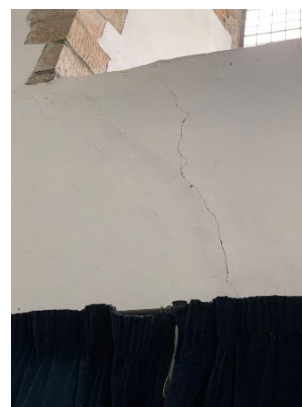
3.1.1.3. There are two cracks from the top of the round headed west doorway arch up towards the sill of the window above. These have appeared since the redecoration and should be investigated.

3.1.1.4. There are also a couple of open joints in the arch from the Tower into the Nave (which is very high and looked at with binoculars). A crack above the arch apex which runs along the junction of the ceiling above and the wall towards the corner, was looked at by a structural engineer in 2011 and relates to external crack which have been pointed up and should be monitored for any evidence of the cracks getting larger.

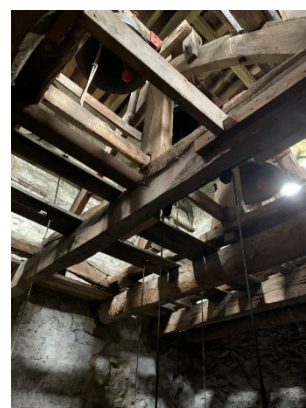
3.1.2.2. **Condition:**
Tall tales have been removed and walls pointed. Timber is displaying some decay.

| M | • Keep an eye out for further cracking. |
| D | • Carry out timber decay survey and treat as necessary. |

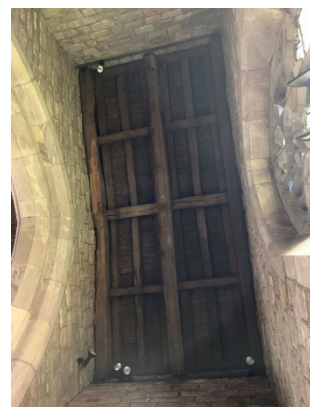
It should be noted that there are areas of damage to the north transept roof caused by historic leaks, and also some wood boring insect damage. It is understood from records that this is likely to have been treated when the ceilings were cleaned between 2003-2005. This should be monitored for activity.

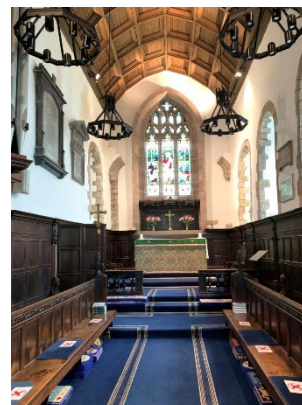
There are some defective areas of decoration on the north wall of the Chancel likely following some damp ingress. Brushing back of any salts should be undertaken. The plaster could then be re-limewashed. Externally ensure gutters and downpipes are clear and pointing carried out to stonework.

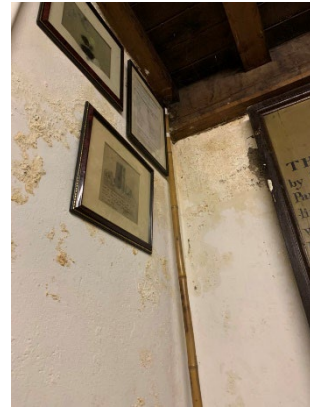
The stainless steel roof above does not appear to have any other obvious defects, although it is possible that the leak was due to unusually deep and persistent snow coverage over the winter and is not normal. This should be monitored.

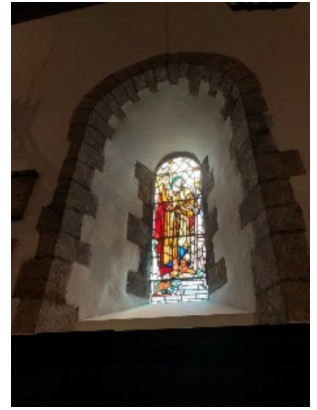
- 3.8.1.4. The three round headed windows to the south chancel and south transept are fitted with polycarbonate. This causes increased humidity and ultimately corrosion of the surface of the stained and painted glass. It is recommended that the polycarbonate is removed, and if protection is required, then to consider powder coated stainless steel guards.

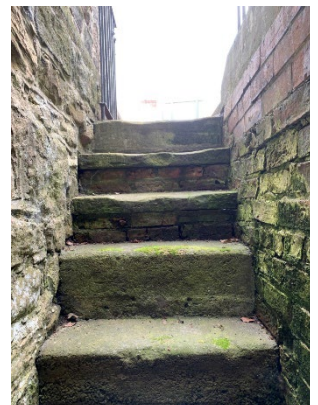
3.11.1.2. **Condition:**
The boiler room enclosure has a concrete roof and stone walls with a brick division wall between the old oil storage tank area.
A handrail should be provided to the steps down.

3.11.1.3. The boiler is connected to a small chimney stack by a relatively recent flue. Check for asbestos. The boiler was converted from oil to gas some time ago and the oil tank is still underground with its redundant pipework. It would be preferable to remove it.
