Diocese of Durham

**St PATRICK
HIGH SPEN**
(22A)

QUINQUENNIAL REPORT
on the architect's inspection on

2 November 2023

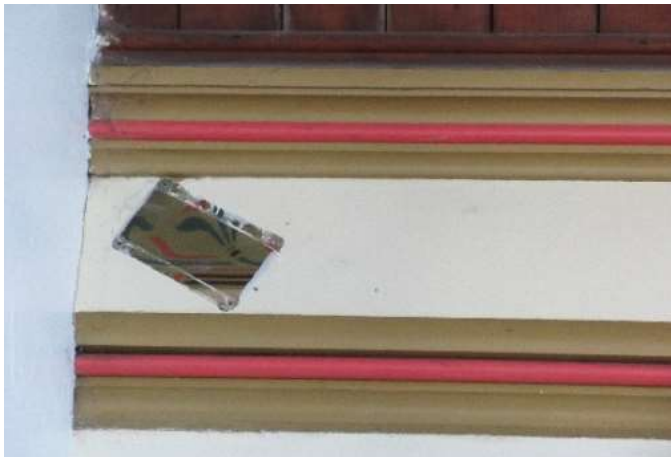
Present frieze colours in chancel with fragment of stencilling

104. It would be easy to remake the covered stencilled frieze if the parish wanted to reintroduce a little colour in this simple building.

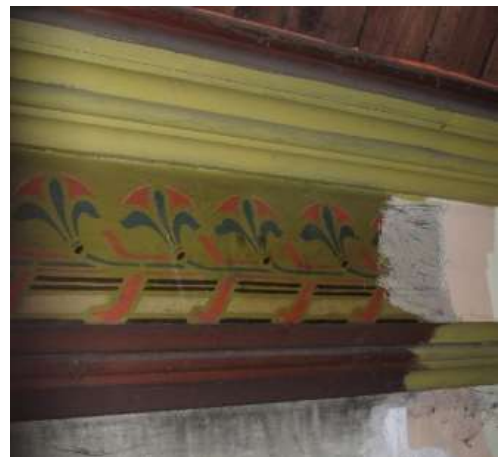
Part of stencilling remaining behind organ

52. Plaster damage unchanged at the inaccessible walls behind and left of the organ. It appears the previous gutter and buttress repairs stopped the damage but observation should continue.

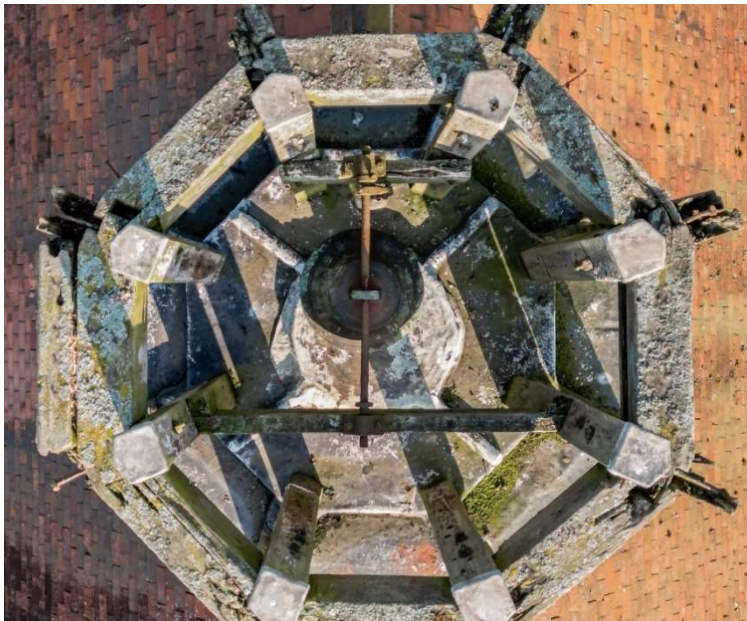
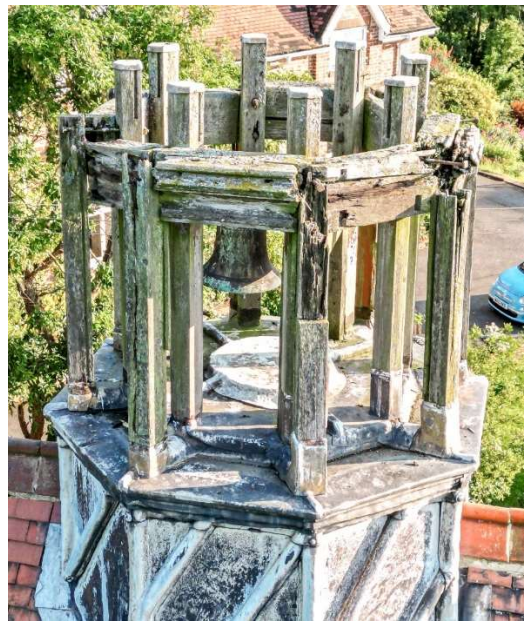
2023 drone photos supplied by the parish

19. The conical turret roof was removed about 35 years ago, exposing timbers and bolts meant to be sheltered. The cut inner posts are lead capped and not obviously decayed though weathered. Decay in the uncapped outer ring of posts and the beams between advances from the exposed end grain. At least one outer post shows past splice repair. Some repair timber lost since the last inspection.

22. Its stepped lead top (see drone photos) covers the vent. It is well dressed up the outer posts and, to varying heights the inner posts.
23. If the posts are cut down and the lead clad base kept the lead will need close examination, perhaps a thorough overhaul and new caps over the reduced post stumps. In that case the bell will need to be taken down or rehung, perhaps under a bracket from the W gable.

24. Alternatively new posts could be inserted under a protective cap roof lower than the original, perhaps reusing the weathercock now standing in the basement and supporting a new bell hanging. Modest grant support may be found.

25. The truncated appearance and decay are unfortunate. The timbers are visibly slightly more decayed than at the last inspection and there is some anxiety in the parish that a larger fall might happen. The time approaches when decision needs to be made between
 - removal of the bell and complete removal of the remains down to roof tile level and roofing over
 - removal of the bell and remaining exposed posts to top of lead level with some further capping and overhaul of the base
 - rehanging of the bell in new timber posts protected by an effective roof

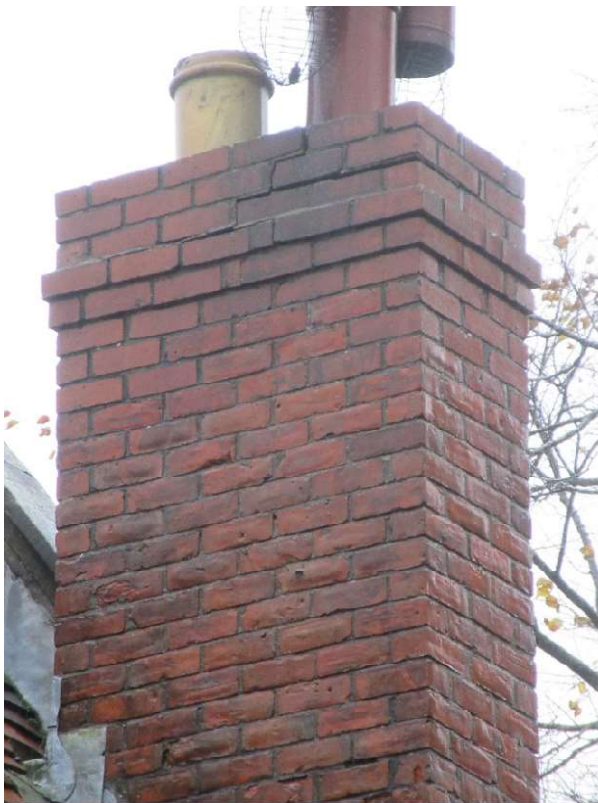
34. Disused brick chimney, two pots and mortar cap seem sound except
 - top three courses at NE have lifted, no visible change. Perhaps a flue liner top plate is rusting and lifting bricks.

Chimney top courses appear jacked up

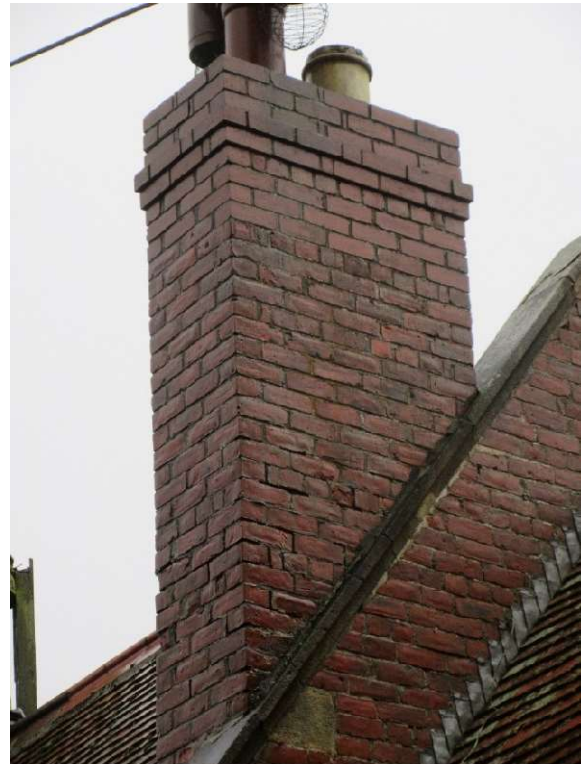
- minor open joints at the W side

scattered open joints in W side

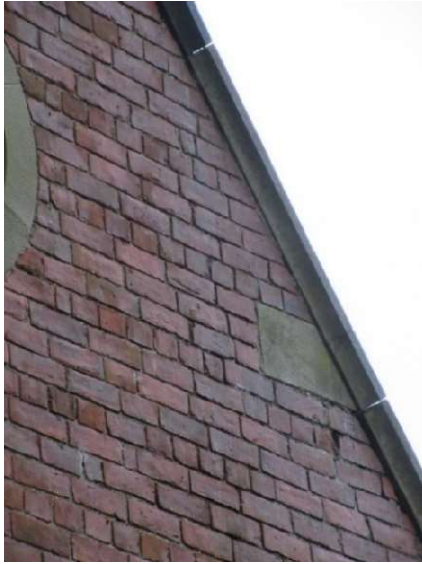
Paragraph 35

35. Sandstone watertables and kneelers on the three gable upstands with a carved cross at E.
Minor spalling of stone on the watertable tops. Some very narrow joints are open, including at SW (photo).

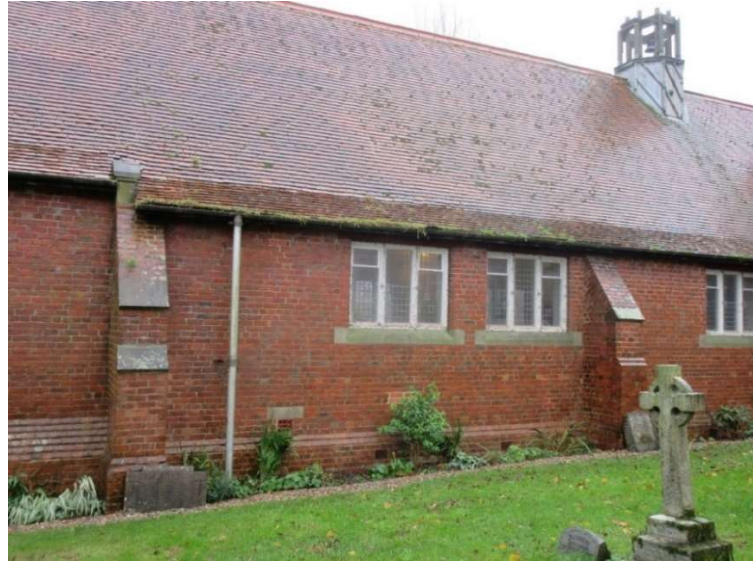
26. The level gutters are round cast aluminium on fascia brackets with large aluminium straight round pipes held off the walls by rusting long steel straps.
27. Parts of the N gutter are choked with plant growth.

paragraph 27 – N gutters choked

Replace broken roof tiles	14, 16
Clear N gutters and all gullies	27, 30
Renew ring handle at entry doors	41

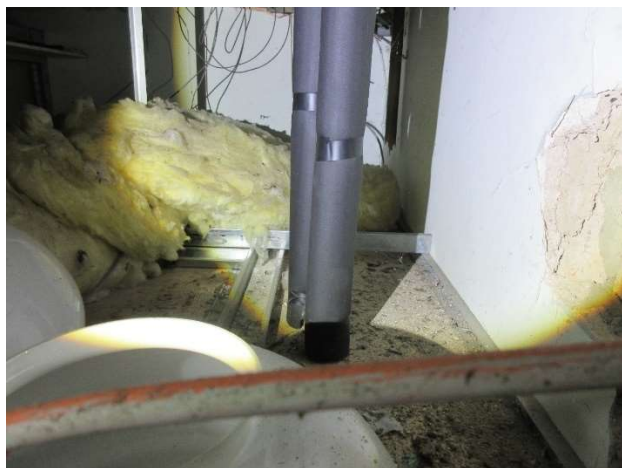
47. Exposed vertical sarking in church. In Vestry, wc and Porch sound painted plaster with insulation quilt but part of the quilt close to the Nave turned back and not relaid.

Insulation quilt not relaid over ceiling N of the wc

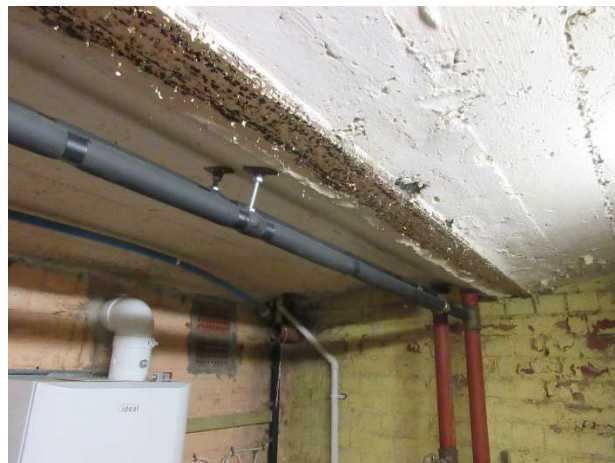
steels at boiler ceiling

48. Boiler room ceiling is vaulted in-situ concrete on two steels whose bottom flanges are rusting.

Act on former bell turret	19 -25
Wire brush and paint steels at boiler room ceiling	48
Obtain periodic electrical installation test report in 2026	86 and Addendum

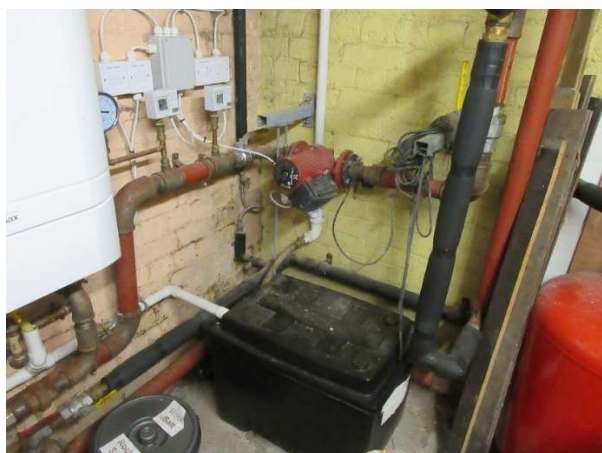
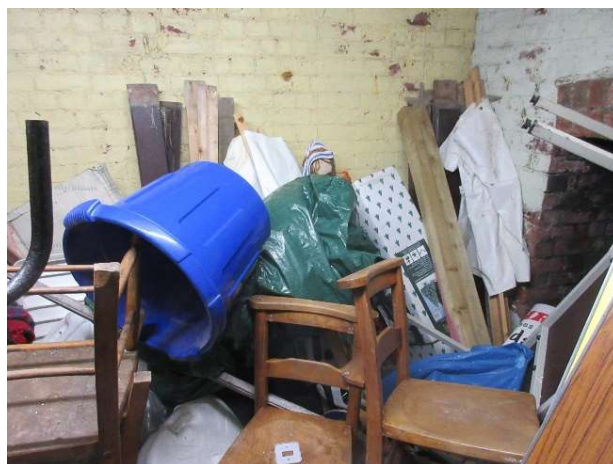
Scope for economy by more lagging at pipes and pump

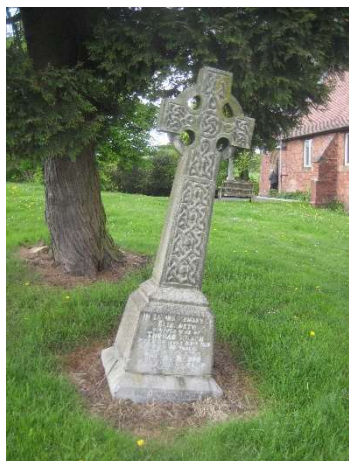
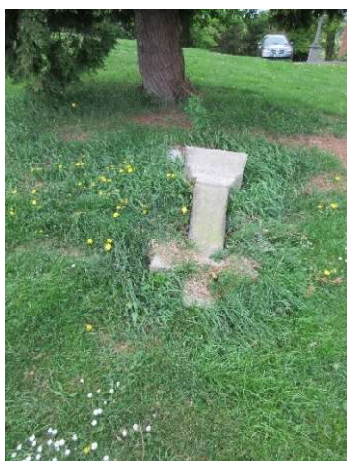
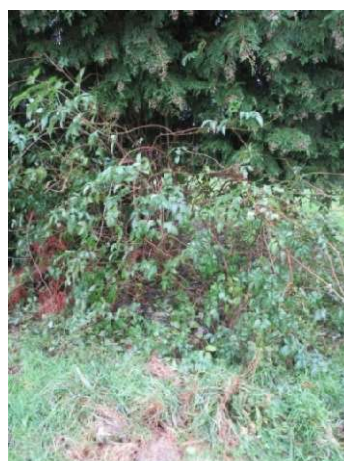
A tall leaning 'Wilson' celtic cross under a fir tree S of the Chancel. Now lies flat and overgrown. Not known whether it was laid down deliberately. It now impedes grass cutting and is a loss to the quality of the churchyard.
