Diocese of Durham

St JOHN the Baptist JARROW
(106)

QUINQUENNIAL REPORT
on the architect's inspection on

7 November 2023

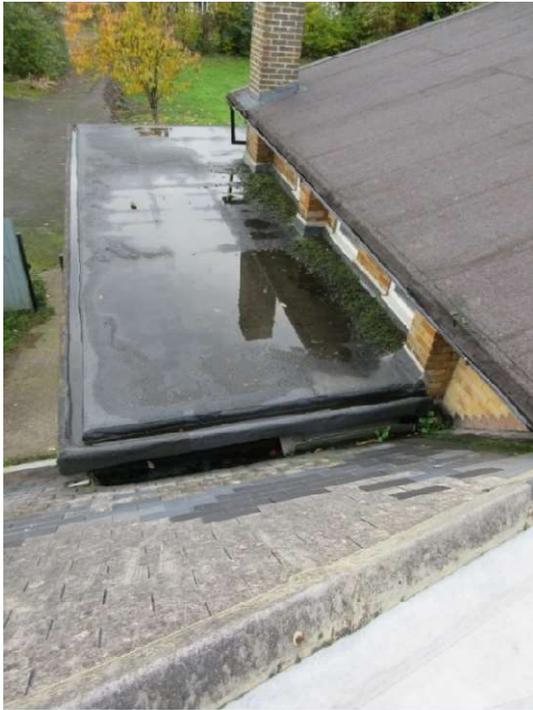
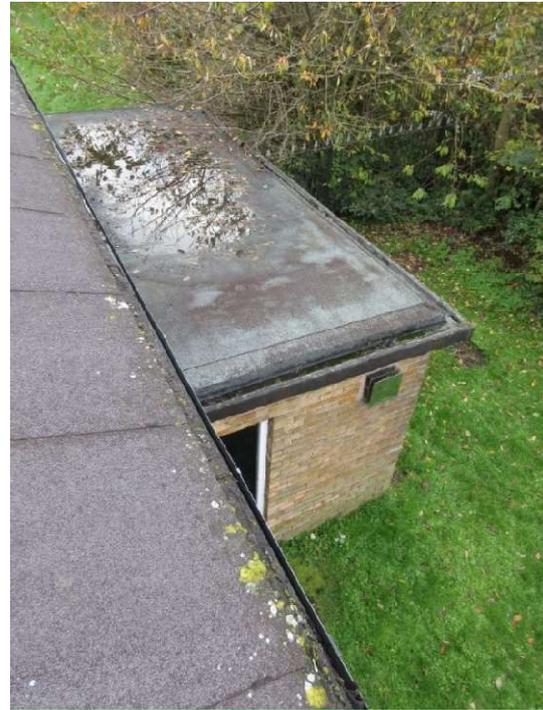
Internal gutter between Church and Hall - Plant in an outlet before part clearance at the inspection

11. The **Church** roof design creates two main risks.
 - the Church and Hall roofs meet at an internal box gutter likely to flood if the outlets block.
 - the Church outer roof eaves at chest height are prone to interference and climbing and the slopes are covered in brittle artificial slates with only moderate life.
12. A short E ridge, two visible side slopes and a shallower hidden hip. Ill fitting ridge tiles meant for monopitch roofs cover the hip angles, joined to the ridge with a Sarnafil patch. One hip tile has a broken end. Another broken hip is patched over with Flashband, itself repatched and now split.

13. The Church's hidden hip and box gutter are covered in Sarnafil pvc membrane over earlier felt. The gutter drains the large hip and part of the Hall by four bottom outlets to two boxed internal pipes. Some of the silt and plants in the gutter were cleared at the inspection but one blocked outlet could not be cleared without tools. Full clearance and water testing to manhole is recommended.
14. The steeper N and S Church pitches have artificial fibre-cement slates down to low overhanging eaves. To deter climbing bands of the lowest slates and a band up the side of the Porch were covered in non setting anti-climb paint now mostly weathered away. Slate breakages have been repaired and the roof is in fair condition, though moss in N joints suggests the weathering surfaces hold some damp.

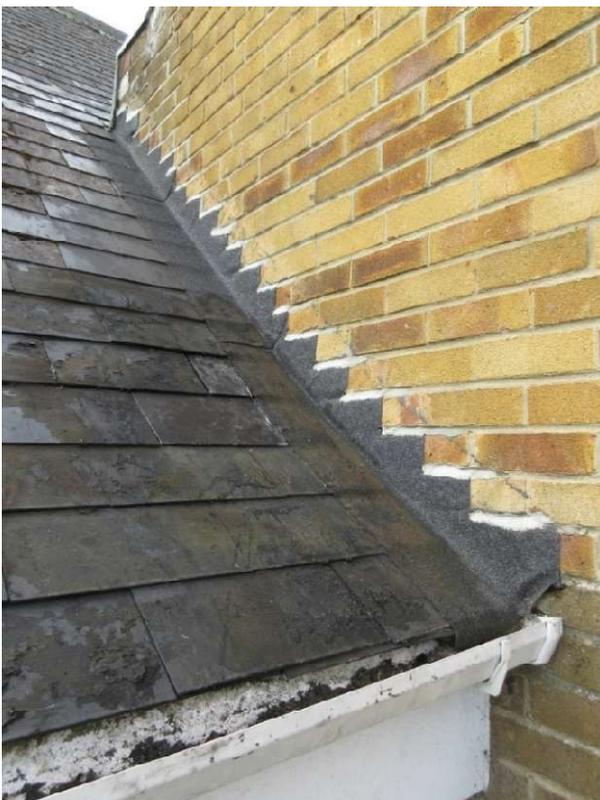
para 16

16. The N slates meet the side of the Porch at an improved felt cover flashing stuck to the slate and turned into brick joints.

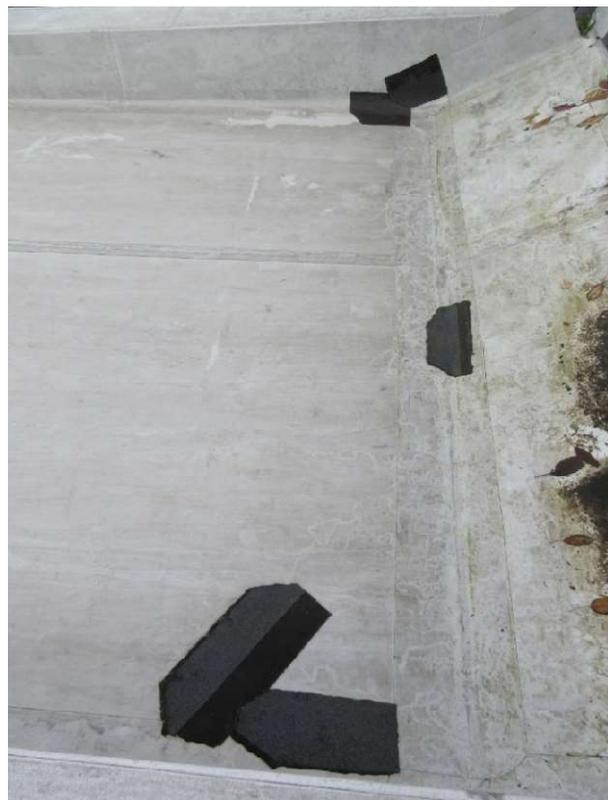
para 18

18. The steep **Porch** roof slopes inward against the church roof. Was bitumen felt, now covered in Sarnafil carried up over its brick parapets to protect them.
The roof appears sound but now has five small bitumen felt patches at the bottom of the slope. Bitumen is not compatible with Sarnafil so is not suitable for this use. Patching with Sarnafil itself would prolong the roof's life.

Replace the patches on the Porch roof	18
Replace missing slate cladding W side of Hall	32
Insulate ceilings and walls at Hall, Meeting Room, SE Entry	52, 53
Renew failed lamps	89
Remove or replace the gate to the N car park	112

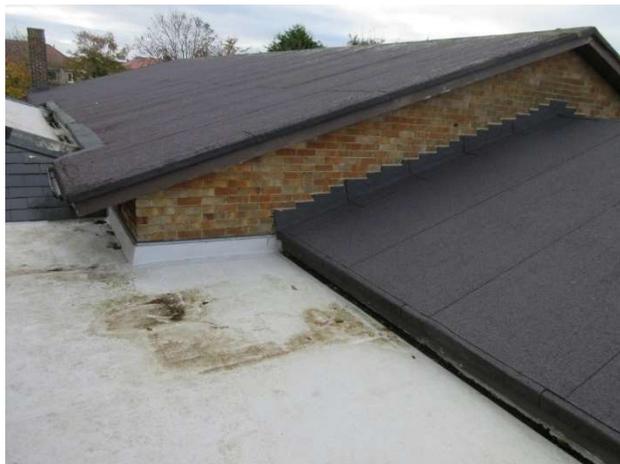
Flat vestry roof

pitched roof on N entry

25. The flat **Vestry** roof deck was renewed in 2004 with replacement of decayed joists at the then unventilated felted cold deck roof. It was changed to warm deck by refelting (as vapour barrier) covered with rigid foam boards and Sarnafil single ply membrane continuous with the covering of the **Porch** valley, its steep monopitch and copings.

The recent fall of vestry ceiling plaster shows at least part of the deck and joists is saturated. The only apparent damage to the membrane is a group of very minor scores or cracks which may be the cause. Though they could be patched as a precaution the visible deck is so wet and sagging that it is not likely to serve again. So it seems at least part of the Vestry roof deck, insulation and membrane will need to be completely renewed.

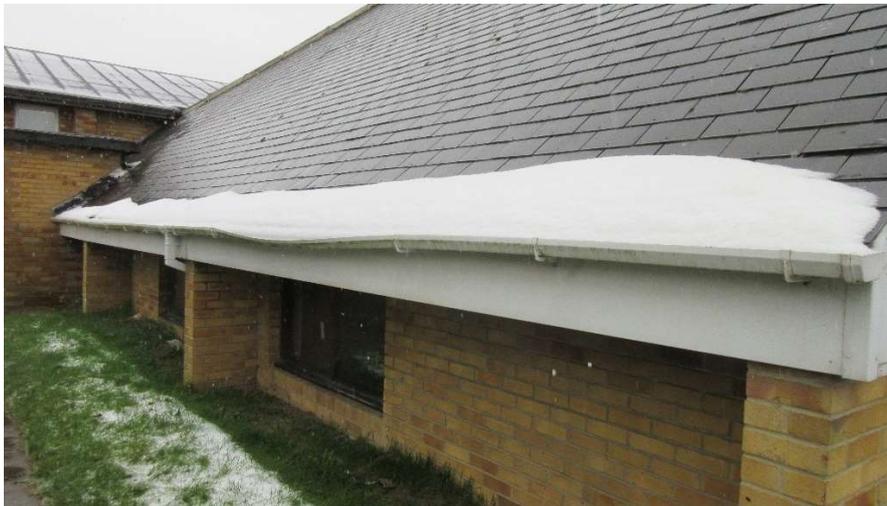
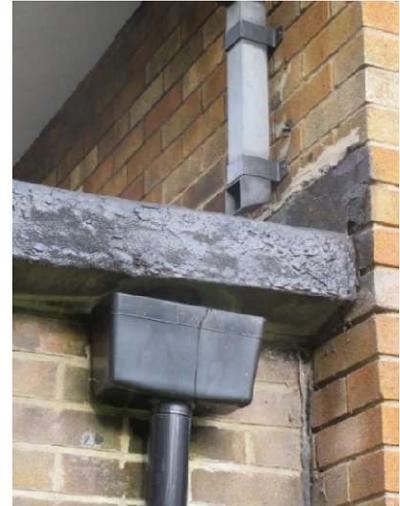
At S at least one bracket is missing and the gutter sags - even without snow. Risks breakage in heavy snow. The Hall plastic gutters are fair.

Sag of Church S gutter increased after snow

All gutters and outlets need regular clearance.

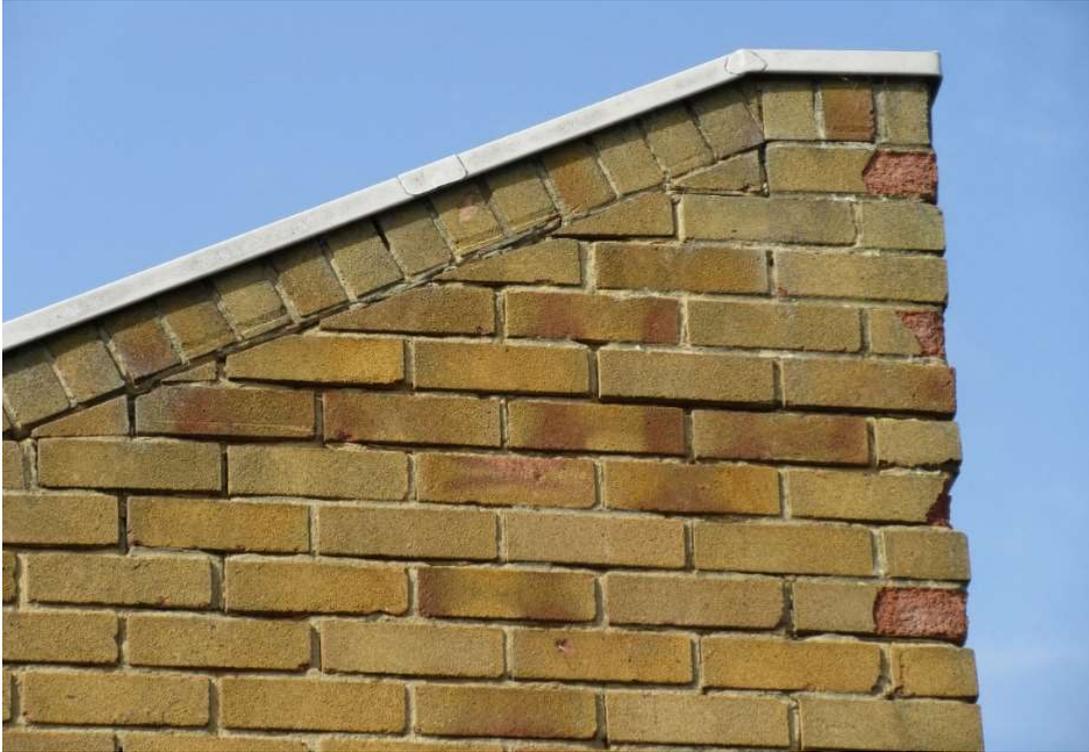
E side of Porch E wall

- a little more spalling at the Porch E wall.
- the exposed peak of the E wall including its N return has many open joints
- W wall and parapet over the Vestry roof again has a few open joints

Thorough raking out and pointing of all open joints at both walls will delay brick replacement becoming necessary as long as possible.

Rake and point all open joints in Porch walls	29
Repair N entry door	37
Restain the windows at Church E and S	40
Reheat at least the Hall side of the building with thorough lagging in boiler room	81 - 85

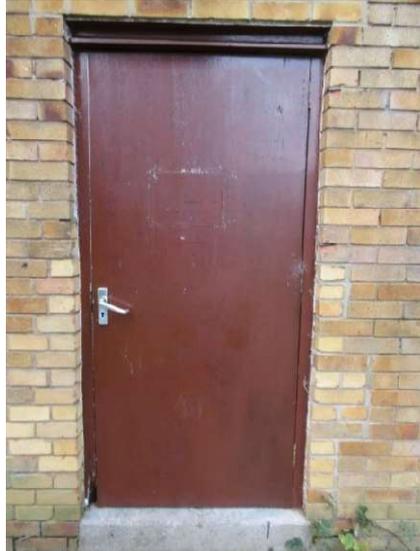
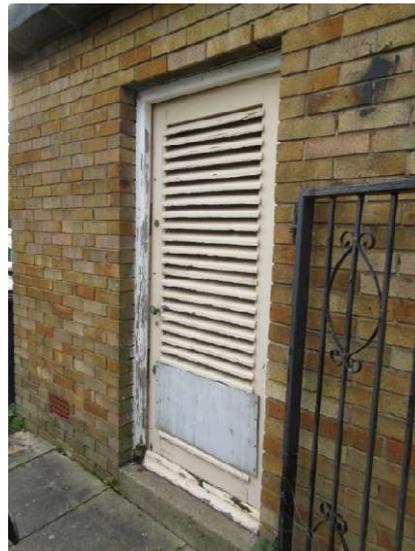
38. At SE

- both feet of the Boiler door frame and one foot of the adjacent SE entry door are decayed
- the Boiler room door paint is poor

Repair decay at feet of door frames at Boiler and SE Entrance and paint frames and door	38
Replace and seal wooden capping on NE sign	111

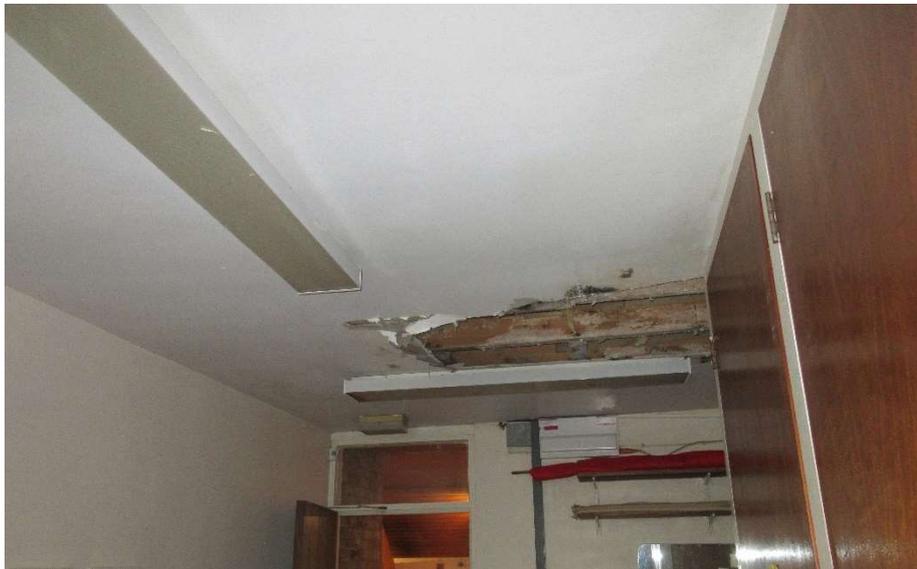
45. At Church pale varnished softwood boards at roof level. Small scorches caused by former spotlights.
46. The N Lobby, wcs and stores have good painted plaster. Most extension plaster is fixed to trussed rafters, part is fixed under retained concrete roofs. The N extension and Vestry ceilings were insulated.
47. At the Vestry about 2 square meters of flat ceiling plasterboard has recently fallen due to roof leak over.
Condensation inside Vestry window

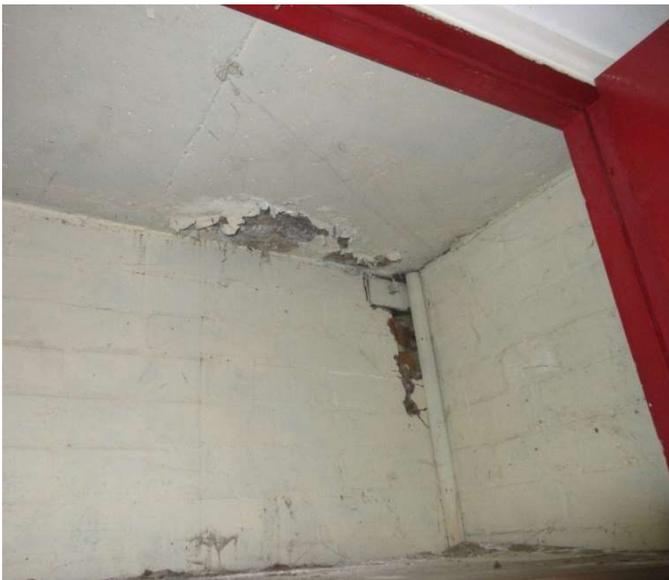
50. The exposed concrete roof slab over the SE Lobby and Store is painted. Unchanged paint and concrete damage at the top of the lobby SW cupboard wall next to the Boiler room suggests an old roof leak.

In cupboard off SE Lobby

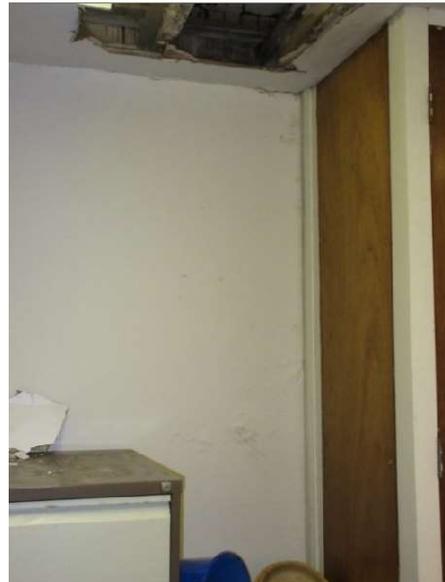
54. The Vestry, Meeting room inner walls, N Lobby, stores and wcs all have painted plaster in good condition except some blistered paint at the Vestry W wall just left of the built-in cupboard, worst at top. The damage is next to and part of the ceiling failure. No damage in the Ladies on the other side of the wall.
55. Kitchen fully tiled with slight mould on some upper grouting, again suggesting excess vapour. The N wcs and Cleaner's store external walls have insulated dry lining in good condition.
56. The SE Store partition is unpainted inside and has no cover mould inside the door frame.

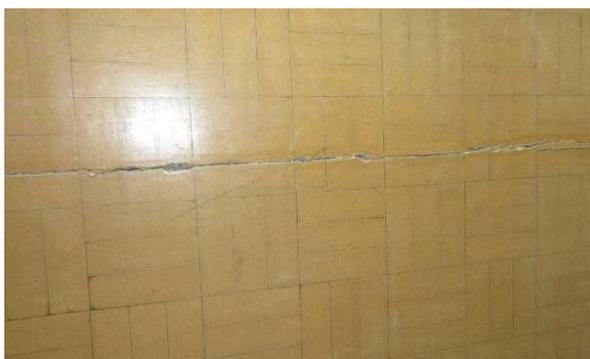
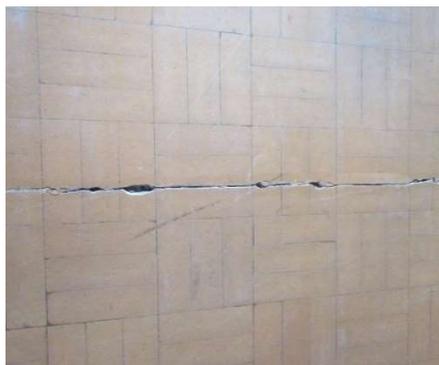
71. Since 1994 the cracking has steadily returned around all of the N, W and S sides of the Church and towards some of the convector heaters. Some edges at open cracks are broken, especially in the middle of the W side where people enter. The cracking seems unchanged so merely unsightly.

72. Cutting new movement joints carefully positioned over each side of the ducts in strips of replacement blocks may prevent future cracking. This would need removal of areas of blocks to trace the ducts fully. Or the whole floor could be covered with a different sheet material.
73. The Hall and SE Lobby floors are hardwood blocks, some slightly loose.
74. Carpet at Meeting room and steps up at each end. Clean off carpet on solid in N entrance Lobby. Vinyl sheet in Kitchen, Cleaner store, N store and wcs. All sound.
75. The two communion rails are heavy angled hardwood on steel legs dropped into five sockets in the carpeted dais. S half slightly loose in the sockets.

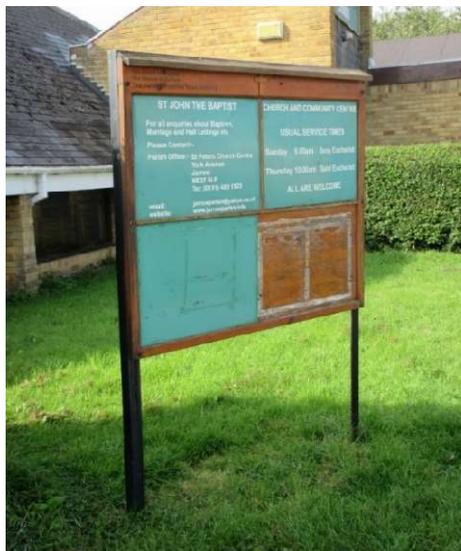
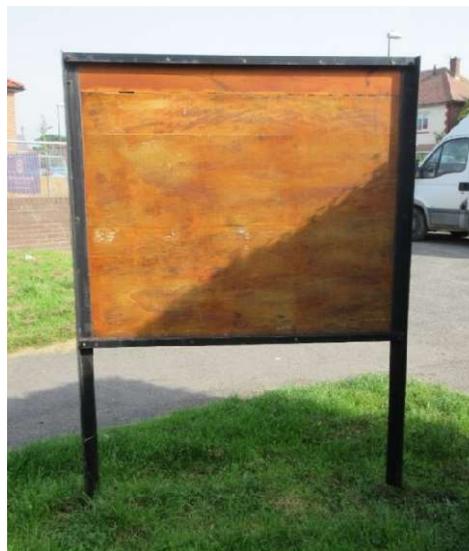
A good free-standing public sign in stained softwood on steel angle legs. Slight decay at wooden capping.

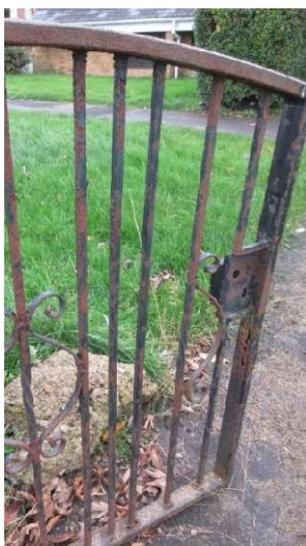
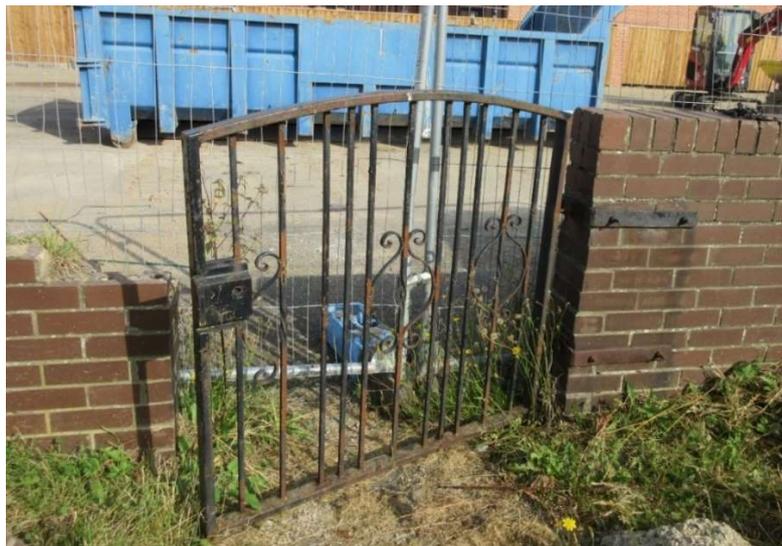
112. Rust advances at the steel gate to the car park at N.
