## 2025 QUINQUENNIAL INSPECTION REPORT

### CHURCH OF ST. ANDREW, ROKER

(Ref: 2518)

**Date of Report: 22<sup>nd</sup> May 2025**

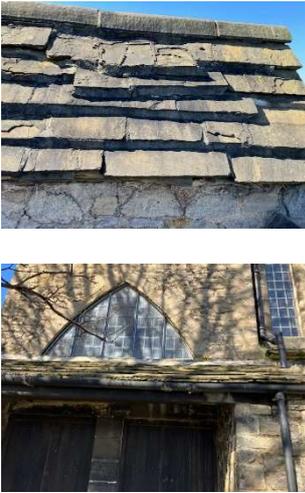
Reference	Condition	Action	Priority	Cost£	Photograph
11.	Porches have stone slates, water ingress and daylight visible through southwest roof.	Investigate and repair as necessary.	X	?

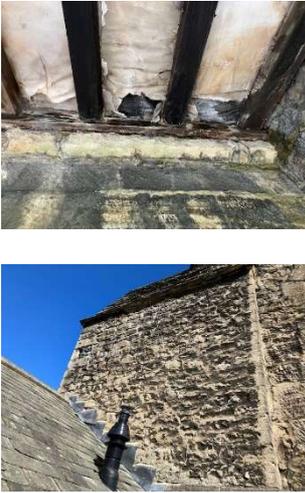
12.	West flashing to Priestman Hall entrance slipped.	Re-fix flashing.	A(M)	50
