Quinquennial Inspection Report

St Luke's Church, Pallion, Sunderland

Date of inspection: 18 September 2023

Date of report: 27 September 2023

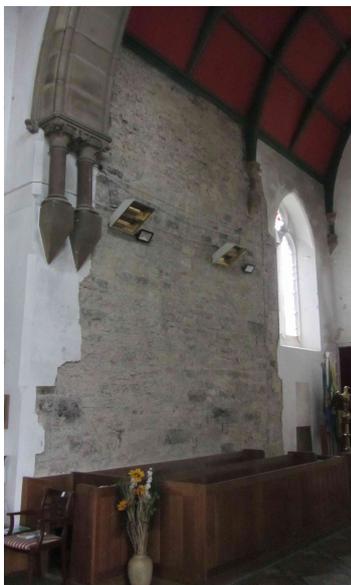
Chancel – north wall

2.6 Internal wall finishes		
Condition	<p><u>Chancel:</u></p> <ul style="list-style-type: none"> ▪ East gable and south wall – mould discolouration and some faking paint ▪ North wall - the previously blistered plaster has been removed from 80% of the north wall. The walls appear to have dried out since the previous inspection though this should be tested with a moisture meter at various heights. The remaining plaster by the north window is in similar condition to the east and south walls. <p><u>Nave:</u></p> <ul style="list-style-type: none"> ▪ East wall – stonework to Chancel arch in fair condition. Some, cracks, mould and flaking paint to plasterwork above the arch. ▪ South wall – some blistering plaster and paint at high level between 2No westernmost windows; some flaking paint in lower arches. ▪ West gable – flaking paint near return to north wall; mould discolouration above the window arch; some cracks at high level and a long crack from the window cill downwards. ▪ North wall – plaster and paint flaking especially by return to west gable; some cracks; stone arcade of columns and arches in good condition. <p><u>North Aisle:</u></p> <ul style="list-style-type: none"> ▪ West half gable – in poor condition with detached plaster and badly blistering paint resulting from water ingress through upstand wall above. ▪ North wall – crumbling plaster and paint by west gable return; some localised cracks. ▪ East half gable – cracks and mould.

Repair needs	<p><u>Chancel:</u> North wall – the cause of the damp (which resulted in the plaster being removed) needs to be fully investigated and appropriate action taken. It may have resulted from the catastrophic leak through the tower roof which damaged all the plaster and ceilings in the Tower. It may also have been caused through a leak in the valley gutter between the south face of the Tower and the north roof slope of the Chancel roof. Only when the dampness has been cured and the north wall is dry, can replastering and redecoration be carried out. (See 1.2 and 1.3 for actions).</p>
