Holy Trinity Church, Pelton

Quinquennial Inspection Report
September 2019

H P Massey BA, BArch. (Hons)
Inspecting Architect

Quinquennial Inspection Report
Church	Holy Trinity, Pelton
	Diocese of Durham
	Archdeaconry of Sunderland
	Deanery of Chester-le-Street
Professional Advisor	Hugh Massey (BA, BArch) Hugh Massey Architects designhaus 205 Park Road South Moor Stanley Co. Durham DH9 7QE Tel: 01207 280095 Email: hugh.massey@hughmasseyarchitects.co.uk
Date of Inspection	September 2019 Fair Weather

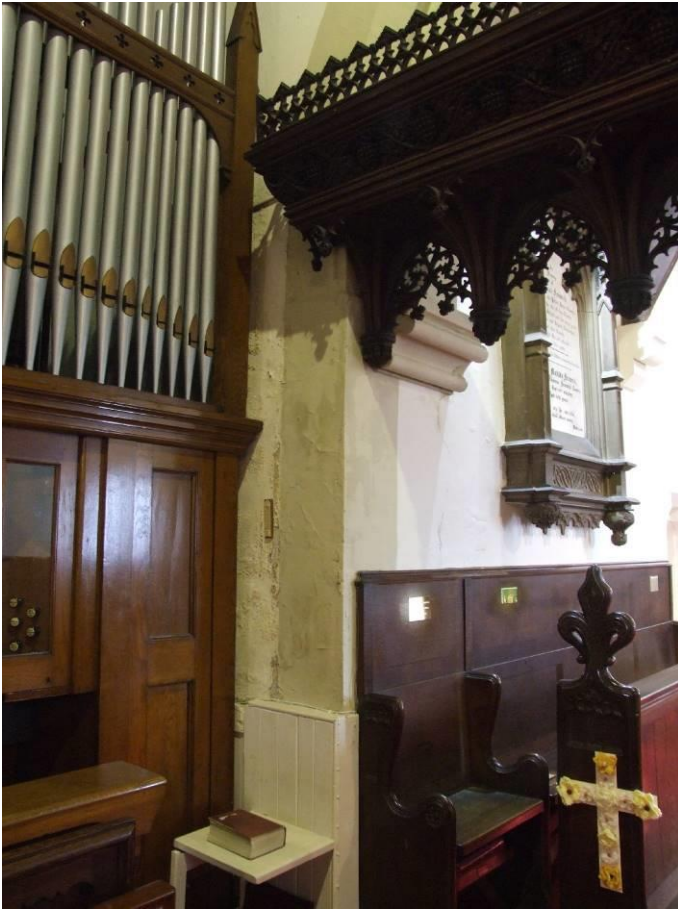
P1 (8795):
Efflorescence at northern side
of chancel arch

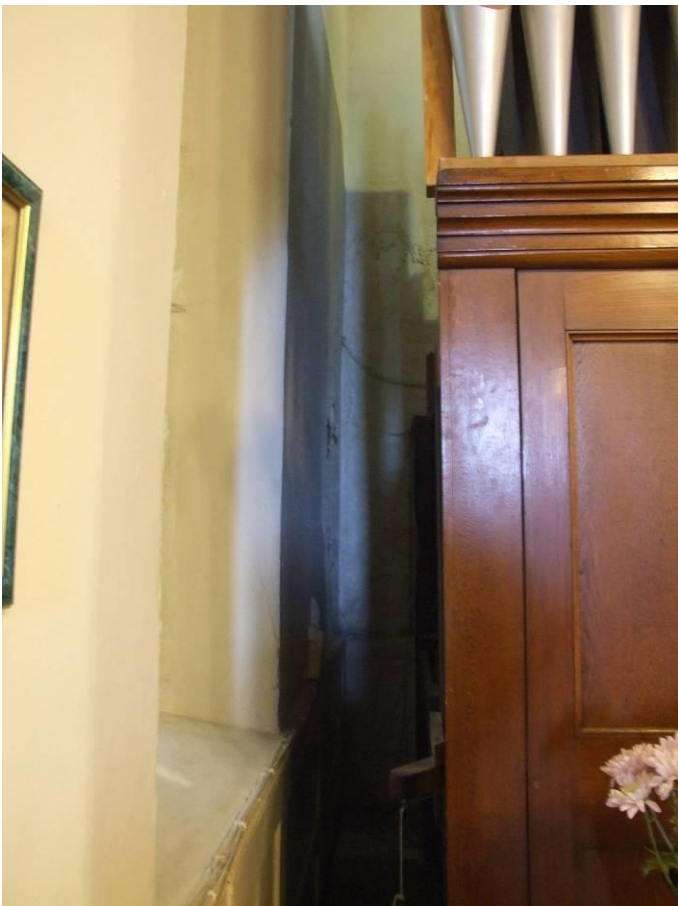
P2 (8798):
Efflorescence to north chancel arch wall,
behind organ

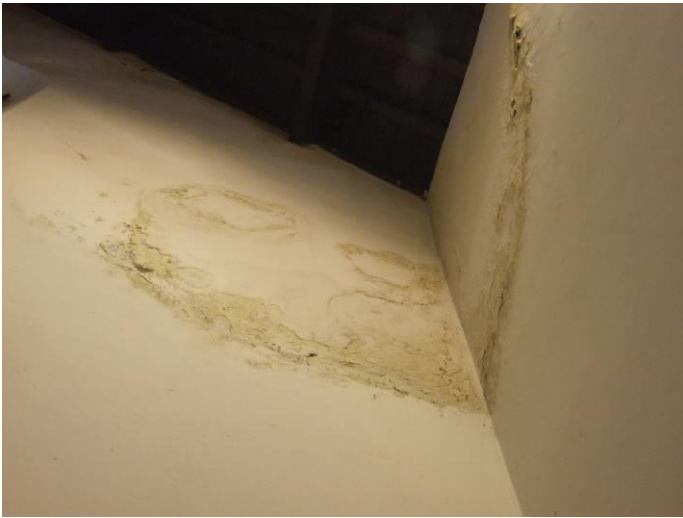
P3 (8796):
Historic water staining to Nave south
wall/chancel arch wall

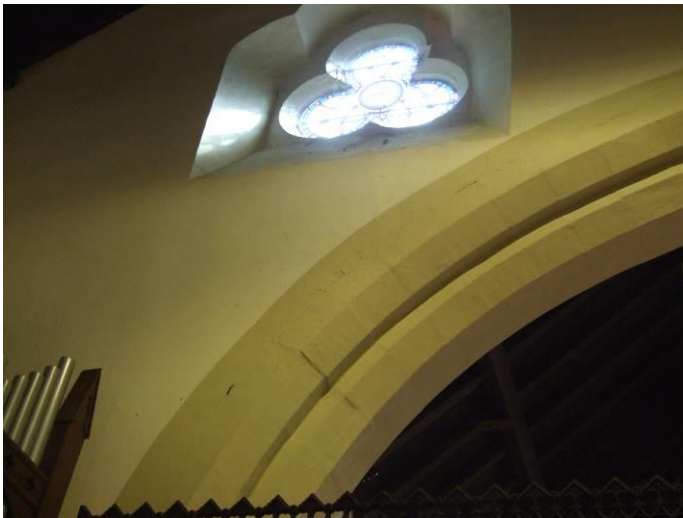
P4 (8797):
Chancel arch, slight stone displacement

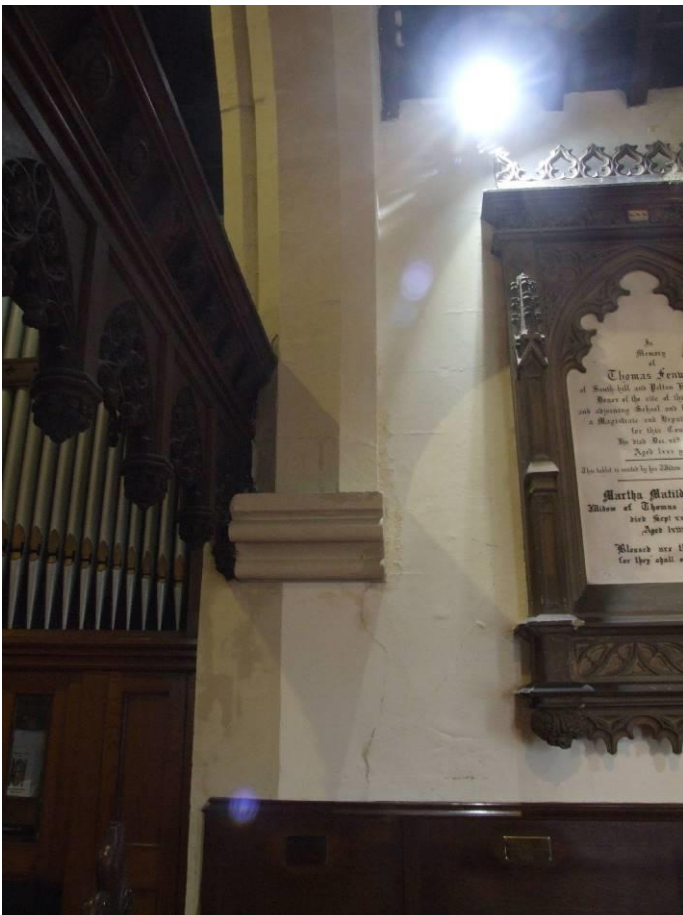
P5 (8799):
Efflorescence at northern side of chancel
arch, chancel north wall

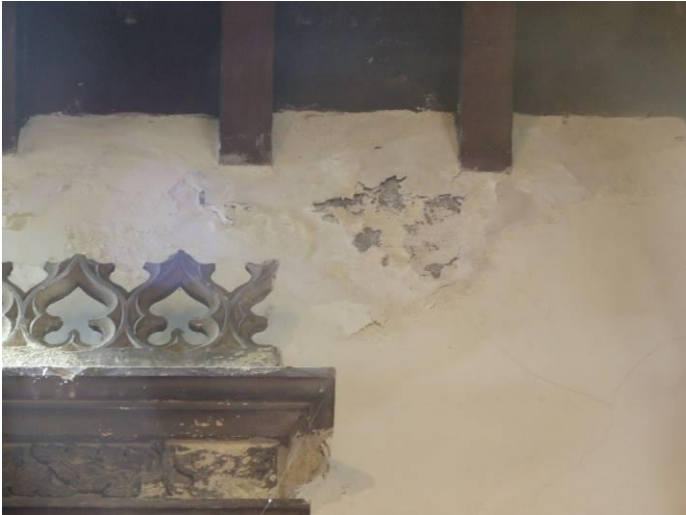
P6 (8800):
Efflorescence to chancel north wall, above
monument

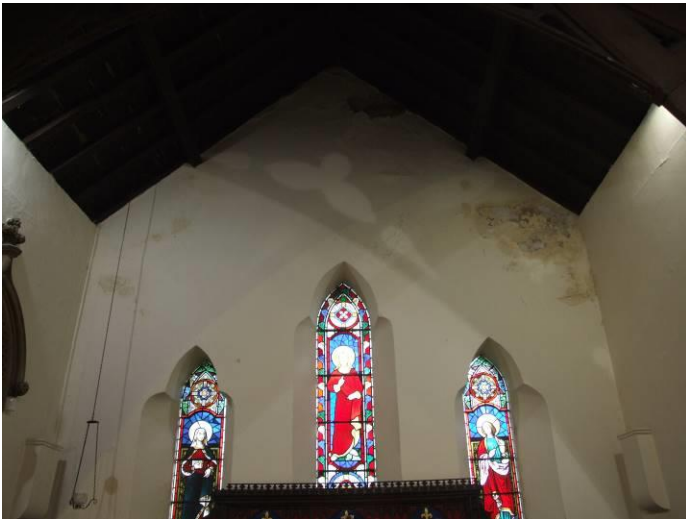
P7 (8801):
High level efflorescence to chancel
east wall, south side

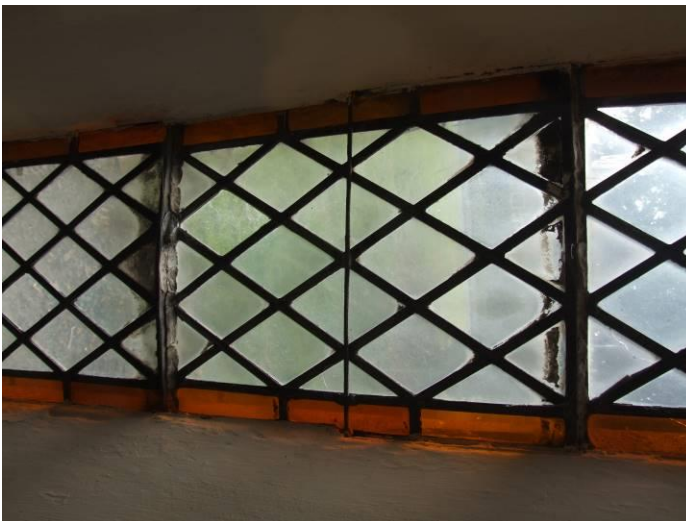
P8 (8803):
Chancel south side window, leading bowed
inwards

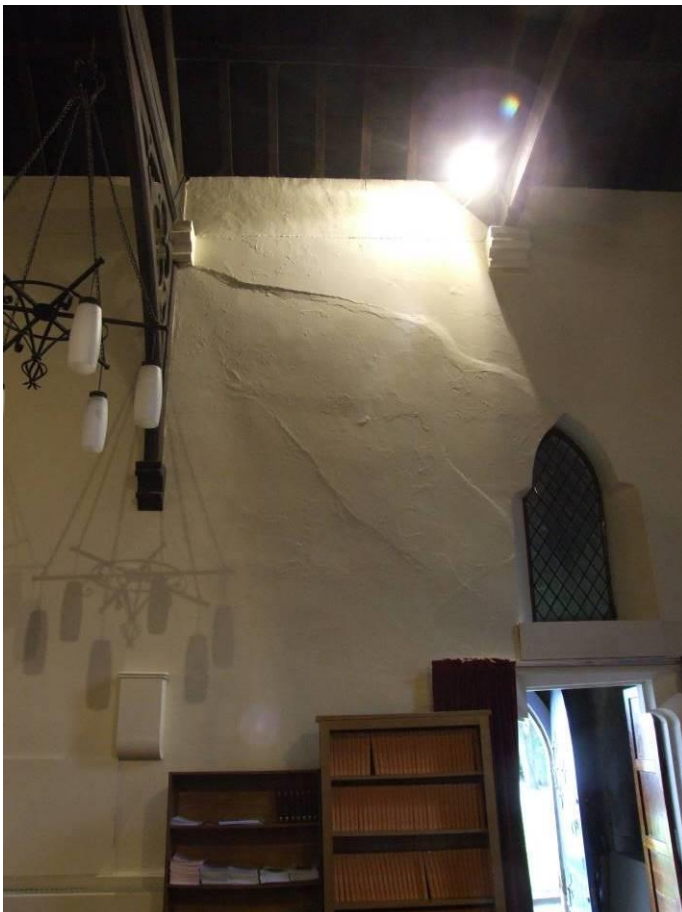
P10 (8817):
Historic cracking, nave wall, south side above porch door (may relate to former organ loft position)

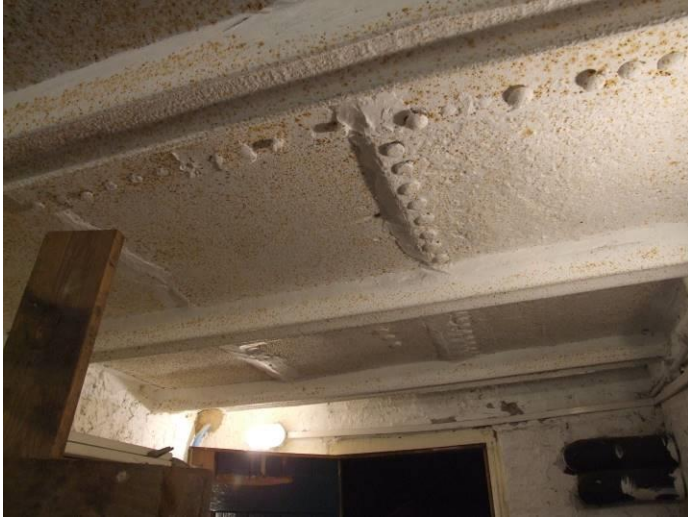
P11 (8826):
Store room ceiling; second-hand boiler plates
and rail structure

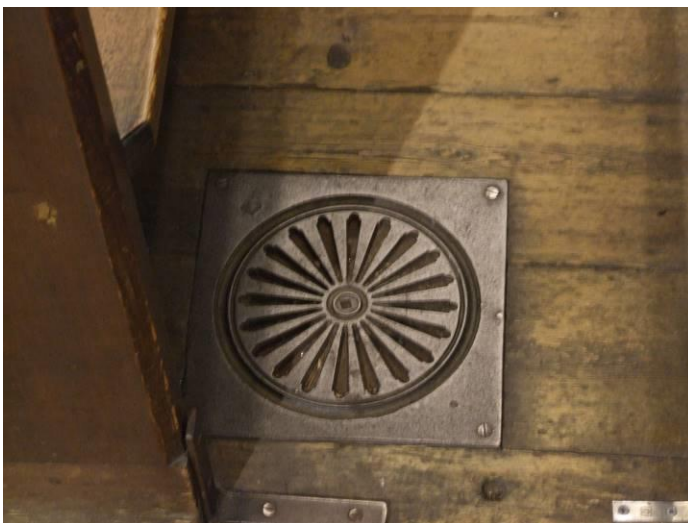
P13 (8834):
Redundant floor heating outlet

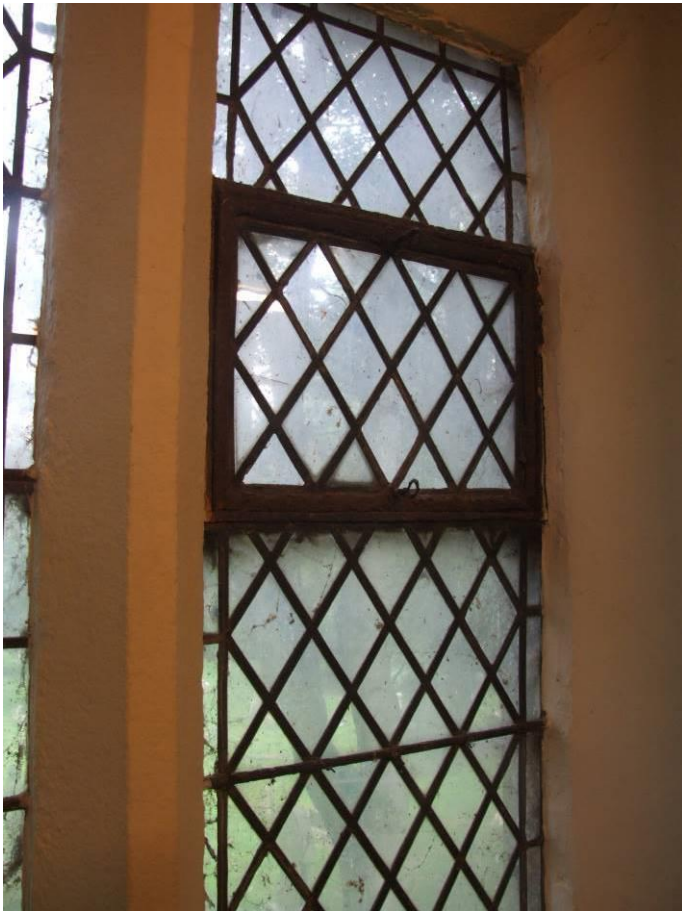
P17 (8850):
Vestry opening lights,
no longer operable

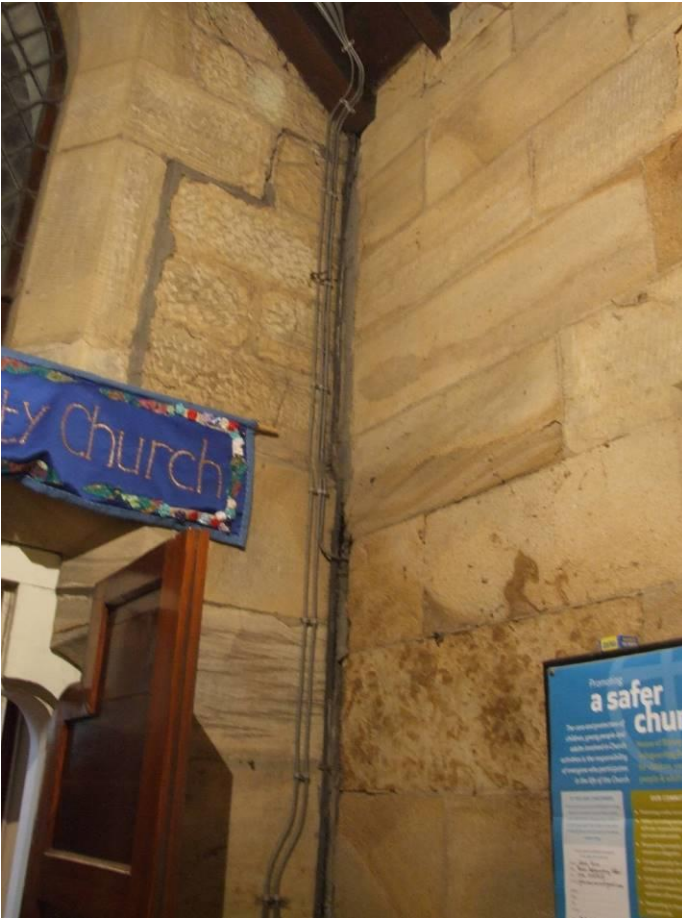
6.1.3	Porch: The Porch/south Nave abutment has separated, probably caused by differential settlement. The gap has been pointed up and may still be active. This should continue to be monitored.

P21 (8856):
Movement cracking between south porch
interior and nave

Remove old pointing to Porch walls abutment and re-point in lime mortar and monitor movement	6.1.3	£300.00
Replace old hard cement pointing with lime mortar, as listed	6.2.1/ 6.2.3/ 6.2.5	£300.00
Re-fix loose frame of Vestry Entrance door	7.2/14.1	£70.00
Replace broken and worn stone flags to entrance porch	9.7	£300.00
Continue to maintain organ annually	11.1	£150.00 pa
Re-fix loose hinge of central altar rail	11.5	DIY
Continue to maintain boiler and Vulcan heater	12.2	£230.00
Continue to test lightning conductor every five years	13.5	£100.00
Continue to test intruder alarm regularly	13.6/14.3	£150.00
Continue to check fire extinguishers annually	13.6	£150.00
Install new extract ventilation to toilet	16.3	£400.00
WORK RECOMMENDED TO BE CARRIED OUT DURING NEXT 5 YEARS - Category 3		
Renew eroded stone to left hand side door jamb of porch	6.2.2	£500.00
Replace 3 No. missing air bricks to wall plinths	6.2.4	£400.00

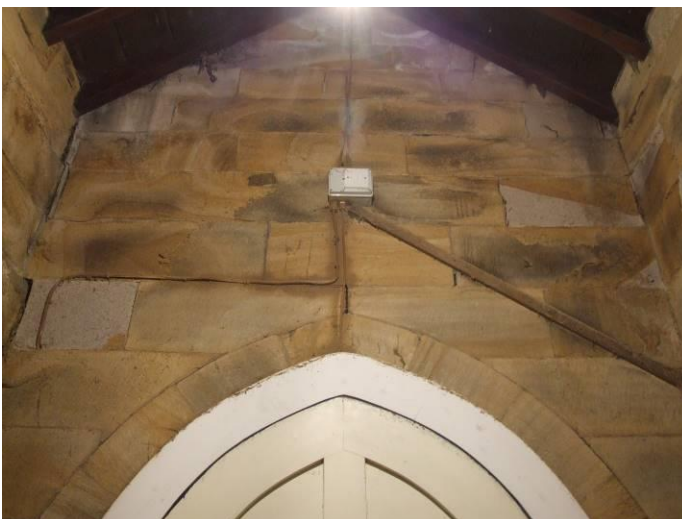
P22 (8857):
South porch stone,
moisture penetration

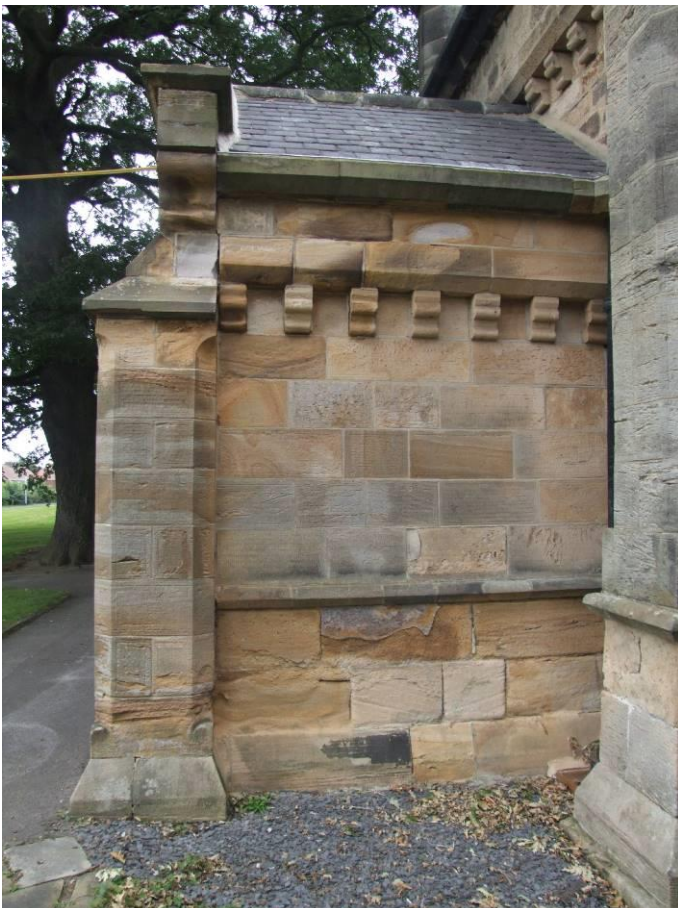
6.2.2	Porch: Masonry at low level is eroding, especially to the door jambs, caused by rising damp and will need renewal in the next few years. There is also surface erosion at high level which should be monitored at future inspections.

P24 (8859):
South porch, low level stone face loss

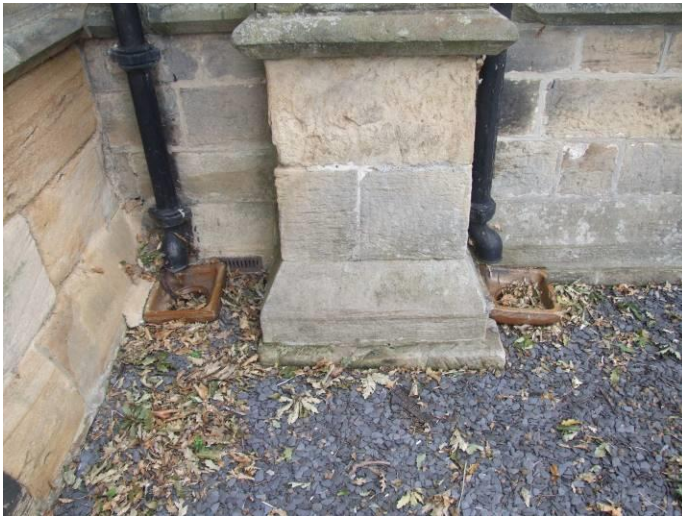
P26 (8861):
Surface water gullies ahead of leaf fall

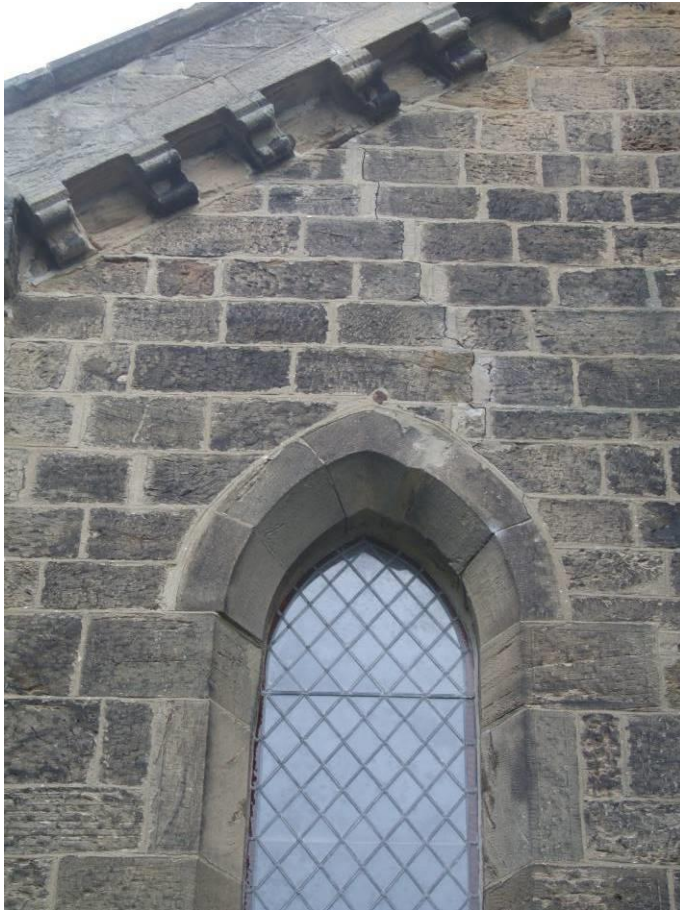
6.2.5	West Gable Wall: Settlement crack over left hand side north elevation up to roof corbels has previously been pointed but has re-cracked and will need repointing in soft lime mortar to act as a monitor for future movement.

P28 (8867):
Historic cracking, west end

Re-point crack in masonry to west gable of Nave	6.2.5	£300.00
Re-point low level masonry to east gable wall	6.2.6	£250.00
Add frame and weather strip to gaps of entrance door / redecorate	7.1	£500.00

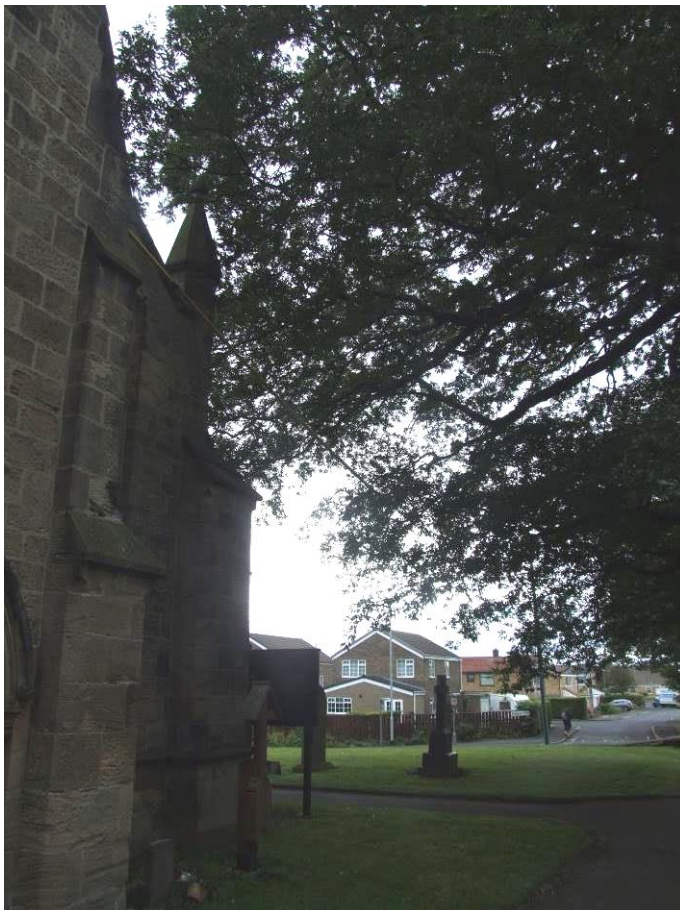
P29 (8868):
Tree proximity, west end

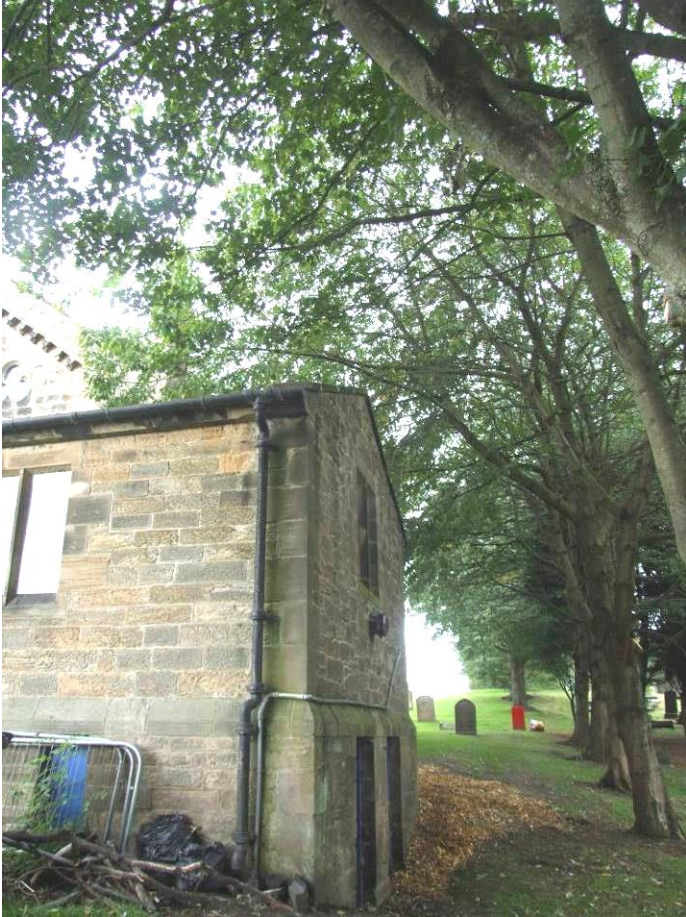
P30 (8877):
Tree proximity, north side

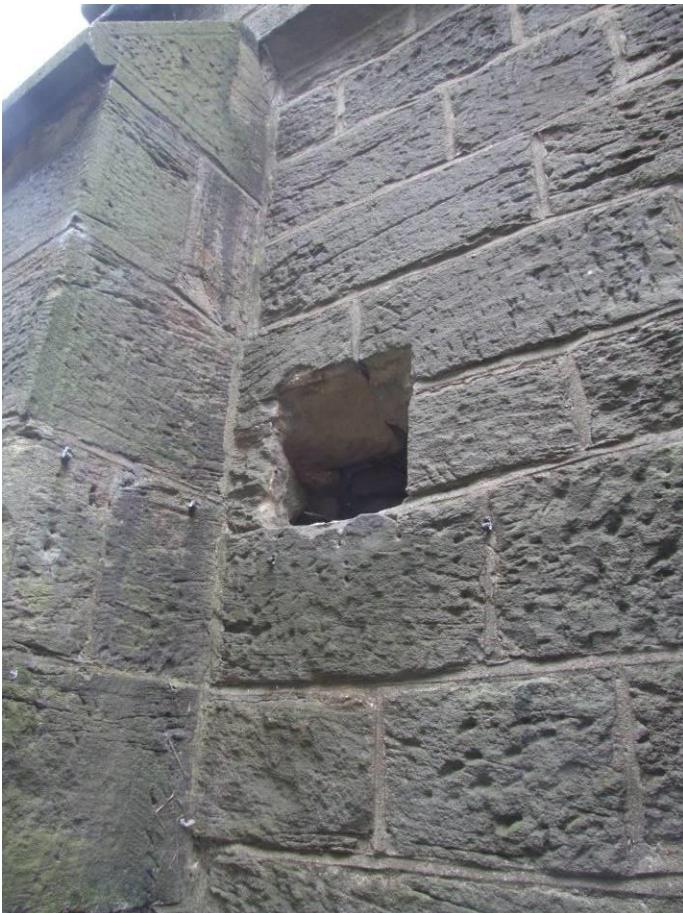
P31 (8880):
Stone removal, to be rectified
