2024 QUINQUENNIAL INSPECTION SURVEY REPORT

HARTBURN: PARISH CHURCH OF ALL SAINTS

Date of Inspection: 11th July 2024

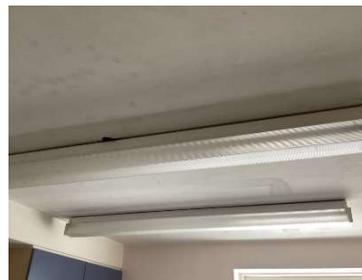
3.2 Ceiling has clearly been repaired in the past and there are some marks on it which could indicate some damp and condensation issues. It seems more likely that this is a condensation issue as there is a note asking users of the kitchen to use the fan to expel air when the kettle is boiled. Nonetheless, it would benefit from redecoration and tidying up when the lighting has been installed.

3 £500

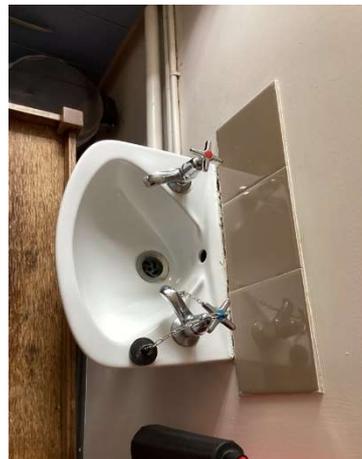
3.3 Walling is in reasonable condition. It is mainly painted, with a tiled splashback, but is missing some grout around the sink. Re-sealing the hand washing sink is required.

2 £50

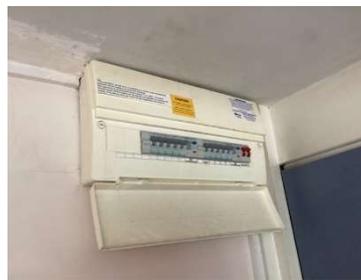
3.5 Electrics are not believed to have been tested within the last five years and there is an issue with the electrics and loading. This should be resolved and a full electrical test should be carried out.

1 £500

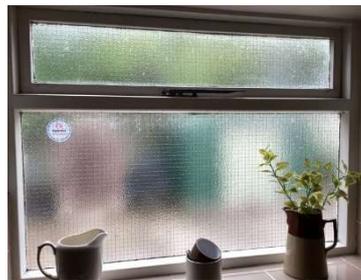
3.6 The window in this room is in reasonable condition, but requires redecoration.

2 £300

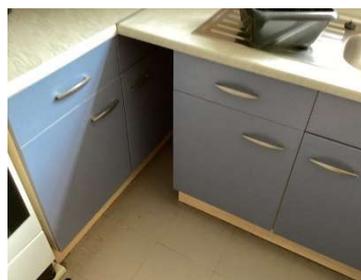
3.7 The kitchen cabinets are showing their age a little bit, and there is some delamination of some of the veneers in places. However, it remains in relatively usable condition.

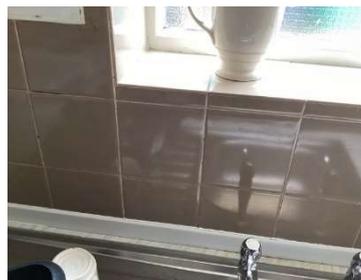
3.8 Some re-sealing is required around the kitchen sink and some of the tiles require some additional grouting.

3 £200

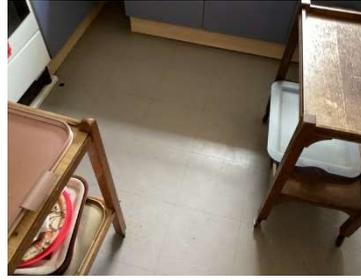
3.9 The flooring appears to be in reasonable condition, as it is throughout this building. It should be checked for asbestos.

2 £300

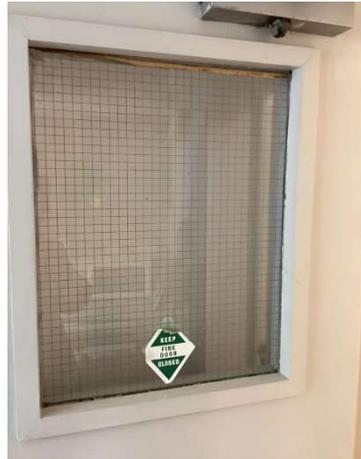
3.10 The glass panel in the kitchen door has slipped. The sealant around the glazing panel should also be checked for asbestos, and the glass panel should be pushed back into place.

2 £300

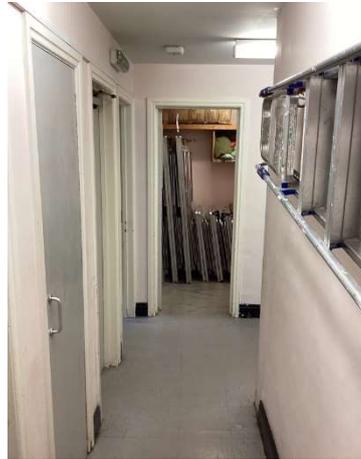
The corridor is plastered and painted, with a vinyl tiled flooring. It is generally in fair condition, although decoratively a little tired. All the doors and timberwork are in need of redecoration.

3 £1,000

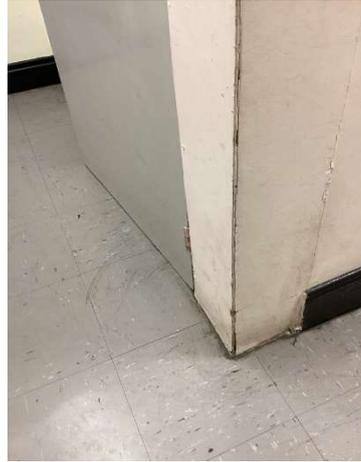
3.12 There is a split in some of the frontage to the cupboard, this should be repaired.

3 £200

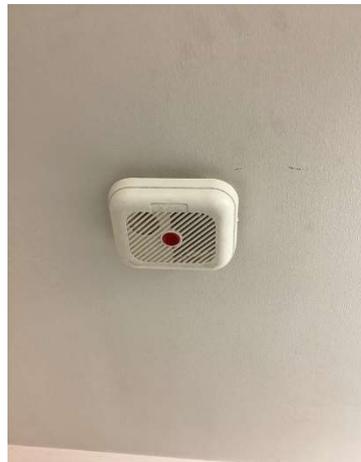
3.13 The smoke alarm should be checked for the date of change. This is an older style alarm, and it may well have passed its expiry date.

1 £30

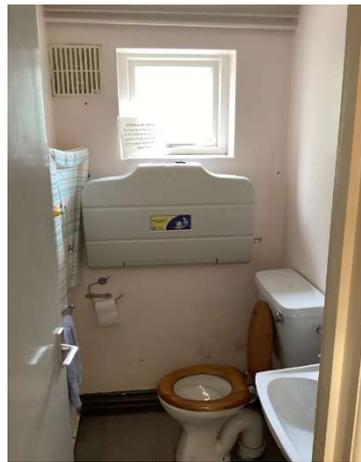
The female WC is in reasonable condition. It is serviceable and the baby change is also in here. It is plastered and painted, with the same vinyl flooring throughout the rest of the building. There is a little bit of damp on the external wall, but this can be redecorated and monitored.

3 £500

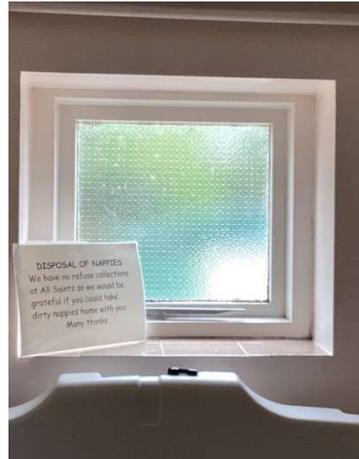
3.15 The window would benefit from redecoration.

3 £200

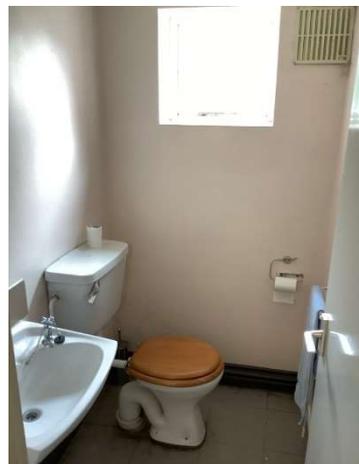
The male WC is plastered and painted, with a vinyl flooring, much like the rest of the building. The room is decoratively a little tired and would benefit from some redecoration, but the WC is functional. There is some mould again on the external wall. It seems likely that this would benefit from redecoration and may actually be related to condensation rather than a damp issue.

3 £500

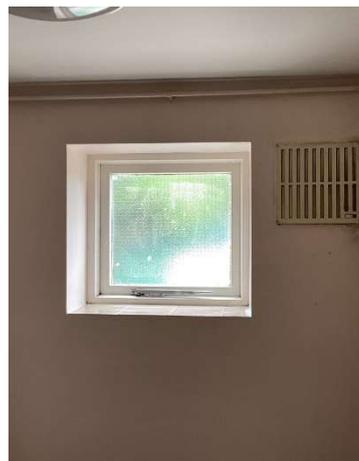
3.17 The window is in need of redecoration.

3 £200

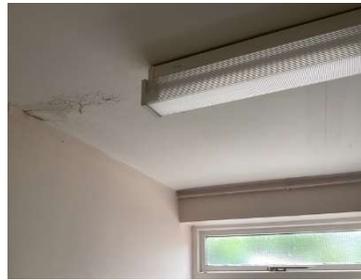
- 3.20 Plastered and painted, ceiling is in reasonable condition, although there is a plaster fracture running down the ceiling and there is also some water damage. The source of the water damage should be investigated and repaired. The area will need replastering and redecoration. Small plaster fracture can be redecorated and repaired at the same time.

2

£1,000

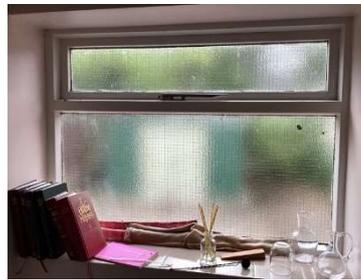
- 3.21 The window cill is rotten and as such towels are currently used to stem the persistent water ingress. The window requires repair and redecoration.

2

£300

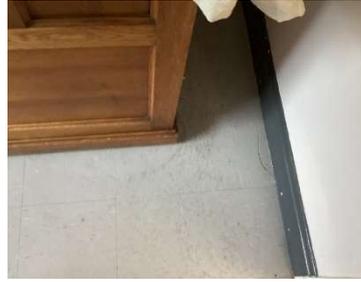
3.23 Aside from a small split in the vinyl towards the wall, the cupboard next to the flooring appeared in reasonable condition.

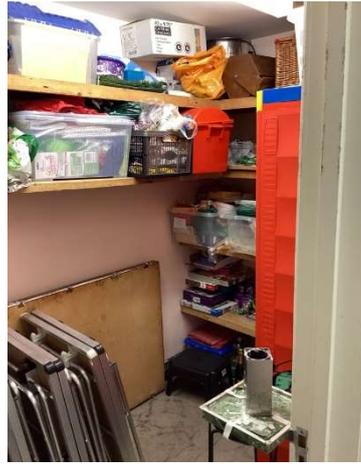
Storage cupboard is generally in good condition and has been well utilised to store materials. The security of the shelving should be checked, as it does bow slightly, but other than that it appears to be in good order.

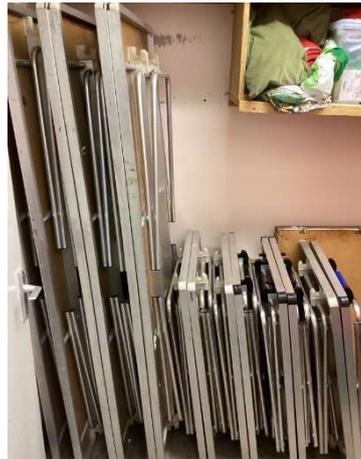
3.26 Walling and flooring is a little damaged from the moving of furniture, and it may be worth adding some protection to the walls to protect them from damage from furniture being leaned up against them, but this is a desirable improvement.

5 £300

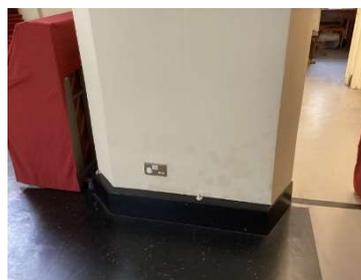
3.29 Walling is for the most part in good condition, particularly having been recently redecorated. There is a little bit of dampness towards the lower section of the wall in the middle of the building. This is probably formerly an external wall and it lacks a bit of airflow. Replastering in a lime plaster may well resolve it, but given that the rest of the building is painted in modern materials, it would be best just to keep redecorating this area. The damp is unlikely to be resolved.

2 £300

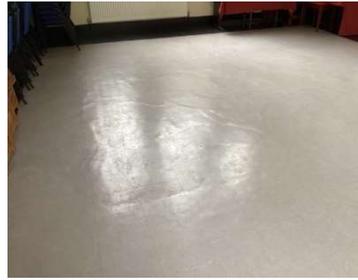
3.30 Flooring is the same vinyl tile that exists in the rest of building. It is a little uneven in places. It will be a desirable improvement to replace this.

5

£3,000

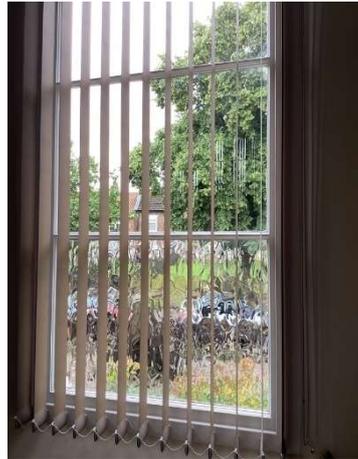
3.31 Windows are in reasonable condition, but it is understood that they don't open and this is a problem for ventilation. They should be modified so that they can easily and securely be opened.

4

£1,000

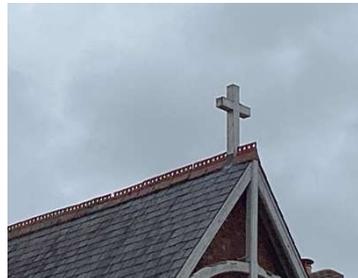
- 4.4 The cross will require redecoration within the next couple of years.

2

£1,000

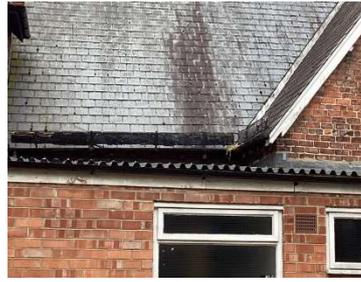
- 4.6 The remains of the snowboards towards the lower reaches of the roof should be removed as they are now heavily rotted.

2 £500

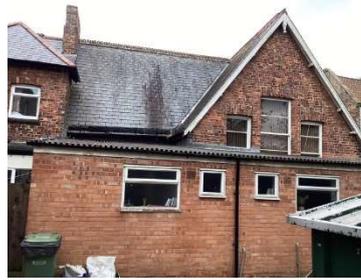
The roof of the extension is a modern profile metal roof. It was a little difficult to view from below, but it does broadly speaking seem to be in reasonable condition. However, there is a leak or evidence of some water ingress within the vestry. A roofer should be asked to investigate this further.

2 £500

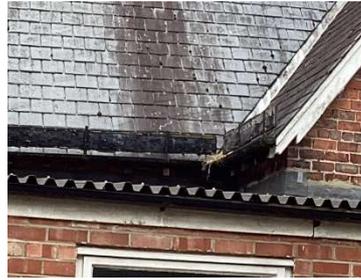
Rainwater goods are mainly plastic and generally speaking appear to be in reasonable order, although the upper sections need clearing.

2 £500

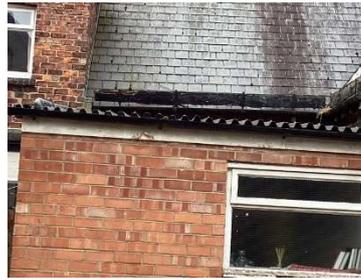
- 4.9 The arrangement of carrying water over the extension roof to the gutter is likely inadequate for the volume of water involved. Additional outlets should be introduced or potential removal of the gutters to the other section and just allowing the water to pass over a wider section of roof.

2 £500

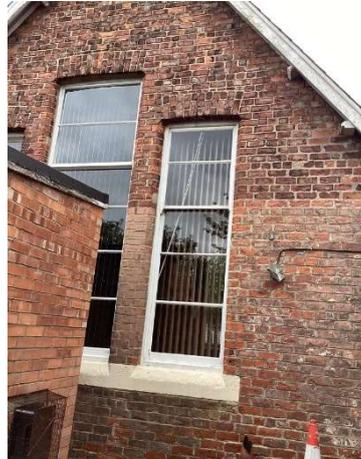
For the most part, the pointing and brickwork on the rear elevation seem to be in good condition. The lower portion of the walling has been repointed in a hard cementitious mortar, however, the brickwork is holding up quite well. There is also quite a bit of brick replacement here.

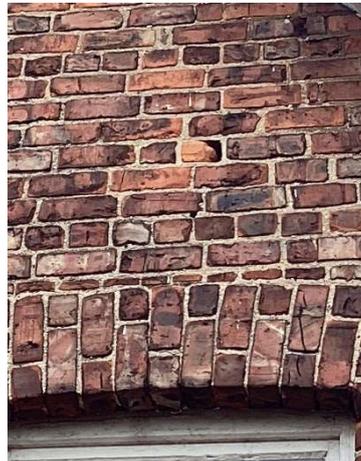
4.12 There is a single brick at high level within the gable which requires replacement.

3 £200

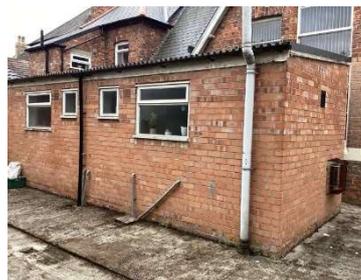
4.13 Brickwork to the extension generally seems to be in good condition. Pointing is tight and the window cills appear to be in good condition. There is a little bit of spalling below the damp proof course, but nothing too concerning.

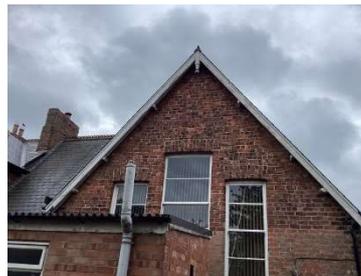
4.14 All of the timberwork externally is in poor condition, timber bargeboards on both the extension and the main building have failed and require redecoration and repair as a matter of urgency. If this work is carried out sooner rather than later then some of the timber may well be saved, otherwise a significant amount of replacement will be required.

2 £3,000

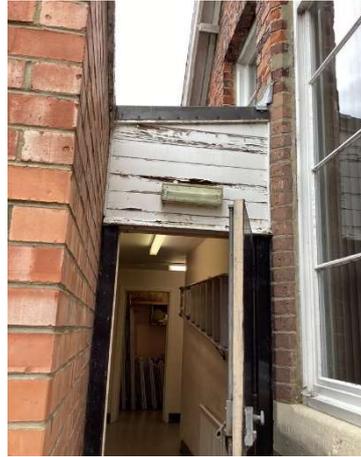
4.15 On the extension, the timber boarding over the doorway has failed and requires replacement.

2 £1,000

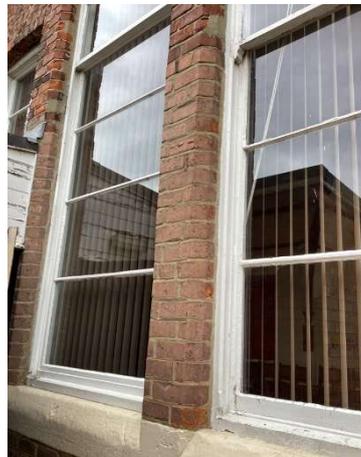
4.16 The windows all require some attention. Those on the main hall are in better condition than those on the extension. The hall windows do require some work, but this is mainly splice repairs, particularly to cills and glazing bars.

2 £2,000

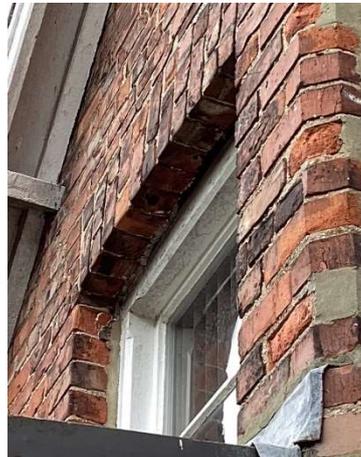
4.17 There are some areas of failed pointing over the windows that would benefit from being refilled.

2 £500

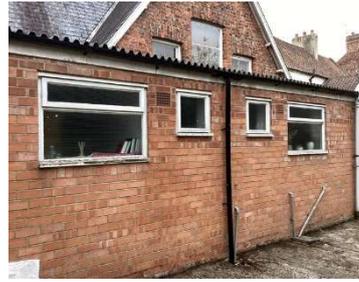
4.18 All of the windows on the extension require attention, particularly to the cills and particularly to the vestry window where the cill has almost completely rotted away. All these windows are single glazed and it would be worth considering upgrading these to double glazed units, which will help with the buildings thermal performance.

2

£5,000

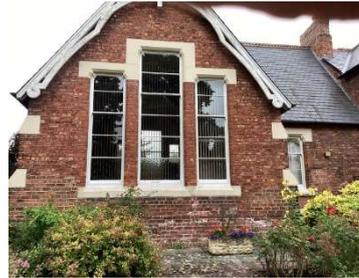
Elevation is also brick built, with large stone dressings. For the most part the brickwork is in good condition and pointing seems reasonable at lower level. However, there has been some repointing in cementitious mortar and particularly at low level there is some salting on the brickwork. This may well resolve if the area is raked out and repointed in a soft lime mortar.

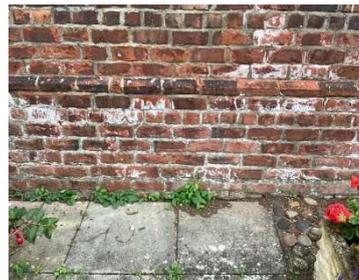
4.20 Raking out and repointing to the lower reaches of the wall will assist in the wall drying out.

3

£2,000

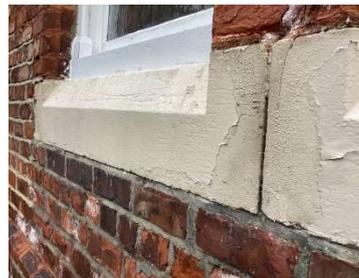
4.21 There is some open jointing throughout the dressings of the cills and a little bit of salting here to the mortar surrounding. This is actually very cementitious and very hard. Raking out and repointing would be beneficial here.

2

£1,000

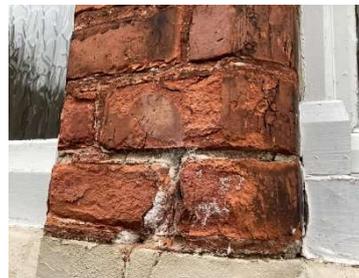
4.22 The lower reaches of the mullion brickwork has also suffered, although the mortar here has weathered back through salting. This has again probably been caused by over hard mortar. Raking out and repointing, with possibly some brick replacement, is needed here.

2

£1,000

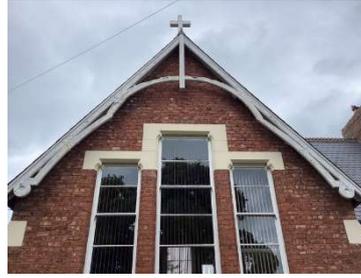
4.23 Again all of the timberwork, bargeboards and decorative external trusses are in poor condition and the timber all needs attention sooner rather than later. If redecorating and repair is carried out soon, it may well be that some of the timber can be saved, otherwise it will need a significant amount of replacement.

2 £3,000

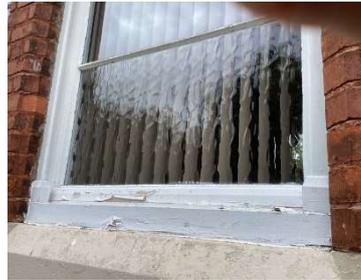
4.24 The same is true of the cills and some of the external window timbers. Some of this is in poor condition and certainly requires redecoration. Again, if this is carried out sooner rather than later, it may well be possible to save some of the timber here, otherwise, splice repairs will be required.

2 £2,000

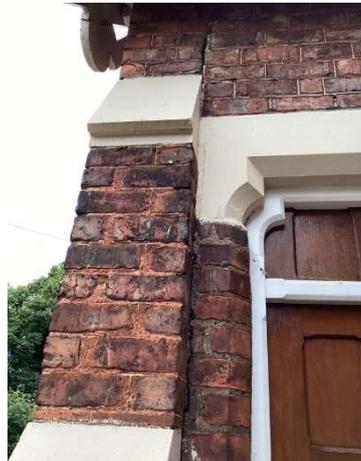
4.25 There is a little bit of separation between the buttress and the entrance door, and this should be repointed so that it can be monitored.

2 £500

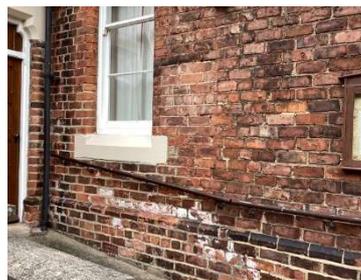
4.26 Again, around the entrance there is a little bit of over hard pointing and salting, and again this would benefit from being raked out and repointed in a lime mortar, particularly in areas where the pointing has completely failed.

3 £2,000

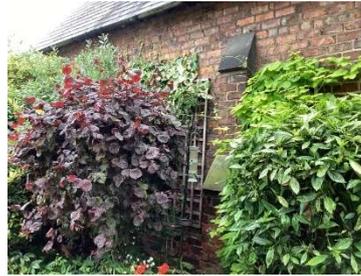
The side elevation is within the neighbour's garden and is a blind elevation, with brick buttresses. Generally the brickwork was in reasonable condition, but it would benefit from being repointed. The neighbour should also be discouraged from growing vegetation up against the walls as it will make the walls damp.

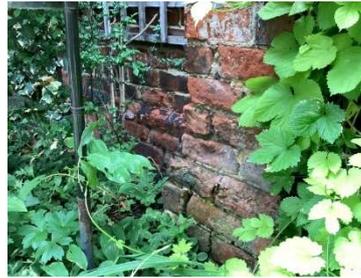
4.28 Particular at a low level the wall is very open jointed and would certainly benefit from a programme of repointing.

3

£5,000

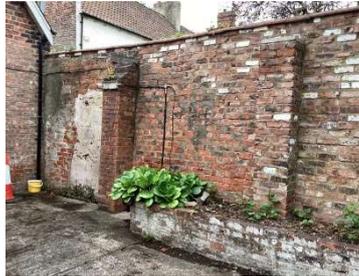
- 5.2 The re-built section of party wall with the adjoining property generally seems to be in good condition. The remaining sections that didn't collapse seem in fair order. Pointing is a little open and certainly cementitious, but it's in fair condition. Any vegetation growing out of joints should be removed and open joints should be repointed.

3

£1,000

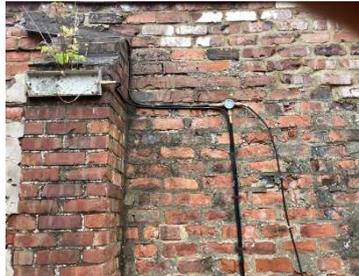
- 5.3 Redundant electrical fittings and wiring should be removed.

2

£500

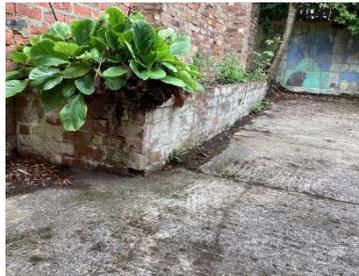
- 5.4 The remaining retaining wall of the flower bed is in poor condition and probably should be taken down, particularly if this area is likely to be used.

2

£1,000

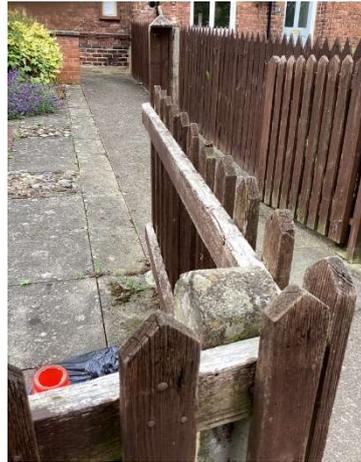
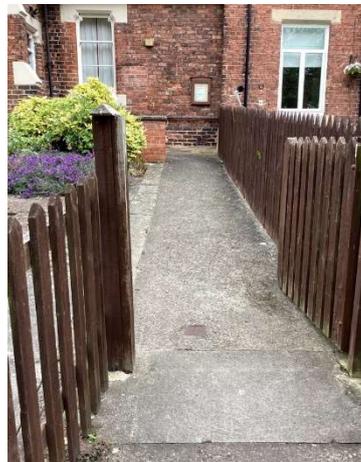
5.7 The front is bound by timber fencing with concrete posts. This looks a little decoratively tired and would probably benefit from a little bit of decoration and remedial work.

3

£1,000

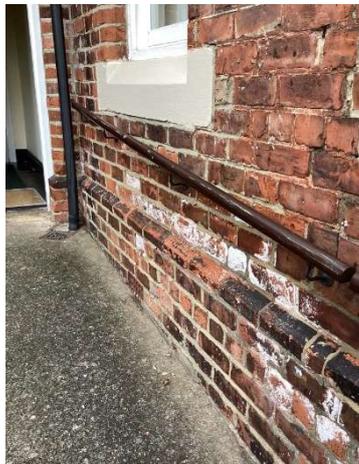
5.9 A handrail should be provided on both sides of the path and the one present should be re-decorated.

2 £500

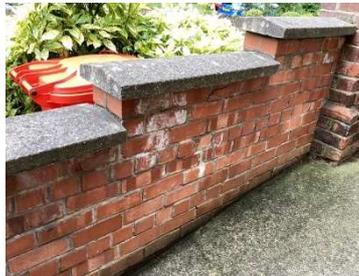
5.10 There was a bit of spalling brickwork and salting, and loose material should be removed and the salts brushed off.

2 £100
