Care of Churches and Ecclesiastical Jurisdiction Measure 1991 – Quinquennial Inspection  
**ST CHAD'S, ROSEWORTH – Non-Listed**

Diocese: Durham  
Archdeaconry: Aukland  
Church Code: 613 316

Date of Inspection: 07<sup>th</sup> Sept 2023  
Inspection undertaken by: Jamie Holden BA (Hons) RIBA RIAS  
Previously Inspection: May 2018 by Ian Ness

**Studio Tamacoco Architects**

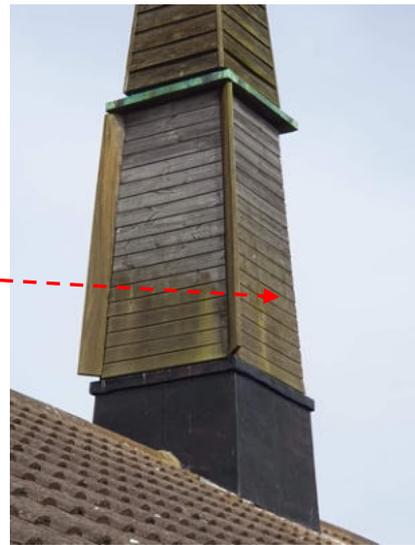
- 2.1.2 The lowest section of the spire, where the bell is housed, is detailed with a timber fin at each of the four corners. The fin to the southeast corner is missing and ought to be replaced. **2**

b) Replace missing timber fin.

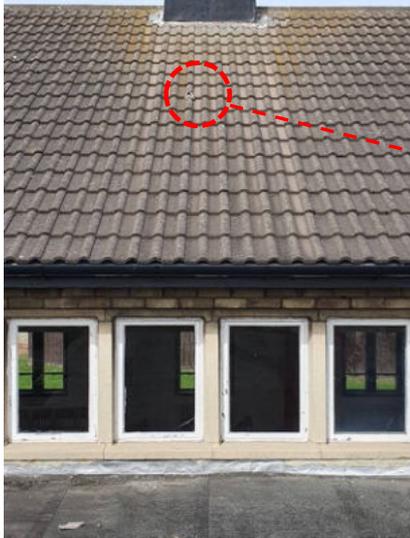
- 2.1.1 The main roof over the nave and chancel is covered with interlocking concrete tiles. The mortar pointing to the verge and ridges is all sound and overall the roof is in good condition with the exception of 1no. broken tile in the centre of the south slope directly below the spire. A membrane is installed below the tiles so the roof should remain perfectly weathertight for the time being, however, the tile ought to be repaired/ replaced promptly. **2**

a) Broken tile at the base of the spire.

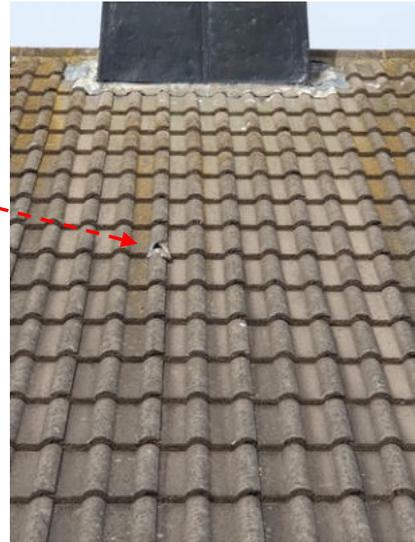
b) Tile to be replaced.

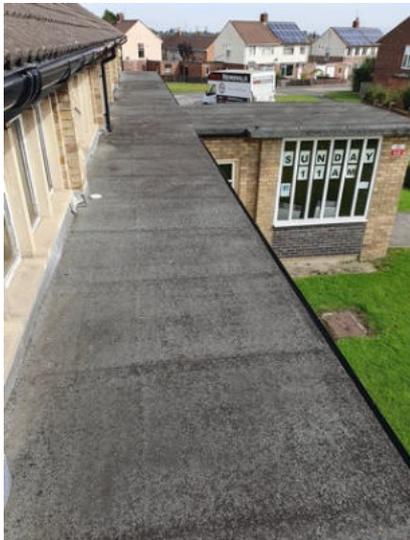
a) Flat roofs re-felted in 2016 all in good order.

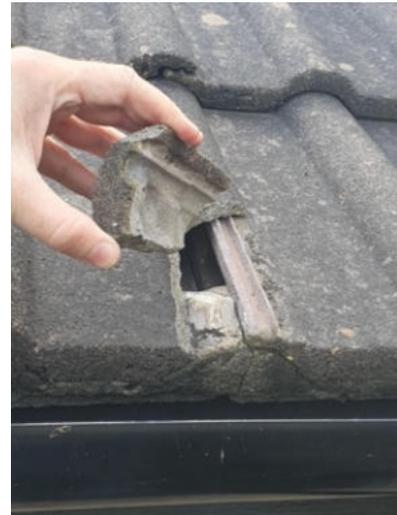
- 2.2.1 The tiling to the north roof slopes is all in good order with the exception of one tile on the chancel roof which has fractured and ought to be replaced. **2**
- 2.2.2 The mineral felt roof covering to the aisle, parish pantry and the apse is all in good order.
- 2.2.3 The SVP ought to have a cowl or mesh cover to prevent it becoming blocked by debris. **2**
- 2.2.4 A metal cross is fixed at the apex of the gable over the sanctuary and it appears to lean forward slightly. Daylight can be seen through its the bracket/ base of the stem. It is not clear whether this has any detriment to the fixing and stability of the cross, however, this should be checked. **M**

b) Broken tile to be replaced

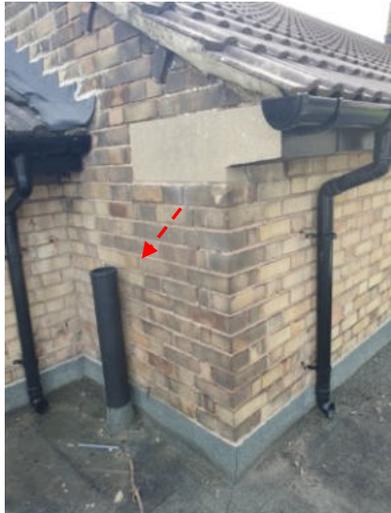
a) Install cowl/ mesh protection to SVP

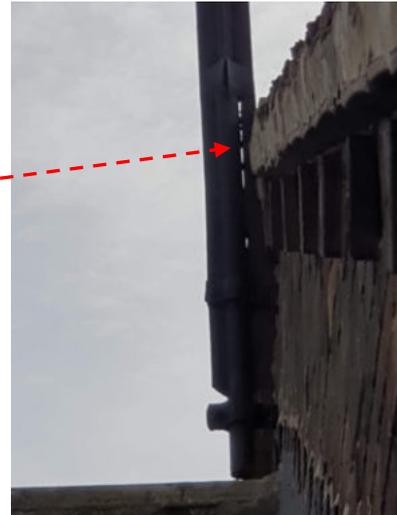
b) *Check fixing is secure*

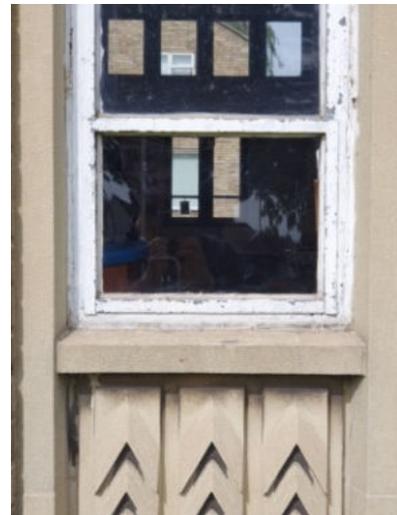
- 3.1.4 The metal frame windows are painted white and all would now benefit from redecoration as the paintwork is starting to flake and expose the raw steelwork. Note that when metal frame windows such as these are decorated it is very important that the opening mechanisms are not painted shut. **4**

*b) Metal framed windows would benefit from re-decoration.*

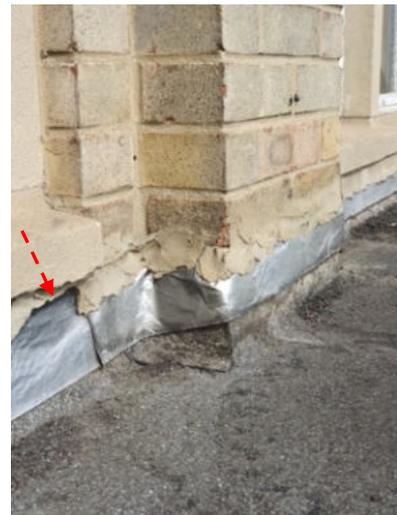
*b) Crude mortar pointing is unlikely to be prove very durable. Some pieces has broken away but generally intact.*

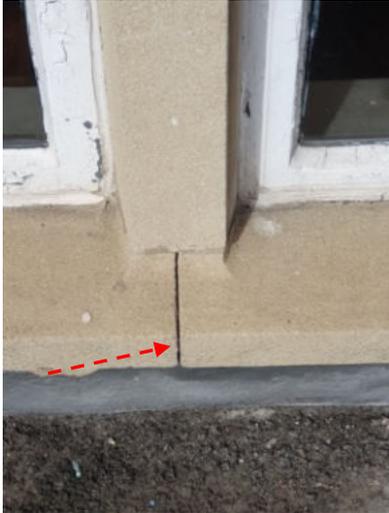
*a) Open joint in the cast stone cills need to be repointed but with much more care than was taken for the flashings.*

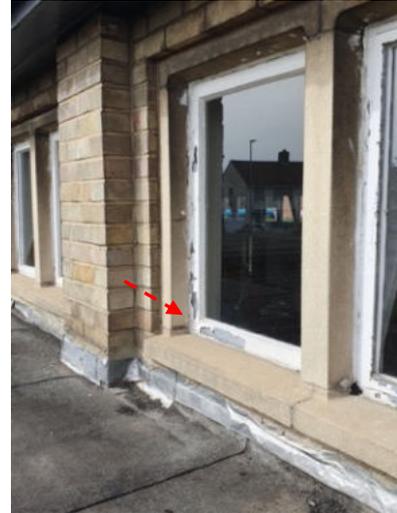
*b) The paint finish is starting to breakdown and expose the steelwork below. Redecoration would be beneficial but the opening mechanism of the window must remain functional.*

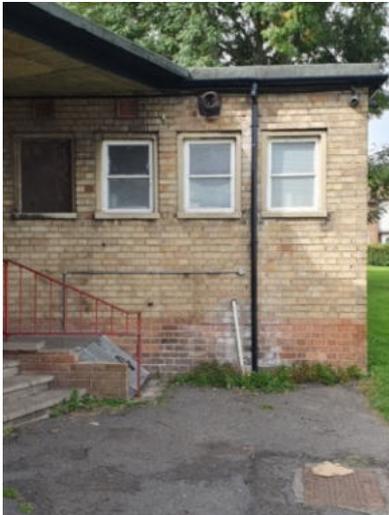
a) Moisture staining is longstanding. Probably the result of defective rainwater goods that have since been replaced.

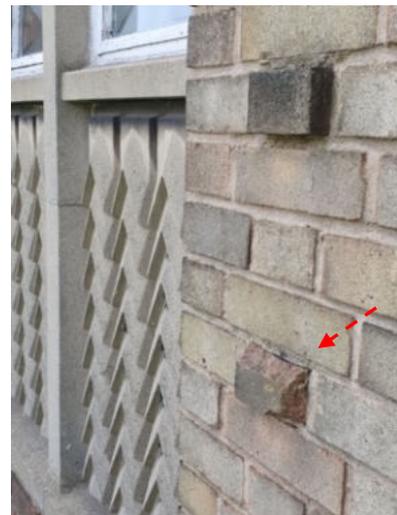
b) Damaged/ eroded headers.

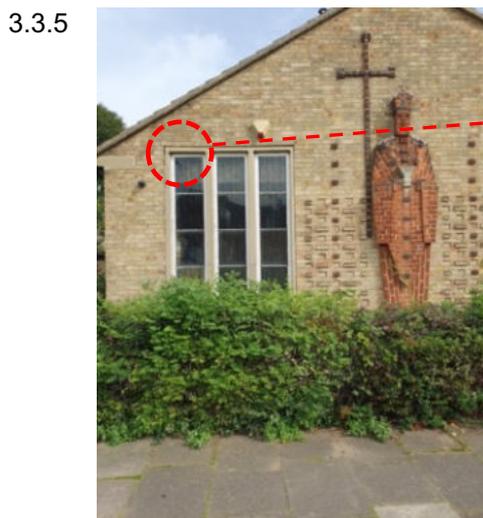
3.3.3 In the top left-hand corner of the window to the left of St Chad, the mortar has fallen out leaving an open joint between the brickwork and cast stone surround. This ought to be carefully repointed to prevent moisture ingress. **2**

a) Minor displacement and mortar loss from the joint between the cast stone surround and brickwork

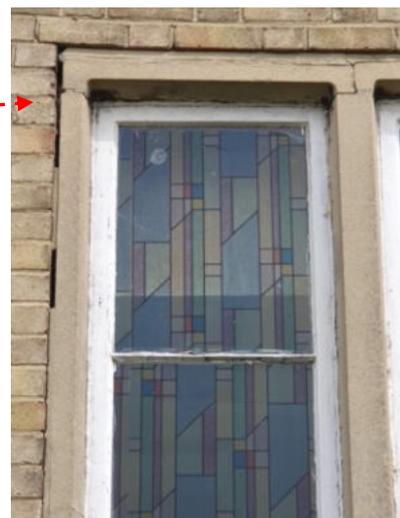
b) Carefully repoint the open joints

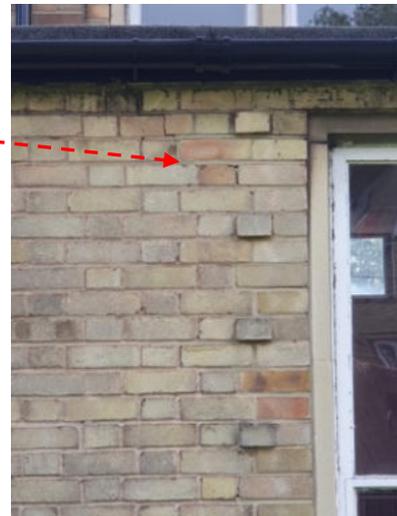
3.4.2 There are a couple of minor settlement cracks in the aisle window second from the west and around the abutment flashing at the far west-end of the aisle roof. These defects were alluded to in the 2018 QIR, they do not appear to have changed significantly but should remain under observation. ○

b) Stepped crack. Noted in the 2018 QIR. To be monitored.

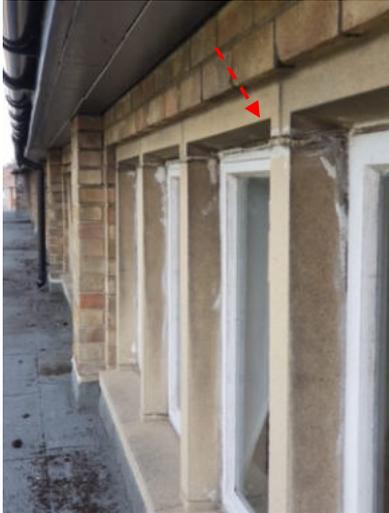
*a) Joints appear to have been sealed with mastic. Unattractive but functional.*

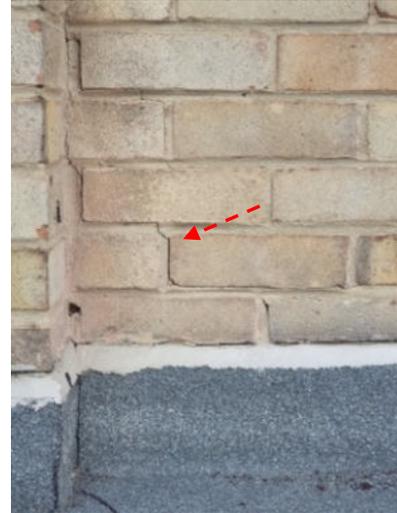
*b) Minor cracks in the last bay above the north aisle roof. To be monitored.*

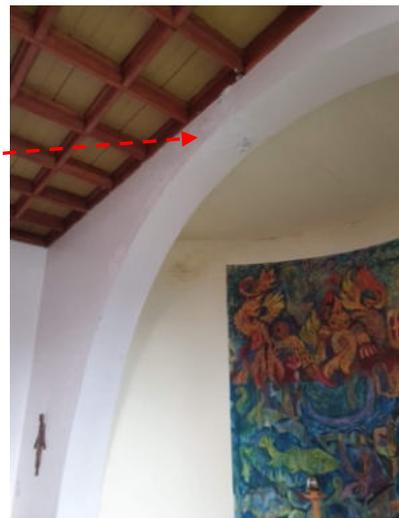
- 4.2.5 The walls are all in good order with the exception of two areas at the east end of the south aisle and at the centre of the arch. The plaster and paint finishes in these areas have been damaged by moisture ingress understood to be the result of leaking rainwater goods and flashings. As the defective rainwater goods have now been replaced once the walls have been given sufficient time to dry, ideally 12 months or so, they should be rubbed down and redecorated. 5

b) Defective finishes due to moisture damage

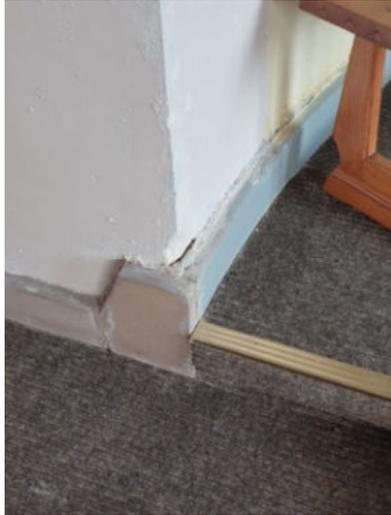
a) Minor defects at the base of the arch.

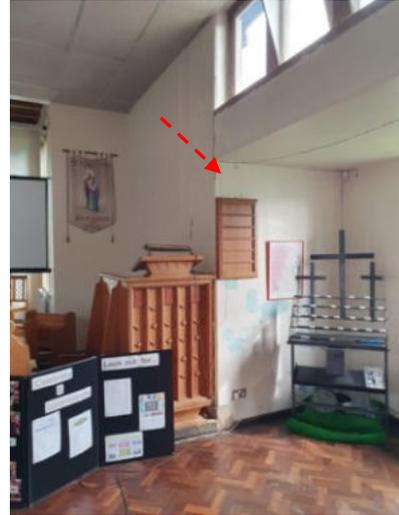
b) Defective finishes at the east end of the south aisle due to moisture damage

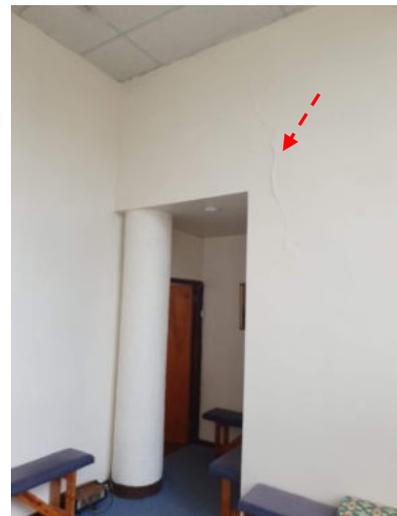
- 4.3.1 **Walls:** Exterior masonry walls and internal stud partitions form the south chapel. There is what appears to be a historic crack in the south wall which has been repaired previously and decorated over. The partition wall that separates the chapel from the vestry is panelled with storage cupboards at low level. All in reasonable order.

b) Historic settlement crack in the south wall

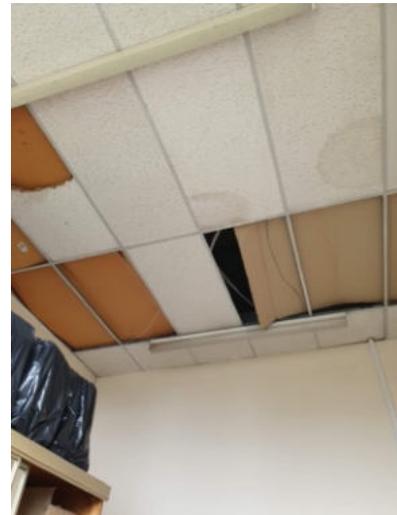
4.4.3 **Ceiling:** The same suspended ceiling system as found in the nave has been used in the vestry. However, nearly half the panels are missing or broken and sheets of hardboard appear to have been temporarily laid over the ceiling grid to block off the roof void. The broken and missing pannels ought to be replaced, however, this is an aesthetic concern and does not prevent the vestry being used for its intended purpose. **5**

b) Missing and broken tiles ought to be replaced

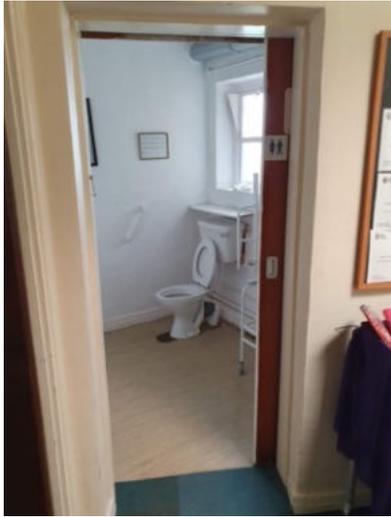
*a) The sliding door and other feature of the WC arrangement fall short of a fully compliant 'accessible' facility*

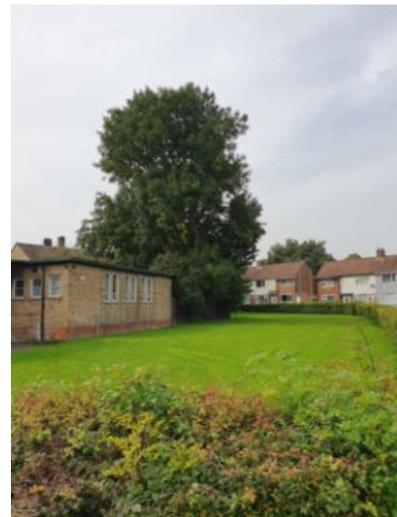
*b) The churchyard is mainly laid to grass and well kept. Note the large tree immediately adjacent to the parish room/ pantry needs to be monitored and managed.*
