Diocese of Durham

**St JOHN the Baptist
STOCKTON on Tees**

QUINQUENNIAL REPORT
on the architect's inspection on

25 July 2019

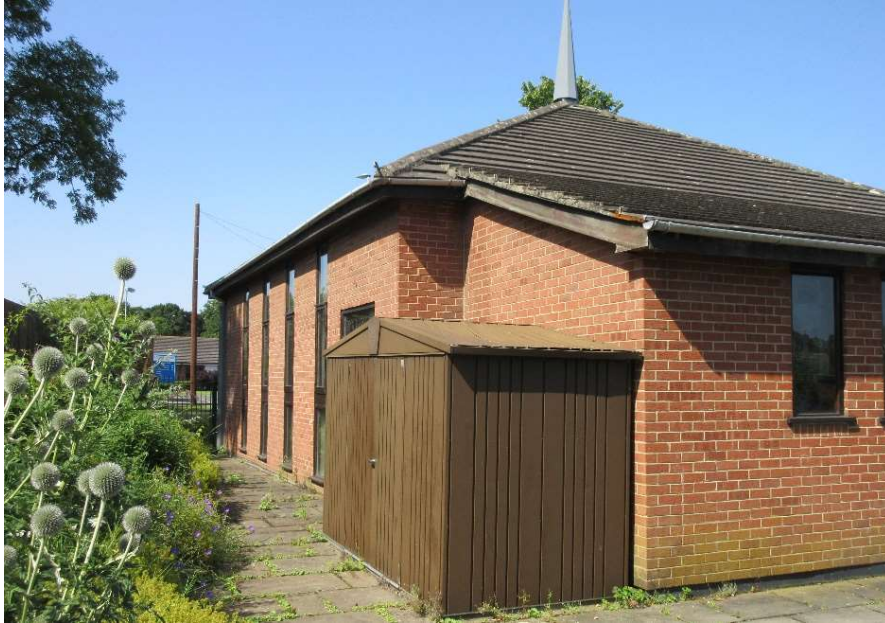
9. Interlocking concrete tiles at low pitch, sound. Minor loss of pointing at parts of the hips and verges.

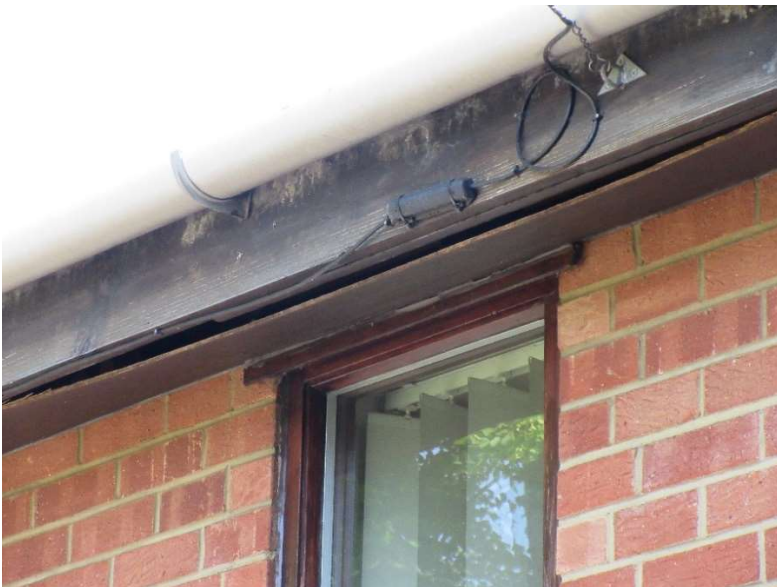
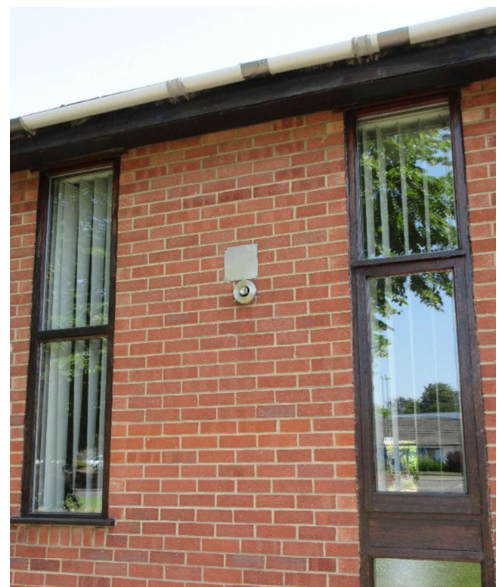
10. Eave fascias and soffits are brown stained softwood, mainly sound
The ply soffit facing Durham Road is part drooped, needing to be refixed or replaced and restained.
The side facing the Garden needs complete preparation and restaining.

Repair soffit board facing Durham Road	10
Restain fascia and soffit facing Garden	10

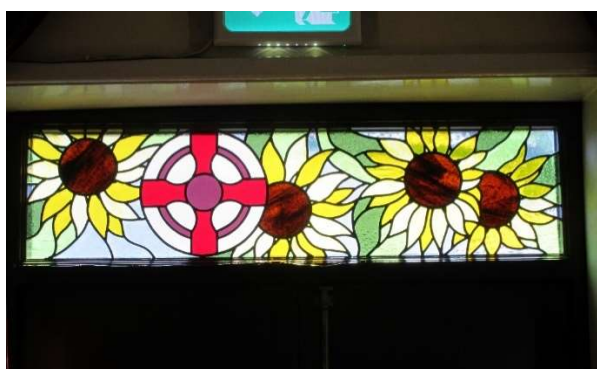
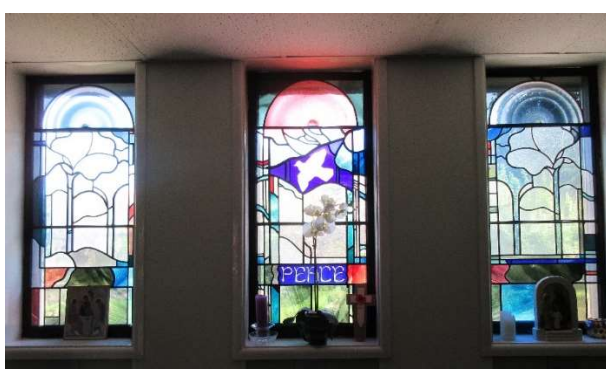
25. All windows and doors are plain double glazed except at the Chapel and escape door fanlight where leaded coloured glass is covered outside with single laminated glass.

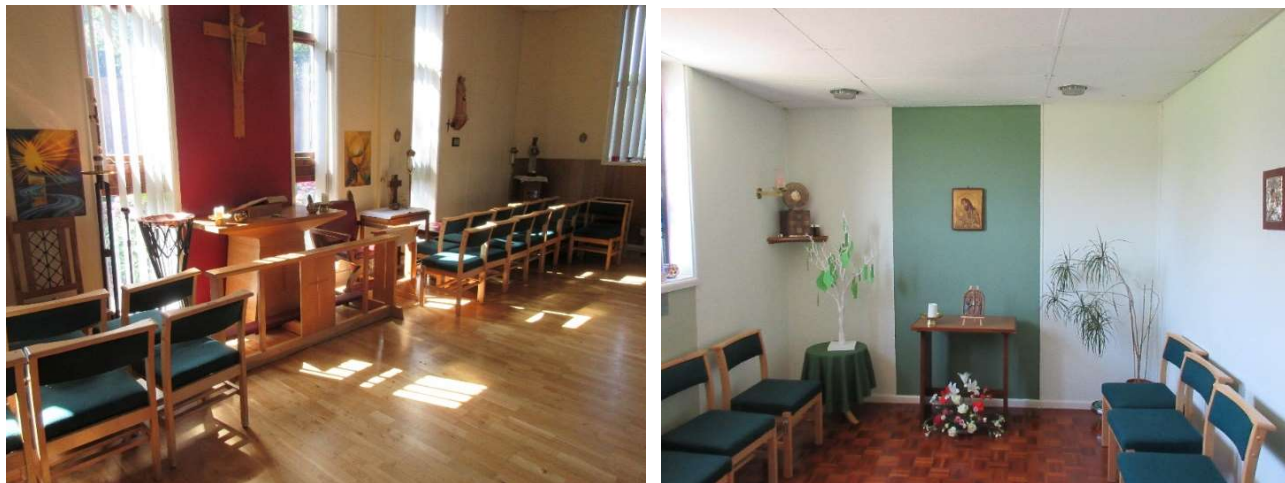
29. A carved hardwood Christ in Majesty on a wall panel painted darker than the remainder, behind the usual altar position.

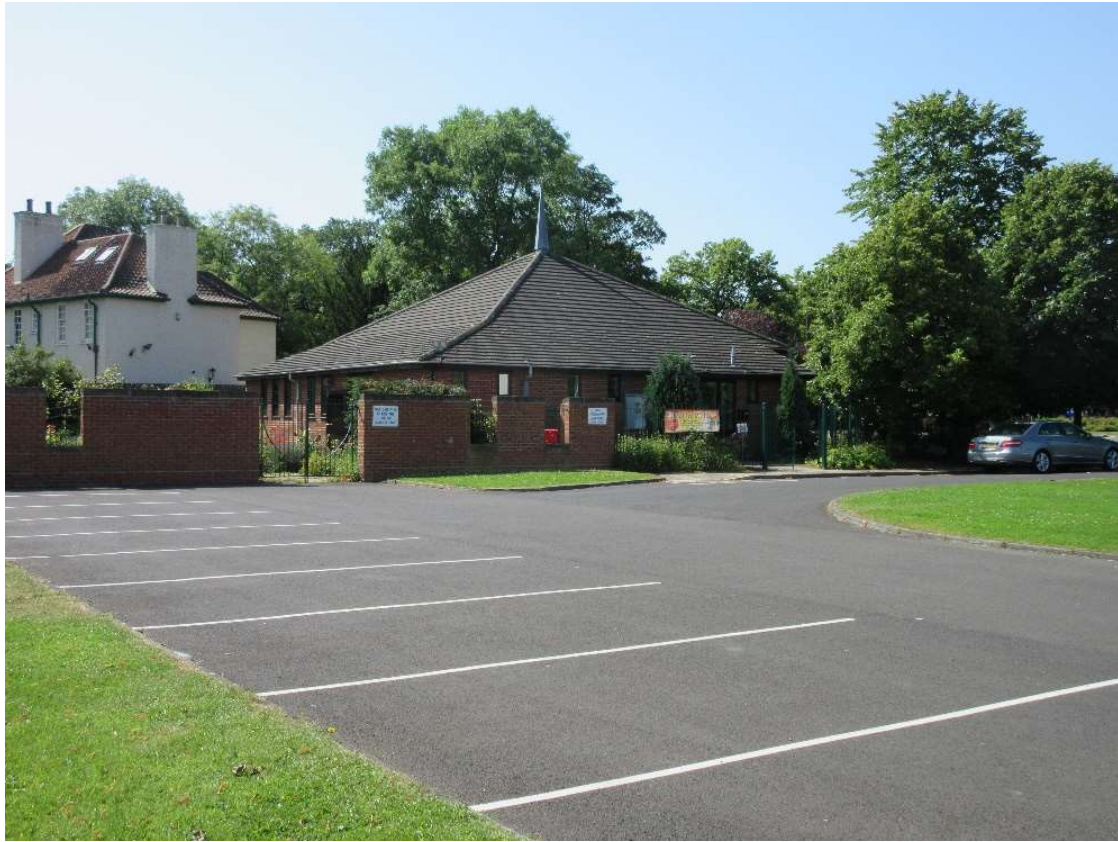
49. An exposed level mainly grassed corner site enclosed on two sides by adjoining garden fences.
A tarmac drive and parking, recently renewed. Concrete flag paving. Good sign close to the road.

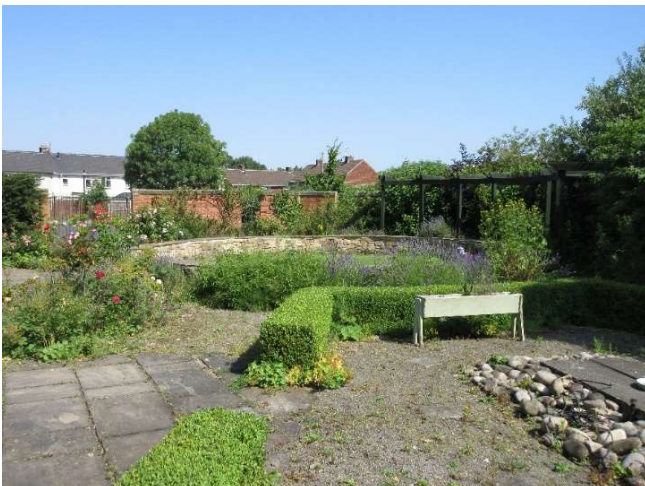
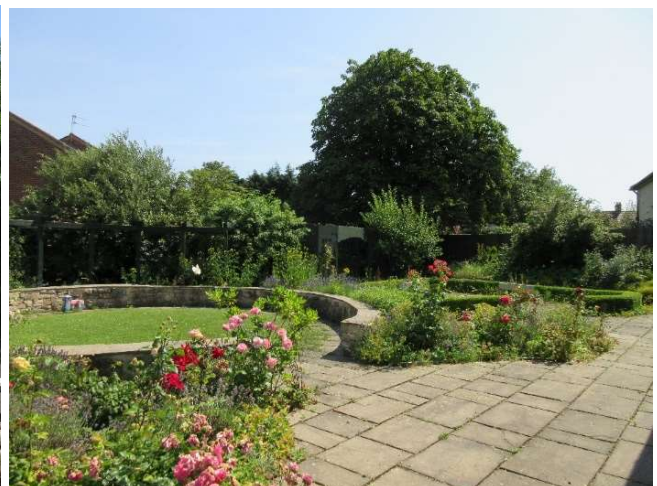
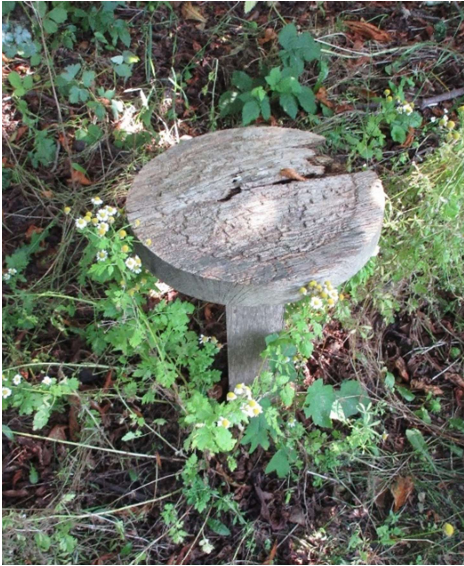
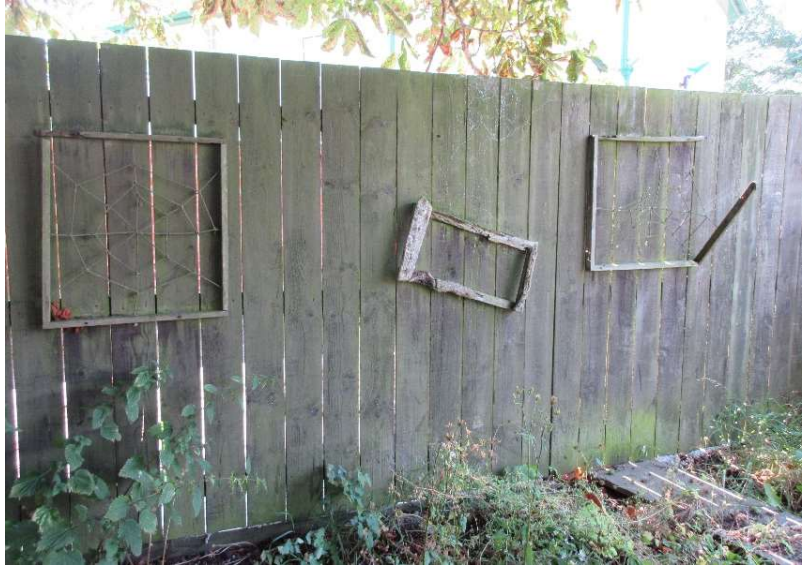
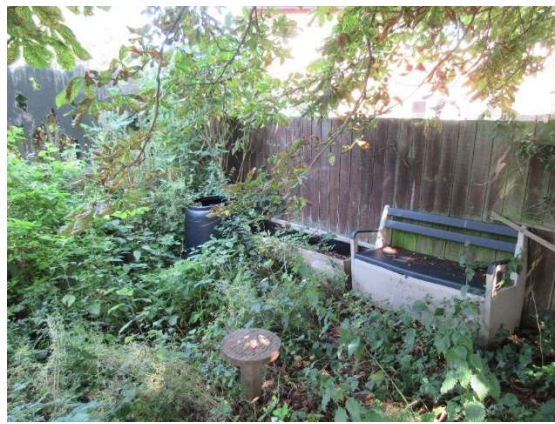
50. A walled garden in the SE corner for church and social use. Part is well maintained but the bank around the main tree is now overgrown. Some wooden features have decayed and may need to be removed. Like all gardens it needs upkeep. A long term maintenance plan is needed.

Maintain the boiler and convectors as maker's recommendation	34, 35
Maintain the Garden, perhaps including removal of decayed wooden features	50
