2024 QUINQUENNIAL INSPECTION SURVEY REPORT

STOCKTON-ON-TEES: PARISH CHURCH OF ST PETER

Stockton-on-Tees: Parish Church of St Peter

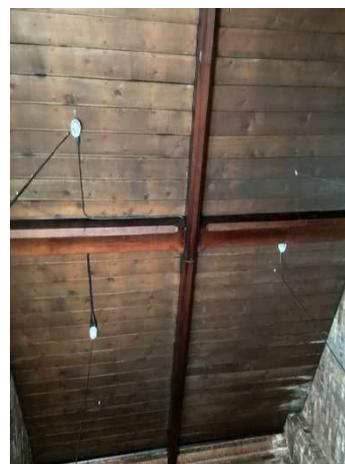
- 3.2 There is a lean-to ceiling, with purlins and a principal rafter with boarding between. In the south-western corner there is a significant amount of staining. This is understood to be historic from a now repaired roof leak. There are a couple of other areas of staining on the roof, particularly towards the lower reaches and they should be kept under observation.

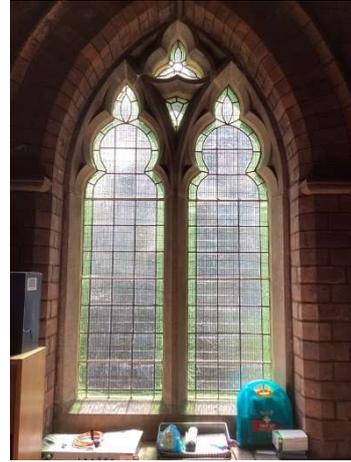
- 3.4 The windows are generally in very good condition. They have been overhauled recently and consequently are in excellent order.

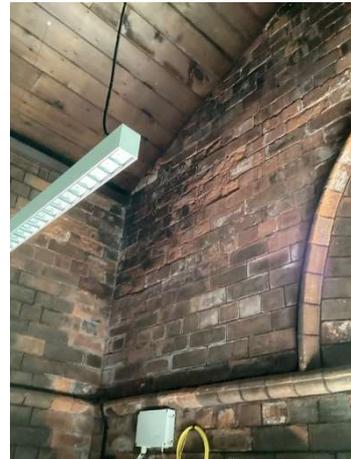
- 3.6 There was a little bit of salting in the north-eastern corner, particularly on the eastern wall. It seems likely this is related to water ingressing into the wall above. The wall requires repointing very carefully in a soft lime mortar.

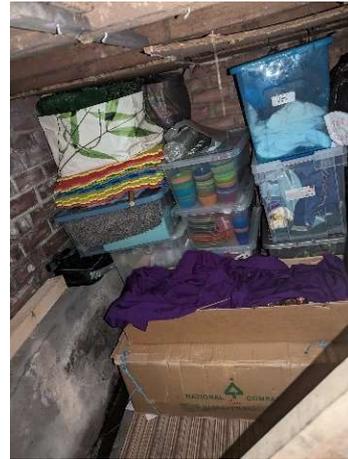
- 3.7 Within the floor there is an access hatch to the former organ blower chamber. This has a secure timber hatch and is currently used for storage. There was a little bit of salting to the brickwork. Generally the space seemed to be relatively dry and in good condition.

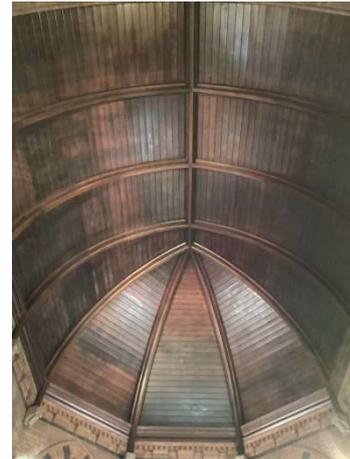
3.10 The barrel vaulted ceiling appears to be in good condition. There is little, if any, staining within the roof structure. All appears to be in good order.

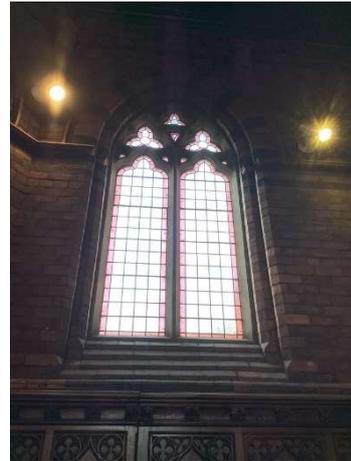
3.14 The plain glazed window seems in reasonable condition, but there is a little bit of openness through the tracery, particularly on the southern side. It would be useful to fill these with mortar. There is a fracture that continues through the cill of the southern window, and it seems likely that this openness to the tracery is related to that. Filling both with mortar would allow for monitoring.

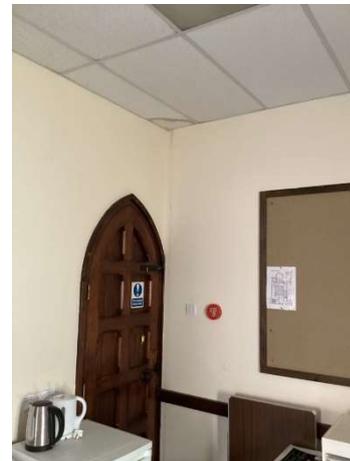
- 3.25 Walling is generally in good condition. There is a little bit of staining in the north-eastern corner where there has been some historic ingress, but otherwise walling is in good order.

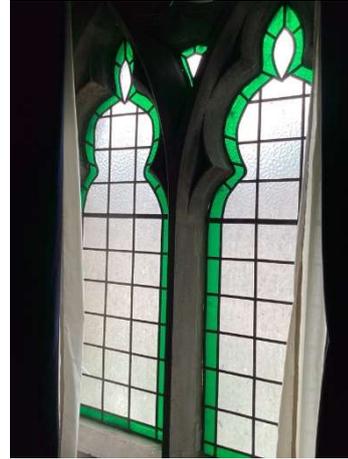
3.26 The plain glazed square quarried windows seem to be in reasonable condition. There are no saddle bars and there are quite a few cracked quarries throughout, but generally they seem relatively straight and in reasonable order, although the broken quarries should be replaced.

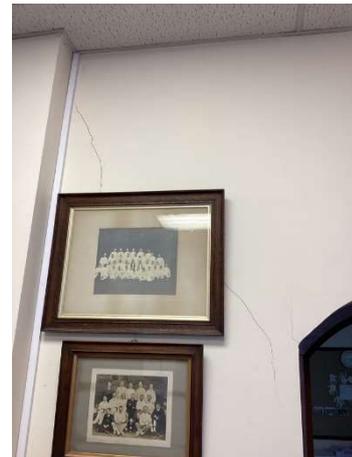
- 3.30 Towards the southern side of the space, there are some fractures on both the southern wall and on the eastern wall. These appear to be fairly minor movement fractures, but nonetheless given that the building is quite old, it does seem unusual to see settlement after so long. The fracture should be filled and painted over so that they can be monitored and reviewed at the next inspection.

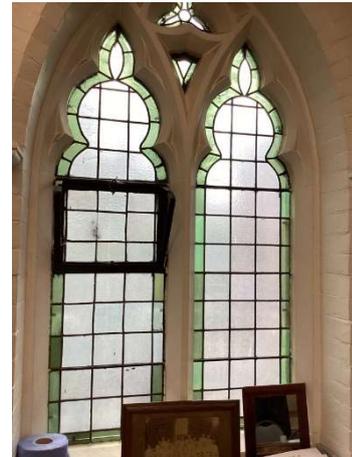
- 3.31 Windows are generally in reasonable condition. There is a little bit of bowing to the window and the lead comes in places are missing or damaged, this requires work. Hopper vents seem to be in reasonable condition, but appear to have been fixed shut. There are also broken quarries which would benefit from repair. Other than that saddle bars and copper ties seem to be intact and the majority of the glazing is in good order, with the exception of the above items.

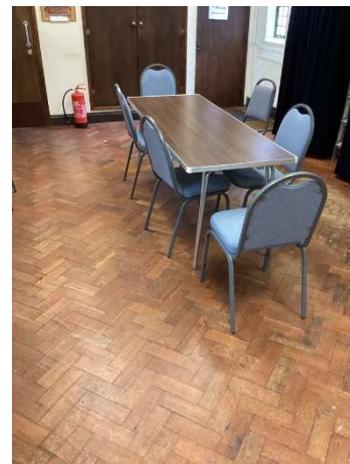
3.33 The parquet flooring is in reasonable condition, but it is quite uneven and it is quite worn in places, particularly near the entrance where it would probably benefit from a little bit of an overhaul. There are also some areas where the parquet is a little loose and again a little overhaul would be beneficial.

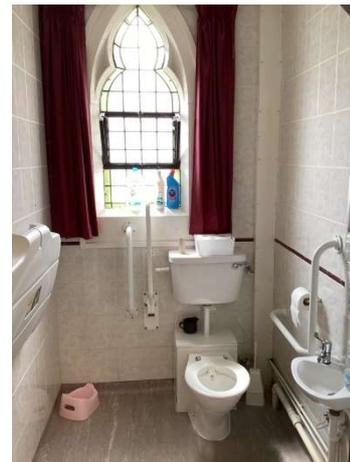
The accessible WC is generally in fair condition and appears to be broadly compliant with current regulations. It would benefit from colour contrasting grab rails.

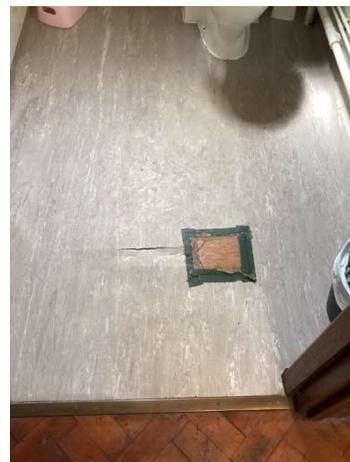
3.36 The vinyl floor has been repaired and is continuing to split, it would benefit from being recovered.

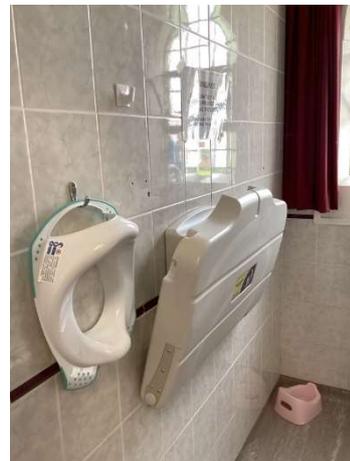
3.37 The baby changing unit has got a changing mat on it which is preventing it from closing properly. This could cause difficulty with somebody entering the WC with a wheelchair as it impinges into the space. The changing mat should be removed so that the unit can close properly.

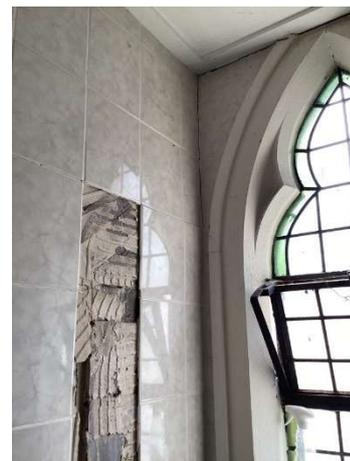
3.40 Some of the tiles have been removed from the walling which shows the fracture which has appeared within the eastern wall and over the southern wall. It is understood that a tree has been removed from the vicinity, and these fractures have appeared in the meeting room and surrounding accommodation. The fractures need to be made good and monitored.

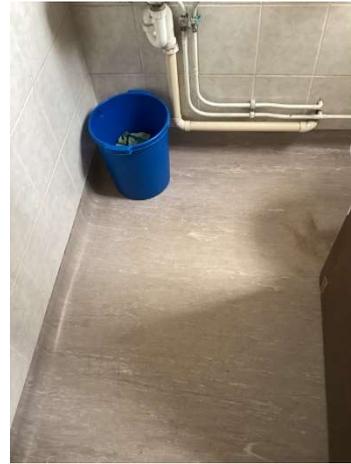
3.41 Flooring is generally in reasonable condition, but is worn in places. It would probably benefit from replacement.

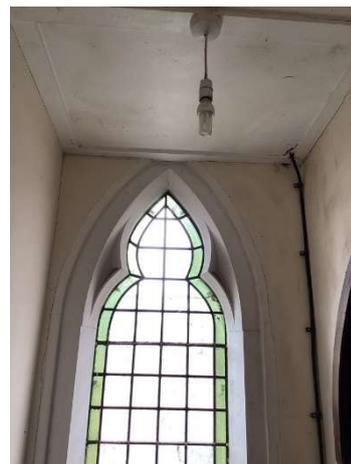
3.43 Like the adjacent male WC, there is a little bit of separation on the south side where some slight movement has taken place. Again, this needs to be repaired and monitored.

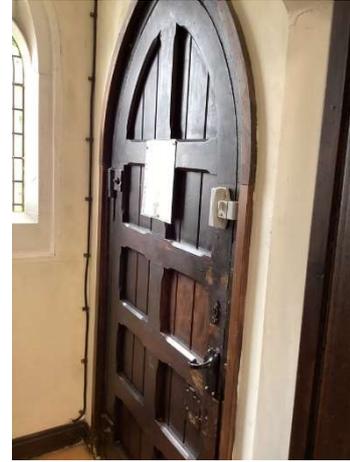
3.44 The door requires decoration within the quinquennium.

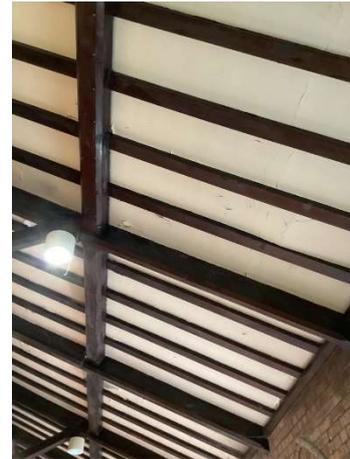
3.47 The plaster is in relatively poor condition. The main structural elements of the roof seem sound, but the plaster panelling between has significant areas of peeling paint, and there are fractures within some of the plasterwork. This particular type of ceiling is very vulnerable to water ingress, and particularly the connection between the lath and plaster is failing. The ceiling requires inspection at close quarters to understand if the connection between the lath and plaster remains secure. If it is, the loose materials can be stripped off and the area can be repaired and redecorated. If it is not, it may be that the plaster requires removal and it needs re-lathing and plastering. Initially close inspection is required.

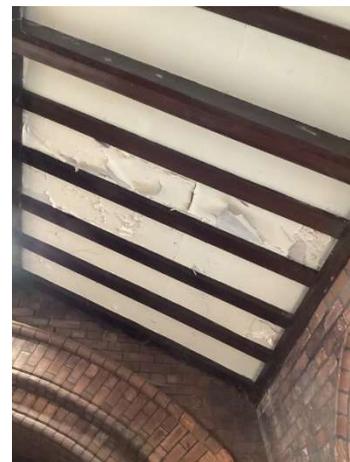
3.48 The ceiling is at its worst at the western end, and it seems that this would be a good place to start examining the condition of the ceiling.

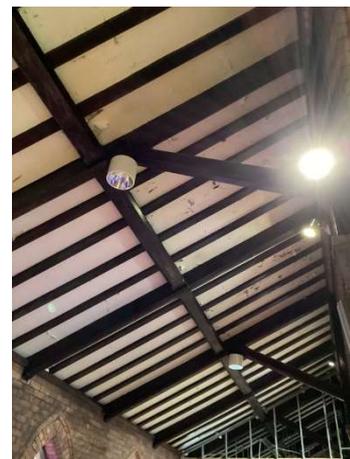
3.68 Ceiling is in a very similar condition to the rest of the building and very similar comments apply. Although the timber structure appears to be in good order there is a significant amount of peeling paint from the plastered elements of the ceiling. Some work has been carried out over the new kitchen to test the ceiling at the western end of the aisle and this seems to be sound, and so there is some hope that actually the remainder of the ceiling may well be in reasonable condition. However, the same comments apply, ultimately a programme of testing the adhesion between the lath and plaster needs carrying out before the loose paint is removed and any repairs are carried out, and it is redecorated.

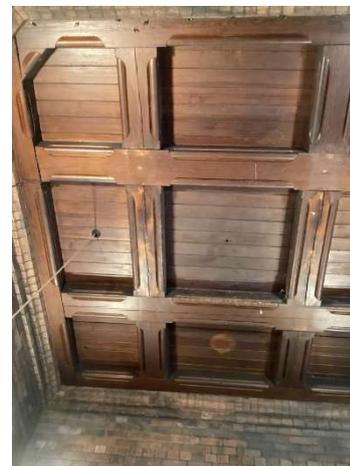
3.74 The ceiling has decorative boxing to the joists and is boarded between. There is quite a bit of staining to the ceiling and splitting to some of the timberwork, and there are quite significant gaps at the western side. Given the concerning condition of the flooring above and the apparent pigeon ingress, it is certainly going to be worth looking at this floor from above and confirming that the structural elements of it all are intact beyond this. The floor needs monitoring as it does look as if it has taken some water from above.

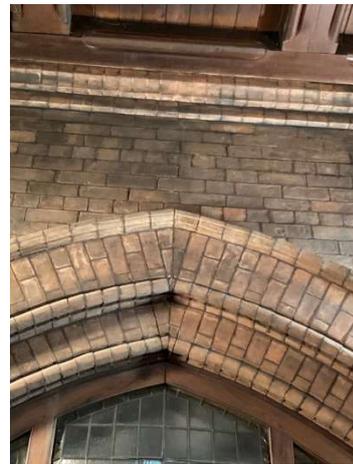
3.77 There is a stepped fracture running through the western elevation, and this should be raked out and repointed and then monitored over the quinquennium.

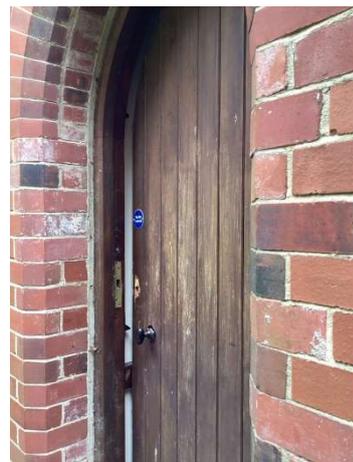
4.31 The door would benefit from redecoration and repair, where the lock appears to have been forced.

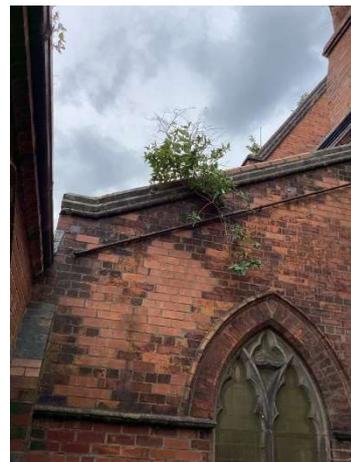
4.34 At high level there is a fracture running through the parapet that appears to have been caused by the vegetation that has taken hold within the brickwork. The vegetation needs removing as soon as possible and the fracture pointing back up.

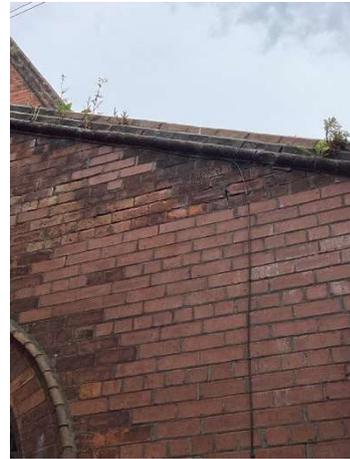
4.45 At high level there is some vegetation within the parapet and spalling stone and missing pointing lower down. It seems likely that water is entering the wall top here and this has caused the spalling of the bricks and the loss of mortar. Vegetation needs removing and open joints need to be repointed.

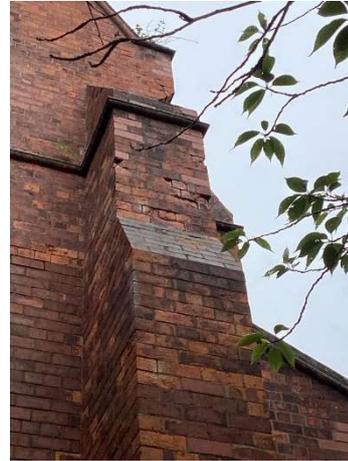
- 4.49 To the upper reaches of the southern buttress there is quite a bit of spalling brickwork. This requires some raking out, replacement and repointing.

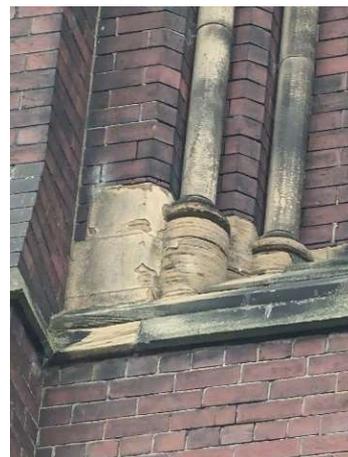
4.62 There is some spalling in some of the stone dressings and this should be kept under observation.

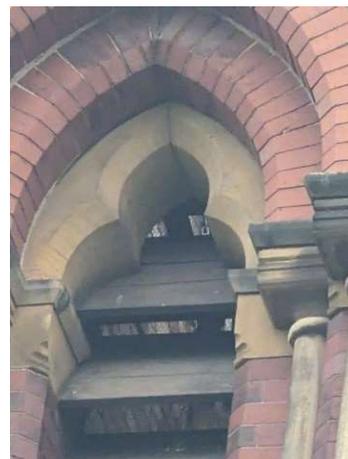
4.65 Viewed through the louvres, it appears that the hatch is missing or has been left off, which would explain the number of pigeons in the tower.

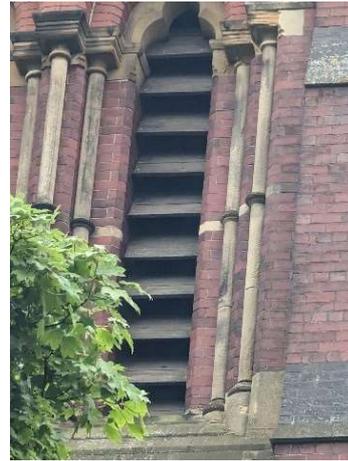
4.66 There was a little open jointing through the stone dressings, this should be kept under observation.
