QUINQUENNIAL INSPECTION REPORT
of
THE MINSTER CHURCH OF SAINT MICHAEL AND ALL ANGELS AND SAINT BENEDICT
BISCOP, SUNDERLAND

SUNDERLAND MINSTER

QUINQUENNIAL INSPECTION AND REPORT October 2017
David Beaumont BA (Hons) Grad Dip, RIBA, AABC

REPORT ON THE 2017 QUINQUENNIAL INSPECTION

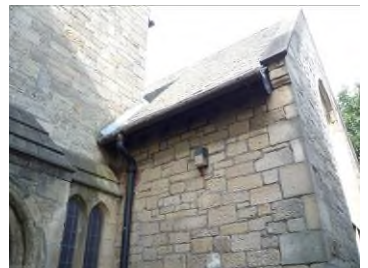
- D** **Small area over the W.C:**
Some ferns growing in the slating.

Recommendation: remove

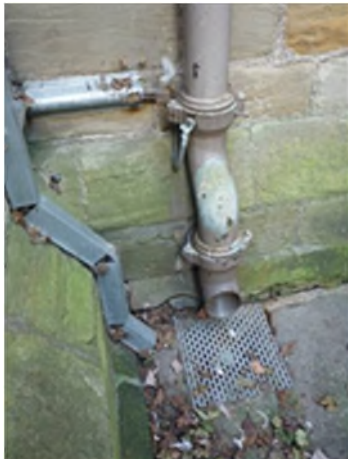
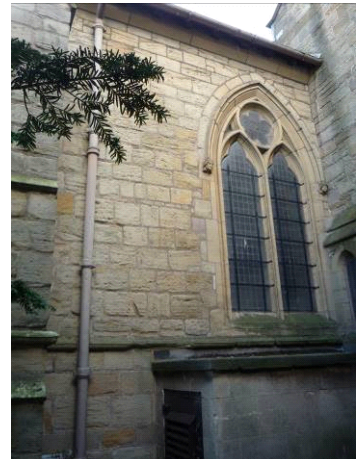
C **North Chancel:**
Rust to the gutter brackets and some to the downpipe which discharges into a gulley with a secondary mesh on to keep off the leaves.

Recommendation: remove rust and decorate

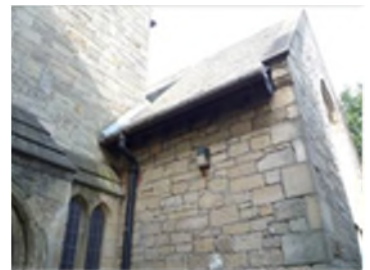
Roof by W.C. – Slight dip in the gutter and the bracket looks to have dropped slightly and the decoration's beginning to fade on the gutter. Downpipe ok although there is some rusting at the collar. The secondary grid is loose.

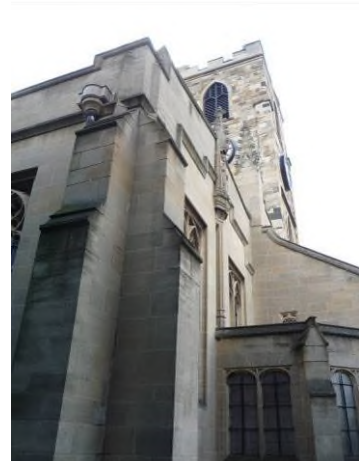
The three major windows are in fair condition though there is some open joints to the tracery but they are sound. They have ornamental ferramenta with polycarbonate and the polycarbonate is dirty and the ferramenta rusting slightly.

Recommendation: ferramenta repair, polycarbonate and glass cleaning and repairs to the parapet are part of the GPOW works in 2018.

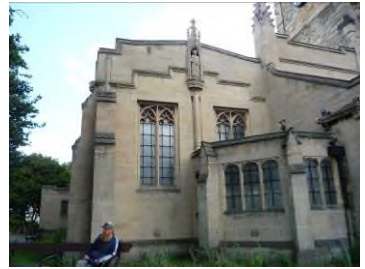
Open joints to the raking parapet and slight cracking's around the lintel creating an open joint. Walling is good, the pinnacle and statue appear in good condition, there has been graffiti scratched on the surface of the stonework and probably needs to have CCTV around this corner.

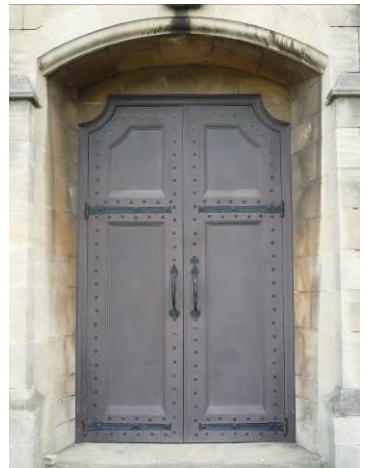
North Entrance: Open joints below the parapet and to the pediment of the doorway. Though water runs off the side of the pediment it washes down and has eroded the joints.

The doors are generally sound though their hinges are rusting and the door decoration is fading now.

Recommendation: repoint open joints to the central section- this is more urgent than routine repointing elsewhere and perhaps to be added into the 2018 GPOW works?, attend to door decoration and rusted ironmongery

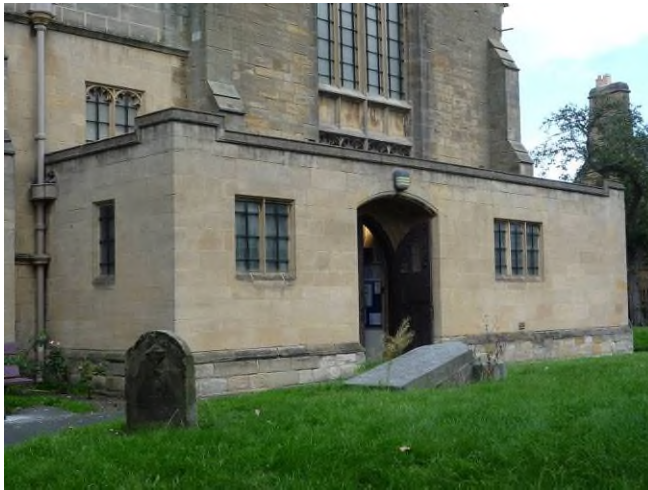
West Side –
Some open joints at high level. Polycarbonate with slightly rusting ferramenta trapping leaves behind it and cigarette butts. Sat on a sandstone plinth which is eroding slightly.

Recommendation: see general comment of ferramenta repairs and polycarbonate cleaning, repoint open joints attend to door decoration and rusted ironmongery

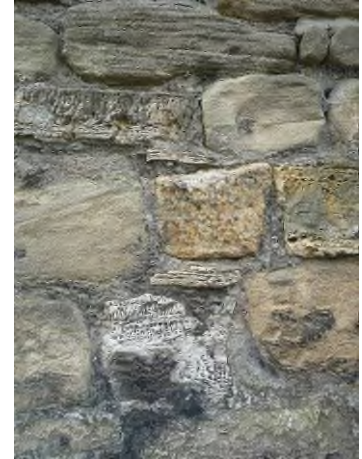
Northern Side – Mixed sandstone and concretionary limestone (showing coralline concretions) masonry wall in fair condition, some slight cracking to the right of the doorway been repaired in cement but no action required. Pair of gate pillars in sandstone much eroded, no longer in use and there is a rather rickety door to it now, badly grazed and looking a little derelict. To the left of the sandstone pier is a crack to the wall, looks to be about 5 - 6mm which needs repair assessment.

Recommendation: assess repair needs of wall cracking, remove cement pointing and repoint in lime

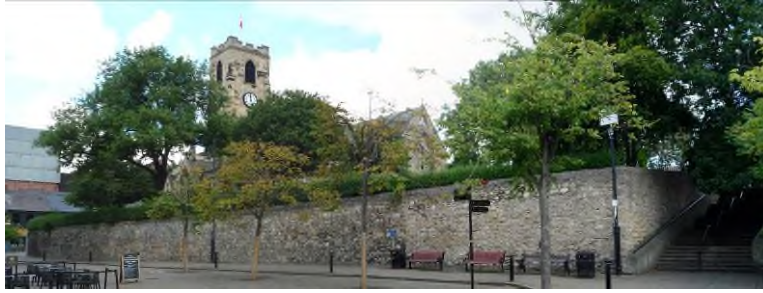
This features a substantial and high retaining wall, retaining the burial ground. Towards the southern end there is a large crack by the memorial 'Hind Street burial ground' sign, doesn't appear to be worse than last time but there are multiple open joints on the wall and some poor historic repairs to it.

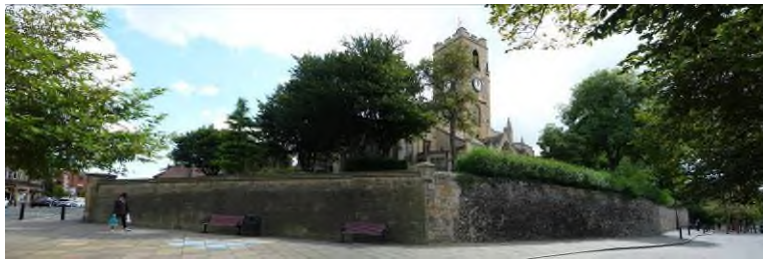
At the very end of the wall it looks to have been rebuilt in modern times but the sandstone has eroded as a result of cement mortar being used.

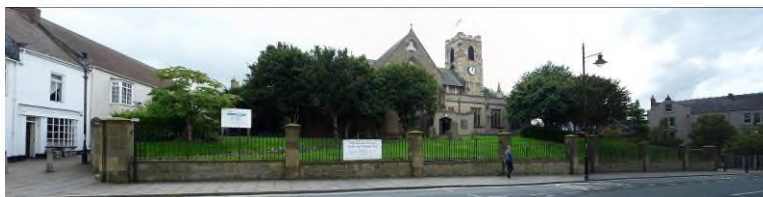
The wall here comprises of low level wall with stone copings supporting an ornamental metal balustrade of good quality. Balustrade is rusting but it is not breaking the joints in the stone

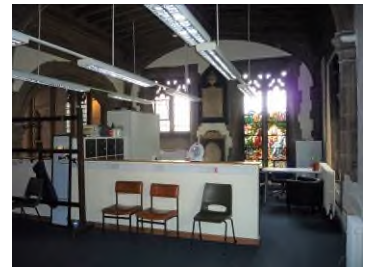
Staining to the ceiling at lower reaches due to water leakage from roof, which is due for repair in 2018. Walls are ok, floor has modern carpet. There is one crack on the west wall below one of the windows, approximately 2mm and is the same as last QI report. Floor squeaks slightly. Modern lighting is to be stripped out and replaced with spots as part of the 2018 repairs.

Recommendation: screw down the floor when the carpet is to be changed

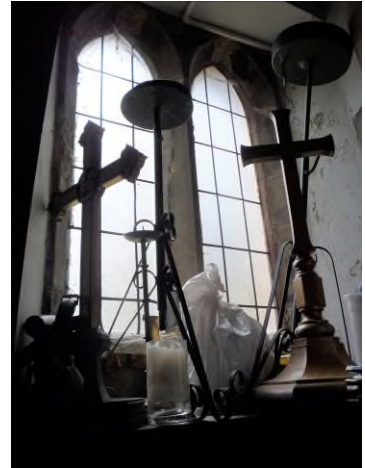
Hole in the ceiling where the blower pipe goes through, the blower pipe itself is 450mm diameter vitreous glaze pipe. Walls are ok as is the window. The rooms contain quite a bit of lumber. The door catches on the floor.

Recommendation: ease door, remove unwanted items
