Diocese of Durham

St Mary and St Peter's Church, Springwell Road, Sunderland, SR3 4DY

Quinquennial Inspection

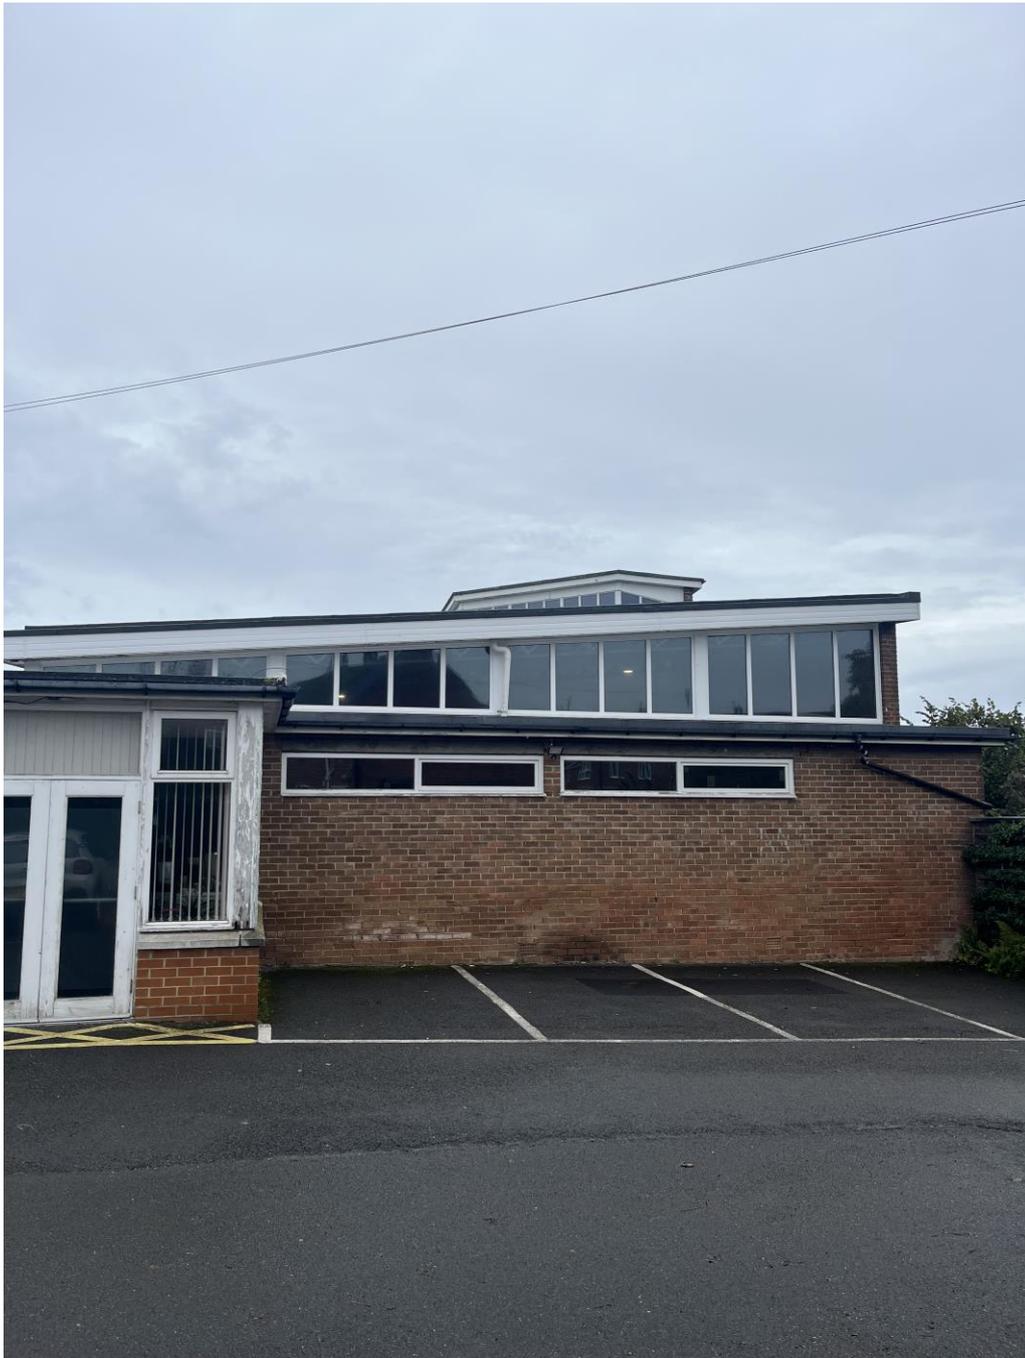
- 5.1 The overall roof area is set at three different levels and made up of three separate flat roofs. The lantern being the highest point and smallest roof area and we understand this is covered in felt, due to it's height it wasn't possible to inspect this element.

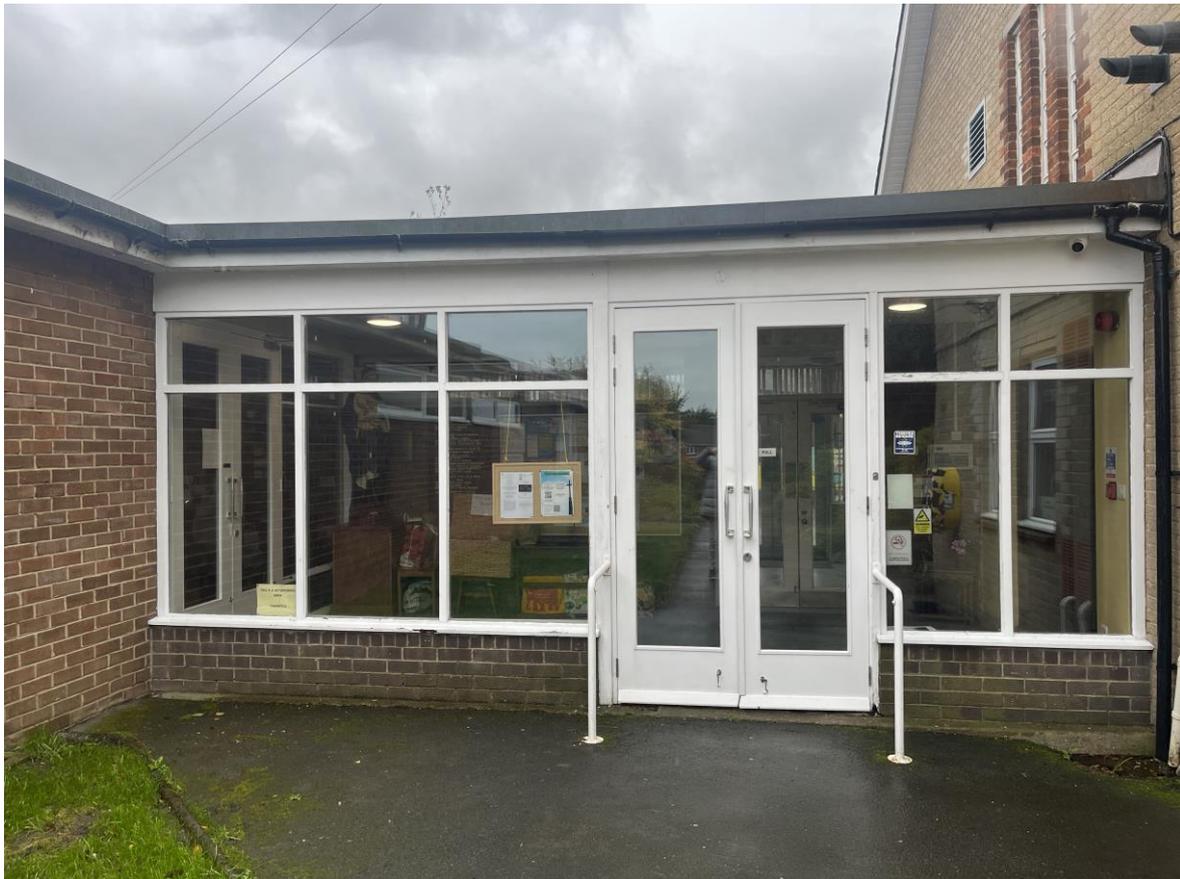
Below this and covering most of the church and nave area is a flat roof with a low pitch falling westwards. This is the roof area that was recently renewed with a new single ply Bauder roof system.

The lowest flat roof which is another grey single ply membrane product covers the Chapel, vestry and Narthex.

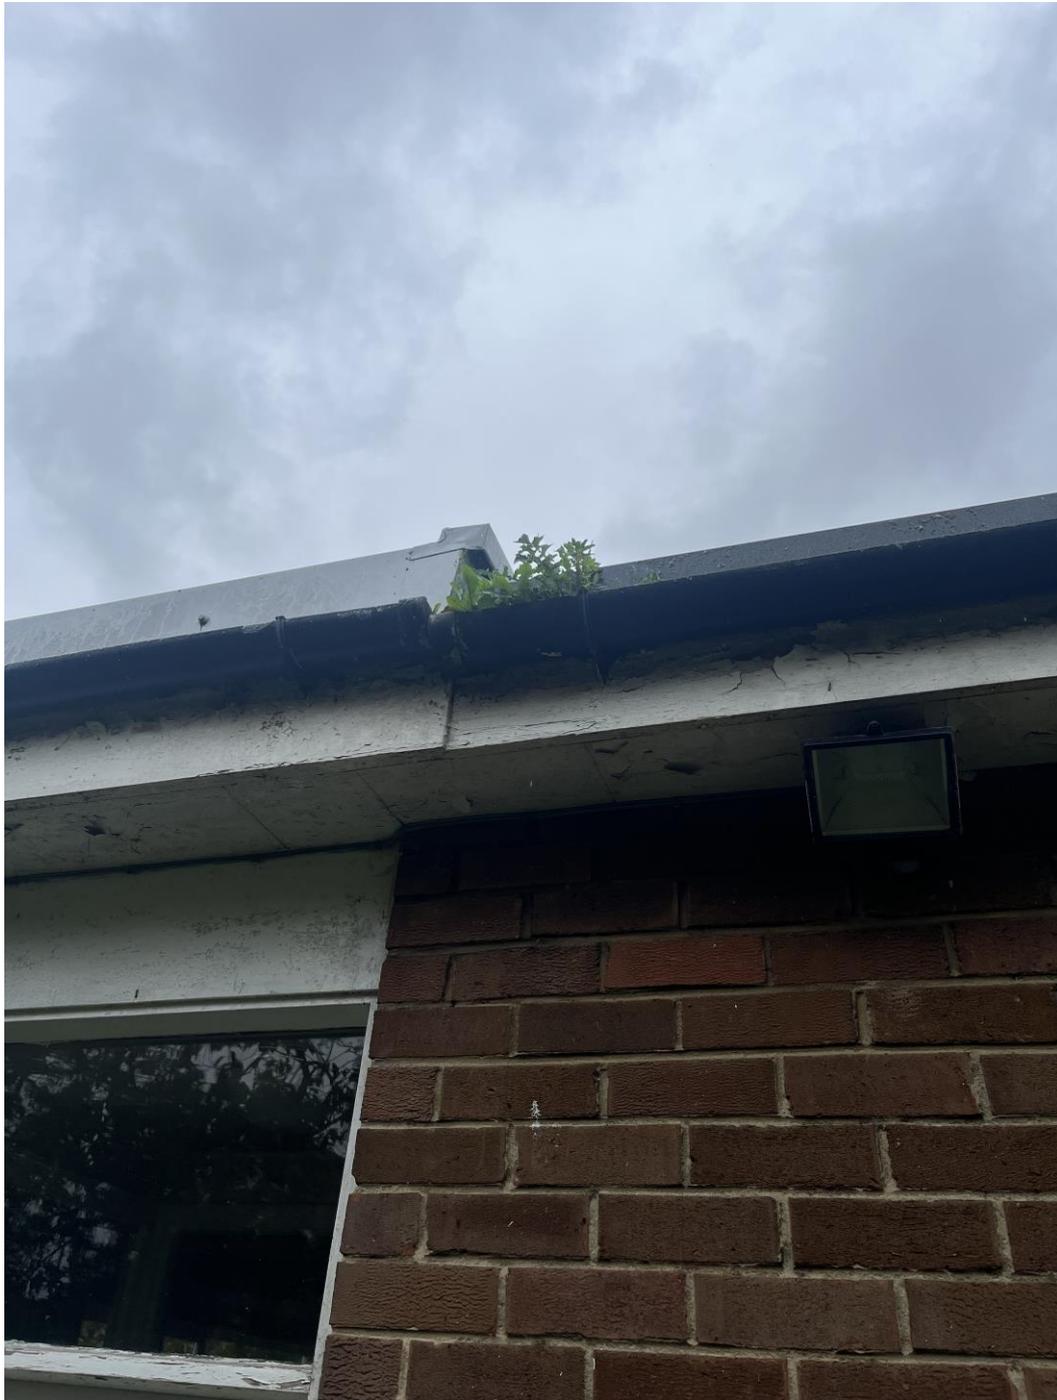
The black upvc gutters are in poor condition with cracks and chips to them and they are also not aligned correctly to the low-level flat roof chapel / nave area facing north which is creating a build-up of water. Plantage has also started to form further adding to the

blocked gutters. On the day of the survey due to heavy rain these were over-flowing considerably. The gutters and rainwater pipes require replacing.

- Gutters need cleaning as blocked with plant growth.

- Gutters have large cracks / chips and are leaking which should be replaced. There is a lack of rainwater pipes on the north and east face taking the water from the lowest roof, it would be prudent to install deep-flow guttering.

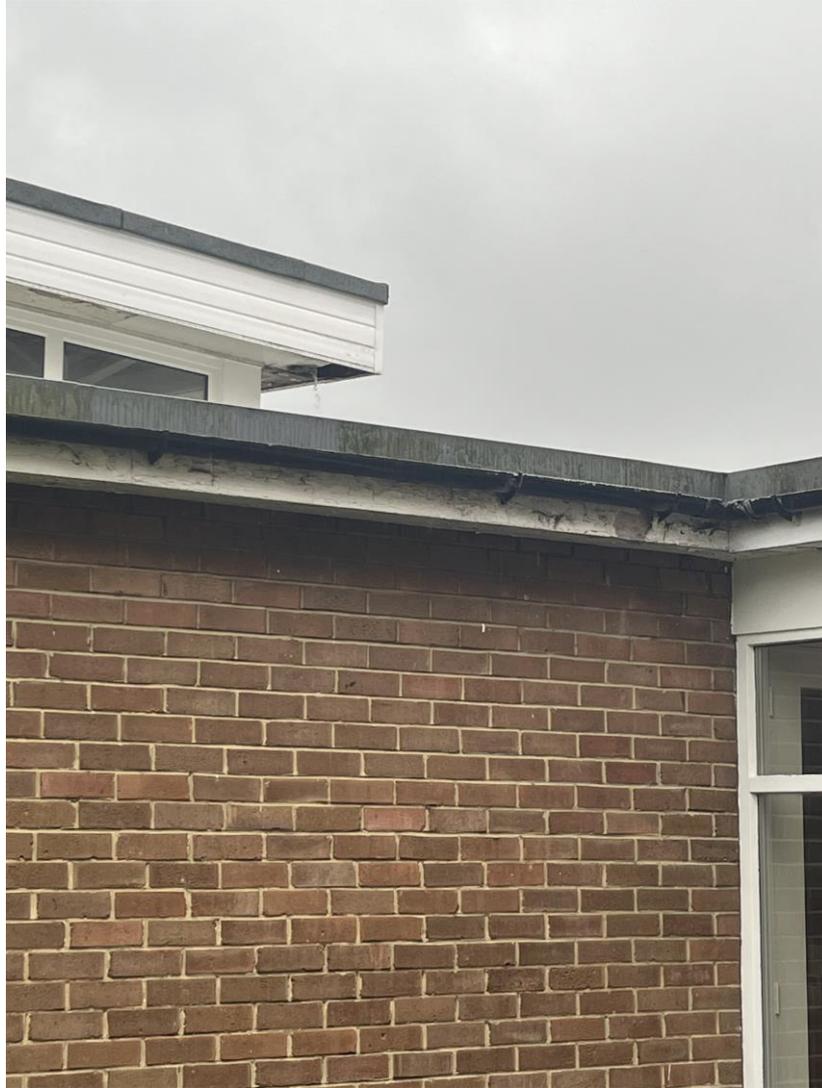
There is a lack of rainwater pipes on the north and east face taking the water from the lowest roof, it would be prudent to install deep-flow guttering.

The fascia boards and soffits to the lowest roof covering are also in poor condition and require either replacing with new timber fascia and soffit boards to receive a suitable external paint finish or sand off the flaky paint and cover with UPVC fascia and soffit boards. The latter option probably being the most cost effective and quickest solution.

- All timber fascia boards to north side single storey roofs be sanded and repainted or covered with new UPVC fascia.

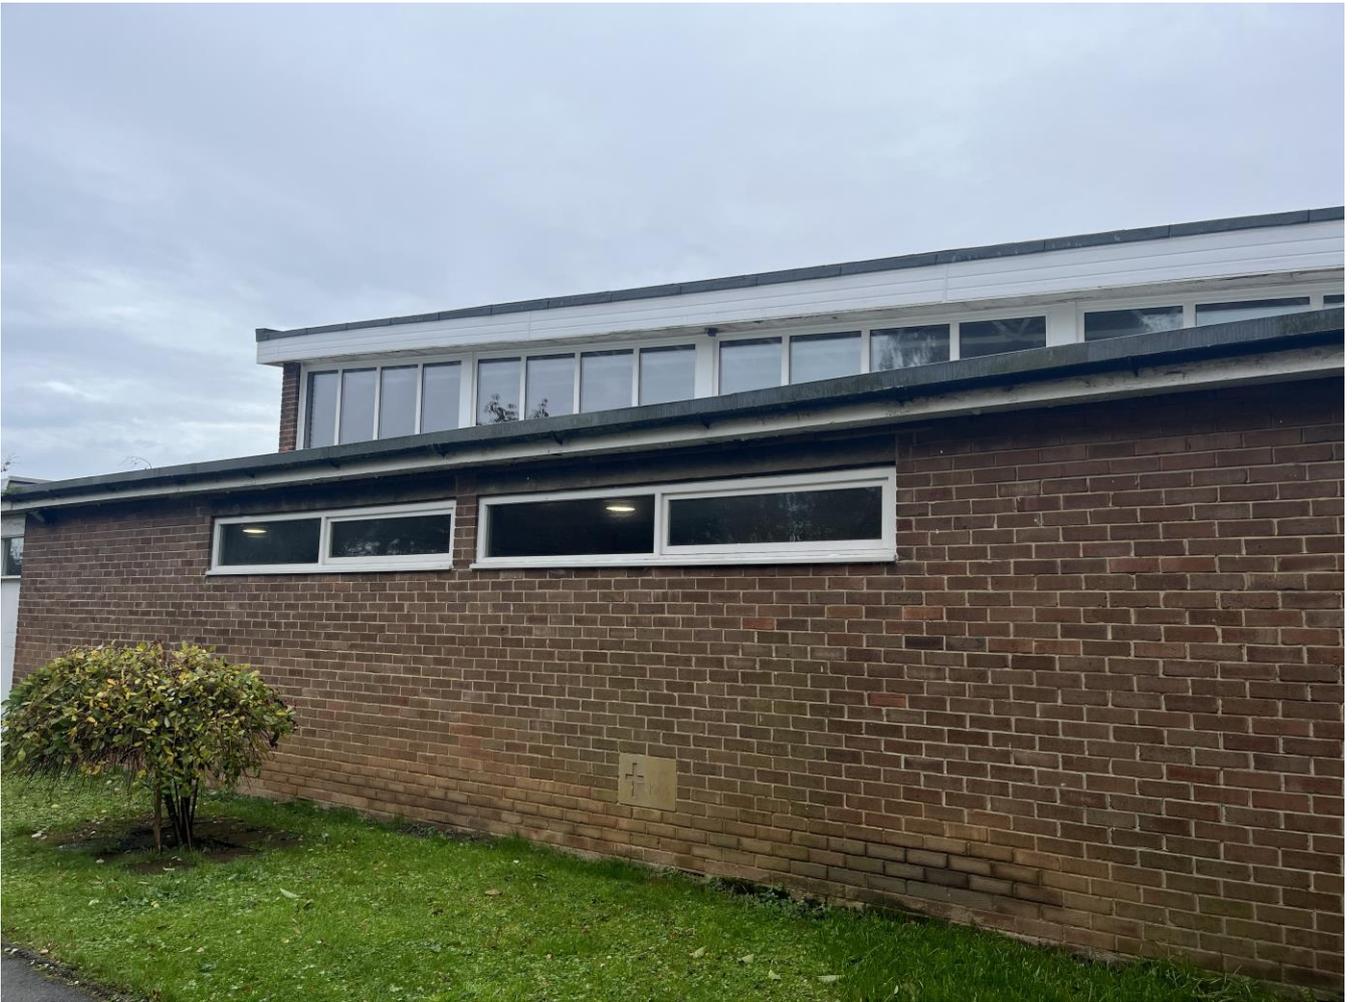
- 5.3** The facing brickwork to the north chapel and aisle wall is single storey with recessed pointing, the walls are weathered and in fair condition. The low-level pointing is deeply weathered and has visible damp patches.

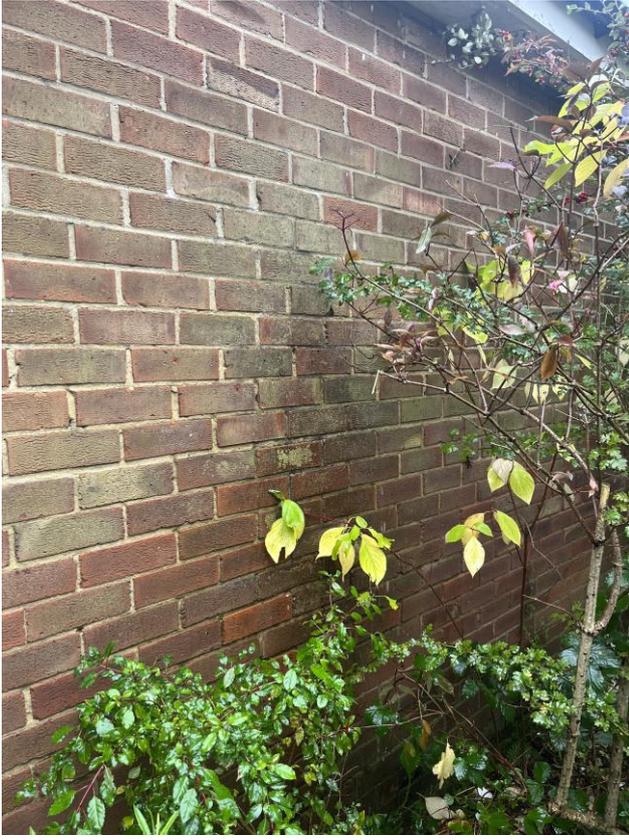
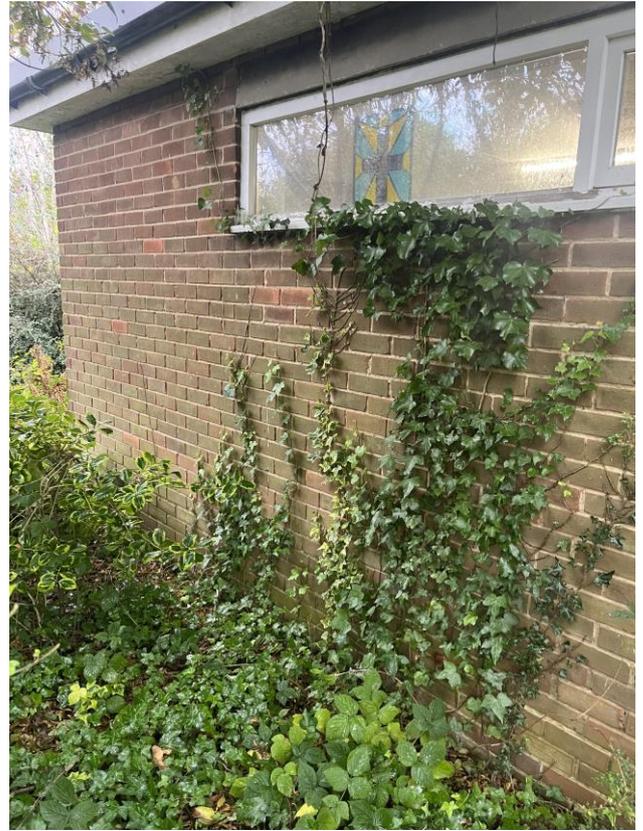
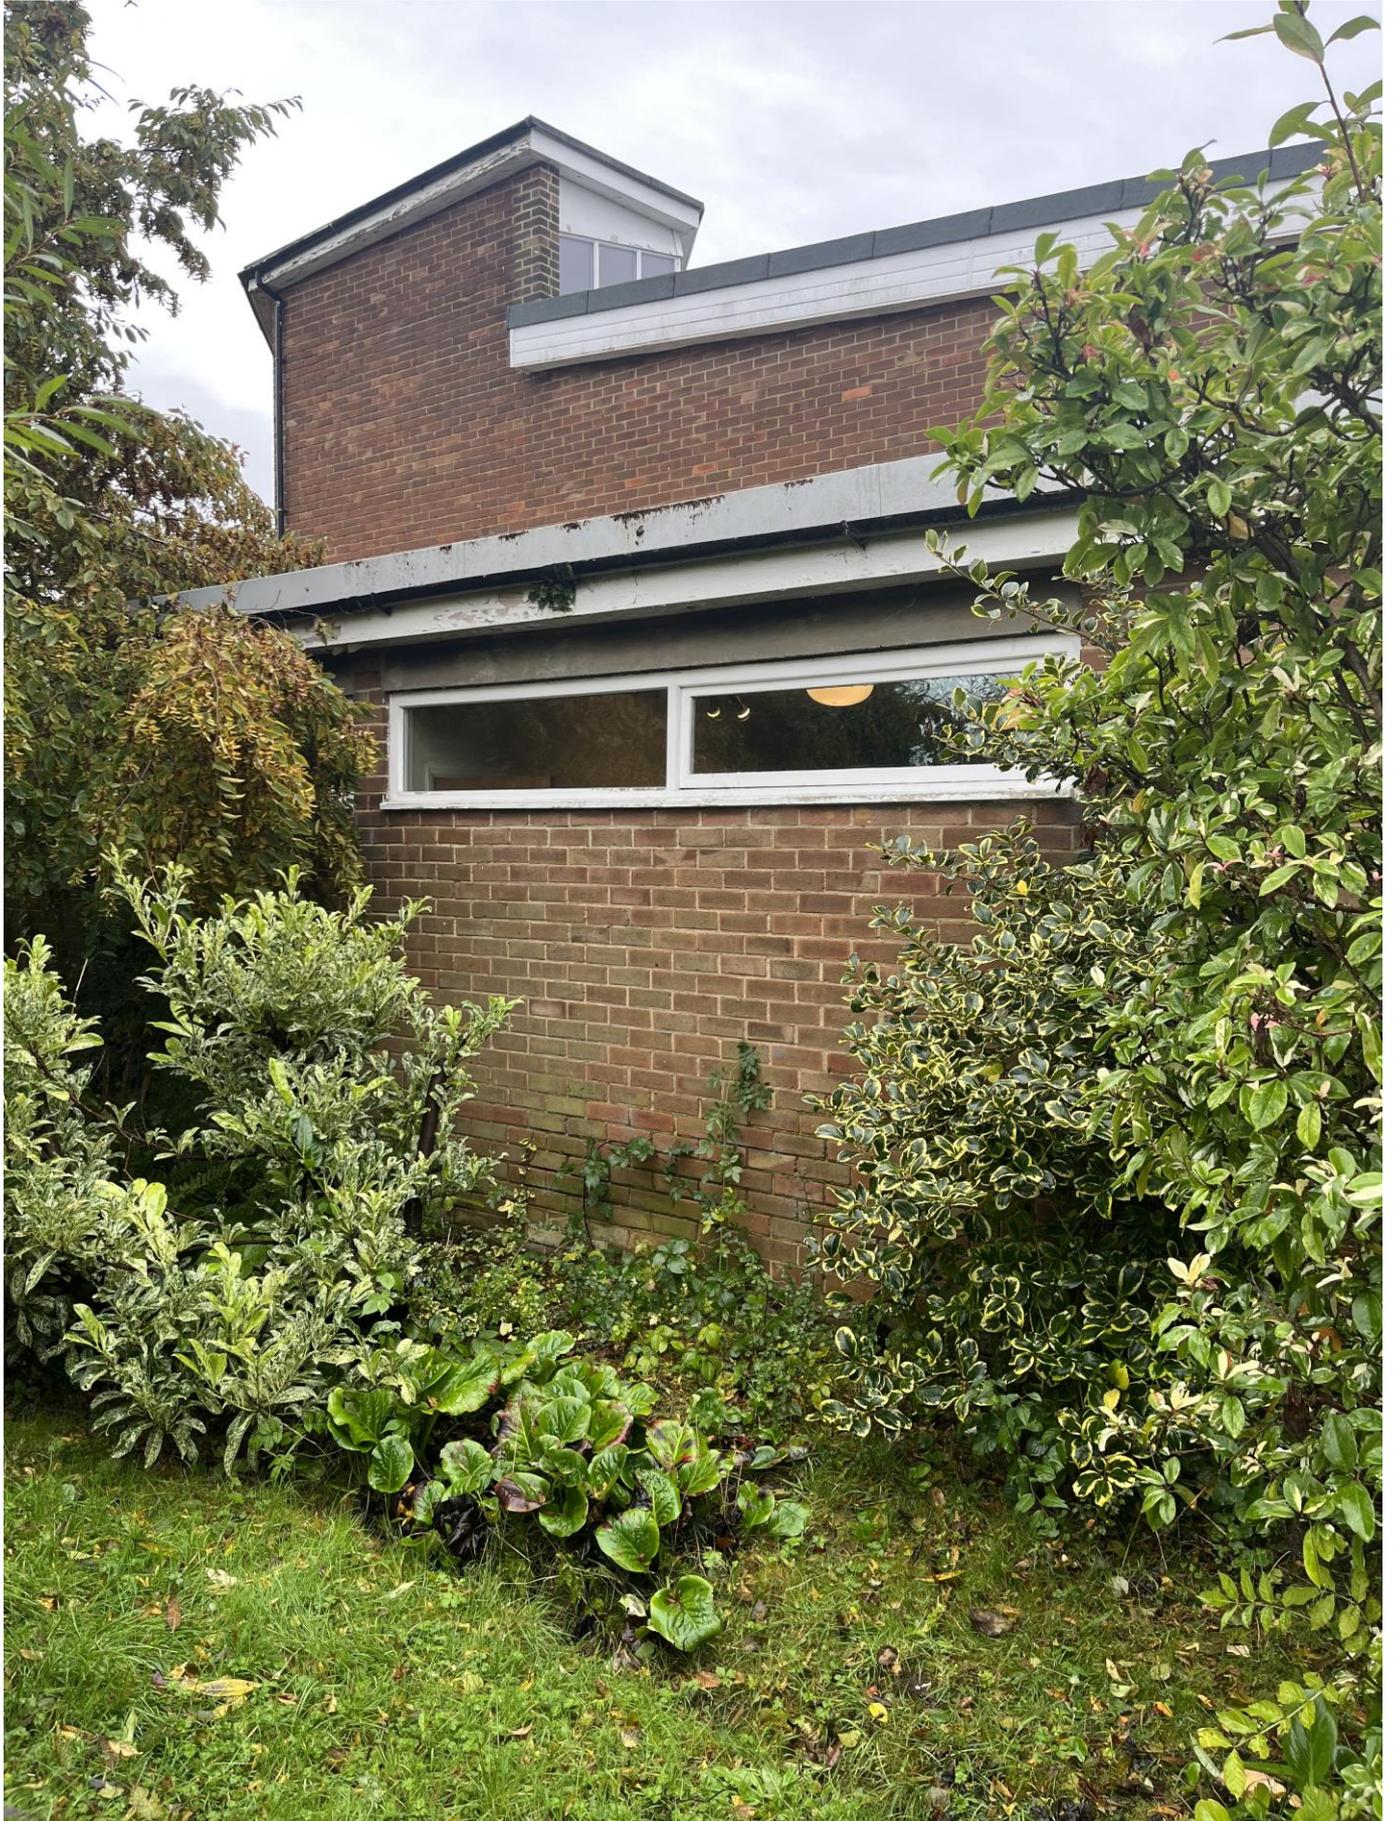
The facing brickwork wall to the east chapel and vestry is single storey with small high-level window openings, it has ivy growing up it and onto the windows. This elevation has penetrating damp to the brickwork. This is most likely to be from the blocked gutters.

This wall also has poor deteriorated pointing, which may be due to raised ground levels and water splashing above DPC level. Heavy damp patches are visible.

- Cut back plant / ivy / tree growth to the north-east external Chapel and Vestry area.

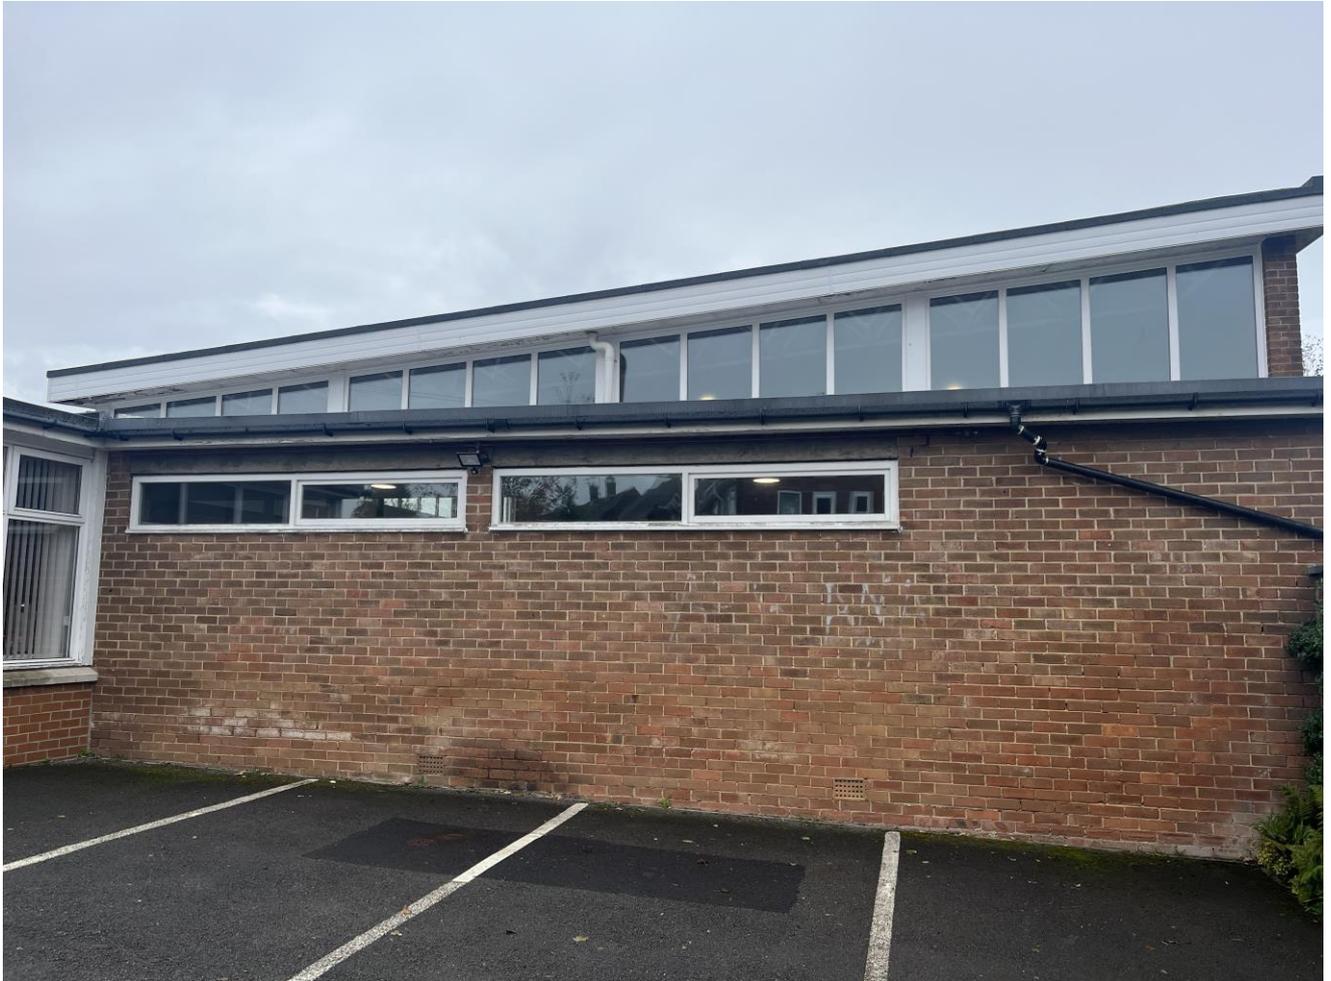
The facing brickwork to the south nave wall is also single storey and recessed pointed, the walls are weathered and in fair to poor condition.

At various sections of the wall the pointing has deteriorated significantly. The missing pointing will make the wall vulnerable to damp penetration.

The missing pointing is prominent in the lower areas of the wall where the efflorescence has appeared.

- Pointing has deteriorated significantly to south-west single storey wall and requires re-pointing.

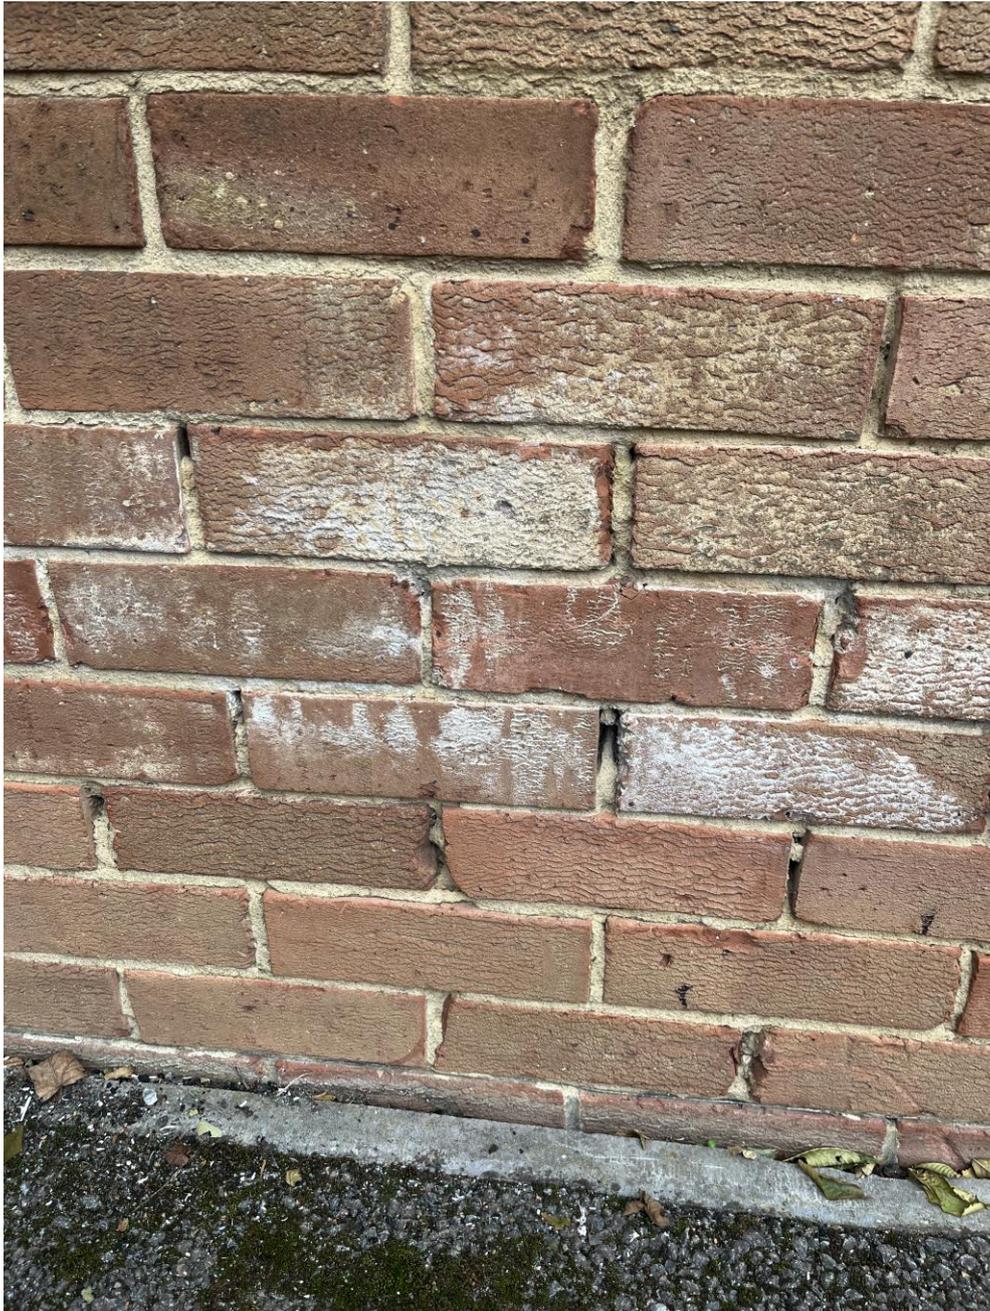
The DPC is only around 25-30mm above the external ground level, this can create potential damp issues as the ground water levels can rise above this. Generally good practice is to have the DPC installed 150mm above external ground level.

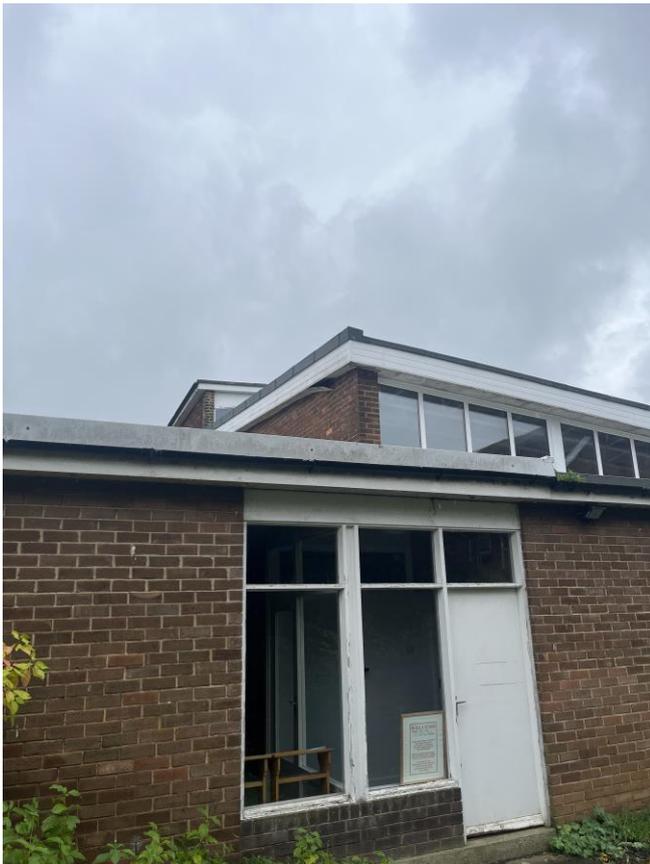
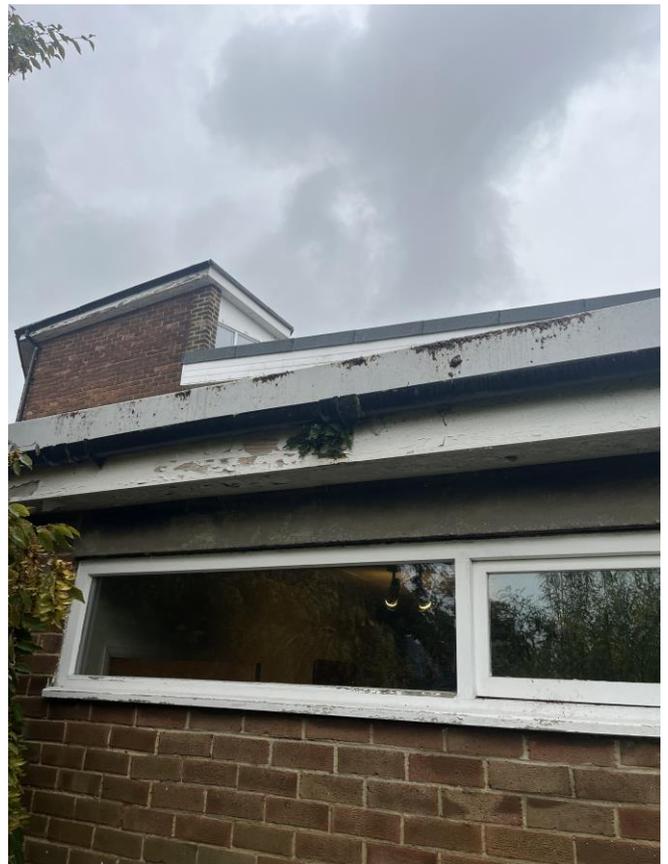
Most of the timber windows and external doors need new external decoration. Bare timber is visible on most windows. Flaky paint is quite prominent and requires attention.

The door jamb and window cill to the north-east link entrance has timberwork that is rotting and in poor condition.

Double doors to the same entrance link are timber and binding / catching the door frame so won't close correctly.

- Repair rotten timber door jamb and window cill to north link entrance prior to decoration.

- Timber windows and external doors need new external decoration.

- Double doors to link are binding / catching the door frame and require easing and then a paint touch up.

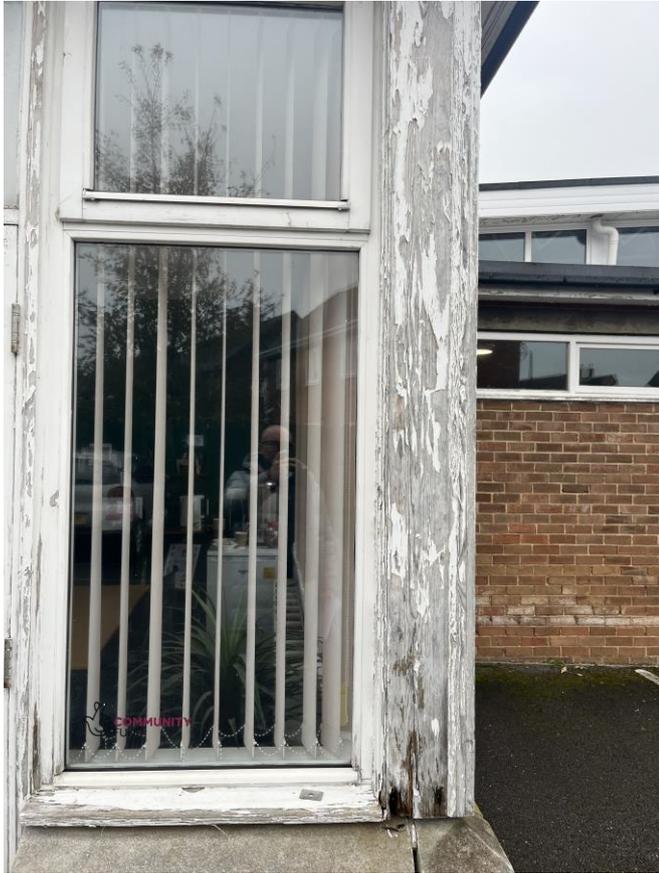
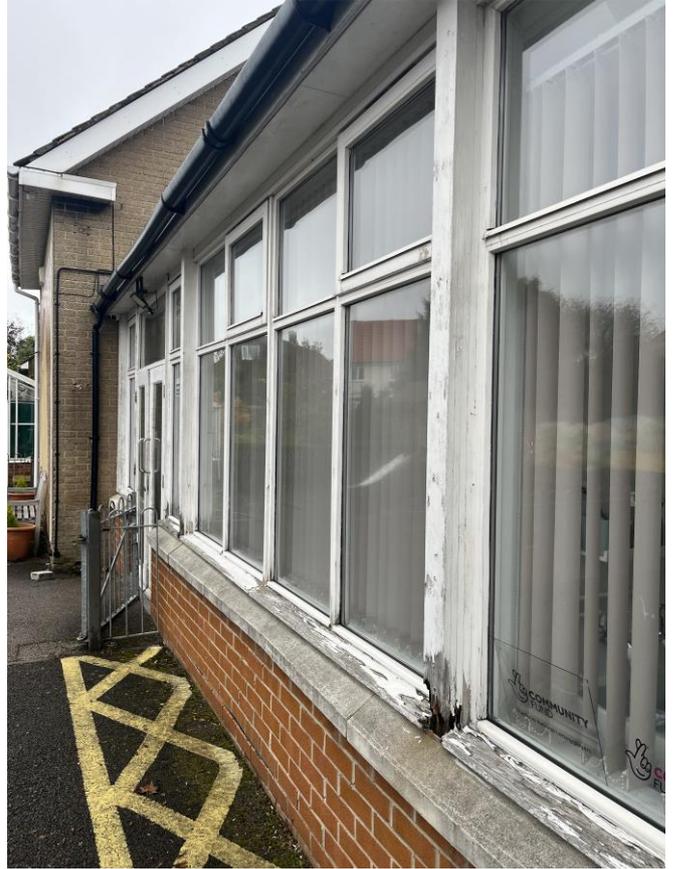
The windows to the south-west entrance area (which we understand are outside of the client's legal ownership boundary) are in extremely poor condition, with many requiring new timberwork.

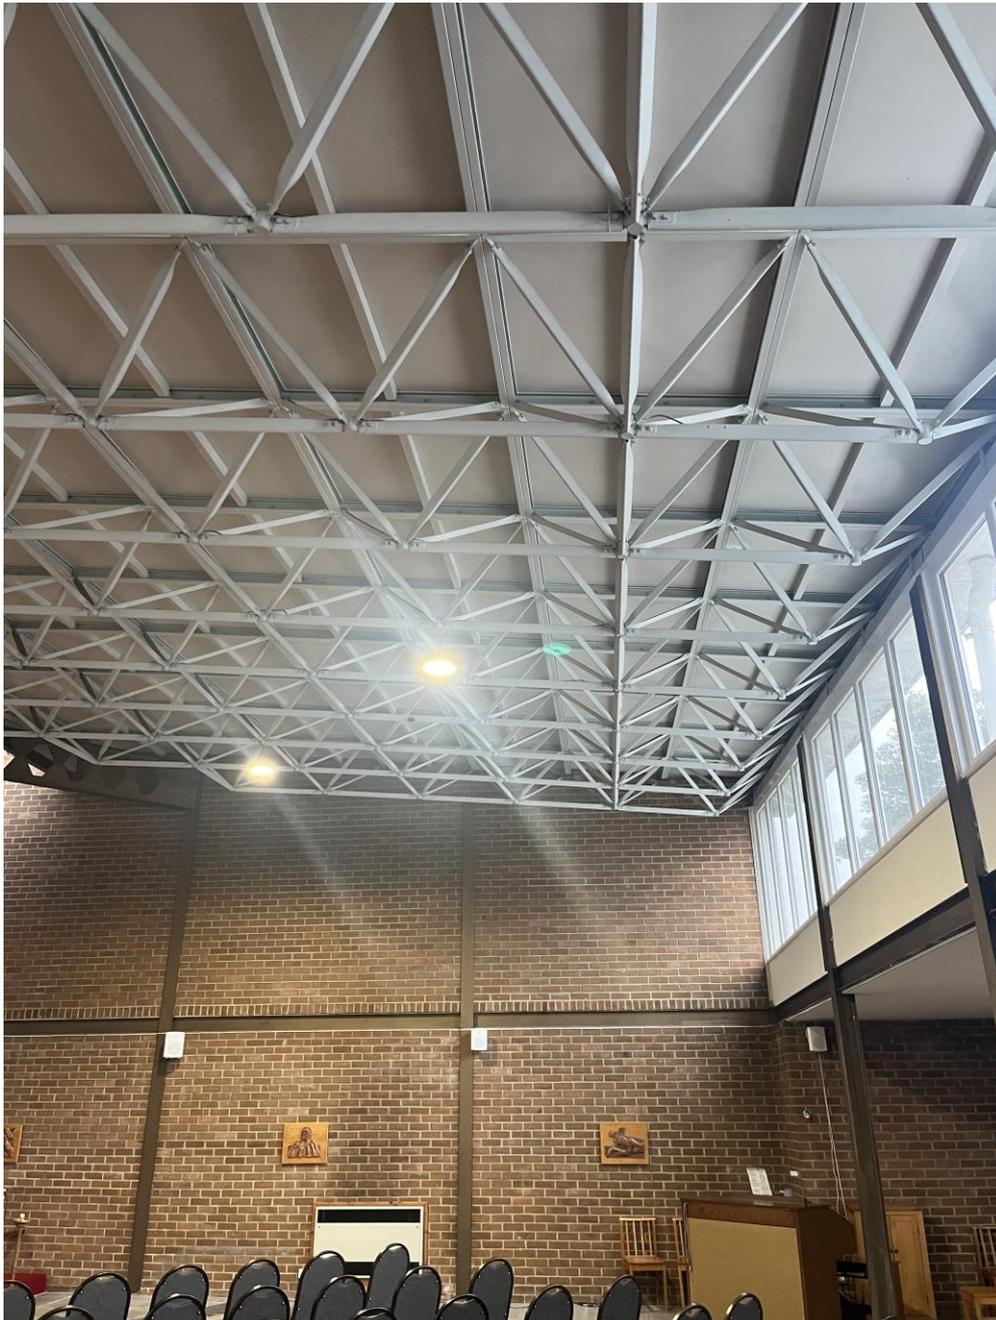
**5.5** The nave / isle roof is a space frame with steel posts at approx. 4/5m centres. The space frame is supported at the edge above the windows and centrally supported on castellated beams. The steel structure is open and painted. From a low-level inspection this looks to be in good condition.

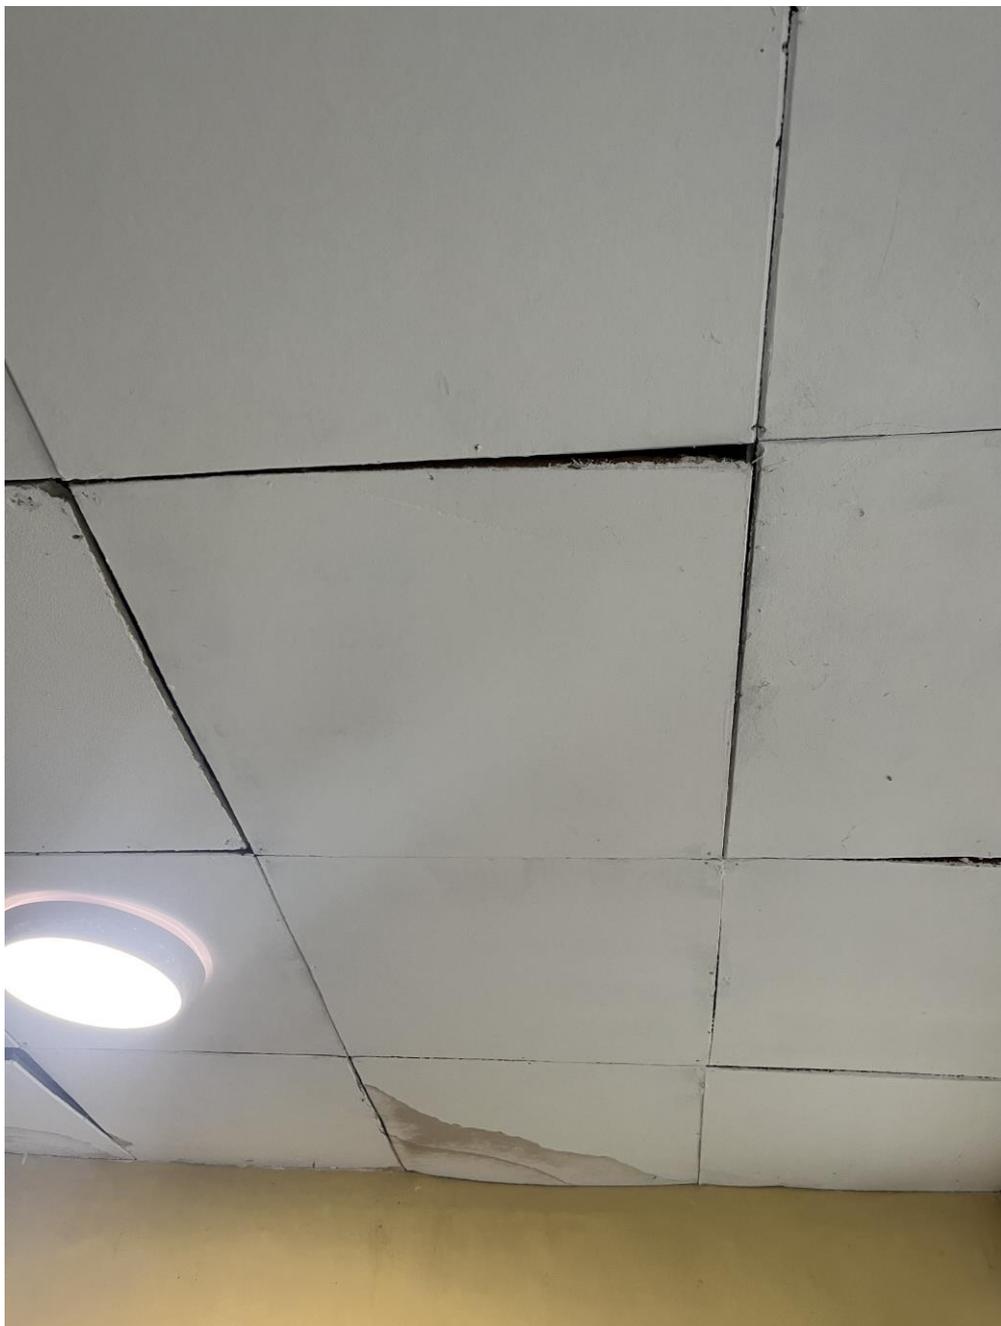
The flush plasterboard is in very good condition. The wood fibre tiles are in poor condition to the entrance link, Chapel lobby and Chapel where several are warped, stained and large gaps have opened up in the joints. These should be removed and replaced.

- The wood fibre tiles are in poor condition to the entrance link, Chapel lobby and Chapel where several are warped, stained and large gaps have opened up in the joints. These should be removed and replaced with either new tiles or probably more suitably a flush plasterboard ceiling.

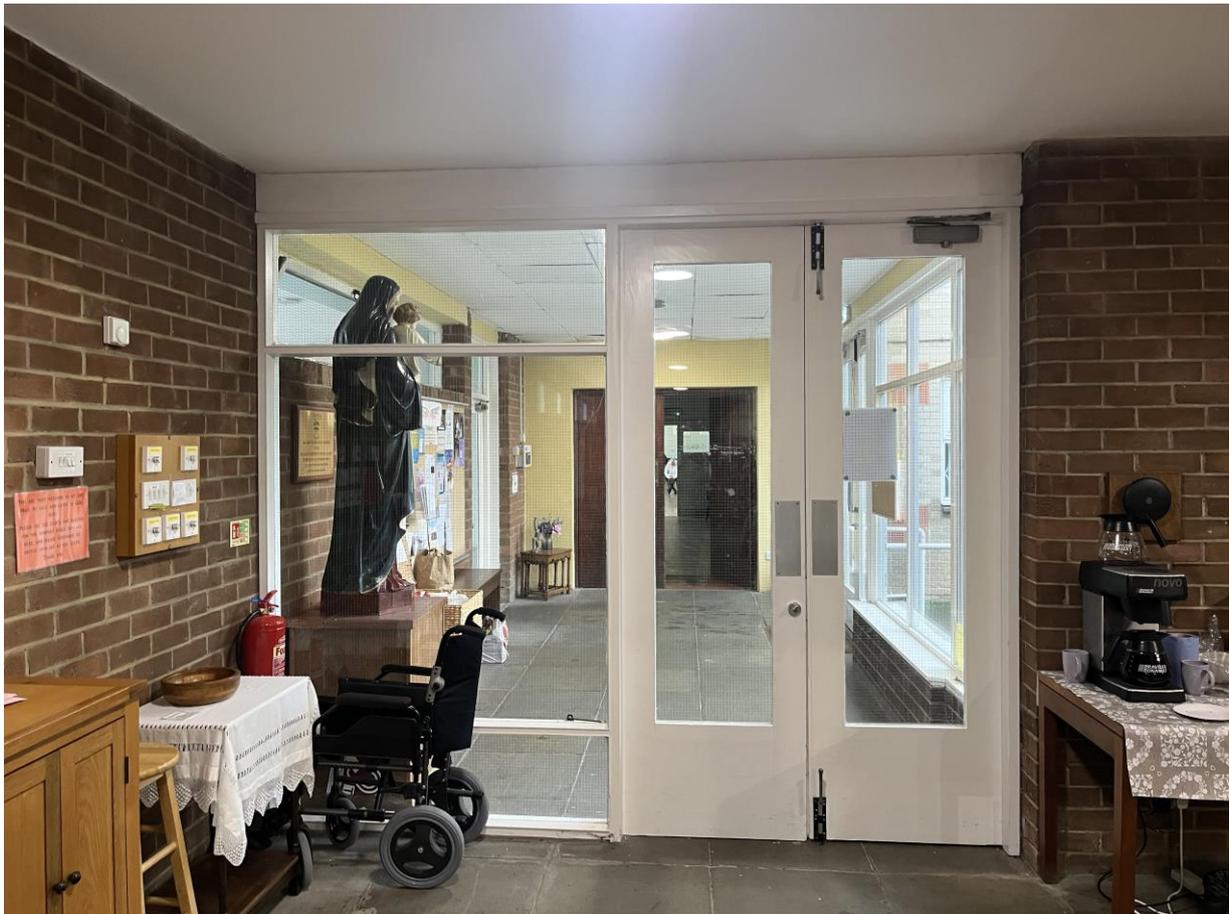
**5.6** The nave to entrance link is separated by a set of double timber doors and a glass screen, both Georgian wired glass, presumably for fire resistance and separation of the escape link. These are in good condition.

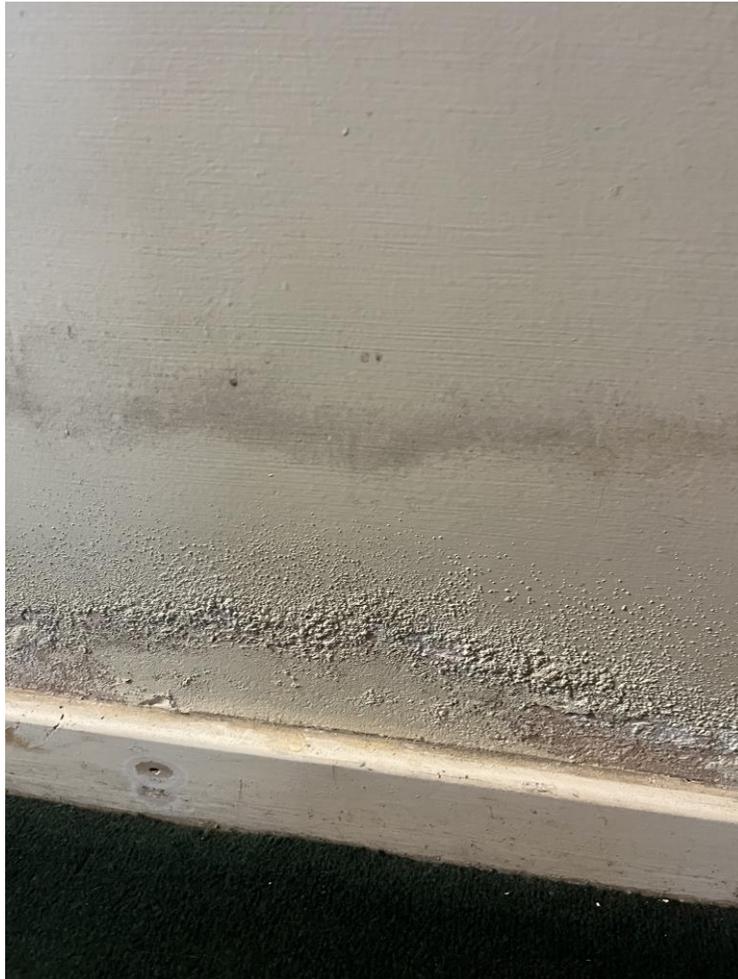
The plasterwork is in poor condition to the Chapel. Historic rising damp damage was evident although it is dry now.

- The plasterwork to the Chapel wall that adjoins the Vestry is in poor condition. Historic rising damp damage evident that is now dry but requires a full damp inspection. The wall requires sanding and re-painting.

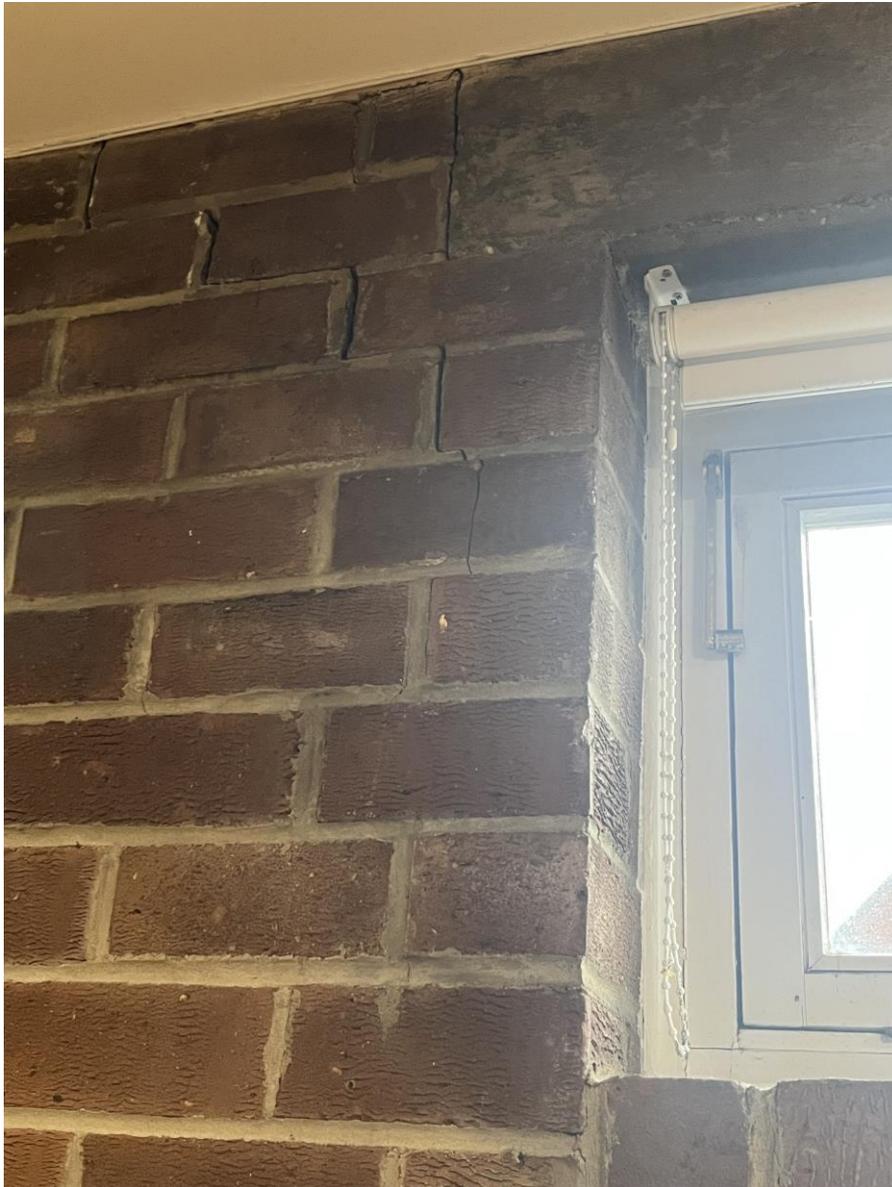
Exposed facing brick to the nave and isle's in mainly good condition but a crack was evident to the left-hand side of one of the high-level windows. This will require an urgent survey and advice from a structural engineer.

- Crack evident to the left-hand side of high-level window in rear aisle. A separate inspection and advice by a structural engineer to take place. Please contact - BDN, The Old School, Simpson Street, Sunderland, SR4 6DR. Tel; 0191 535 6189 [bdnltd.com](http://bdnltd.com)

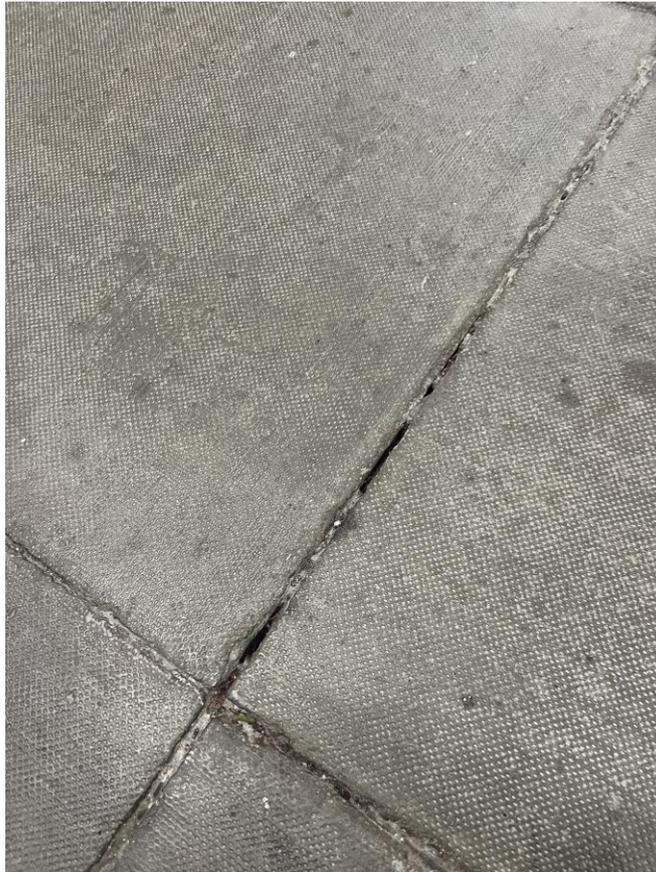
The floors in the link and narthex are solid concrete paving slabs with a non-slip textured finish and these continue into the nave and are all in generally good condition, the joints have degraded and become open in several areas but it hasn't yet affected the stability of the slabs.

- Concrete paving floor slabs in the link and narthex have open joints in several areas.
