Diocese of Durham

St Mary and St Peter's Church, Springwell Road, Sunderland, SR3 4DY

Quinquennial Inspection

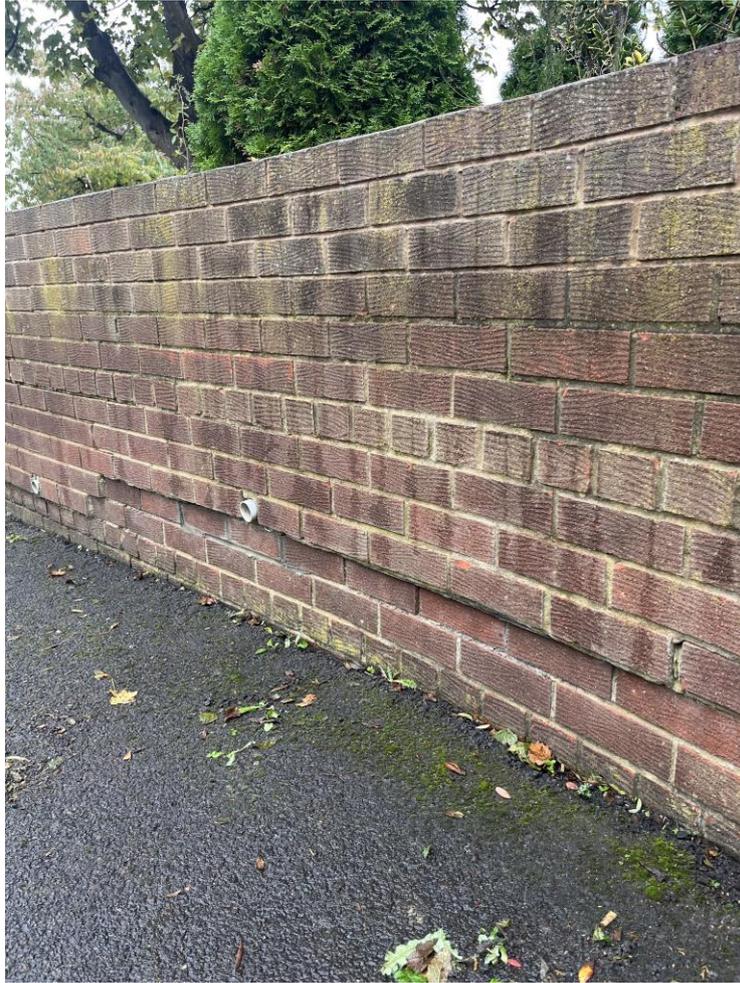
This wall has moved and slipped approx. 30mm on the DPC which requires immediate attention.

- The southern entrance retaining wall has moved and slipped approx. 30mm on the DPC which requires remedial advice by a structural engineer. Please contact - BDN, The Old School, Simpson Street, Sunderland, SR4 6DR. Tel; 0191 535 6189 [bdnltd.com](http://bdnltd.com)
