St Margaret, Tanfield

Quinquennial Report

On the architect's inspection of

25th October 2022

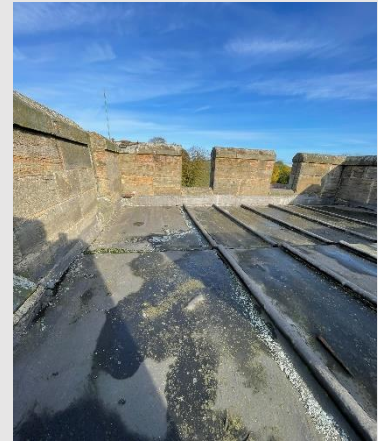
Figure 1- Tower roof

6.1.1 As previously reported - To the tower roof, the lead is covered with brushed-on grey resin reinforced with fiberglass. The resin could have been applied historically to stop leaks through cracked lead. Unfortunately, it has no flexibility and does not stop the lead changing size with temperature, so the lead will also crack the reinforcement. The records show bitumen patching in about 1990 has been split again for at least 15 years. Lichen grows in damp silt trapped in the cracks.

6.1.2 The lead upstands are tucked into grooves in the backs of the parapet stones. At S where the lead is highest. the grooves are under the stone openings themselves. At SW by the hatch the lead is coming loose and has split at the seam.

6.1.6 The lead may be original 1853 so well over 100 years old, and now also covered with a defective resin, used inappropriately. Given the history of rot in the tower, the poor lead sizing, the present edge defects, historic leaks (prompting the attempt to use of resin) and the present damp, a thorough repair/ replacement is now required. The lead needs to be stripped (salvage value limited by the adhered resin) and new replacement lead fixed in narrower bays with a redesigned gutter and fixings to allow movement. New hatch needed (covering

lighter than lead, perhaps copper). A sump overflow would be a further improvement. Meanwhile the roof timbers should be regularly checked for rot by a specialist with access equipment.

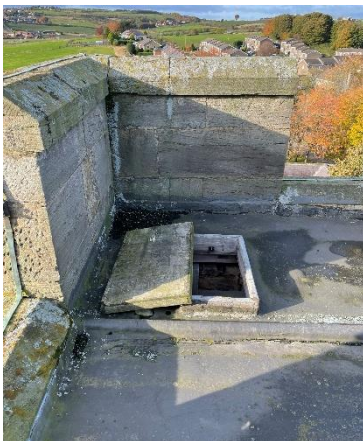
Figure 2 - Hatch

6.1.3 The hatch's felt covering was reportedly lost at the last inspection, leaving saturated bare ply, the condition has further deteriorated from the last inspection and the ply is delaminating. This is no longer a waterproof covering.

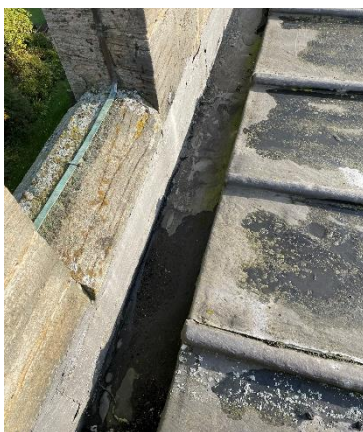
Figure 3- Box Gutter

6.1.5 The box gutter is twice the recommended length. A bottom outlet through the overhanging parapet from a large NW sump (covered by a wire cage). A previous blockage by bird litter caused a leak all the way down to the N wall of the entry lobby. Gutter remains silted at both ends and dammed up each side of the cage. The lead/ glassfibre coating is cracking at the upstand with the parapet. The boards and beam end below were not accessible to check condition.

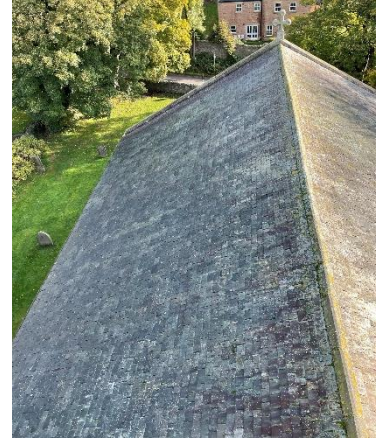
Figure 4- North Face of Nave Roof

6.3 **Nave and aisles** low pitched diminishing Westmorland slates. Felt on the sarking boards so the roof has been re-laid in modern times. Bedding at ridge appears sound. Some cracks at tall mortar fillets at copings. Lead cover flashings at tower. Slate generally sound but some uneven, one slate cracked at top edge to the North side, close to tower. One slate slipped and one cracked on the south slope, near to the west end. Several replacements, in Welsh slate, on lead clips near SW corner.

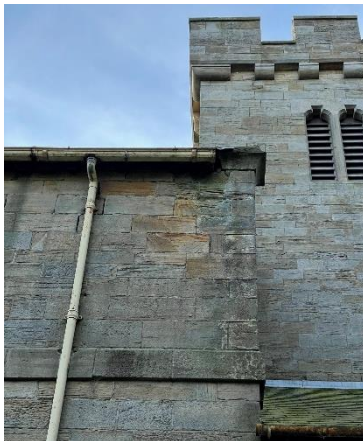
Figure 5- Gutter to north Nave

7.3.2 The S gutter is very rusted but appears sound with falls. It has been refixed on cast aluminium brackets. The rusted N gutter is held up by hooks and screws through the back. All joints are mastic sealed beneath. The old, rusted cast iron straps are weak or failed. The levels are poor and new brackets are needed.

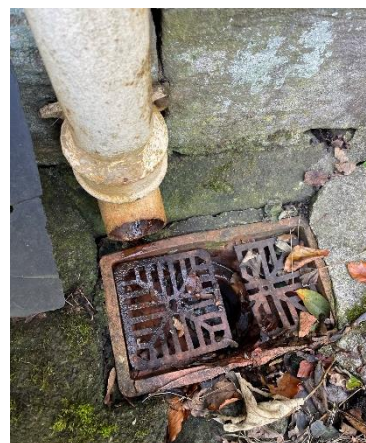
7.3.1 The SW pipe falls onto a slate bridging to a hollow stone with no visible gully. Plastic gully at the SE pipe. The NW gully has a broken cover which is half missing and the downspout is too short to successfully discharge slow flowing water into this outlet. Gullies and drainage believed installed late 2000's. The pipes previously without drains correspond to the worst floor decay inside.

Figure 6- broken gully to N Nave

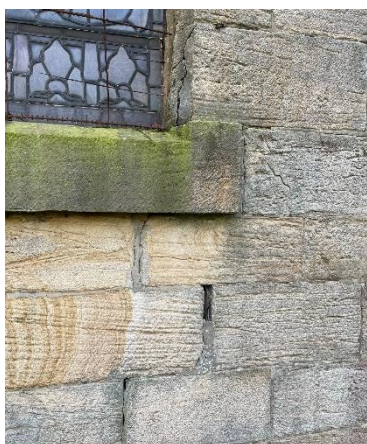
Figure 7- Crack to NE window

8.1 **To Nave** - Minor opening of joints below SW window where the infill was poorly bonded. Also, to the NE corner under the last window, a large opening to a perp joint forms part of a historic crack. Two cracked stones to the RHS of the SE window cill. Minor spread above the SE, SW and NE windows with historic wide pointing where some joints are reopened, due to this being the first inspection with no photographs available in the last report, it is currently unclear if this is progressive.

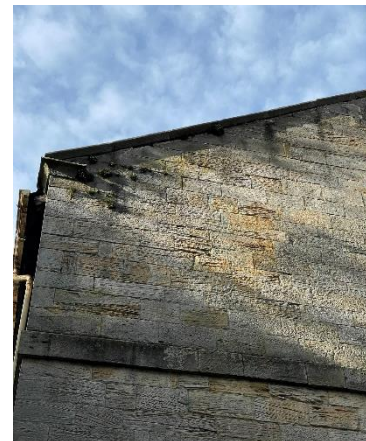
8.1.3 **Nave gables** raised when roof pitch steepened in C19th, using well matched stone. The E end good except plant growth in several ashlar joints under the copings, especially at SE corner. The plants are persistently growing in this area, having images available from 2010 & 2016, the damp issue here clearly remains. It is assumed that the recommended action from the previous report was not undertaken, therefore remains as follows; The plants and all roots need to be thoroughly raked out and the joints raked and pointed including open joints under the copings. The coping joints should be checked at the same time and repointed if needed, as it is thought to be a contributing cause of the vegetation growth.

Figure 8- Growth to E Gable 2022

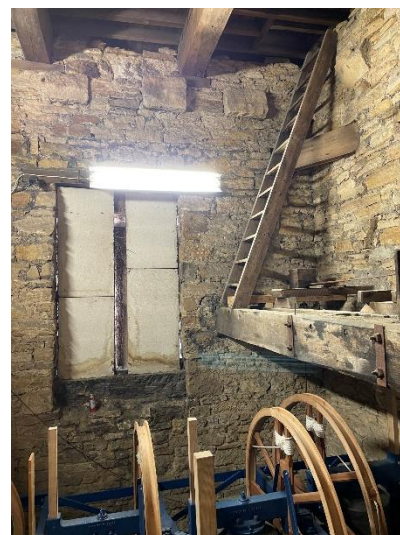
Figure 9- Bells and upper access ladder

9.3 The lower access ladder to the tower roof had been removed (presumably during the bell installation) there was therefore no safe access and a ladder was improvised at the time of inspection – this will not be satisfactory for any future access and should have been included to be replaced in the design scheme for the replacement bells.

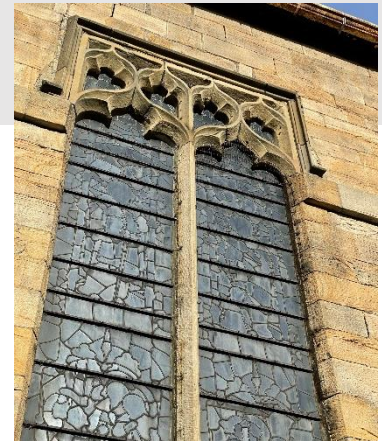
10.1 All openings in good condition. Minor opening of tracery joints, mainly to the south. Minor decay at the NW tracery. The mullions are sound except at the W vestry window (as below). At the tower W opening the long mullion has some delamination. At the SW window one side of the mullion begins to split.

Figure 10- Open joints to tracery

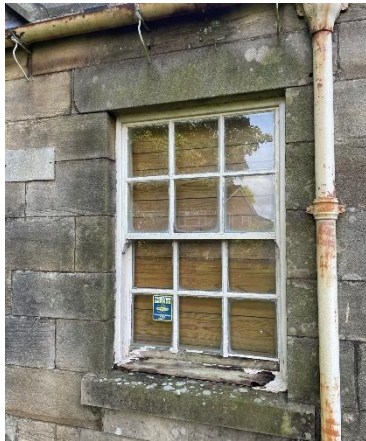
Figure 11- NE weathered window

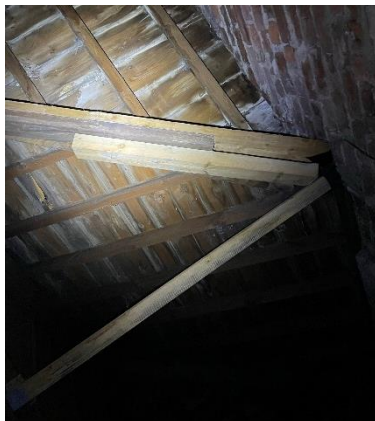
Figure 12- Roof over NE vestry

12.6 The E part of the NE room roof is rafters and sarking boards. The lower timbers are modern replacements. The old upper timbers above the flat ceiling are severely watermarked. Air movement from the modern slate vents may prevent rot but adding an air brick through the wall would be a further precaution.

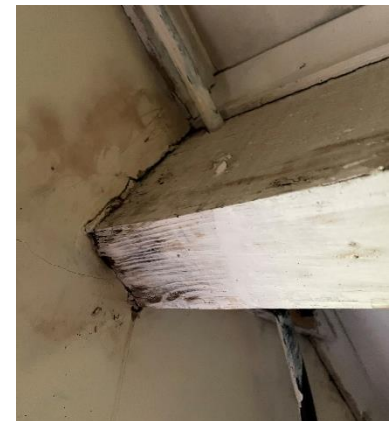
Figure 15- Purlin to upper NW room

12.7 Lean-to upper NW room – painted purlins. One end discolored as if damp, some softening to edge of timber, closely monitor condition for further deterioration as this could be historic.

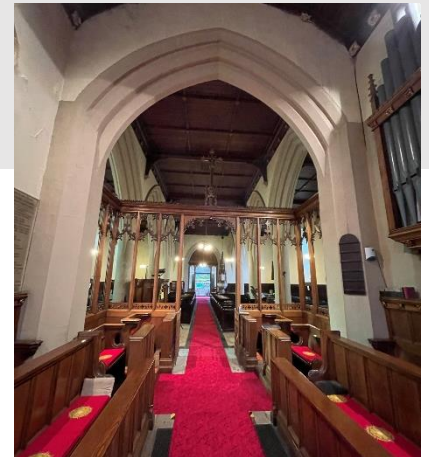
14.2 Slight staining to E face of chancel arch – could be linked to moss at item 8.1.3.

Figure 16- Chancel Arch with staining

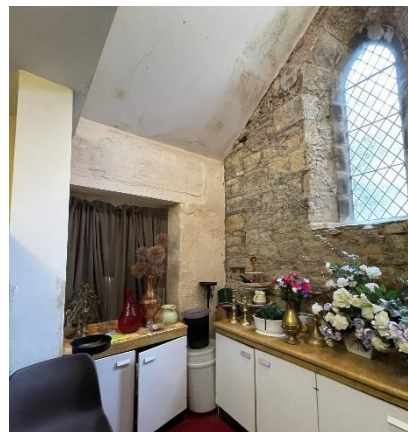
15.3.1 The upper E wall plaster and decoration broken down by damp, reportedly when removing paint from this area, plaster also de-bonded from wall. This is linked to an ongoing roof or upper wall defect (items 6.5 & 8.4).

Figure 17 - Damp wall to NE vestry

15.3.3 The loss of paint and plaster may be an advantage, allowing the external wall to breathe. Solutions to the remaining low-level damage may be, in order of increasing cost and reliability:

- As per the Eastern most wall; the plaster could be removed and the masonry left exposed to breathe permanently
- as above but covered with ventilated and isolated wainscot panelling similar to the organ panelling
- The previous report suggested an injected damp course, however the conservative (SPAB) approach suggests this can cause more issues than it solves. Therefore, improved ground drainage to the outside would be more appropriate.

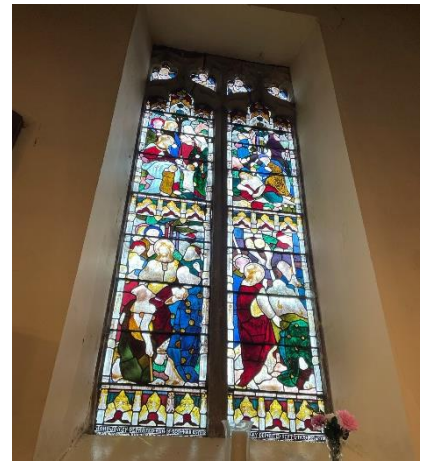
- NW sound but very dirty leaded white quarries, internal saddle bars and external ferramenta. Gives good daylight at font.
- next modern painted glass in clear background. SS Andrew and Peter, Davison family memorial, internal saddle bars, sound
- next Archdale memorial 1925, good painted and stained-glass late Kempe & Co. similar to S windows including external saddle bars, sound but dirty
- NE Joicey memorial 1881, split open vertically at many leads, apparently due to slight past wall movement. Paint severely lost to the point where urgent attention is required and complete removal should be considered. A different design or change to completely white glass would improve daylight (as at font).

Figure 18- N window – urgent renewal

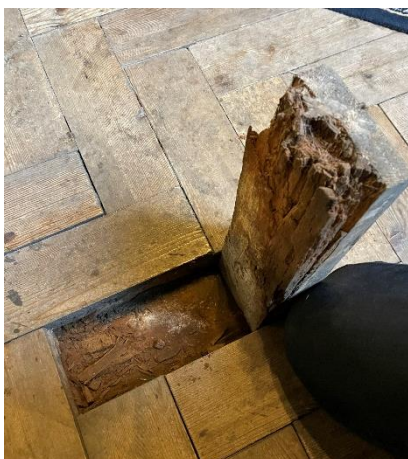
Figure 19 - Wooden floor block

19.2 The **nave** and **aisle** walkways have regular stone flags with iron heating grills. Under the pews softwood blocks 2" thick on concrete without bitumen bedding or other damp proofing. It seems the whole floor has no barrier to rising damp which must protect the walls from rising damp by letting moisture evaporate. However, this has caused almost all blocks to become loose.

19.2.1 Woodblocks at the **SE and SW corners** are sunk and loose due to slight wet rot in the undersides. The cause may be slight rising damp due to exposure at the corners or to the former lack of drainage at the downpipes. Attempts have been made to get prices to lift the damaged blocks, clean the concrete, piece in sound wood and to treat the lifted blocks against decay before relaying in bitumen compound. New blocks may be obtainable.

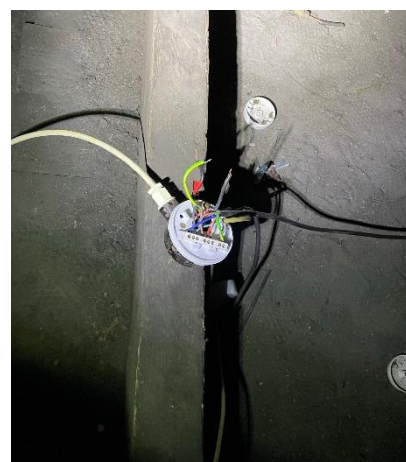
Figure 20 - wiring in nave attic

22.3 In the roof space above the nave an exposed wiring junction was left on top of a ceiling joist.

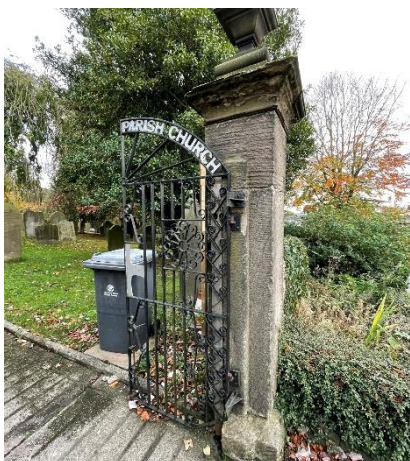
Figure 21- main gates to west

28.1 The upper yard main gates to the west are modern painted mild steel, gates are in good condition with minor rust. Parts of the moulded cornices at the (listed) classical stone piers are broken.

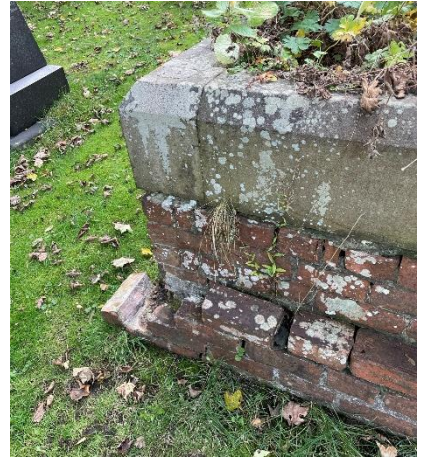
28.8 A stream emerges from the NE corner as if the cemetery lies over a culvert. *Figure 22- spawling brick on Clark*
