**QUINQUENNIAL INSPECTION REPORT
OF
TRIMDON, ST. MARY MAGDALENE, COUNTY DURHAM**

**DIOCESE OF DURHAM
ARCHDEACONRY OF DURHAM
PARISH OF THE UPPER SKERNE**

2014 QUINQUENNIAL INSPECTION AND REPORT

DATE: JANUARY 2025

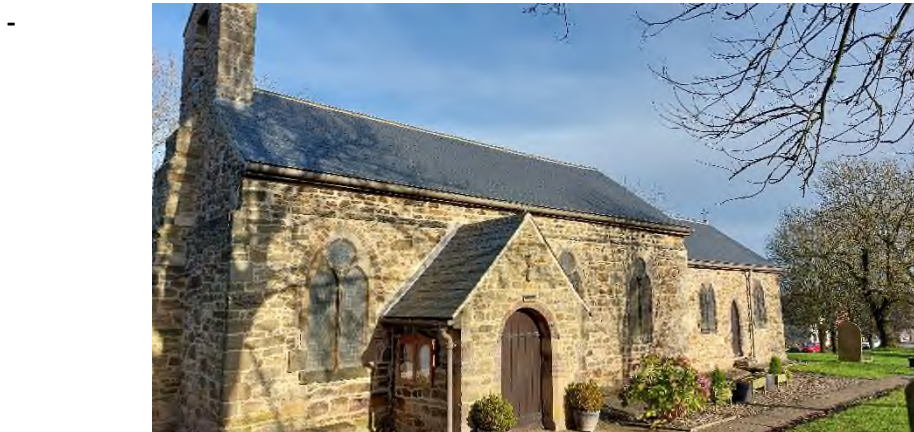
7.4.2 ROOFS

The nave and chancel roof coverings were renewed in 2016 Welsh slate and is all ok. The porch roof covering has also been renewed. Chancel ridge has had two ridges rebbeded.

Recommendation: none

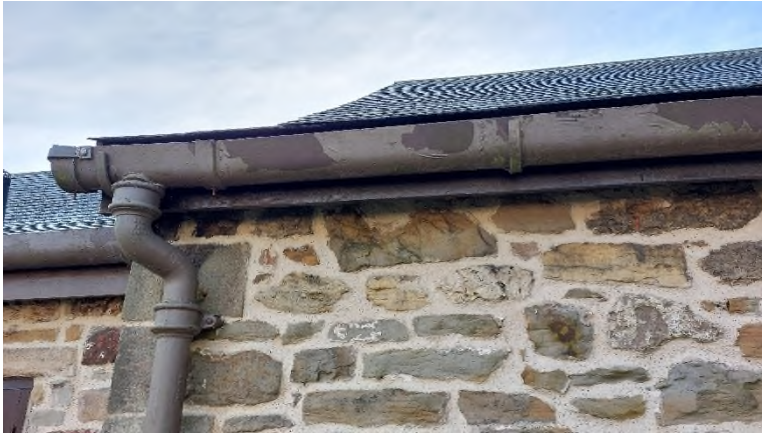
7.4.3 RAINWATER GOODS

Cast-iron half round gutters and cast-iron downpipes to open shoes discharging onto the perimeter concrete benching, the decoration is starting to break down a bit on the gutter end caps and some junctions, looking a bit green on the south side underside of the gutter.

Recommendation: redecorate rainwater goods

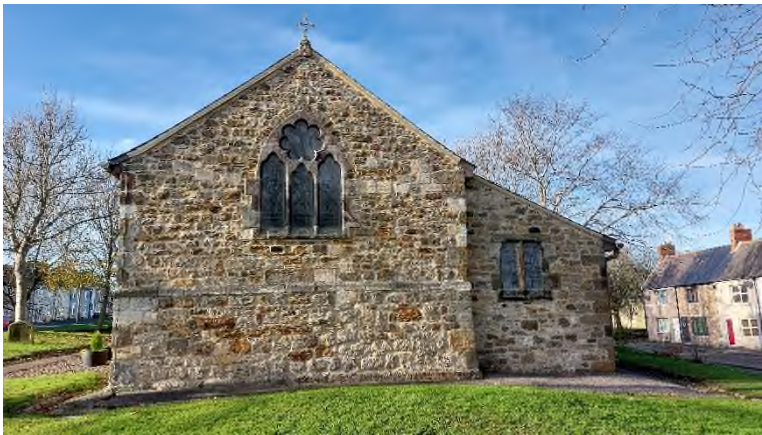
7.4.4 WALLS, BUTTRESSES AND CHIMNEYS

Random and mixed walling of limestone and sandstone roughly laid to course with finer limestone quoins on the corners all of this was lime repointed in 2016 in NHL 3.5 (as was the specification at the time), and all looks ok. There was a particular problem with cracking on the west gable of the nave and there is no sign of that now, so the walls are in very good condition.

Buttresses - There are two low height buttresses on the north side supporting the vestry these were also repointed and are ok.

Recommendation: none

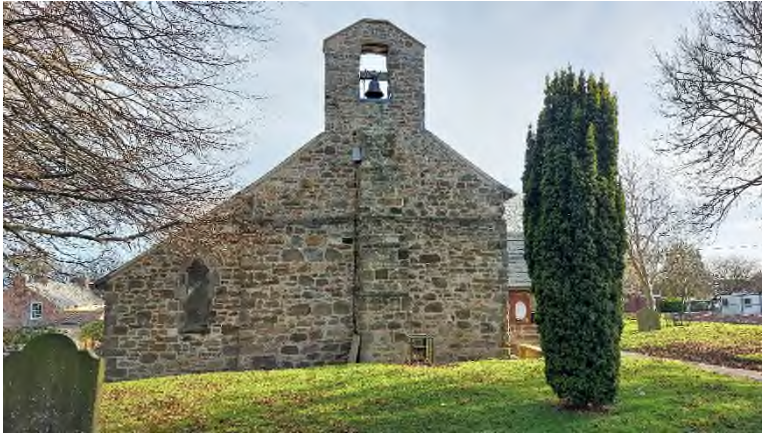
7.4.5 FLECHE, BELLS, FRAME AND CLOCK

There is a bellcote at the west end. This was partially rebuilt in 2016 and capped with new sandstone capping and kneelers also the linteling arrangement in the bell opening was renewed, all appears satisfactory. Leadwork is all in position. The timber bell head stock looks good as do its brackets and the bell looks alright, this is regularly rung and sounds ok.

Recommendation: none

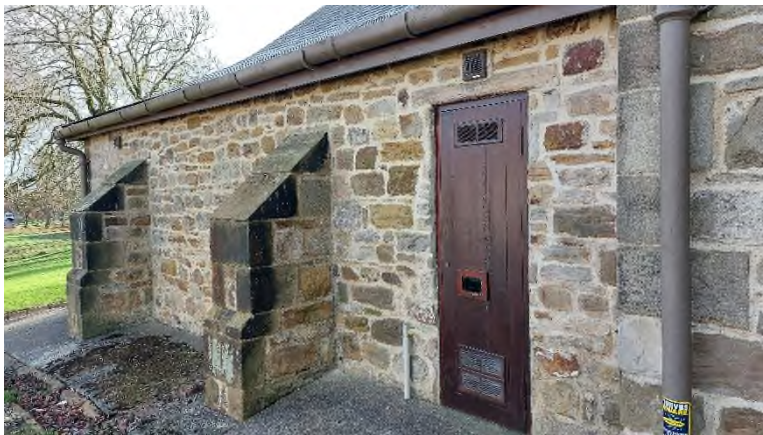
Door openings:

Vestry Boiler room – Simple cut into the masonry, some breaking up of the rebate but no action required.

Chancel South Side – Timber door, decoration needs updating, PCC want to draught proof this probably with an external hardwood frame. Ashlar surround ok.

Porch – Heavy boarded door ok and the arched surround has had masonry repairs or replacement units in the jambs.

Recommendation: update the chancel south door

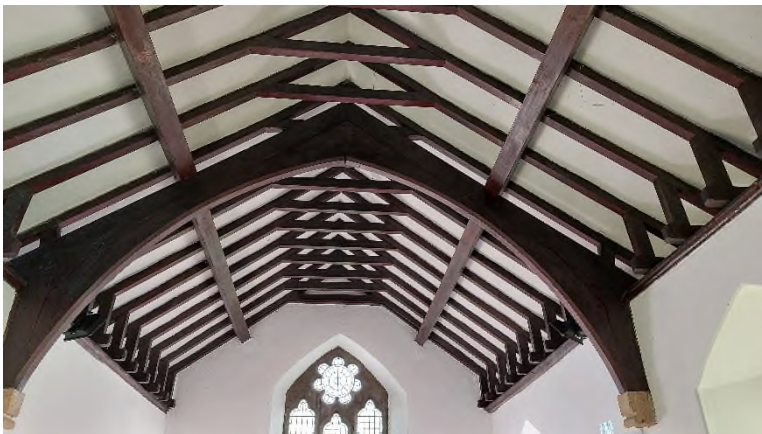
7.5.1 ROOF TIMBERS

Exposed rafters, purlins and trusses throughout and these are from the 19th Century repairs, all in good condition and decoration.

In the nave the eastern most truss on the northside has its rafters support shoe dislodged (just above the speaker) but I don't think this is anything to worry about other than we ought to be sure it is not loose and fall on someone. The timber shows some shakes to it purlins on the southern side, there are some gaps to the trusses at the apex, but these look historic. The walls particularly the south has moved outwards and so there has been some creep to the joinery.

Recommendation: check that nave, northern side, eastern end rafter shoe is secure

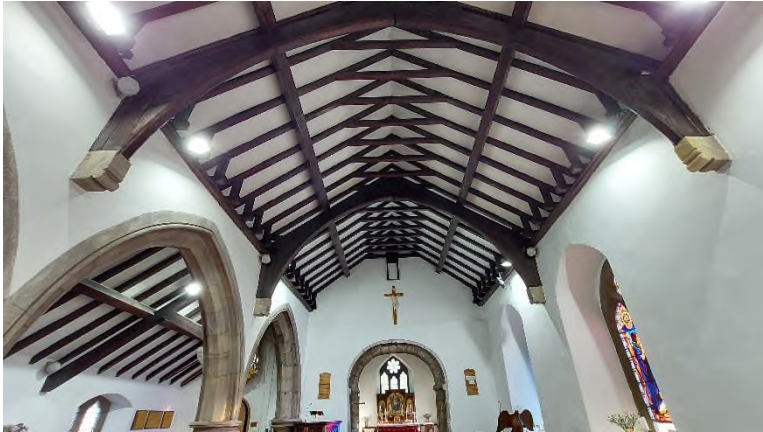
7.5.2 CEILINGS

Ceilings are formed from plaster within the rafters, 50mm Kingspan was added above the nave when it was reroofed and so suspect that there is no roof insulation in the chancel and that there maybe some in the vestry as works were carried out in 1990.

Recommendation: none

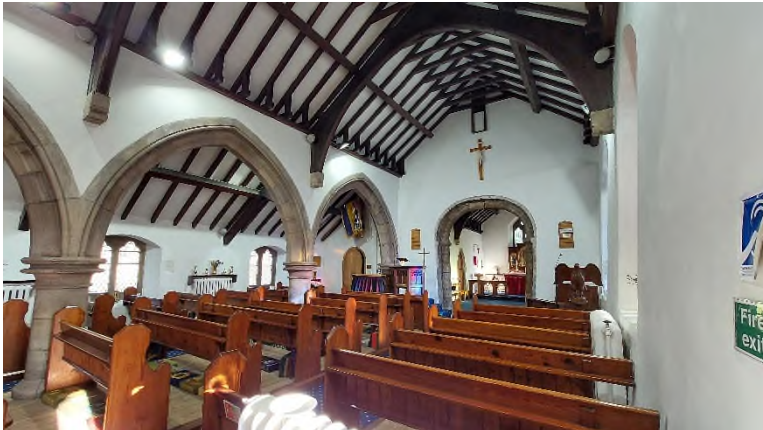
Chancel Arch:

The chancel arch is severely depressed and its imposts are spreading outwards as a result of the wall head moving outwards and it's not wholly symmetrical more bellowing out to the southside and the arch has probably been rebuilt as a consequence of the movement, important thing to note is the remnants of decoration at the base of the imposts on the south side.

Recommendation: none

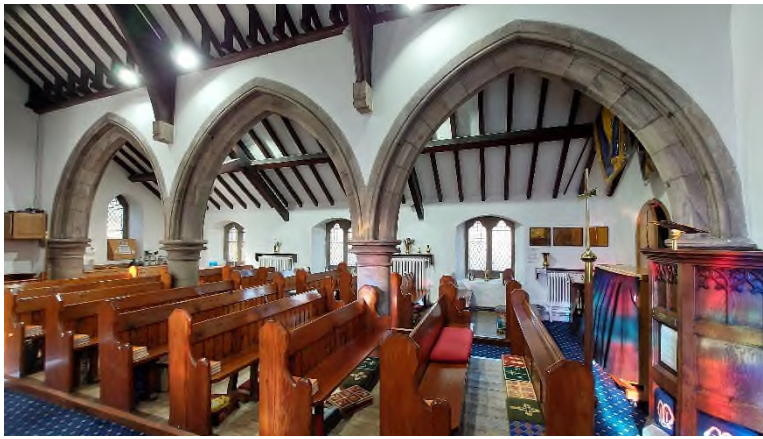
- **Arcades:**

There is one arcade separating the nave from the north aisle and this is chamfer arches with circular columns and bases. There is a slight purple hue to some of the stones which overall appear to be sandstone. There is no movement to the arches.

Recommendation: none

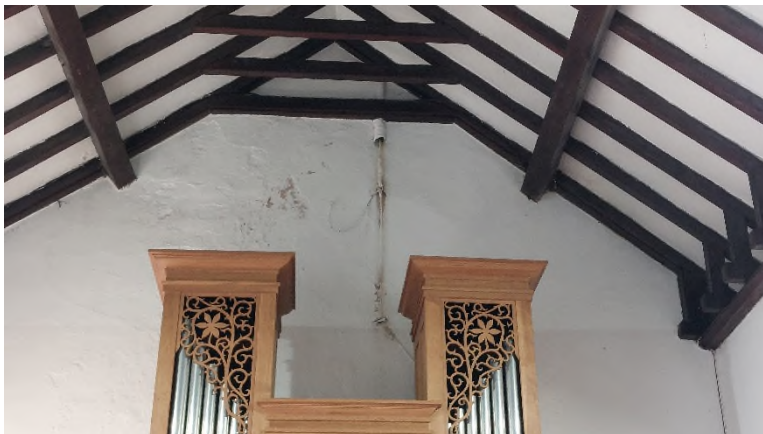
B **Plaster:**

The whole of the interior is plastered and is sound. Apart from above the organ at the west end which needs looking at close quarters. It was planned to be attended to in the 2016 works but the decision then was to leave it alone and wait for the wall to dry out and be sure there was no active cracking (as could be seen on the outside then- which there is no evidence of now)

Recommendation: inspect at close quarters

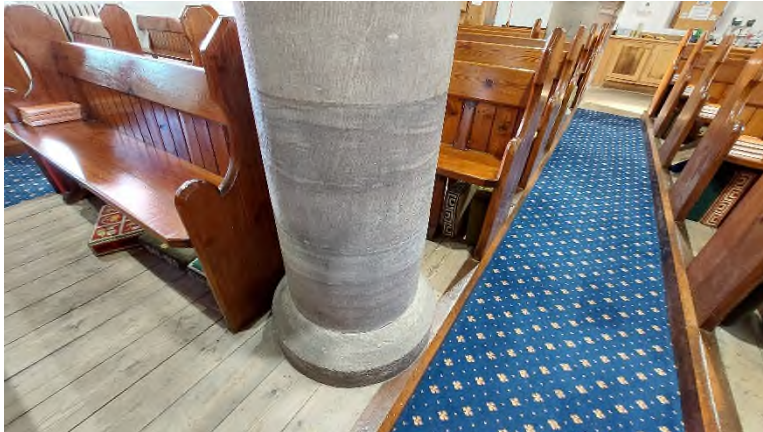
E **Floors:**

Circulation areas are solid and there are pew platforms in timber.

The chancel floor has been replaced in 1989 and the vault beneath it recorded. It contains the Beckwith Family Vault of four adult coffins and one child's.

The sanctuary floor is also solid, all of this is carpeted, and the carpet is recent and in good condition, the carpet edge strips to the lectern area look a little tatty.

Recommendation: fix down carpet edging

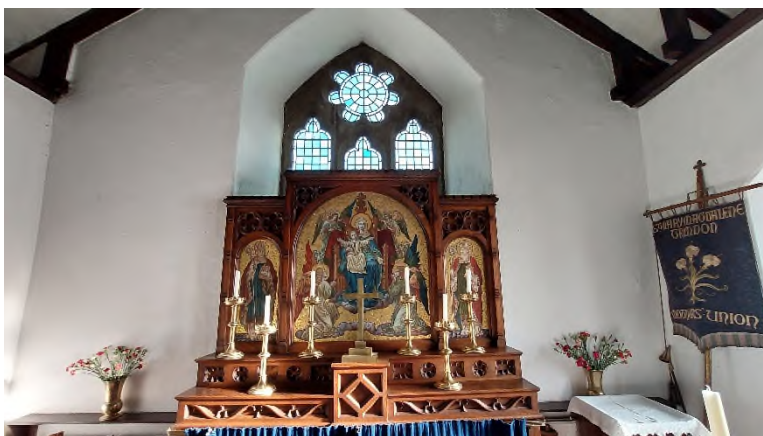
- **Reredos:**

Fine oak reredos with triptych panel in mosaic with figurative scenes.

Recommendation: none

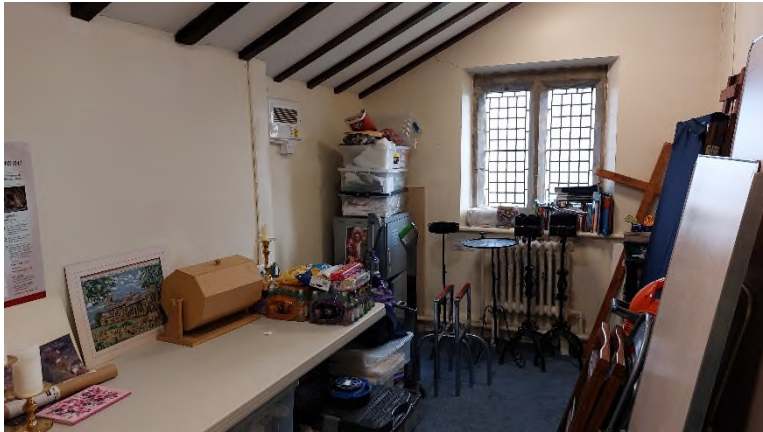
- **Vestry:**

Ceiling – Plastered ceiling with exposed rafter feet ok.

Walls – Are plastered and decorated. Crack to the north east of the eastern window at the lintel.

Room contains the safe, loose vestments not in a cupboard, rather old desk, there is a build-up of chairs and bits and pieces in here, that would be better tidied up. Door is ok.

Recommendation: none

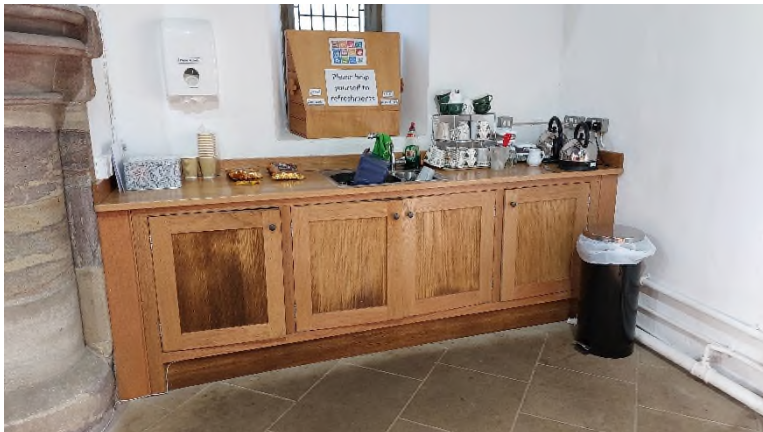
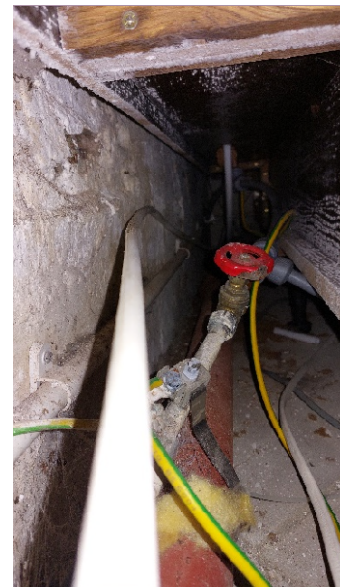
E **Servery:**

A modest servery is formed at the west end of the north aisle with oak fittings with a sink, it is macerated pumped waste connected by a long pipe along the north wall to the drainage of the w.c. Problem with damp as mildew has formed on the surfaces due to a lack of ventilation.

Recommendation: Ventilate the unit.

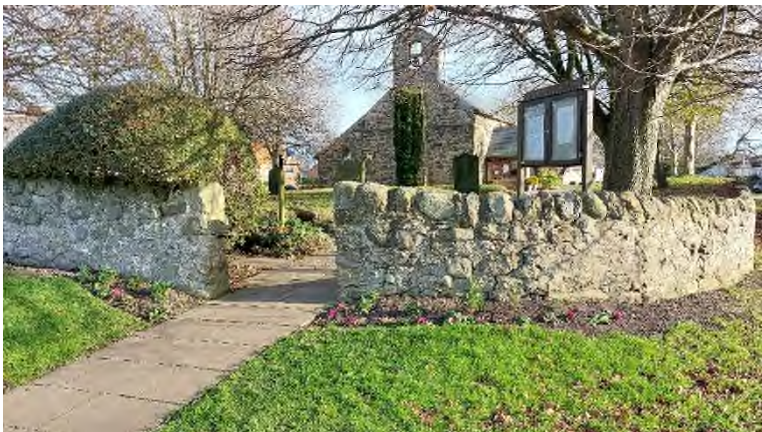
West Side – Metal gate kept open with a timber chock, perhaps that could do with a bolt, slight cracking either side of the gate and as it comes round to the south boundary heavily cement pointed, the churchyard is approximately 3 feet above the external level, mixture of trees on this boundary, large Yew on the south east corner beginning to look straggly.

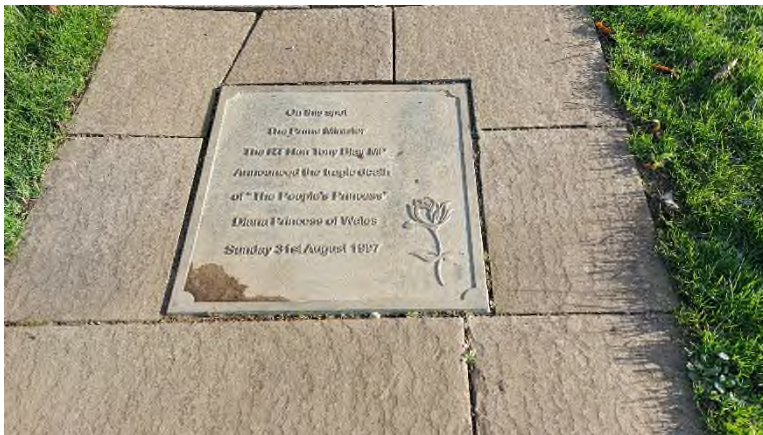
Paths and church surrounds:

The concrete aprons are breaking up, they are not managing the rainwater disposal as well as originally intended

Recommendation: Consider remaking the surrounds

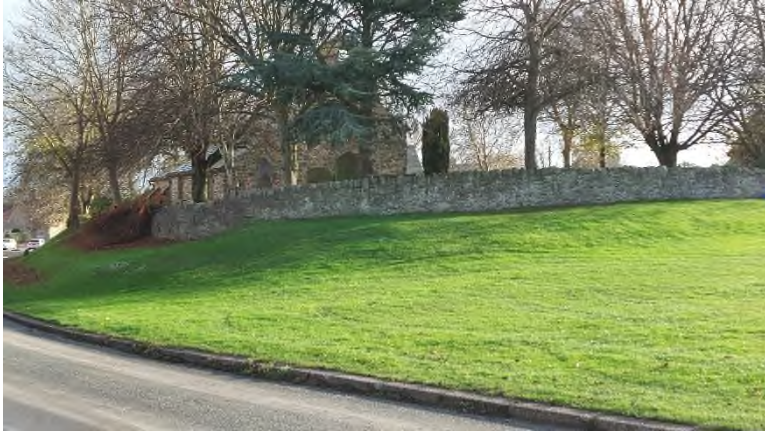
M Trees:

There is one suspect at the west end that the LA have their eye on.

Recommendation: monitor
