# Asbestos in Churches

What you need to know

**Ian Simpson**

*Updated November 2019*

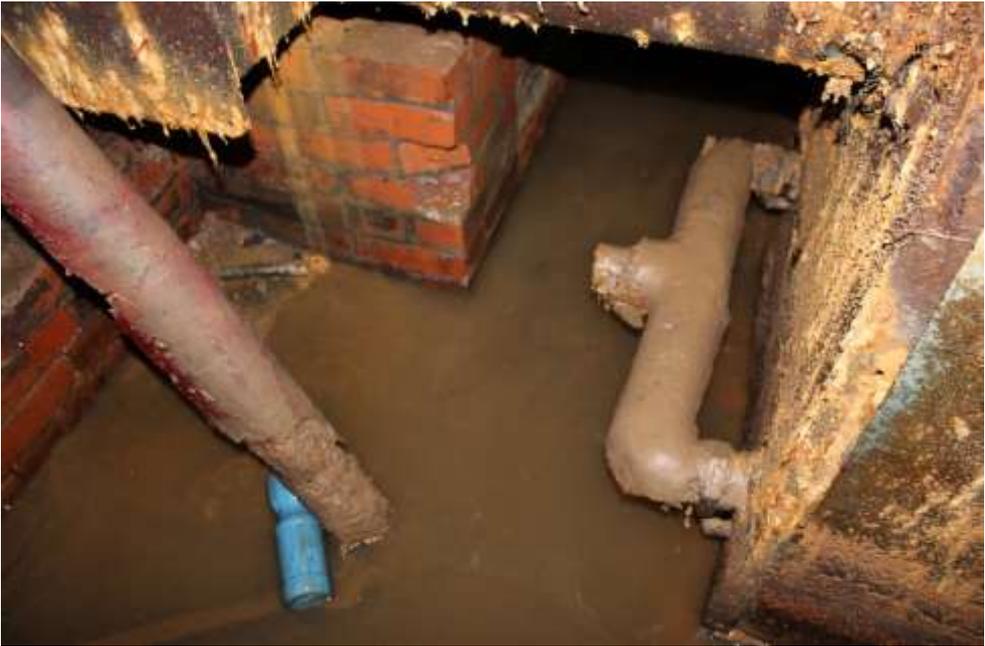
*One place asbestos-containing materials can often be found in churches is in the Plant Room. This particularly bad example is underneath a church in the north-west of England. Note the pipe lagging (which almost certainly contains asbestos) and its damaged state.*

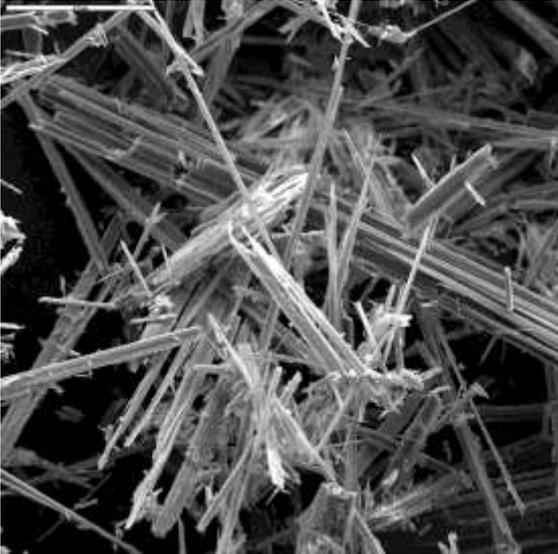
*Photo: anthophyllite, a rare form of asbestos, viewed through an electron microscope. (US Geographical Survey, Public Domain)*

When ACMs are damaged, broken, drilled or otherwise disturbed, tiny fibres of asbestos escape into the atmosphere. Invisible to the naked eye, under an electron microscope the needle-like shape of the fibres is clear. These tiny needles, when breathed in, lodge in lung tissue and can cause tremendous damage over time.

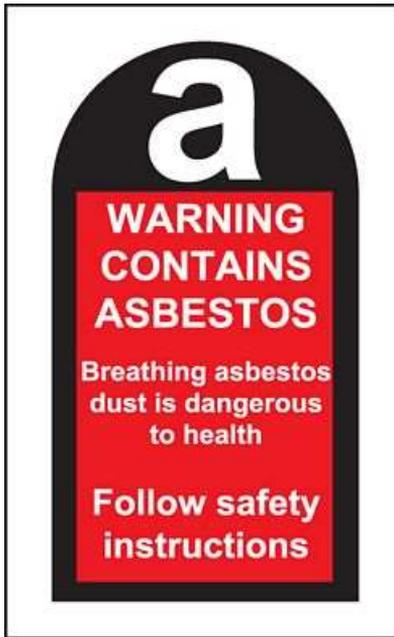
1. You must arrange to put the plan into action. Depending on what is suggested by your asbestos surveyor this might be as simple as affixing warning labels (left) and arranging for access to the affected area to be restricted, or it may mean a substantial removal and remediation programme (see below).
