#### 4. THE STEPS ON THE WEST OF THE TOWER

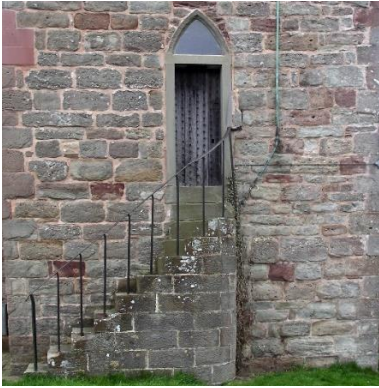
The lower window on the west wall of the tower has been enlarged and converted to a doorway to the bellringers' chamber. The stone steps leading to the door and the iron handrail were installed soon after November 1845, when Sir Samuel Meyrick wrote to a friend about it. Access to the floors inside is by ladder. A steep ascent leads to the bell chamber itself from the ringers' chamber. A full description of the bells can be found in the Heritage Trail for inside the church.

The handrail and steps have been repaired as part of the 2017 Heritage Lottery- funded project.
