## 7. THE NORTH WALL OF THE CHURCH

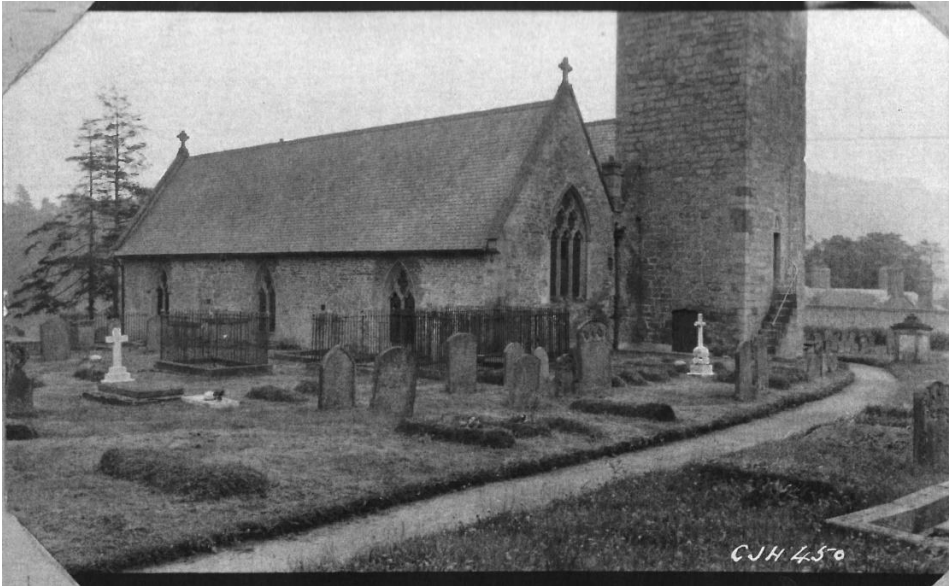
The earliest view of the north wall of the church found so far dates from 1927 when the Historic Monuments surveyors visited. It shows the graves with railings before these were taken away in WWII; the only one which retains its originals being that of Sir Samuel Meyrick of Goodrich Court, by the good offices of the vicar. It had a new slab cut in the 1940s, funded by The Meyrick Society.

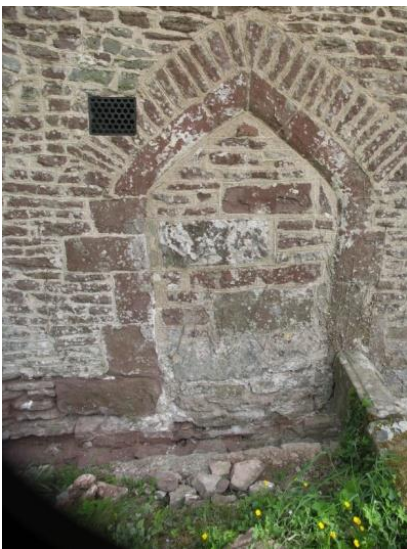
Between the rightmost two windows in the north wall is a blocked up doorway (left). It is directly opposite the main entrance door to the church and is clearly old. A new step and cill was made for it in 1739, but permission was granted in the 1870s to block it.

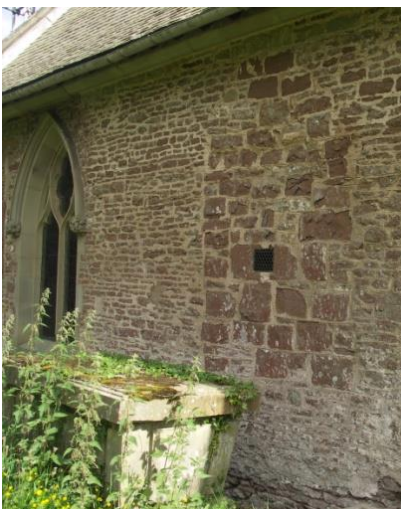
The easternmost window shows disturbance about its head. To the left of the window a delicate piece of window moulding has been built into the wall (below right). Above it the stones in the wall are of the same quality and type as those of the tower. Could these be the only remnants of the vanished north chapel?

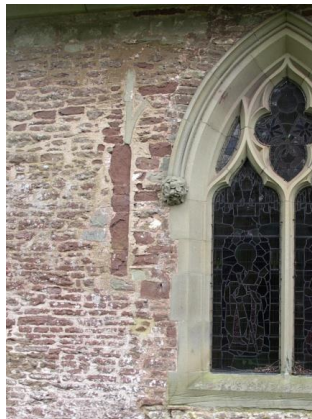
There is a large blocked window between the two current leftmost (eastern) windows (left below). Strangely, it has been filled with large better quality sandstone blocks rather than the rubble of the rest of the wall.
