Bebington St Andrew – Organ protection

Note to parish

SCHEDULE OF WORKS OR PROPOSALS

Installation of an organ canopy.

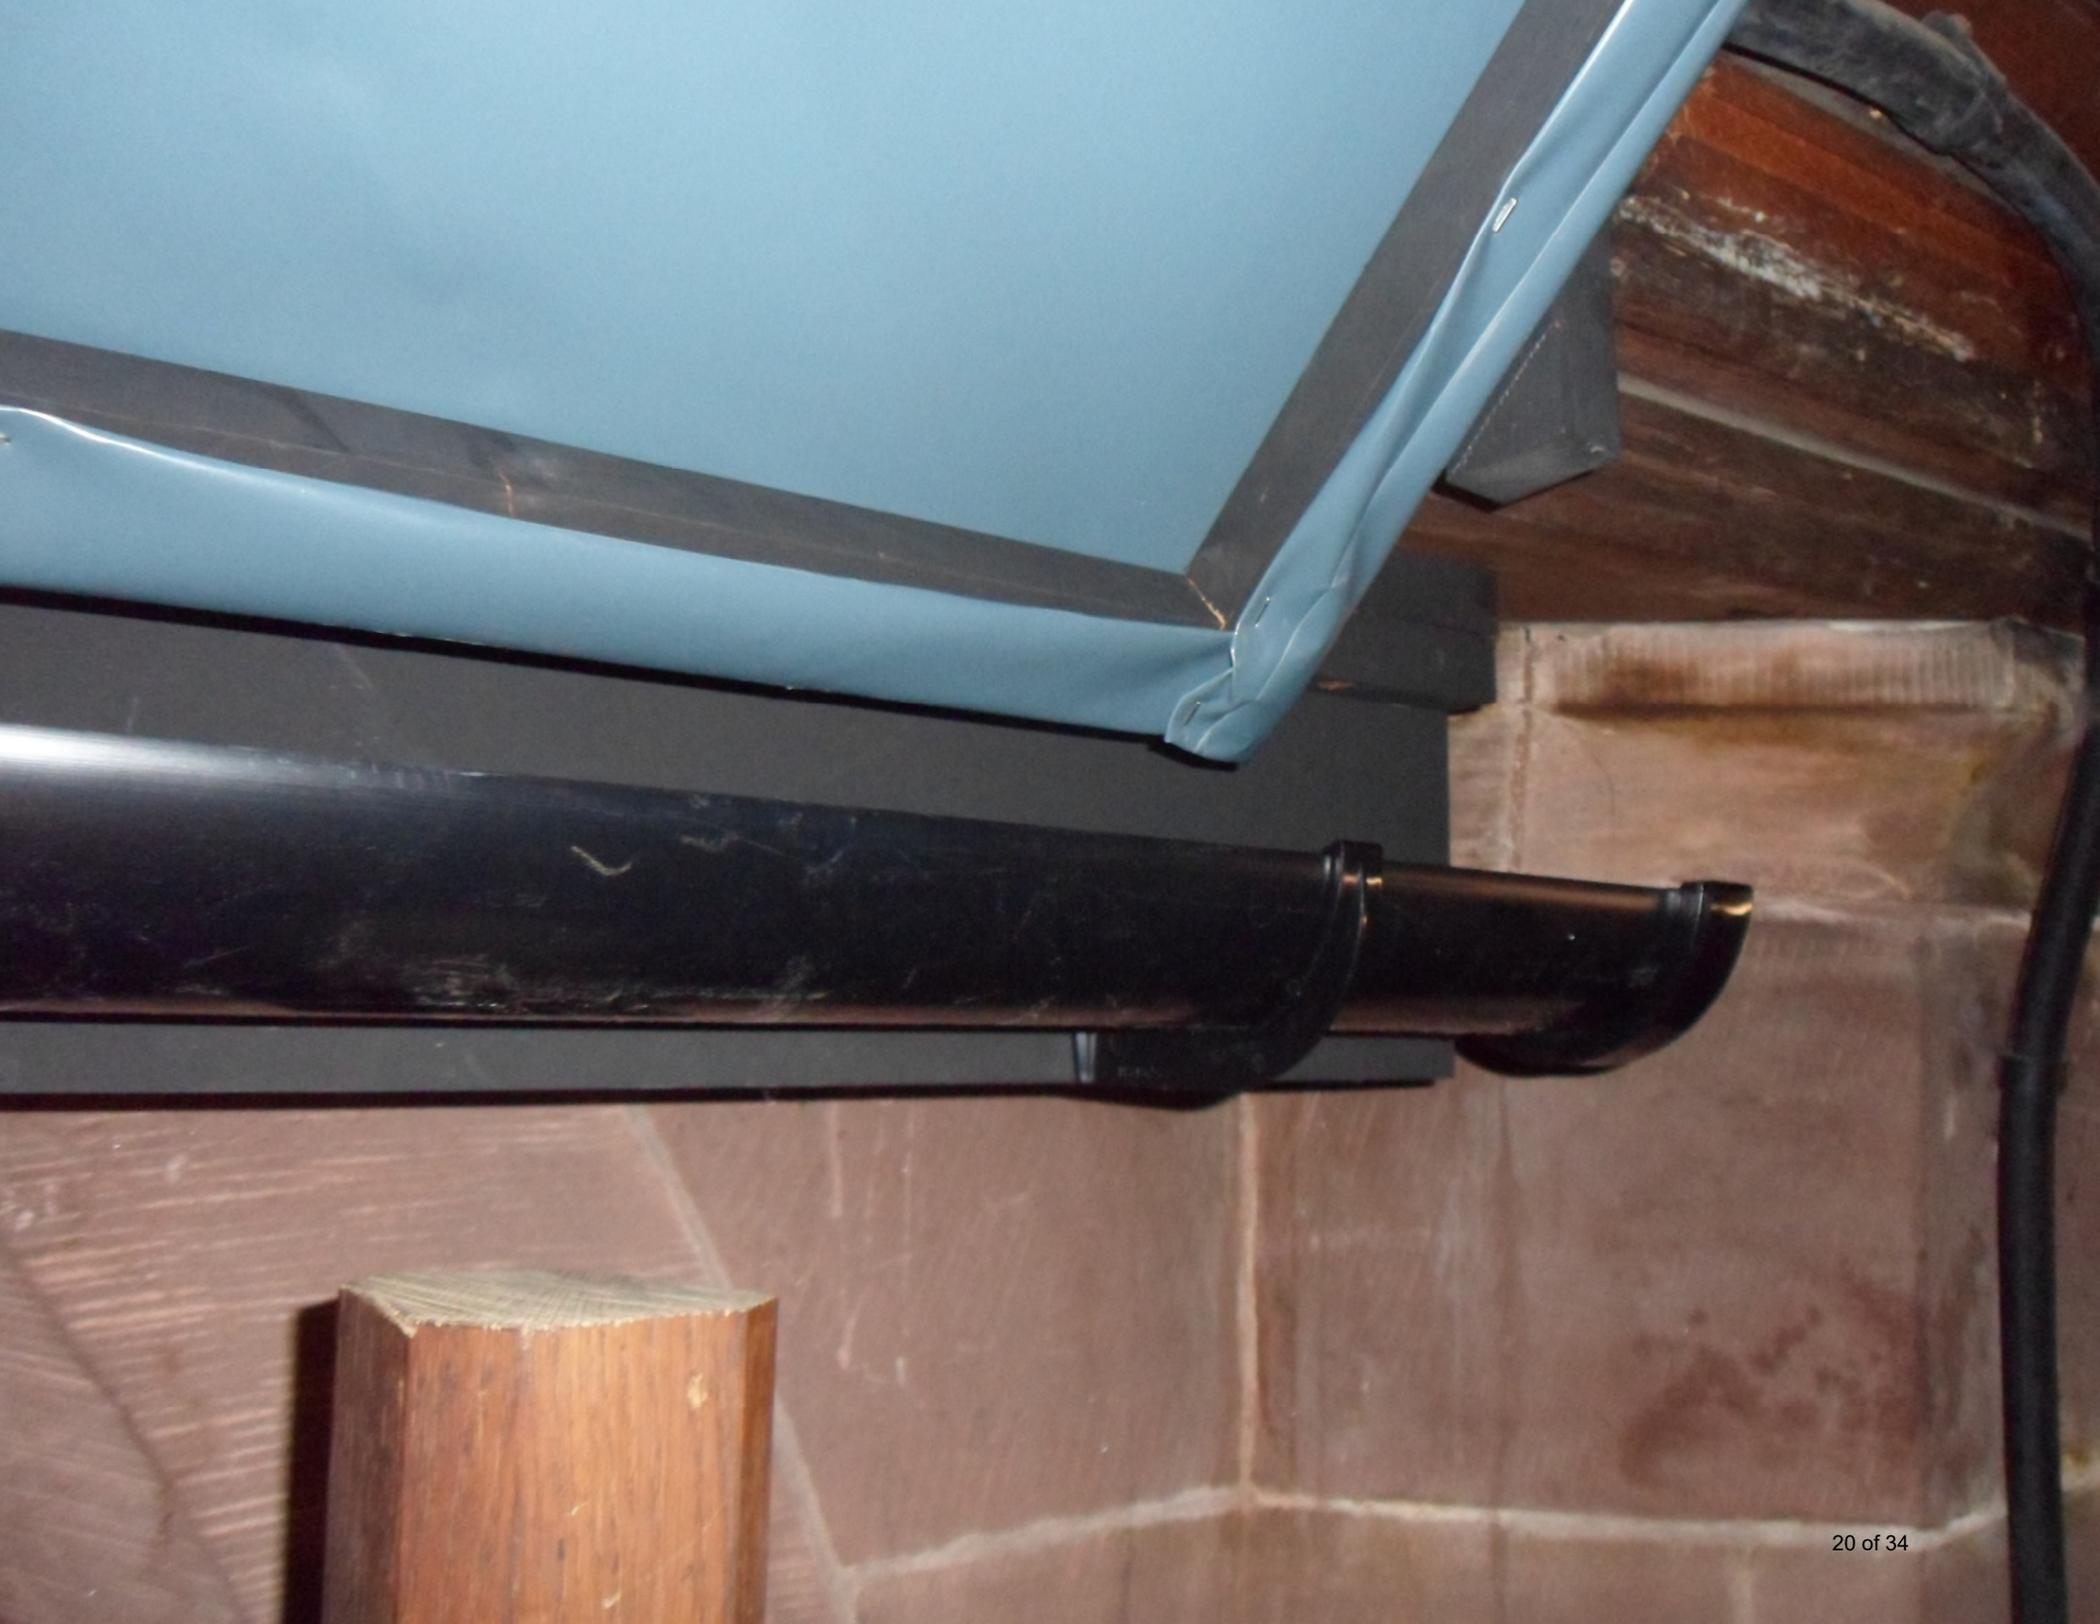
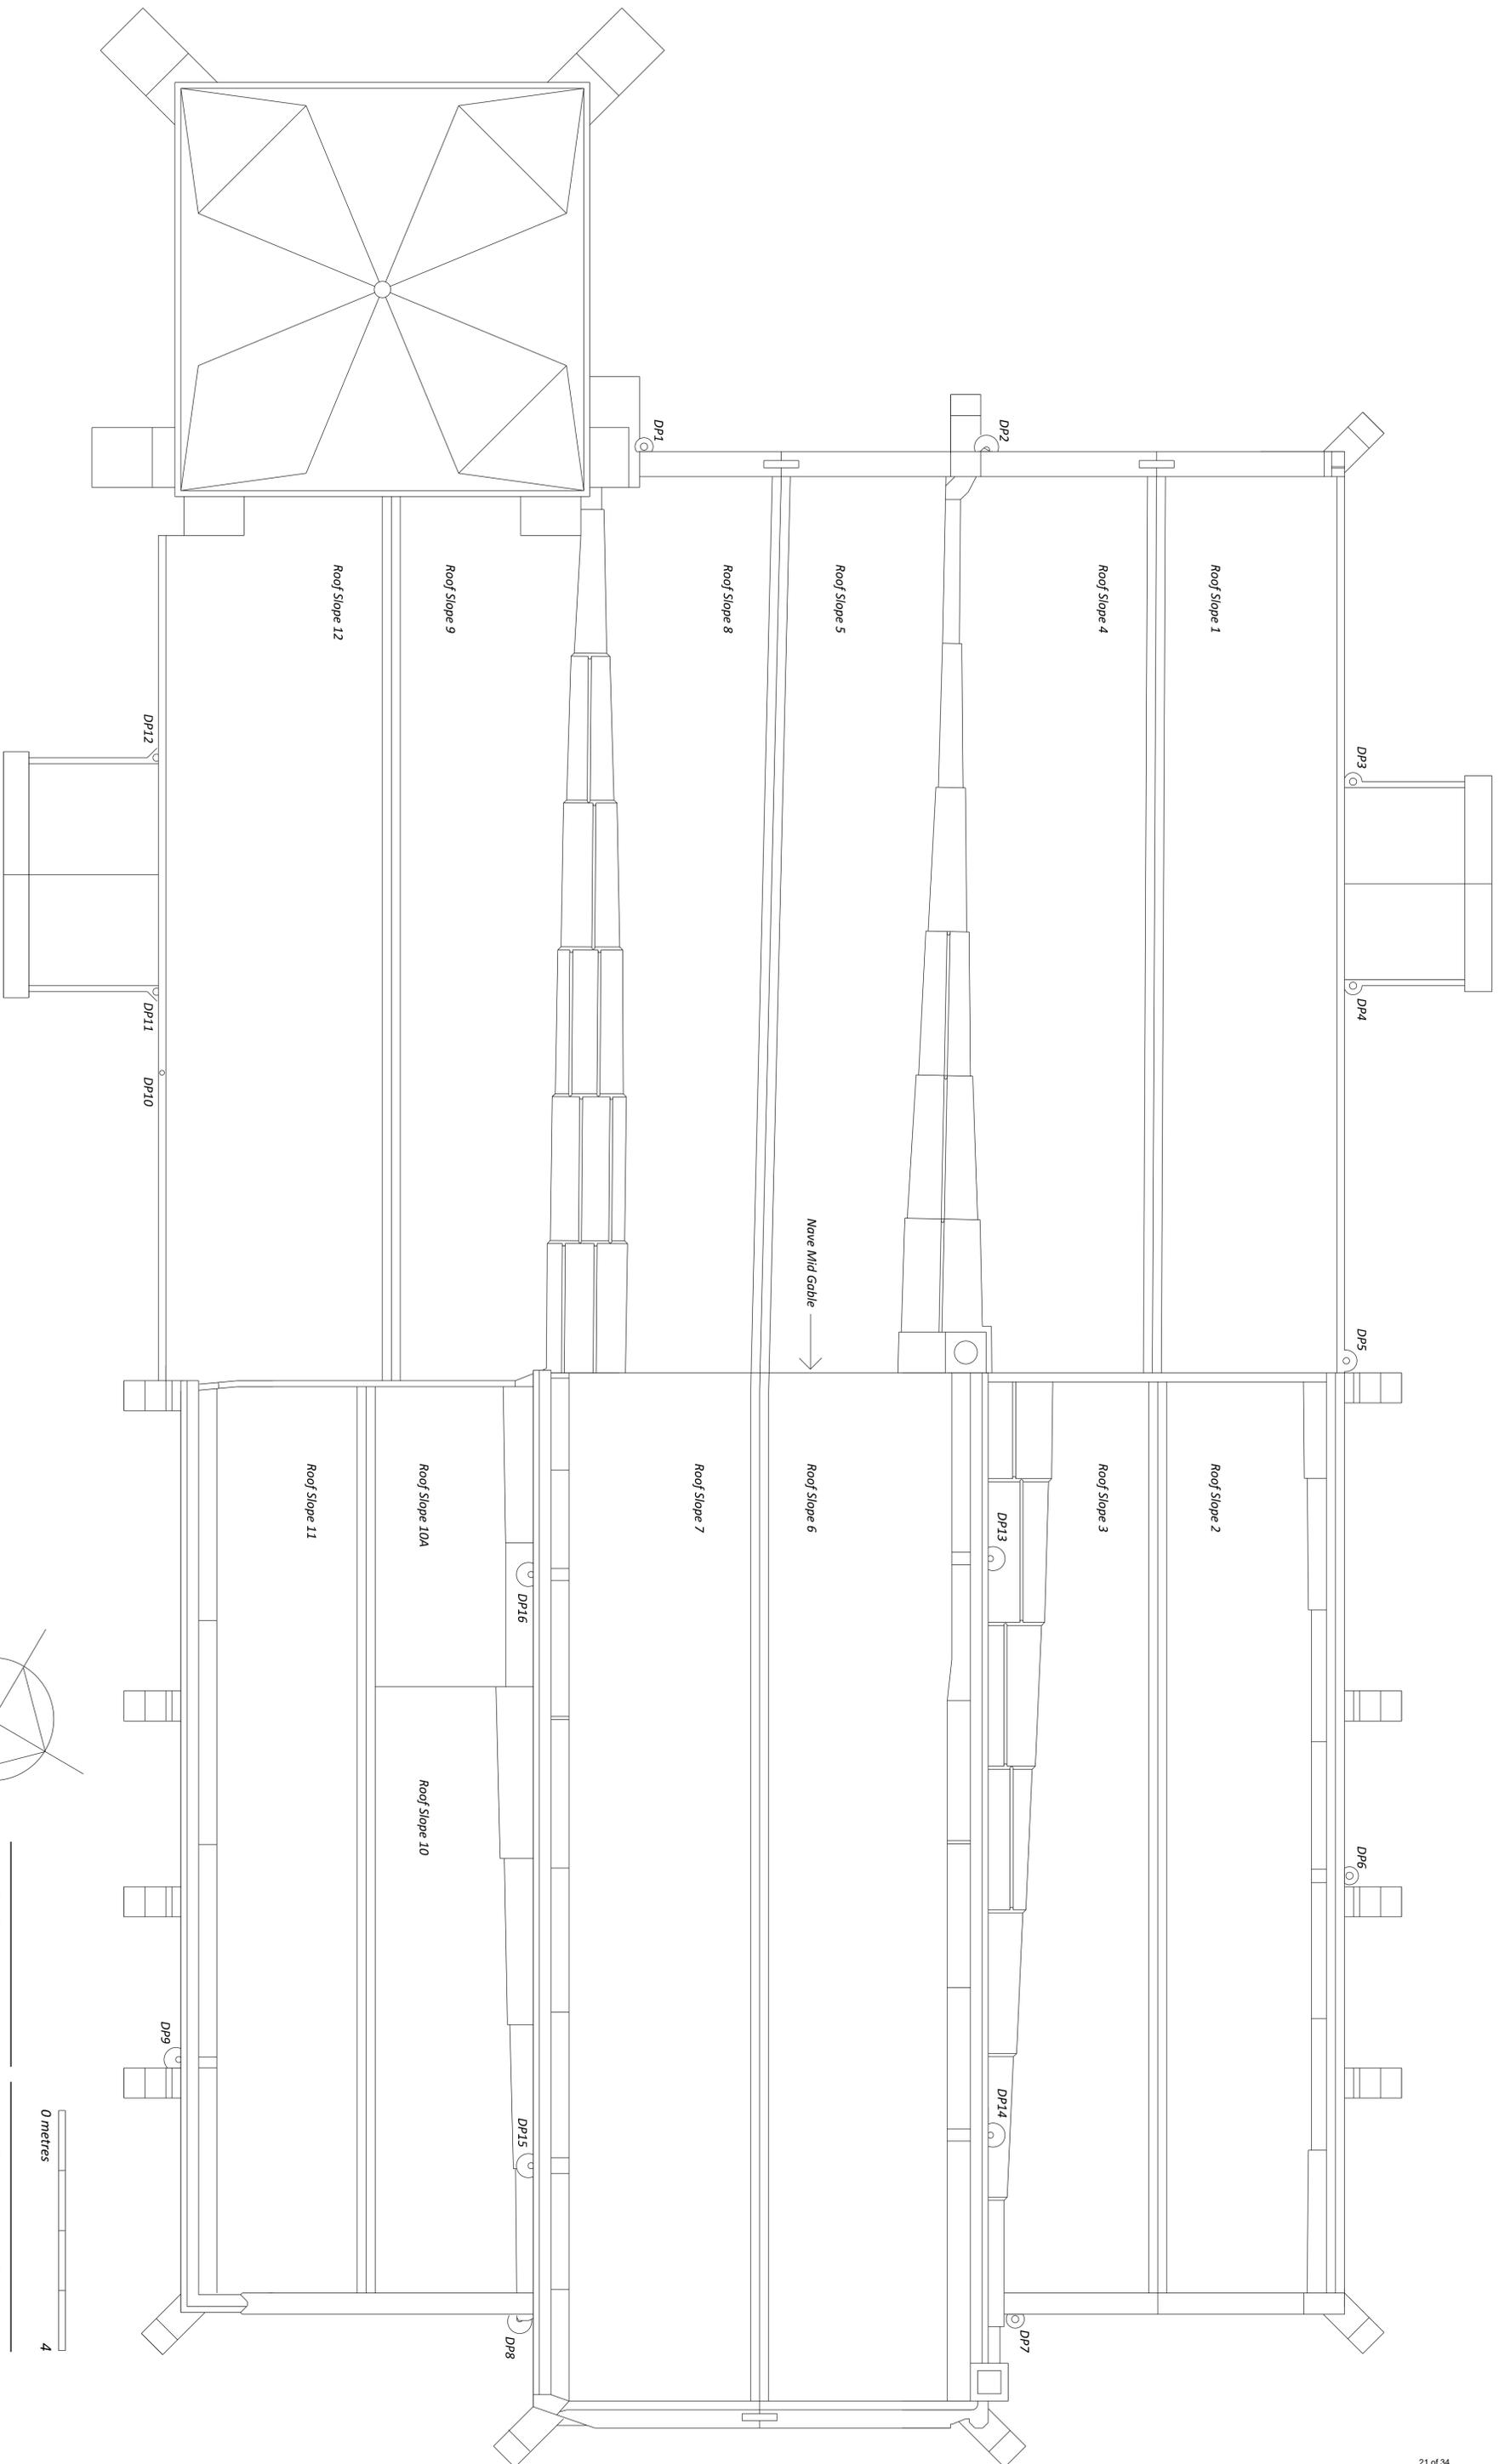
**Roof Plan
Survey**

Dwg No: 117/02/02	Scale: 1:50 @ A1	Bryan Martin, Architect 36 Bonbury Lane, Byfield, Northants, NN11 6UX tel: 01327 264358 Do not scale - check all dimensions on site
Drawn:	Date:

Our Architect advises that the roof (which underwent major repairs a few years ago) is in good order, and the valley gutters are constructed to modern standards, but they inherently carry the risk of leaks if there is a build-up of debris (we have them cleared twice a year), or in very heavy rain, hail or snow. Although it would be possible to redesign and reform the gutter using modern materials, this would be prohibitively expensive and might not eliminate the risk even then.

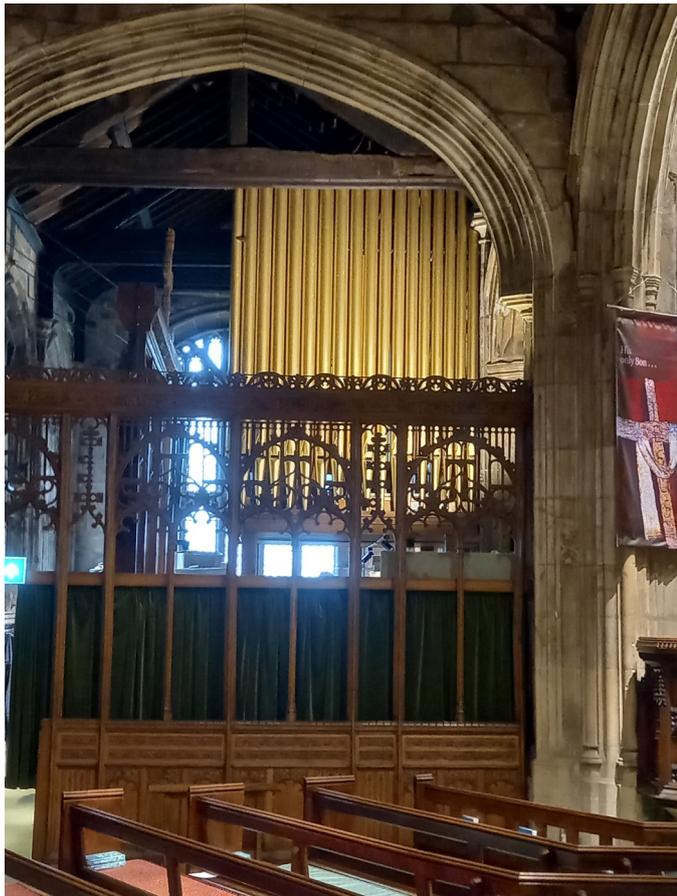
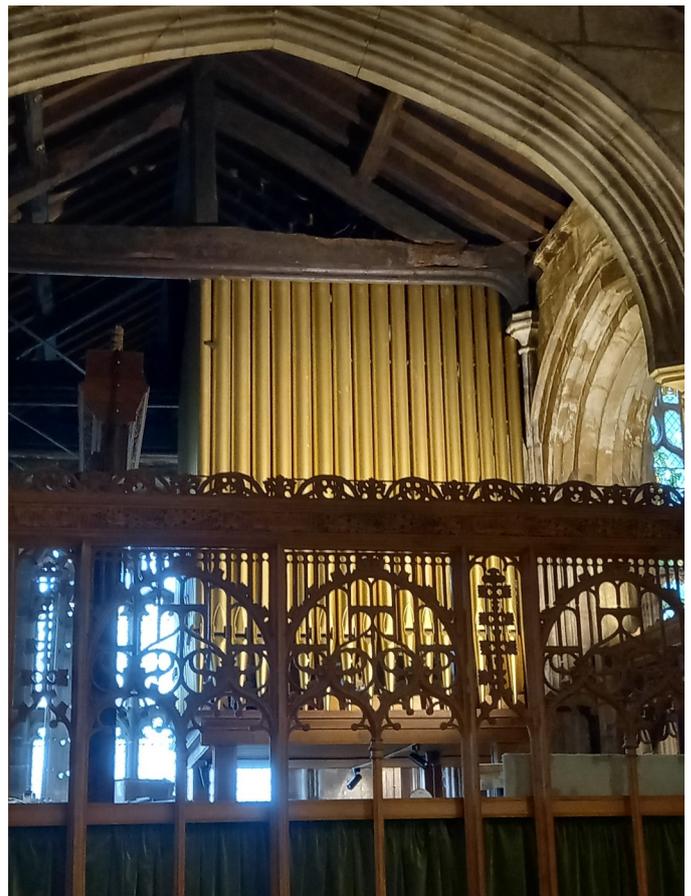
Organ chamber from the North Aisle. Canopy would sit inside the organ, behind the gold pipes. From the nave, it will not be visible at all.

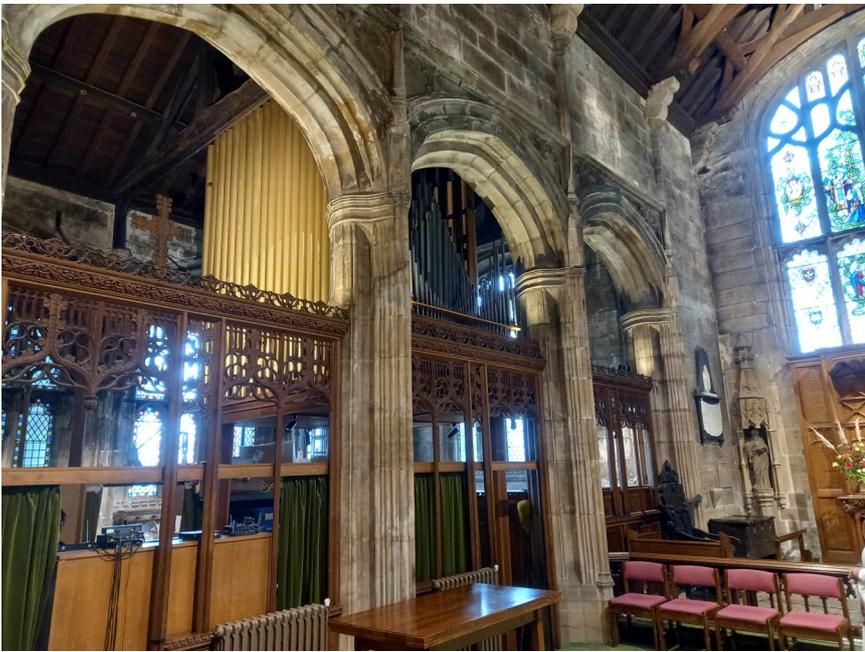
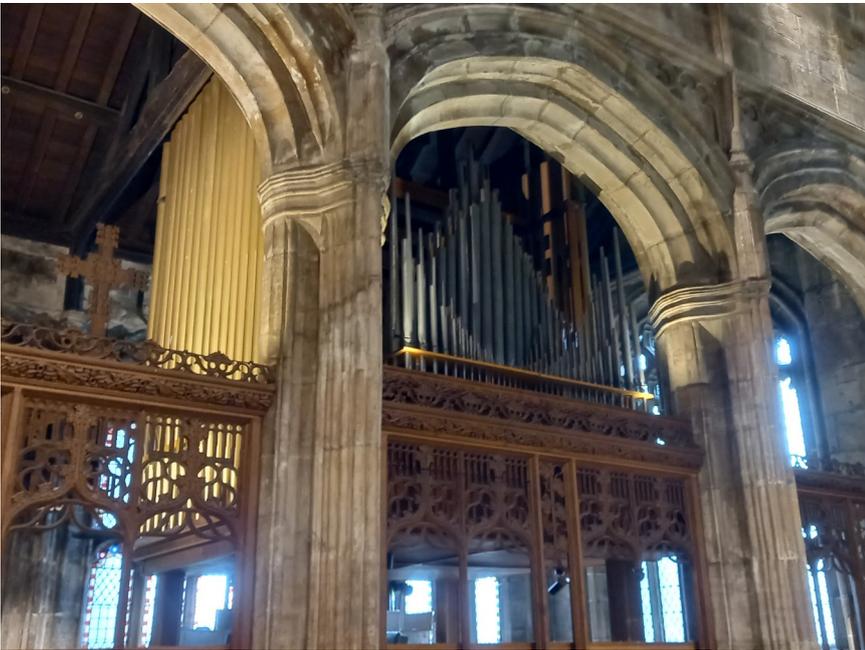
Organ chamber from the chancel. The canopy will run from the rear side of the wall, above the arch, and above the visible pipes. From this side, from the chancel (but not the nave), the underside of the timber canopy would be visible, but as it will be dark stained timber it would be unnoticeable.

The canopy will be lower than the gold side case pipes so will not be visible from a side view. When looking directly at the organ from the Chancel, you may be able to see the underside of the canopy as it will span the gap between the unexposed Great pipework and the Swell box.

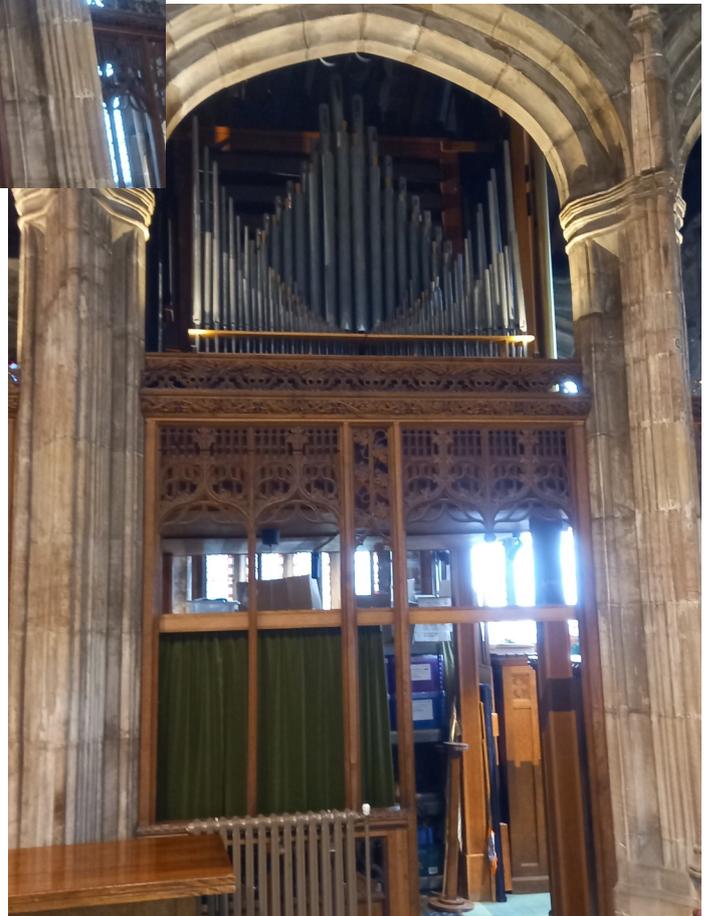
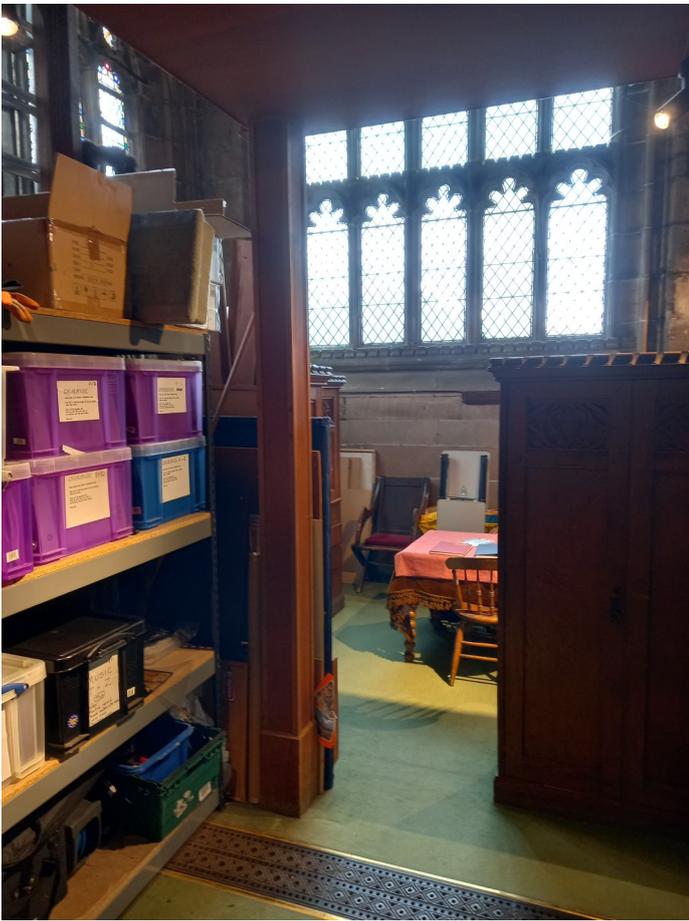
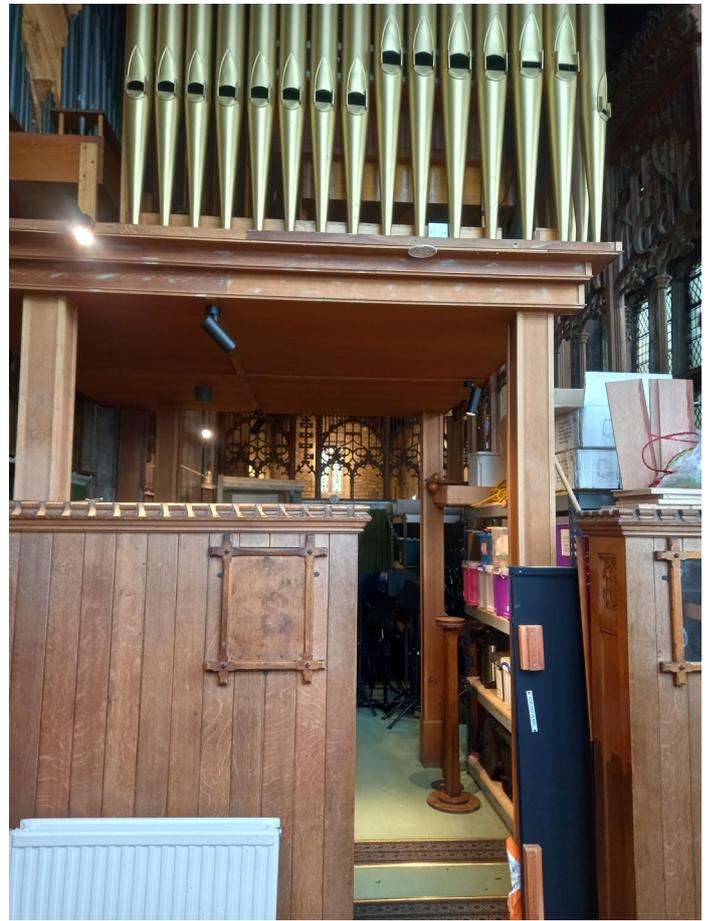
The vestry area, showing the organ and its supporting posts. The proposed drain would run down the rear of the north east post, on the left of the LH photo and the right of the RH photo, boxed in with timber so that it would not be noticeable, and would discharge into a container approximately the width of the post, at floor level.

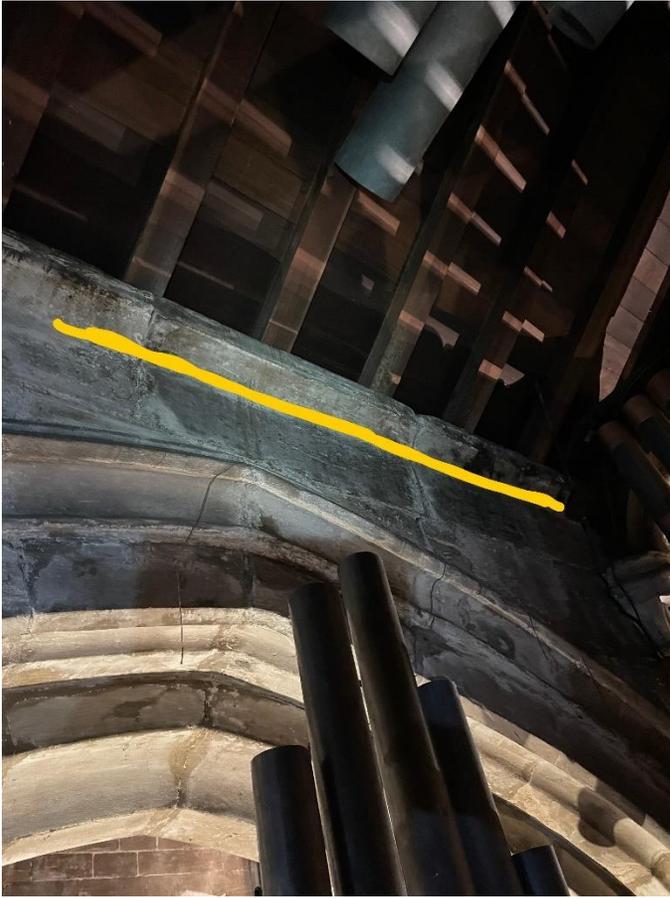
Canopy to butt up to this ledge and span the gap between the ledge and the Swell box, approx. 4'.

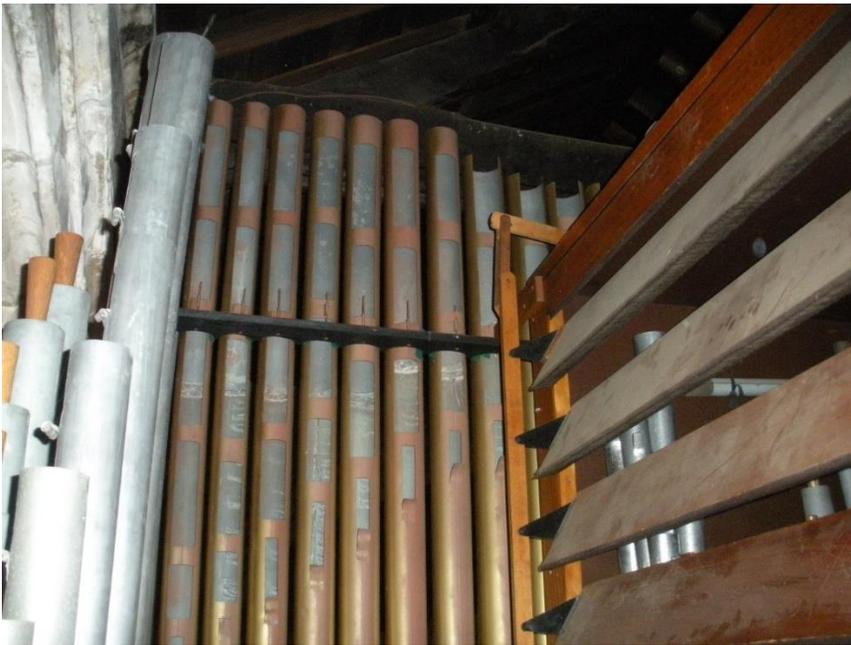
Canopy will not be visible from the side view as it will be below the level of the case pipes.

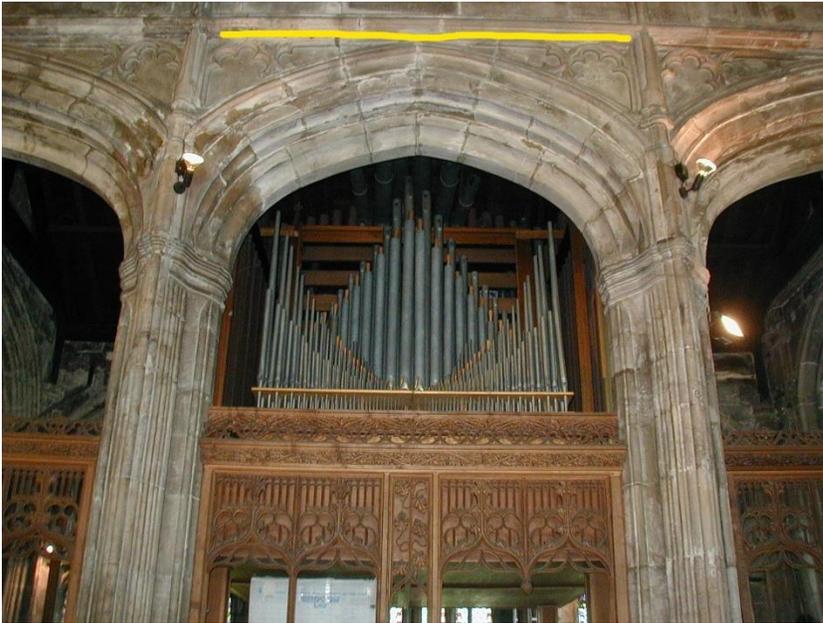
Canopy to sit against the inside of this arch at the level indicated, and angled down to above the swell box..

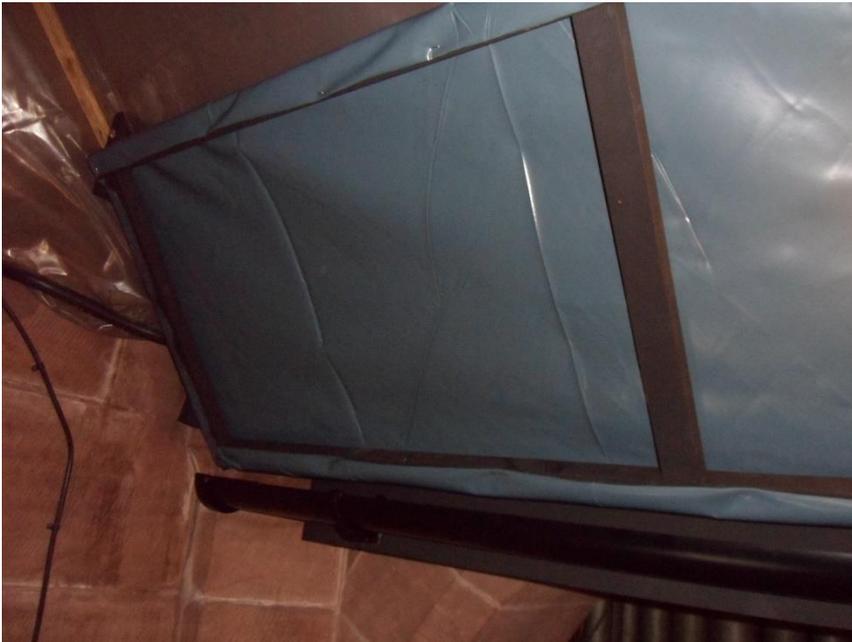
Canopy frame to be of similar construction to this installation, although polythene will not be visible.

between the organ and the roof soffit, and stained out, it would be pretty much imperceptible.
Attached is a photo of one they have done elsewhere – ours would **not** have blue polythene visible.
