# Christ Church Great Ayton

## Chancel Ceiling Restoration

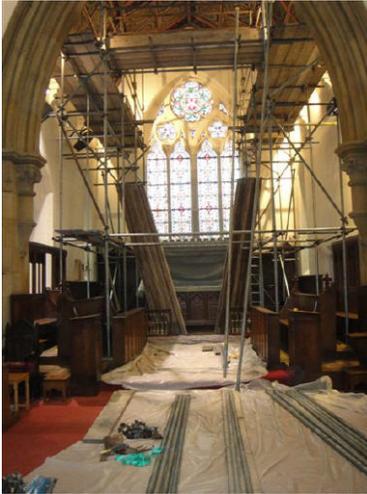
A two-tier scaffold was erected to ensure access to all areas of the ceiling. The cleaning of the panels began using a spirit-based solvent. Some of the panels had been made of a thin linen glued to a lath backing which had impregnated into the material. Most of the panels however were made of canvas and proved easier to clean. Seven panels on the north side were in need of major restoration. The worst of these (a) below had suffered severe damage and had to be carefully treated with several layers of a water-based acrylic filler (b). The canvas was then painted to match the dark grey of the original (c).

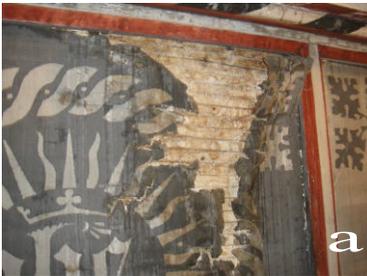
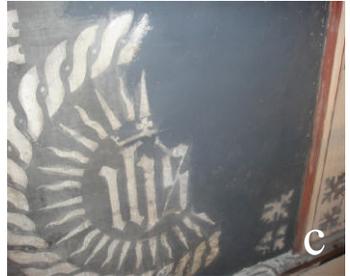
A stencil (d) was then prepared from an existing panel to enable the original pattern to be returned to the restored area. (e) shows the completed panel.

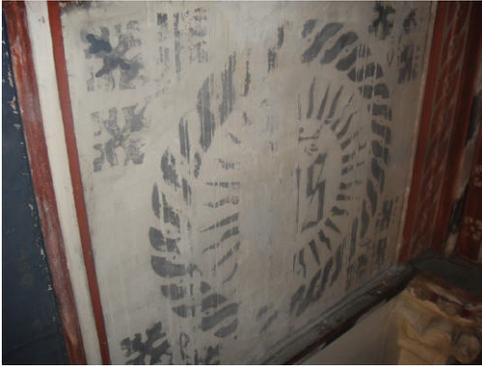
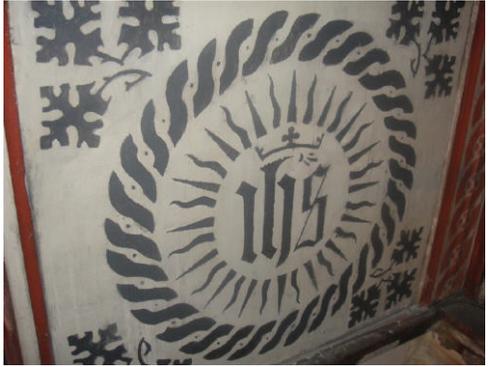
Another ceiling panel before.....and.....after restoration

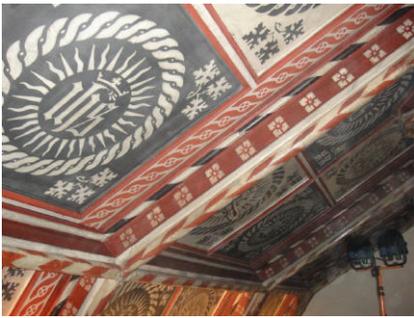
Finally two coats of resin-based varnish were applied to protect the ceiling for hopefully, at least another 100 years!! All under the watchful eye of the restorer, Francis Downing.

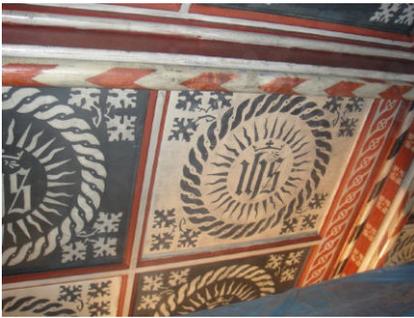
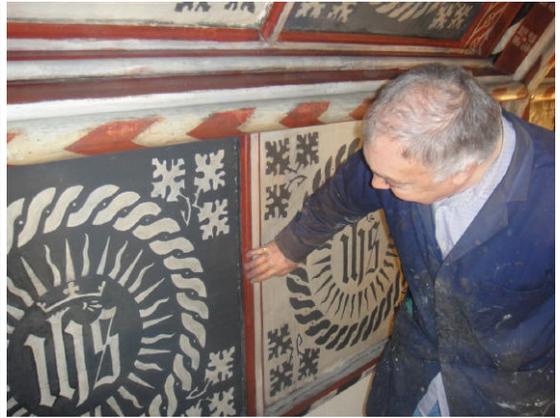
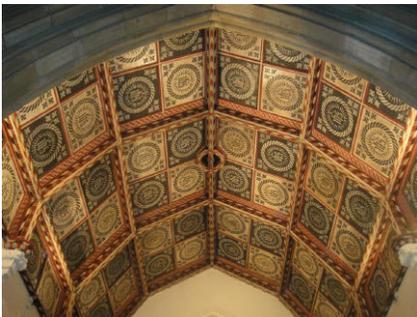
The end product - a fine new ceiling completed in time for Christmas!
